GIS REGISTRY

Hoida Lumber Property

SUBJECT: Final Case Closure with Continuing Obligations
Hoida Lumber Property, 1599 University Avenue, Green Bay, Wisconsin
WDNR BRRTS Activity #: 02-05-555515

Cap Maintenance Plan

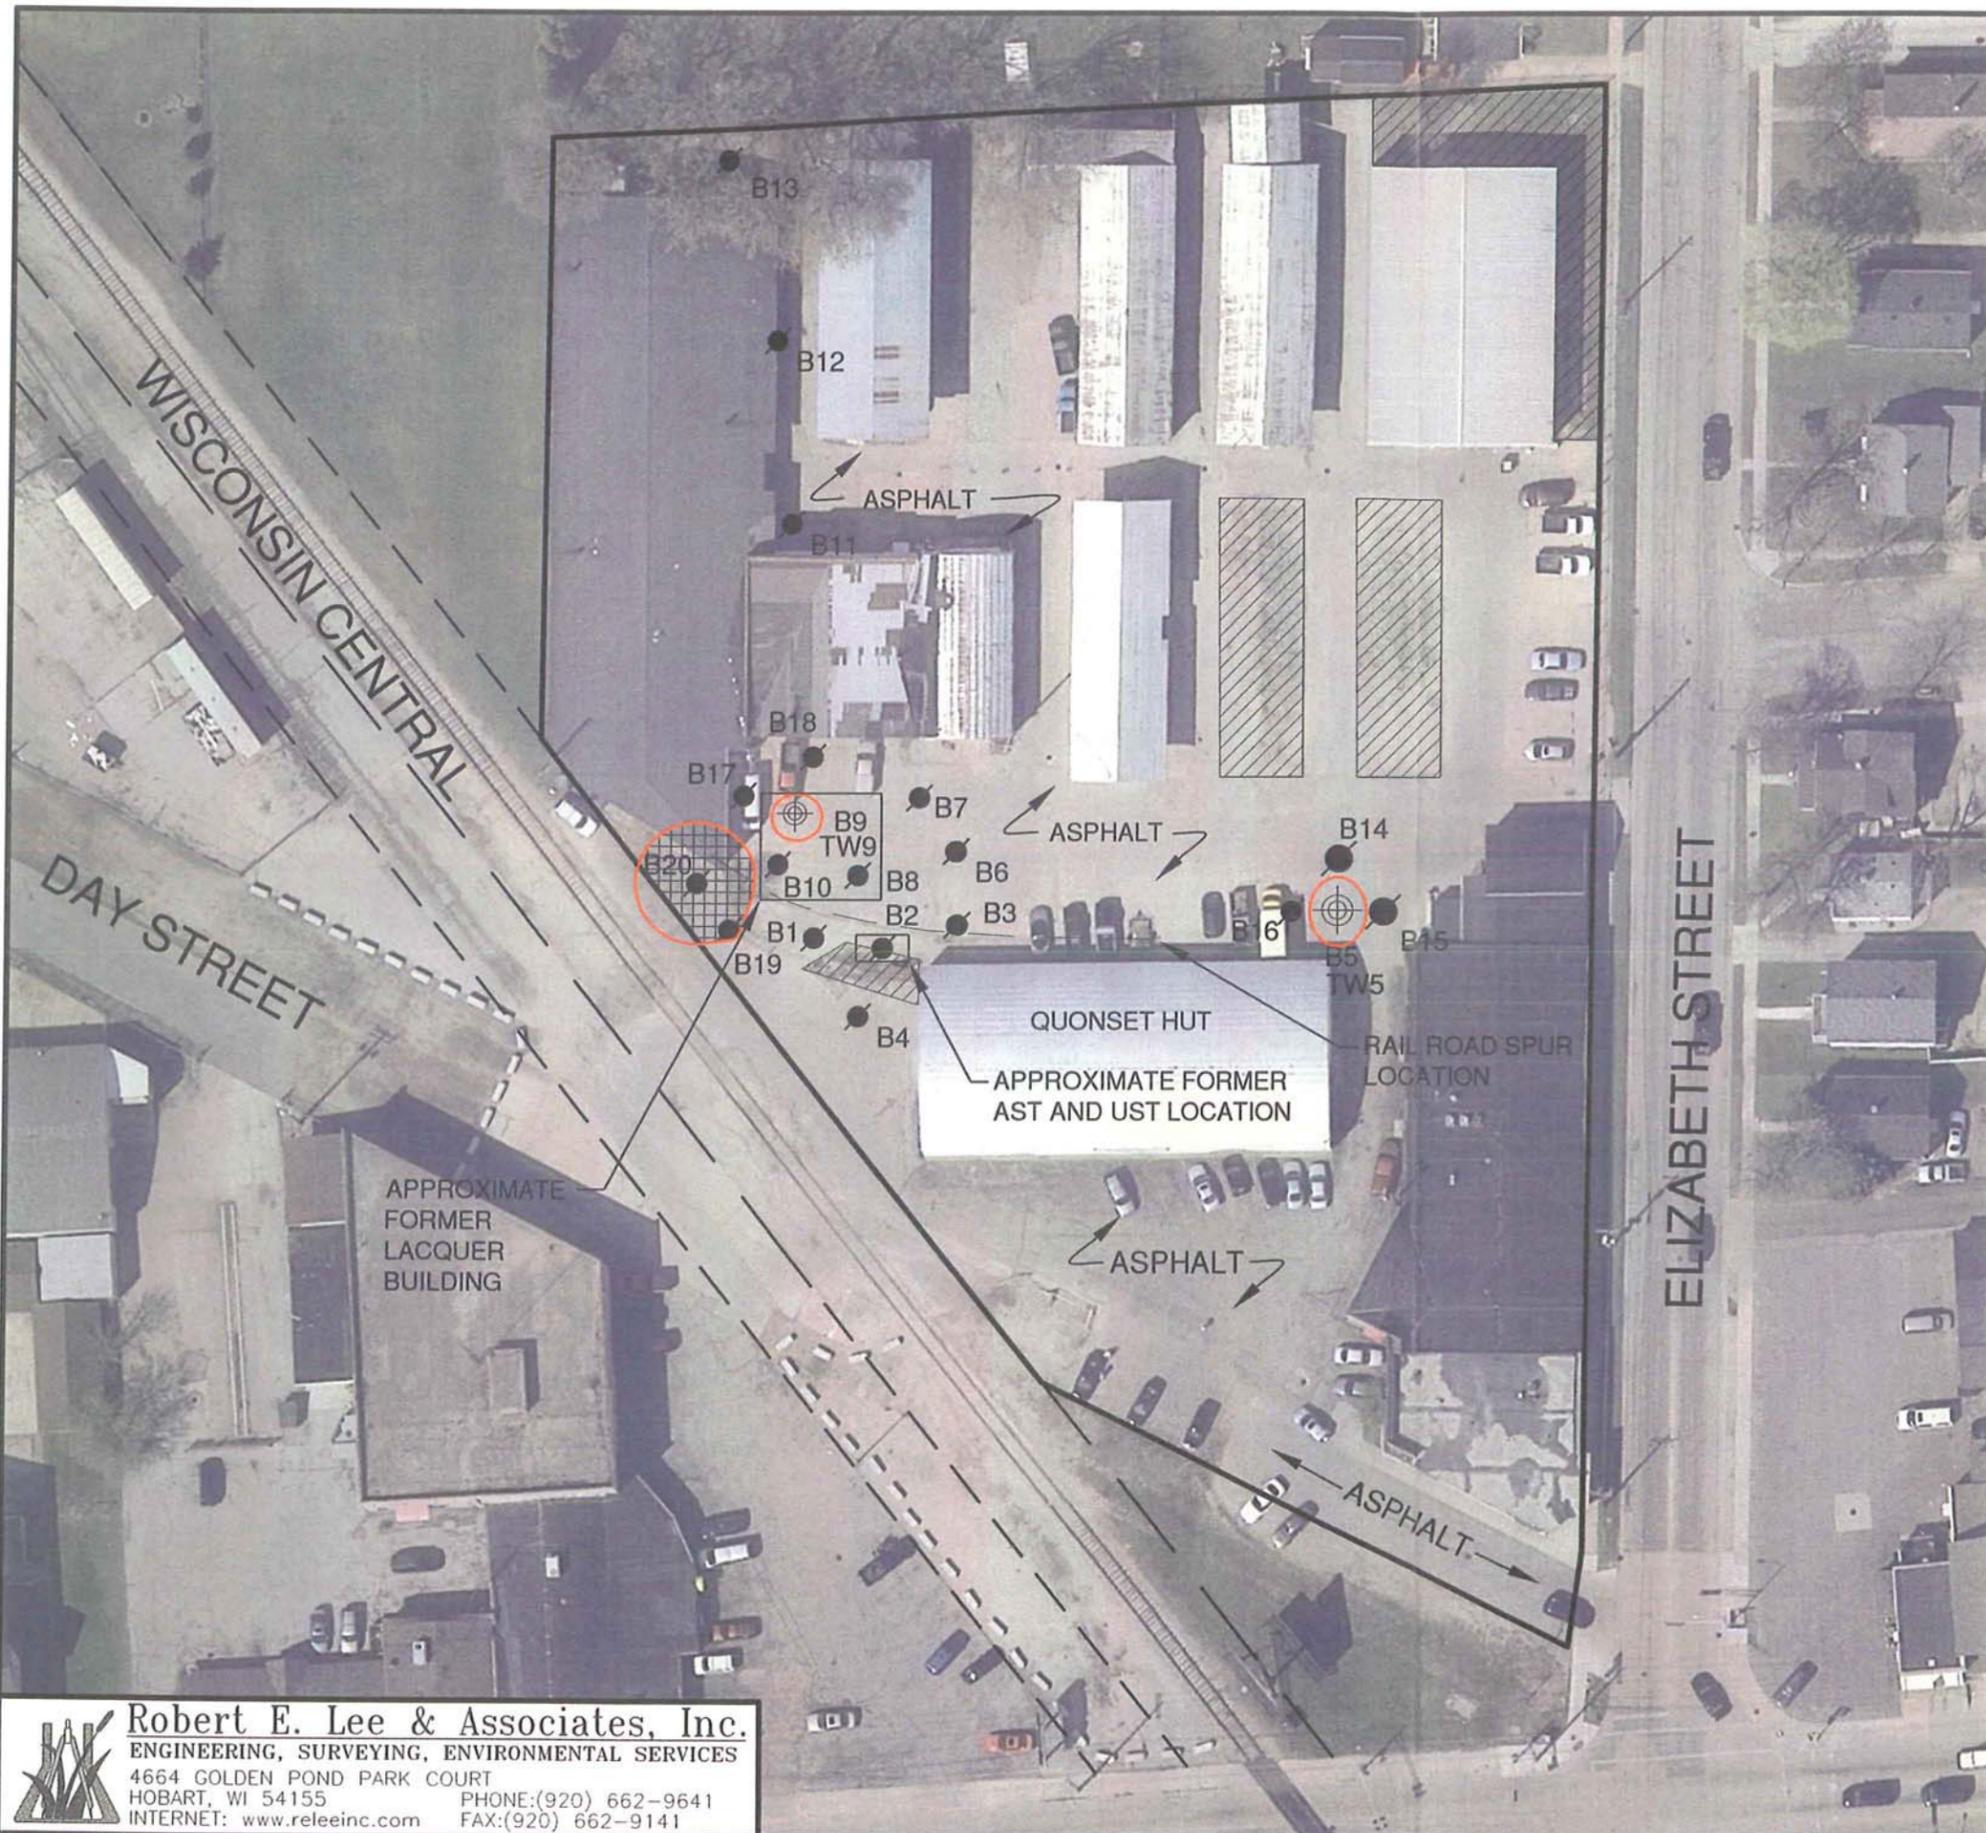
Soil contaminated by polycyclic aromatic hydrocarbons (PAHs) is located at a depth of approximately 0-4 feet at Boring B20. The extent of soil contamination is shown on Figure 1 of Exhibit A.

The cap consists of approximately 3 inches of the existing asphalt cover and a portion of the existing building. It is located at B20 as shown on Figure 1 of Exhibit A. The cap over the contaminated soil serves as a barrier to prevent direct human contact with residual soil contamination that might otherwise pose a threat to human health. The cap also acts as a partial infiltration barrier to minimize future soil-to-groundwater contamination migration that would violate the groundwater standards in ch. NR 140, Wisconsin Administrative Code. Based on the current and future use of the property, the cap should function as intended unless disturbed.

The cap overlying the contaminated soil, as depicted in Figure 1, will be inspected once a year, normally in the spring after all snow and ice is gone, for deterioration, erosion, and other potential problems that can cause additional infiltration into or exposure to underlying soils. The inspections will be performed by the property owner or their designated representative. The inspections will be performed to evaluate damage due to settling, exposure to the weather, wear from traffic, increasing age, and other factors. Any area where soils have become or are likely to become exposed and where infiltration from the surface will not be effectively minimized will be documented. A log of the inspections and any repairs will be maintained by the property owner and is included as Exhibit B, Cap Inspection Log. The log will include recommendations for necessary repair of any areas where underlying soils are exposed and where infiltration from the surface will not be effectively minimized. Once repairs are completed, they will be documented in the inspection log. A copy of the inspection log will be kept at the address of the property owner and available for submittal or inspection by the Wisconsin Department of Natural Resources (WDNR) representatives, upon their request.

The following activities are prohibited on any portion of the property where the cap is required as shown on Figure 1 of Exhibit A, unless prior written approval has been obtained from the WDNR: 1) removal of the existing barrier (i.e., asphalt cap, building); 2) replacement with another barrier; 3) excavating or grading of the land surface; 4) filling on capped or paved areas; 5) plowing or agricultural cultivation; or 6) construction or placement of a building or other structure.

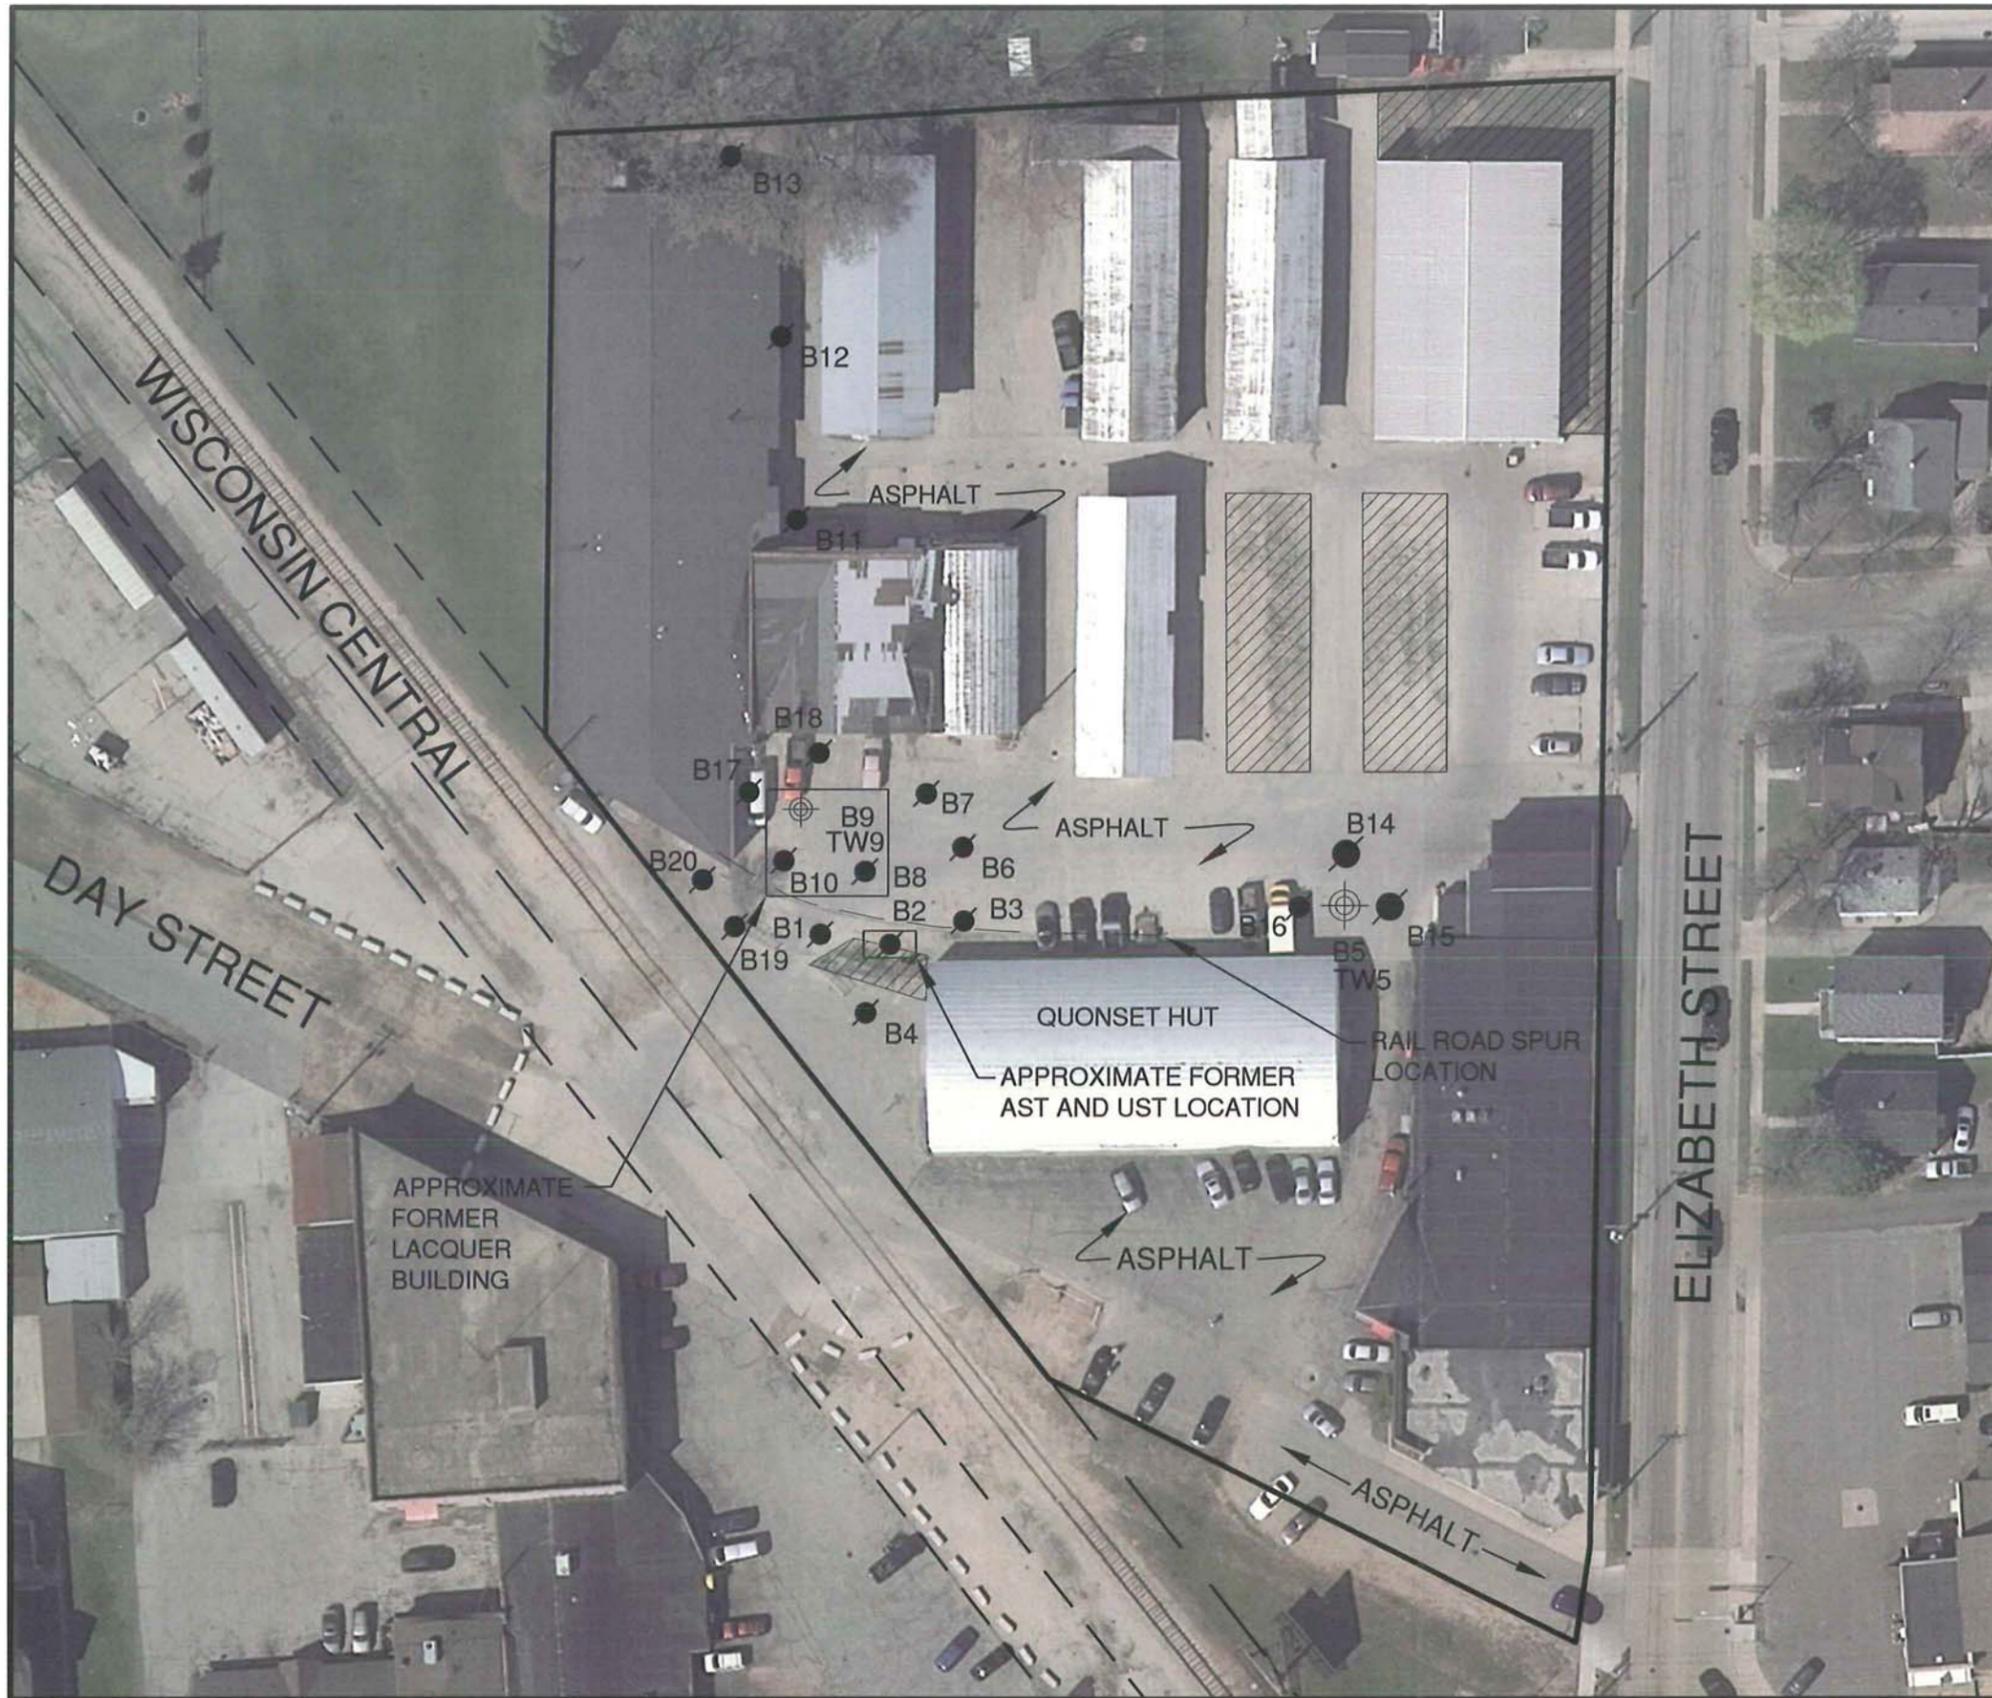
FIGURE 1

- Detailed Site Map:** A map that shows all relevant features (buildings, roads, individual property boundaries, contaminant sources, utility lines, monitoring wells and potable wells) within the contaminated area. This map is to show the location of all contaminated public streets, and highway and railroad rights-of-way in relation to the source property and in relation to the boundaries of groundwater contamination exceeding a ch. NR 140 Enforcement Standard (ES), and/or in relation to the boundaries of soil contamination exceeding a Residual Contaminant Level (RCL) or a Site Specific Residual Contaminant Levels (SSRCL) as determined under s. NR 720.09, 720.11 and 720.19.
Figure #: 1 **Title: Ground Surface Cover**

Pursuant to s. 292.12(2)(a), Wis. Stats., the asphalt pavement or other impervious cap that currently exists in the location shown on the attached map shall be maintained in compliance with the attached maintenance plan in order to minimize the infiltration of water and prevent additional groundwater contamination that would violate the groundwater quality standards in ch. NR 140, Wis. Adm. Code, and to prevent direct contact with residual soil contamination that might otherwise pose a threat to human health.

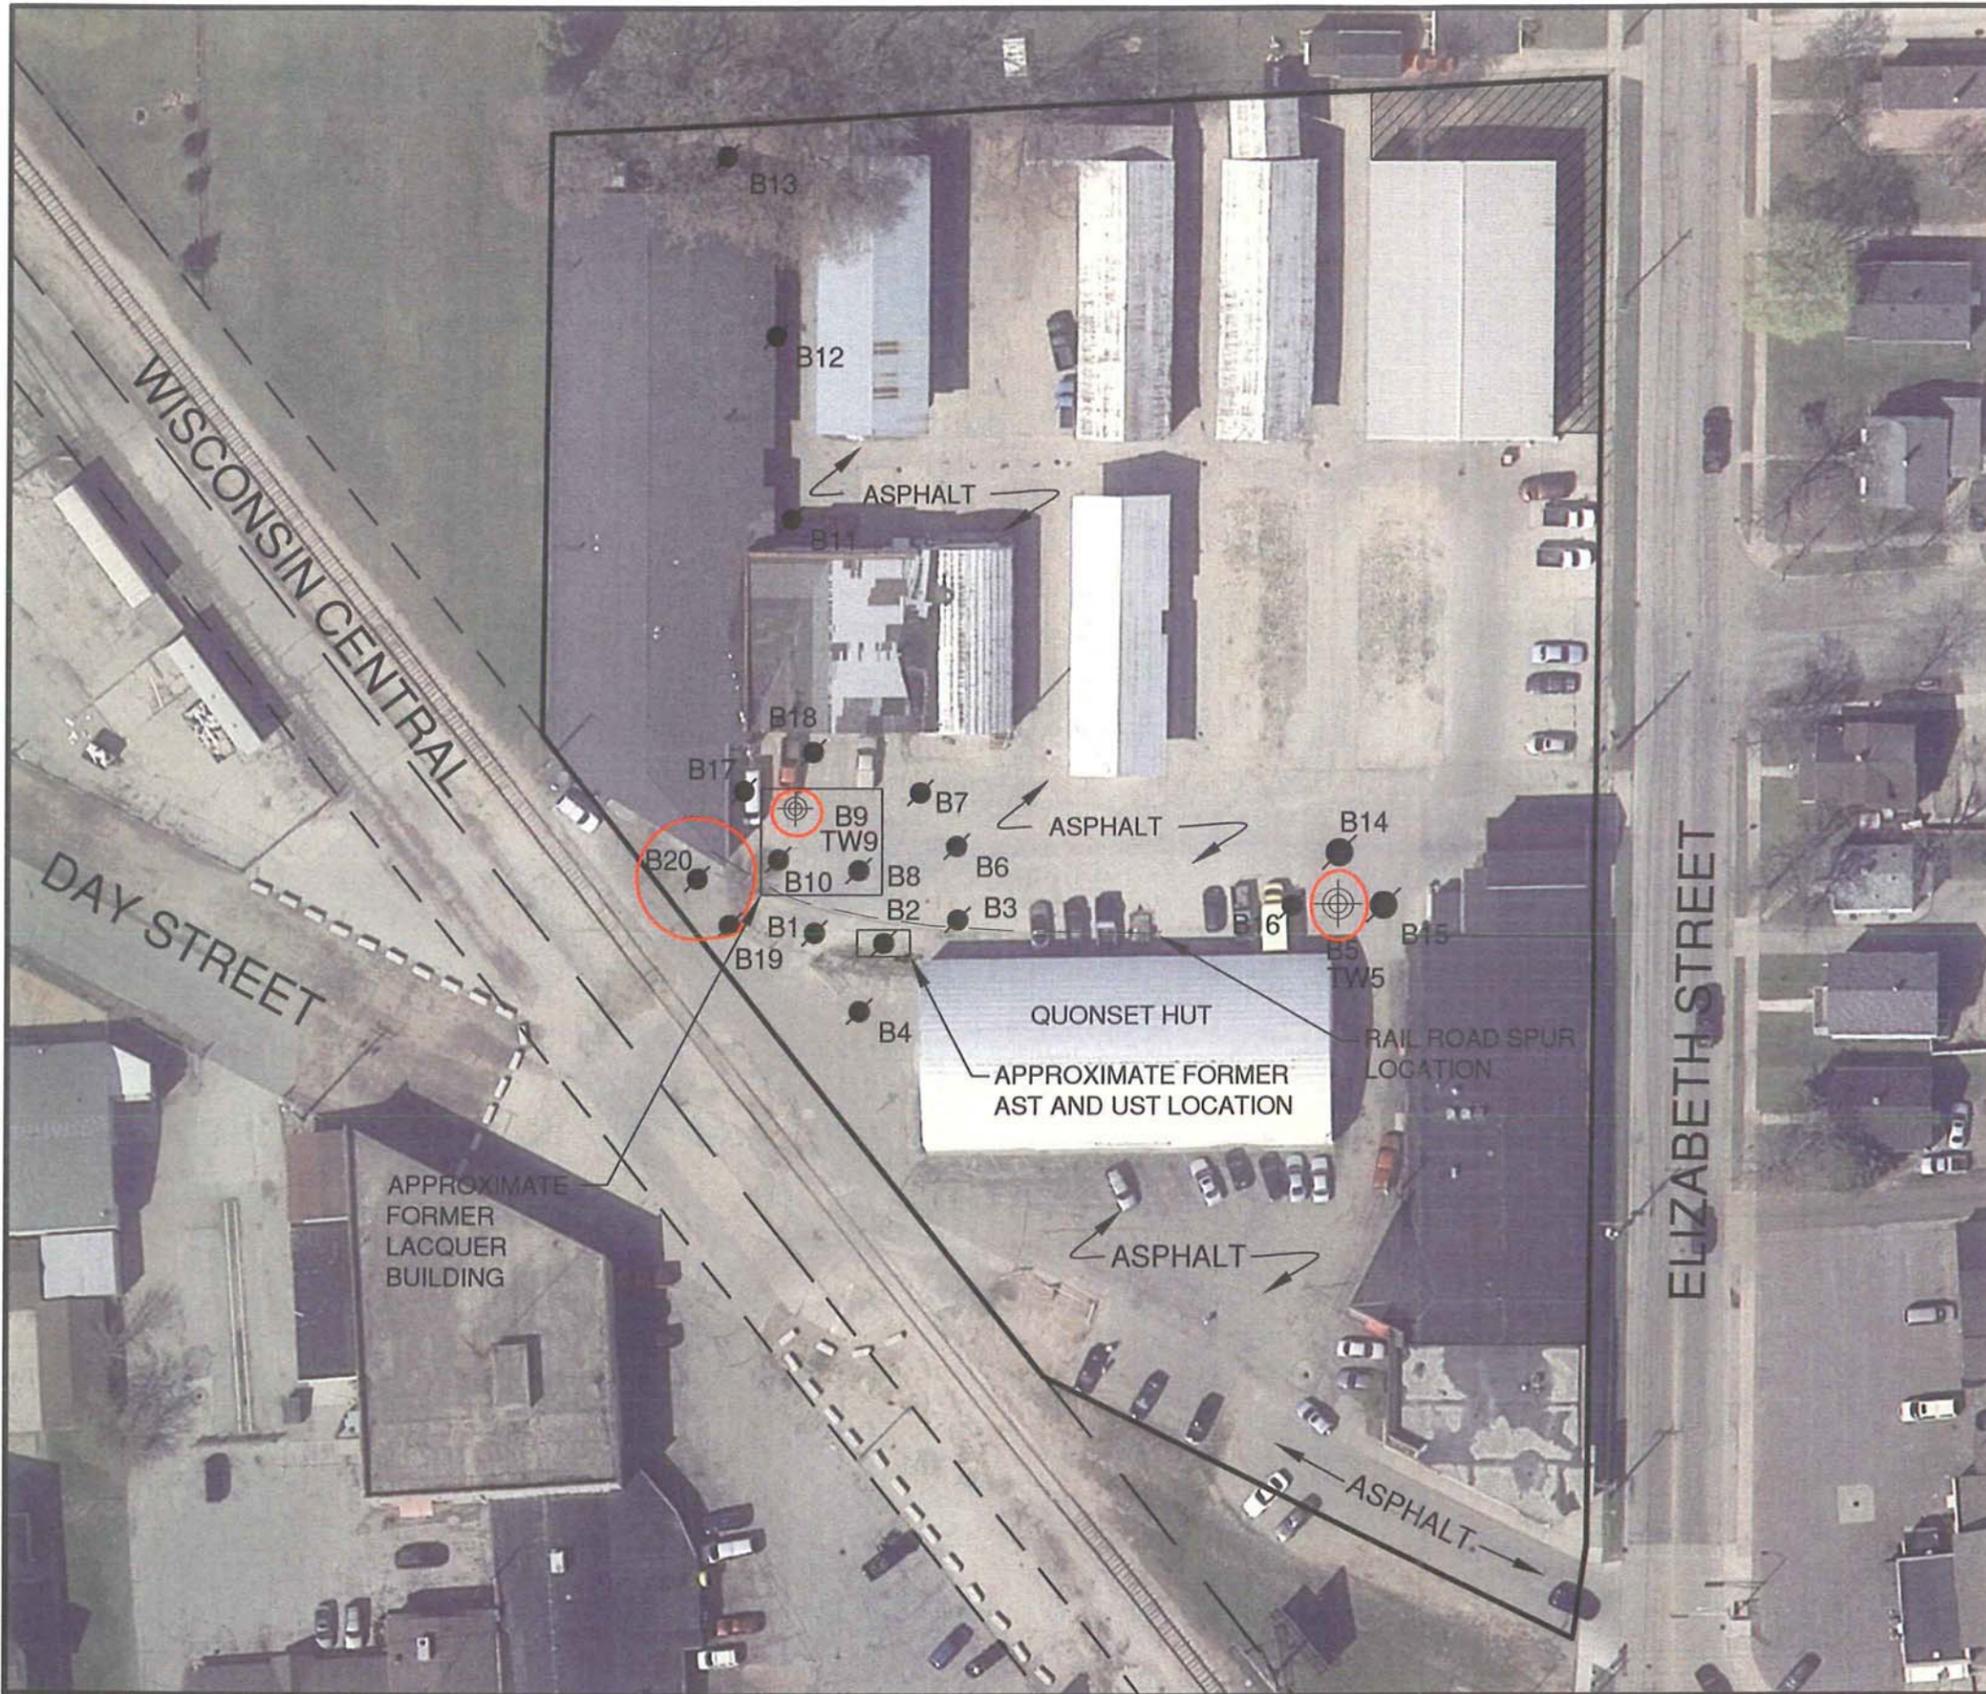
FIGURE 3

- Soil Contamination Contour Map:** For sites closing with residual soil contamination, this map is to show the location of all contaminated soil and a single contour showing the horizontal extent of each area of contiguous residual soil contamination that exceeds a Residual Contaminant Level (RCL) or a Site Specific Residual Contaminant Level (SSRCL) as determined under s. NR 720.09, 720.11 and 720.19.
Figure #: 3 **Title: Extent of Soil Contamination**

Soil contamination remains at soil boring B20 as shown on the attached map and in the information submitted to the Department of Natural Resources. If soil in the specific locations shown on the attached map is excavated in the future, the property owner at the time of excavation must sample and analyze the excavated soil to determine if residual contamination remains. If sampling confirms that contamination is present the property owner at the time of excavation will need to determine whether the material is considered solid or hazardous waste and ensure that any storage, treatment or disposal is in compliance with applicable statutes and rules. In addition, all current and future owners and occupants of the property need to be aware that excavation of the contaminated soil may pose an inhalation or other direct contact hazard and as a result special precautions may need to be taken during excavation activities to prevent a health threat to humans.

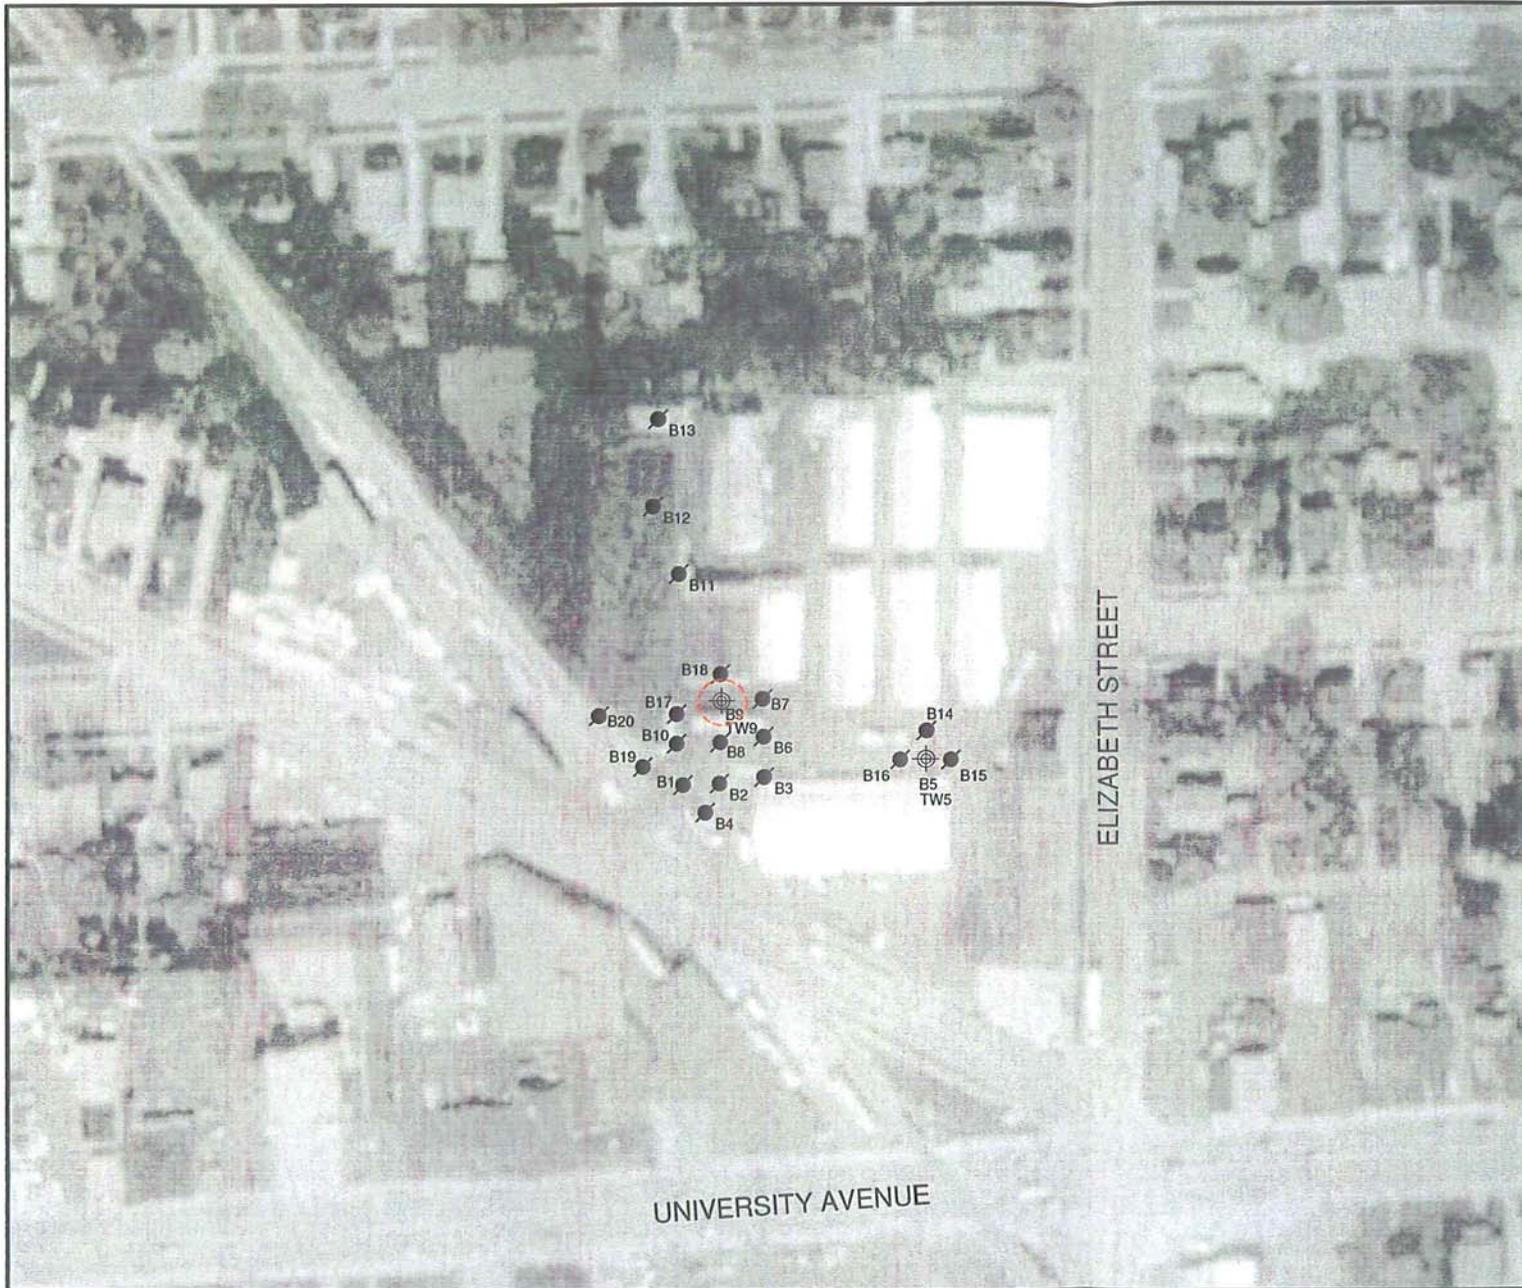
Figure #: 4 **Title: Extent of Groundwater Contamination**

Recent groundwater monitoring data at this site indicates that tetrachloroethylene and benzene contaminant levels at TW9 exceed the NR 140 preventive action limits (PAL) but are below the enforcement standards (ES). The Department may grant an exemption to a PAL for a substance of public health concern, other than nitrate, pursuant to s. NR 140.28(2)(b), Wis. Adm. Code, if all of the following criteria are met:
