# GIS REGISTRY

ACTIVITY NAME: Sturgeon Bay Utilities

PROPERTY ADDRESS: 230 E Vine St

Cap Maintenance Plan Map

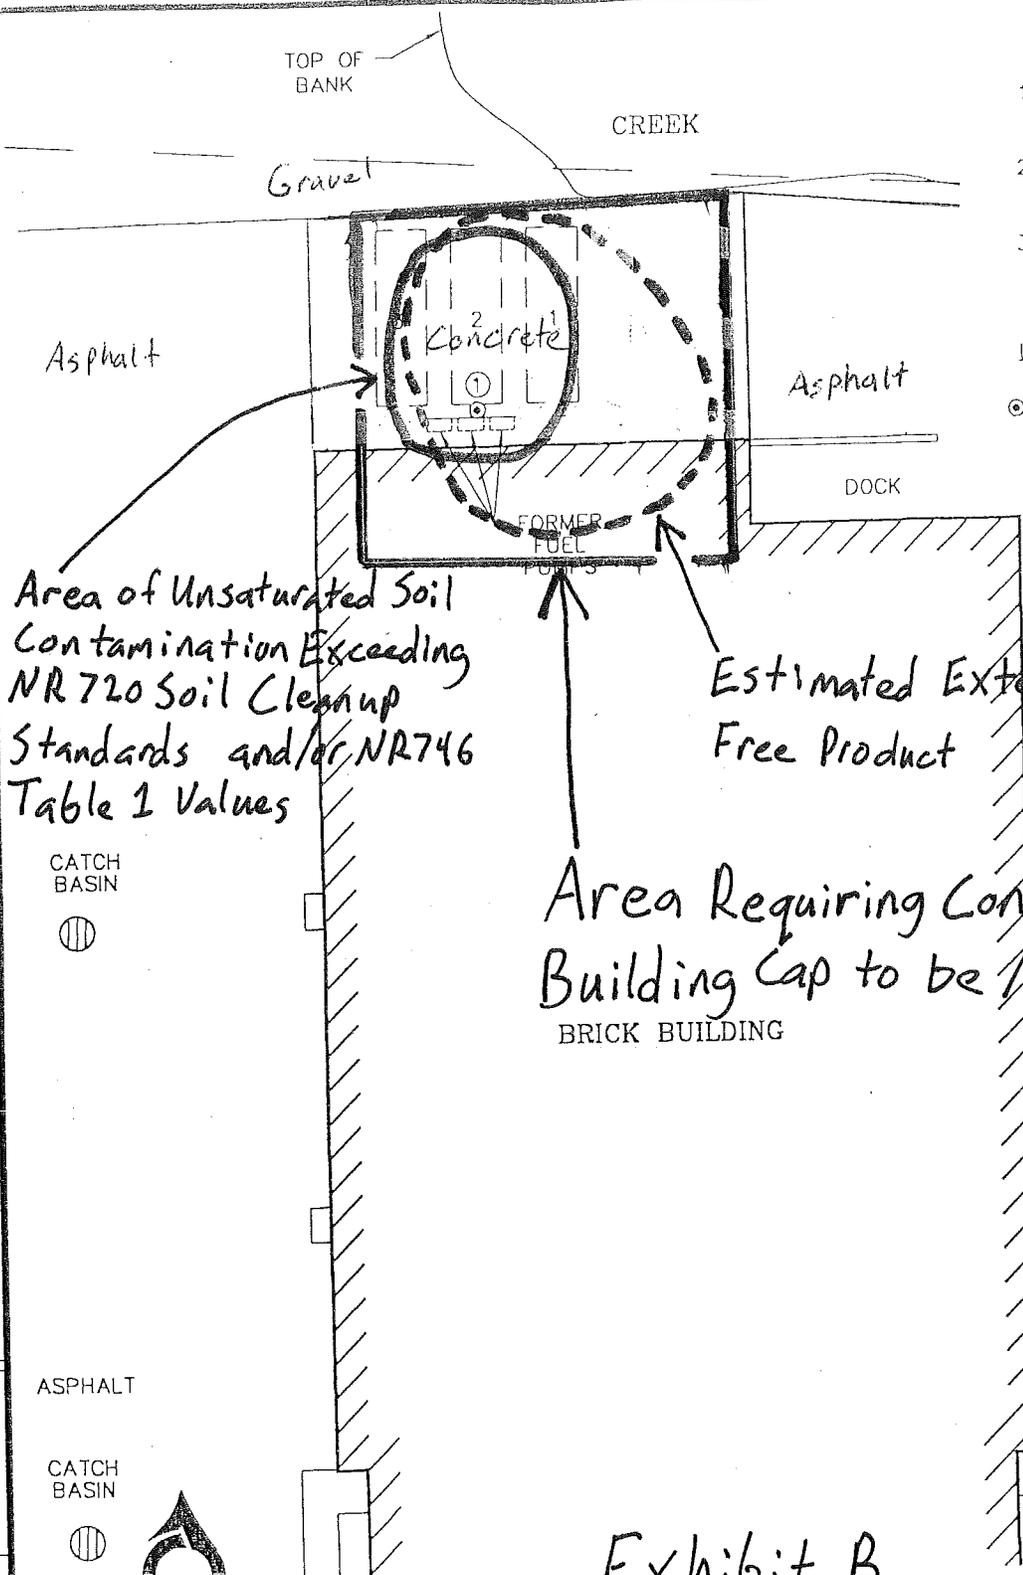
**Exhibit B**

Area of Unsaturated Soil Contamination Exceeding NR720 Soil Cleanup Standards and/or NR746 Table 1 Values

Area Requiring Concrete and Building Cap to be Maintained

The surface to be maintained consists of a 4-6 inch thick concrete pad located on the north side of Sturgeon Bay Utilities building along with the building itself, which has a slab on-grade foundation, as shown on the attached Cap Maintenance Plan Map (Exhibit B).

The concrete surface and building overlying the contaminated soil and as depicted in Exhibit B will be inspected once a year, normally in the spring after all snow and ice is gone, for deterioration, cracks and other potential problems that can cause exposure to underlying soils. The inspections will be performed by the property owner or their designated representative. The inspections will be performed to evaluate damage due to settling, exposure to the weather, wear from traffic, increasing age and other factors. Any area where soils have become or are likely to become exposed will be documented. A log of the inspections and any repairs will be maintained by the property owner and is included as Exhibit C, Cap Inspection Log. The log will include recommendations for necessary repair of any areas where underlying soils are exposed. Once repairs are completed, they will be documented in the inspection log. A copy of the inspection log will be kept at the address of the property owner and available for submittal or inspection by Wisconsin Department of Natural Resources ("WDNR") representatives upon their request.

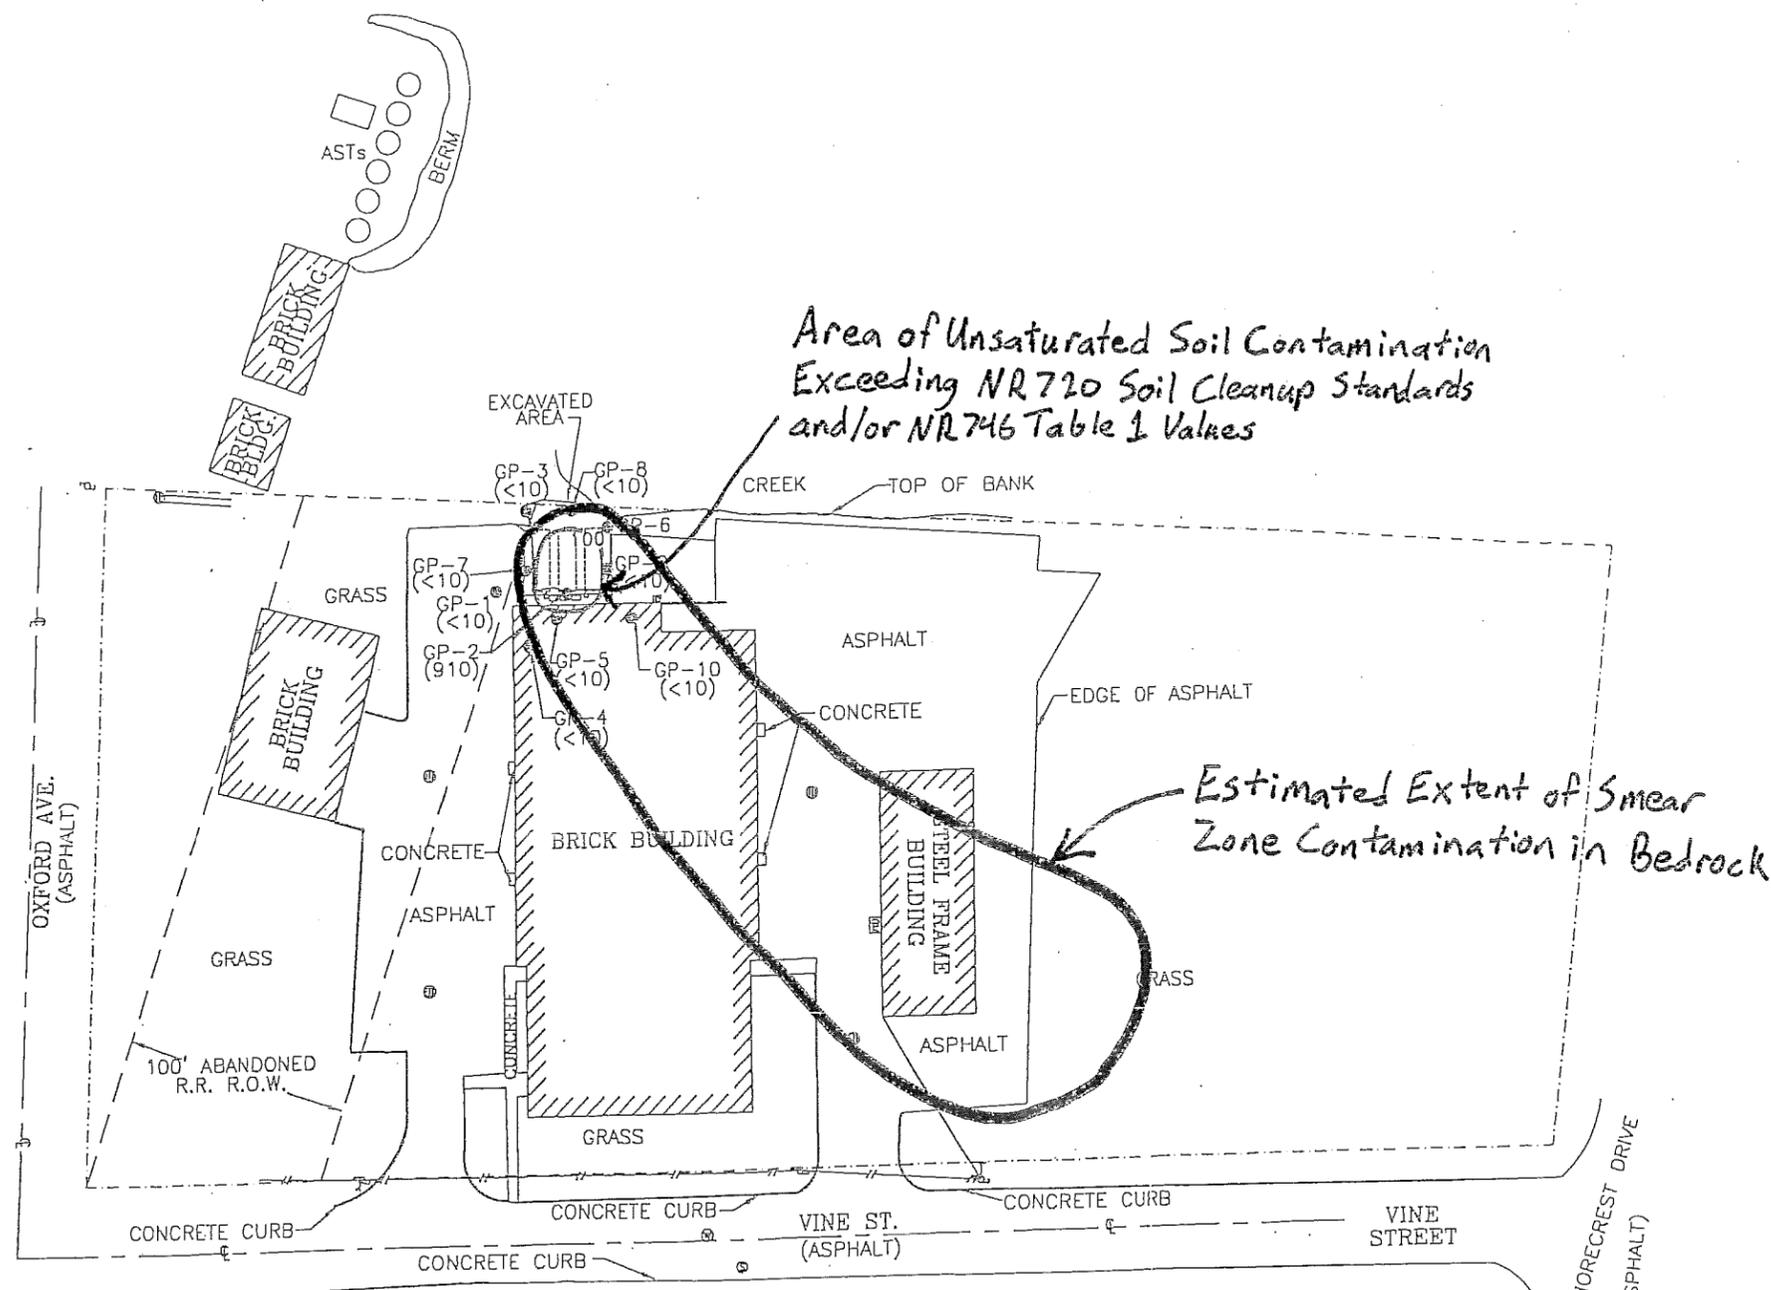
- LEGEND**
- APPROXIMATE BOUNDARY LINES
  - ⊙ CATCH BASIN
  - ⊠ GAS METER
  - ⊙ WATER VALVE
  - ⊙ MANHOLE
  - OVERHEAD UTILITY LINE
  - FORMER UST
  - GEOPROBE BORING
  - ( ) CONCENTRATION IN ppm
  - 100 ISOCONCENTRATION CONTOUR

NOTE: THE NR720 GENERIC SOIL STANDARD FOR DRD IS 100 ppm.

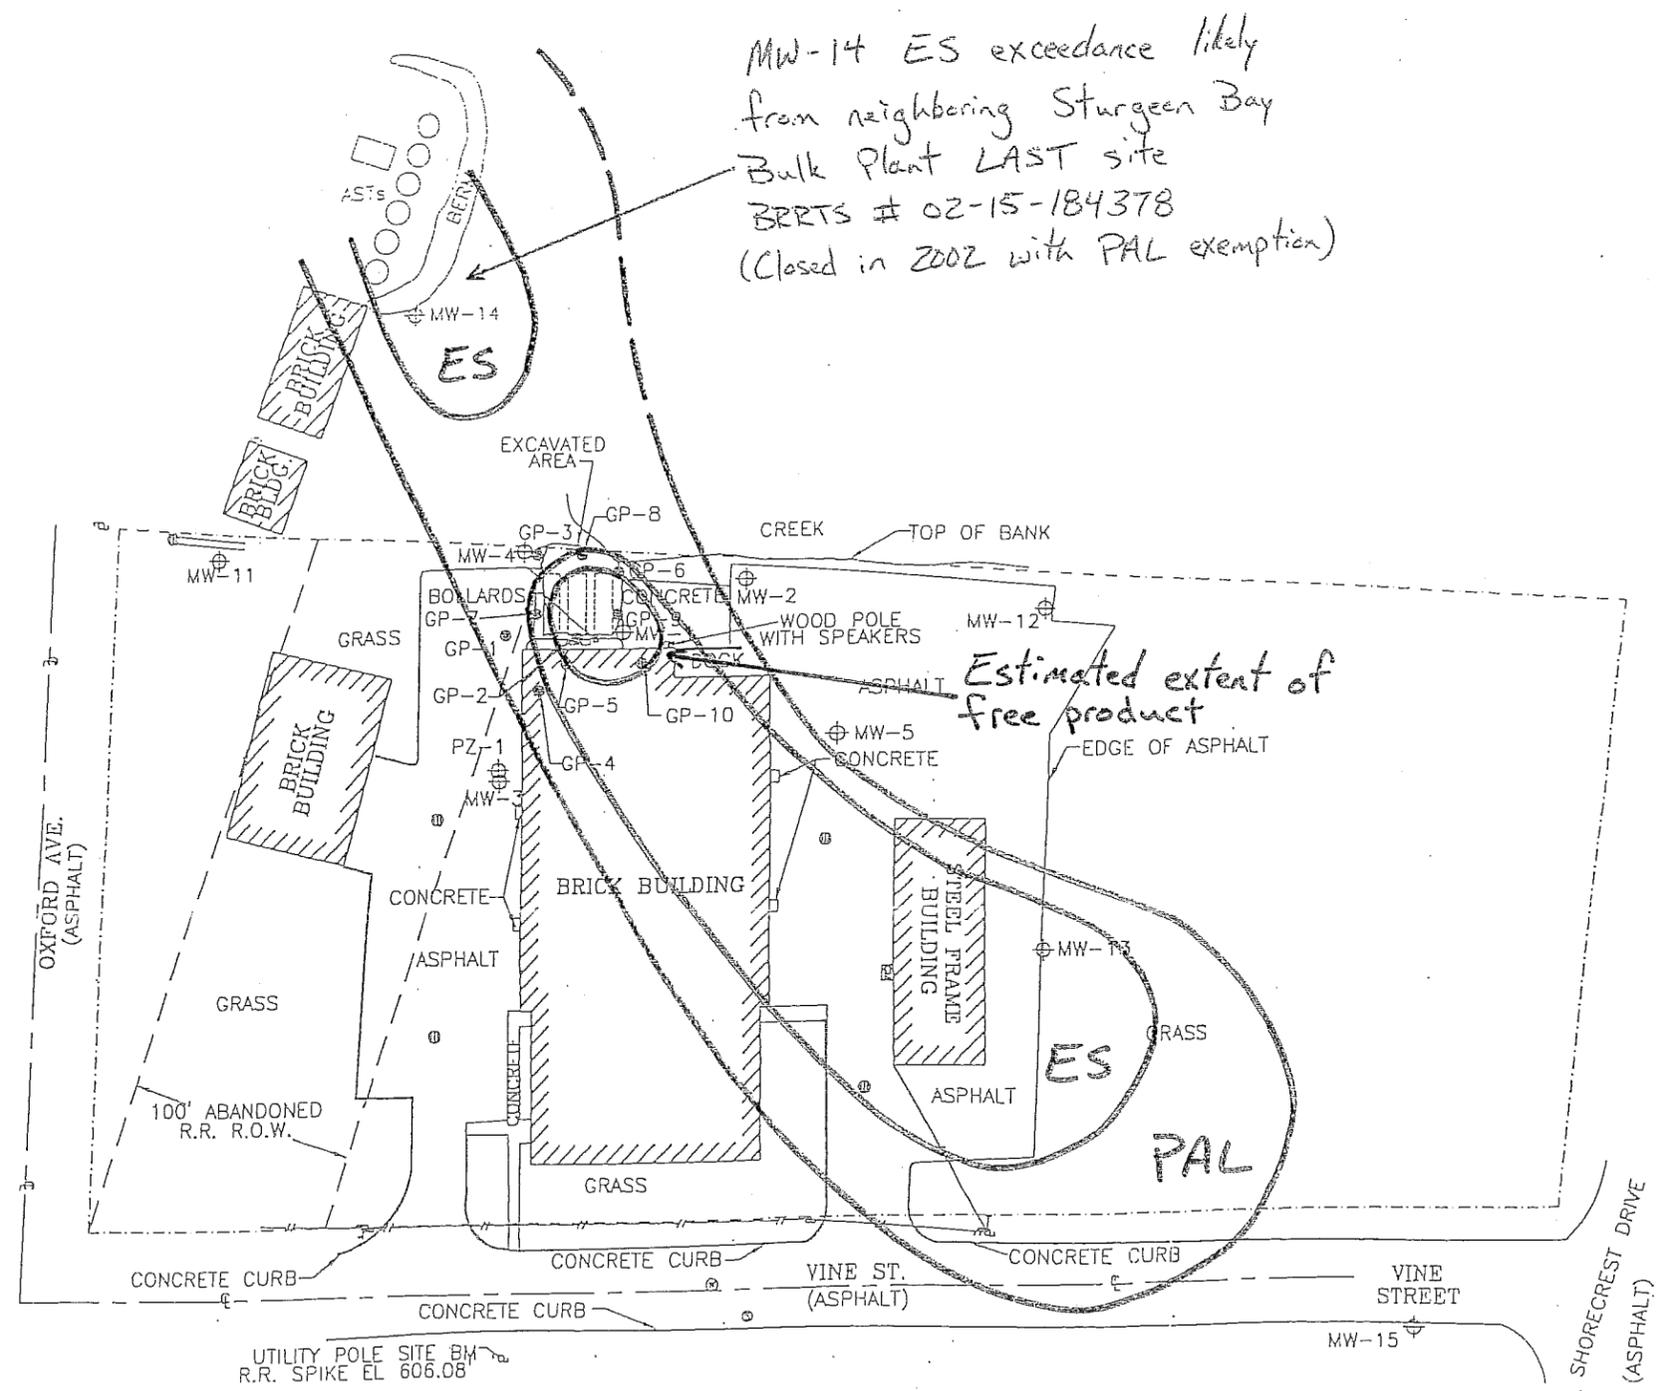
Groundwater Contamination Map  
 May 4, 2010

- LEGEND
- - - - - APPROXIMATE BOUNDARY LINES
  - ⊕ CATCH BASIN
  - ⊕ GAS METER
  - ⊕ WATER VALVE
  - ⊕ MANHOLE
  - OVERHEAD UTILITY LINE
  - ▭ FORMER UST
  - ⊕ MONITORING WELL
  - ⊕ PIEZOMETER
  - ⊕ GEOPROBE

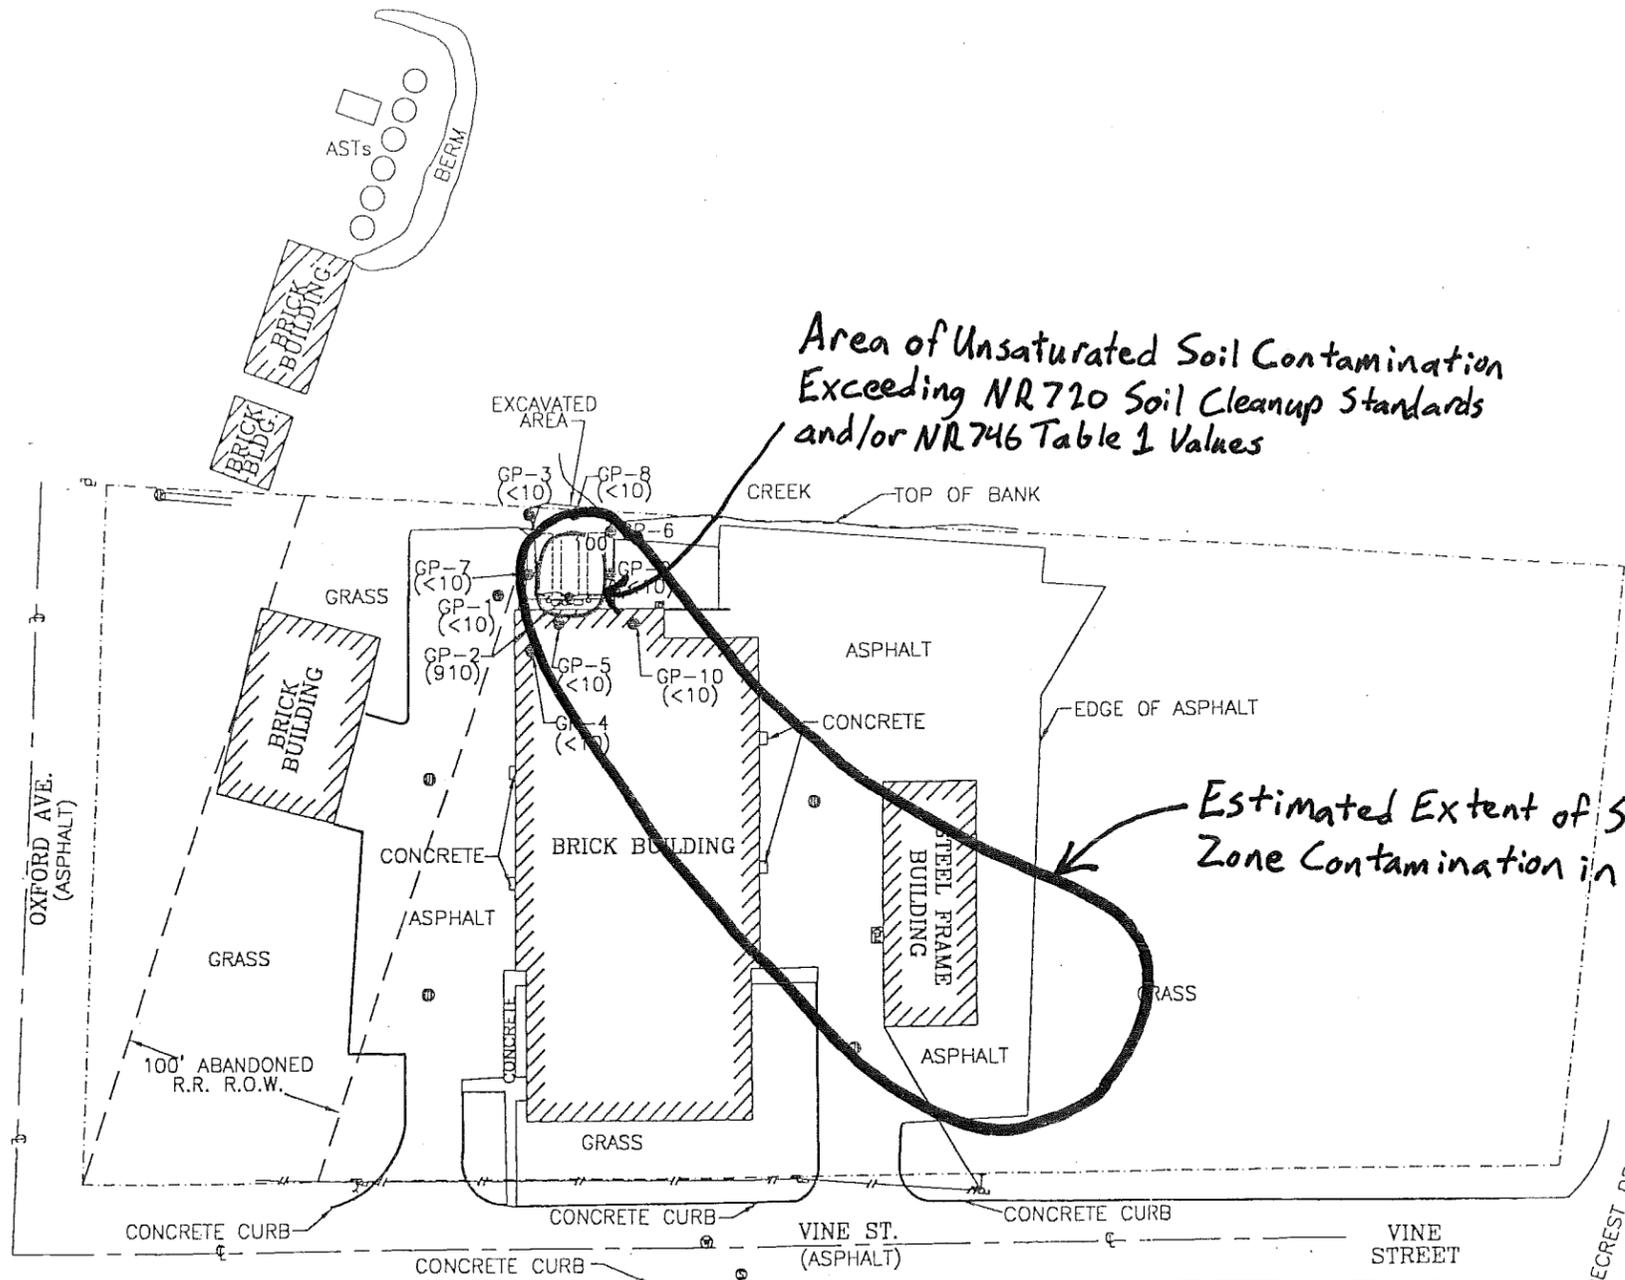
- LEGEND**
- APPROXIMATE BOUNDARY LINES
  - ⊙ CATCH BASIN
  - ⊠ GAS METER
  - ⊕ WATER VALVE
  - ⊙ MANHOLE
  - OVERHEAD UTILITY LINE
  - ▭ FORMER UST
  - GEOPROBE BORING
  - ( ) CONCENTRATION IN ppm
  - 100 ISOCONCENTRATION CONTOUR

NOTE: THE NR720 GENERIC SOIL STANDARD FOR DRO IS 100 ppm.

**Figure #: 8**                      **Title: Soil Contamination Map - May 4, 2010**

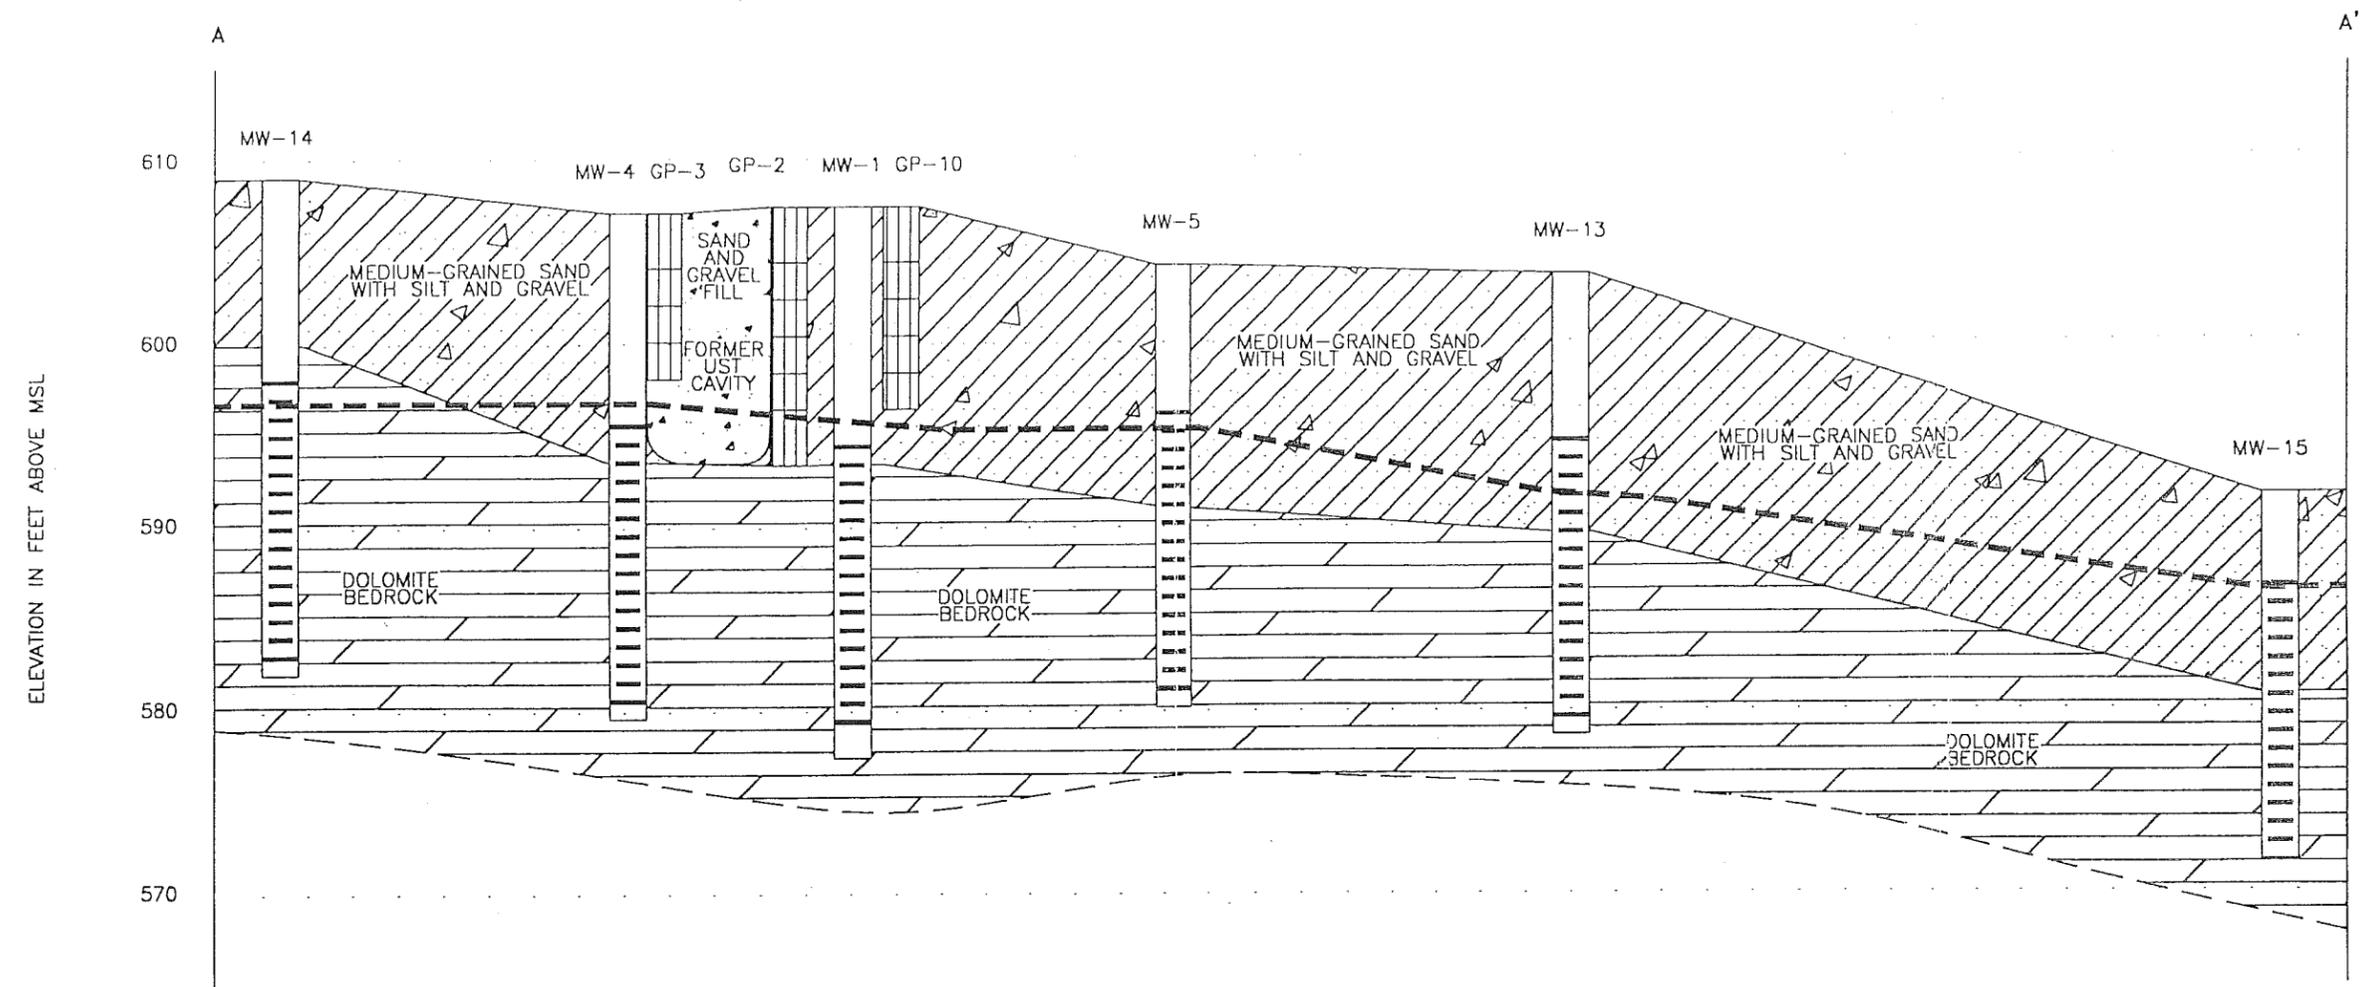
**Geologic Cross-Section A-A'**  
**Sturgeon Bay Utilities Site**  
**Sturgeon Bay, Wisconsin**

- LEGEND**
- SAMPLE INTERVAL
  - SCREENED INTERVAL
  - POTENTIOMETRIC SURFACE (4/7/98)

SCALE  
 HORIZONTAL: 1" = 60'  
 VERTICAL: 1" = 10'

**Figure #: 6**                      **Title: Geologic Cross-Section A-A'**

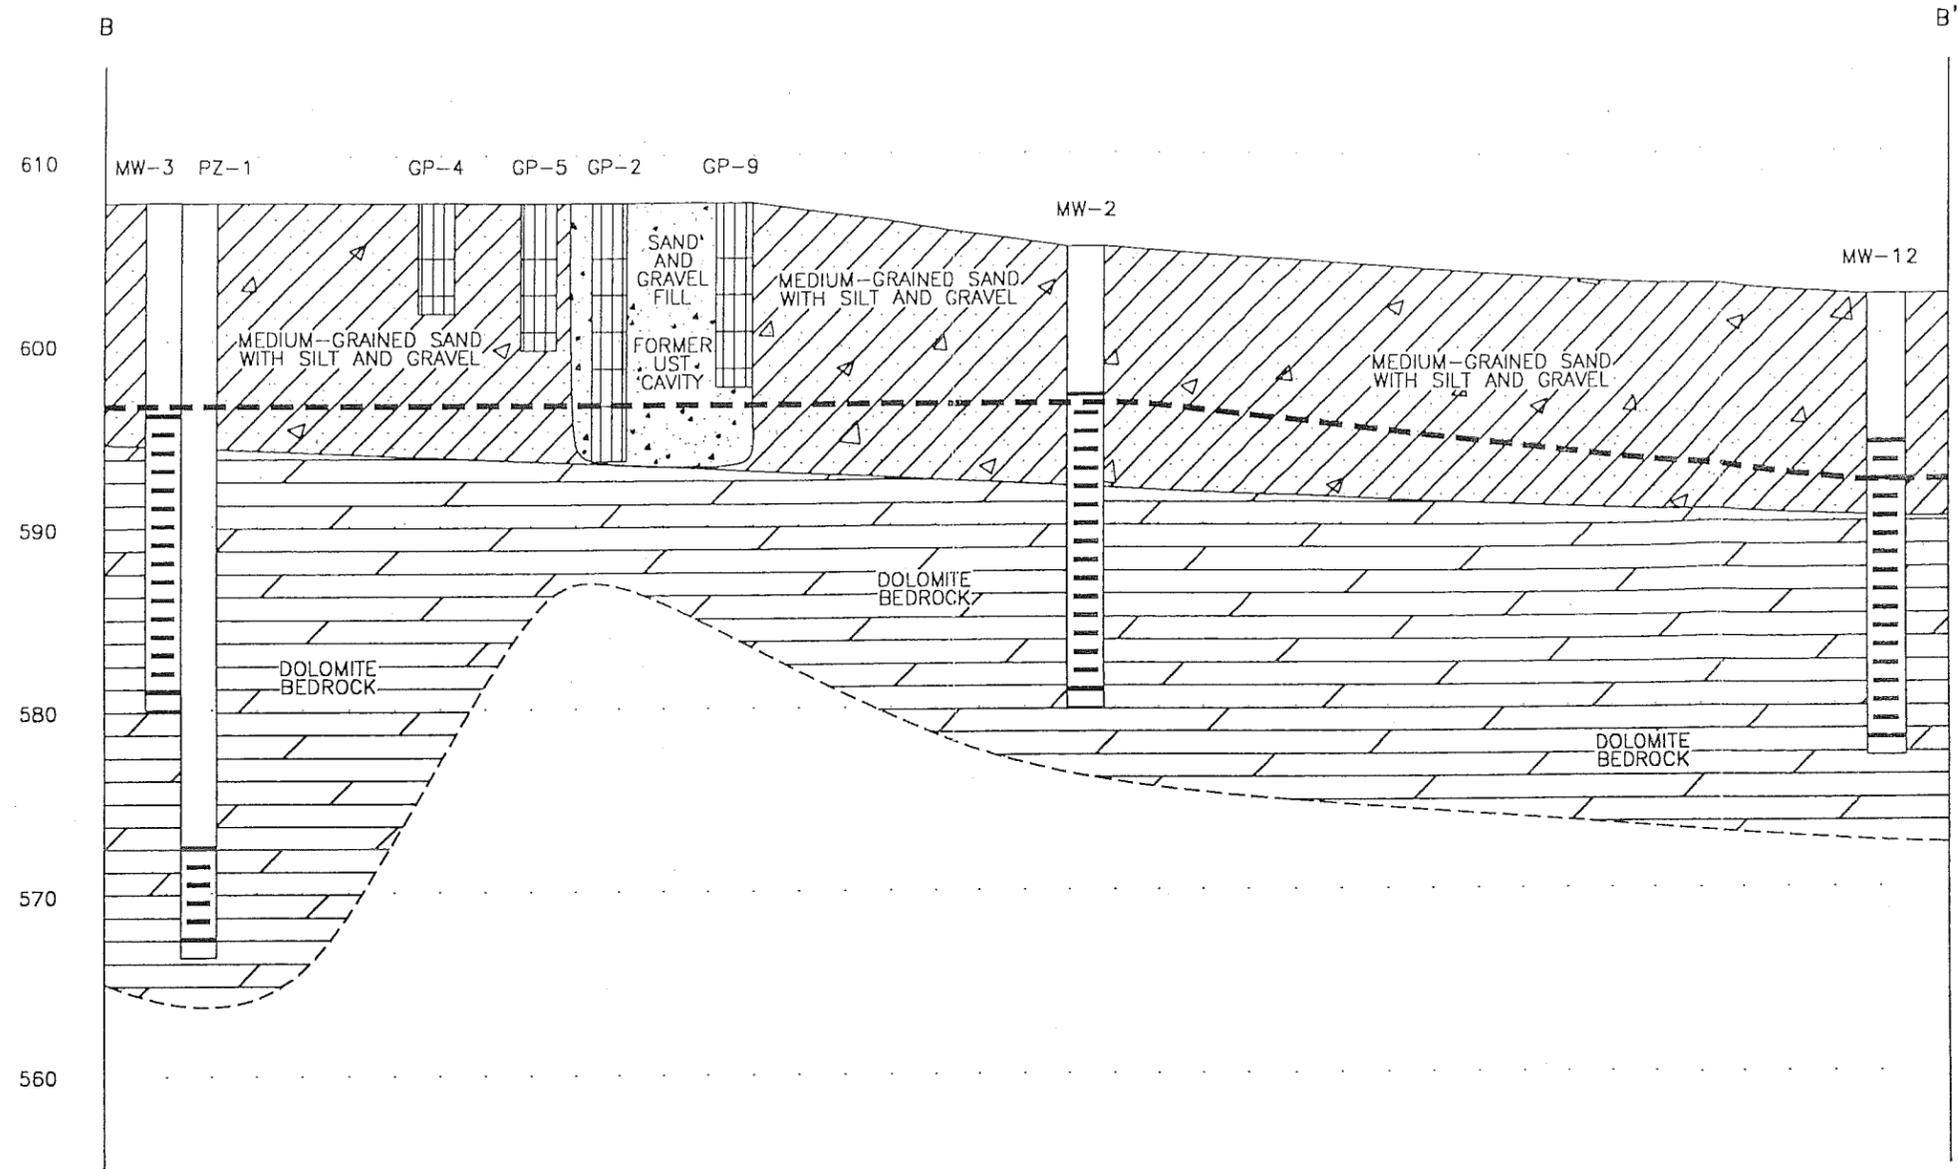
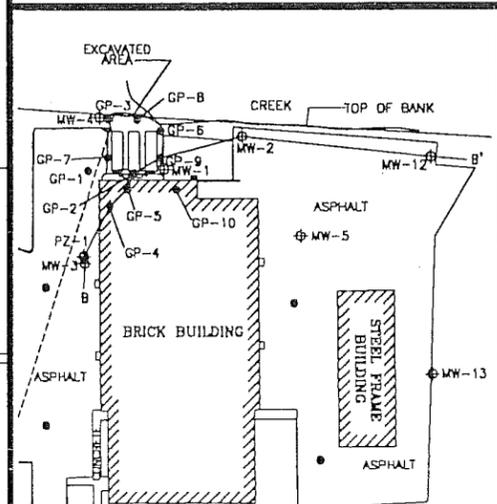
- SAMPLE INTERVAL
- SCREENED INTERVAL
- POTENTIOMETRIC SURFACE (4/7/98)

**Figure #: 7**                      **Title: Geologist Cross-Section B-B'**

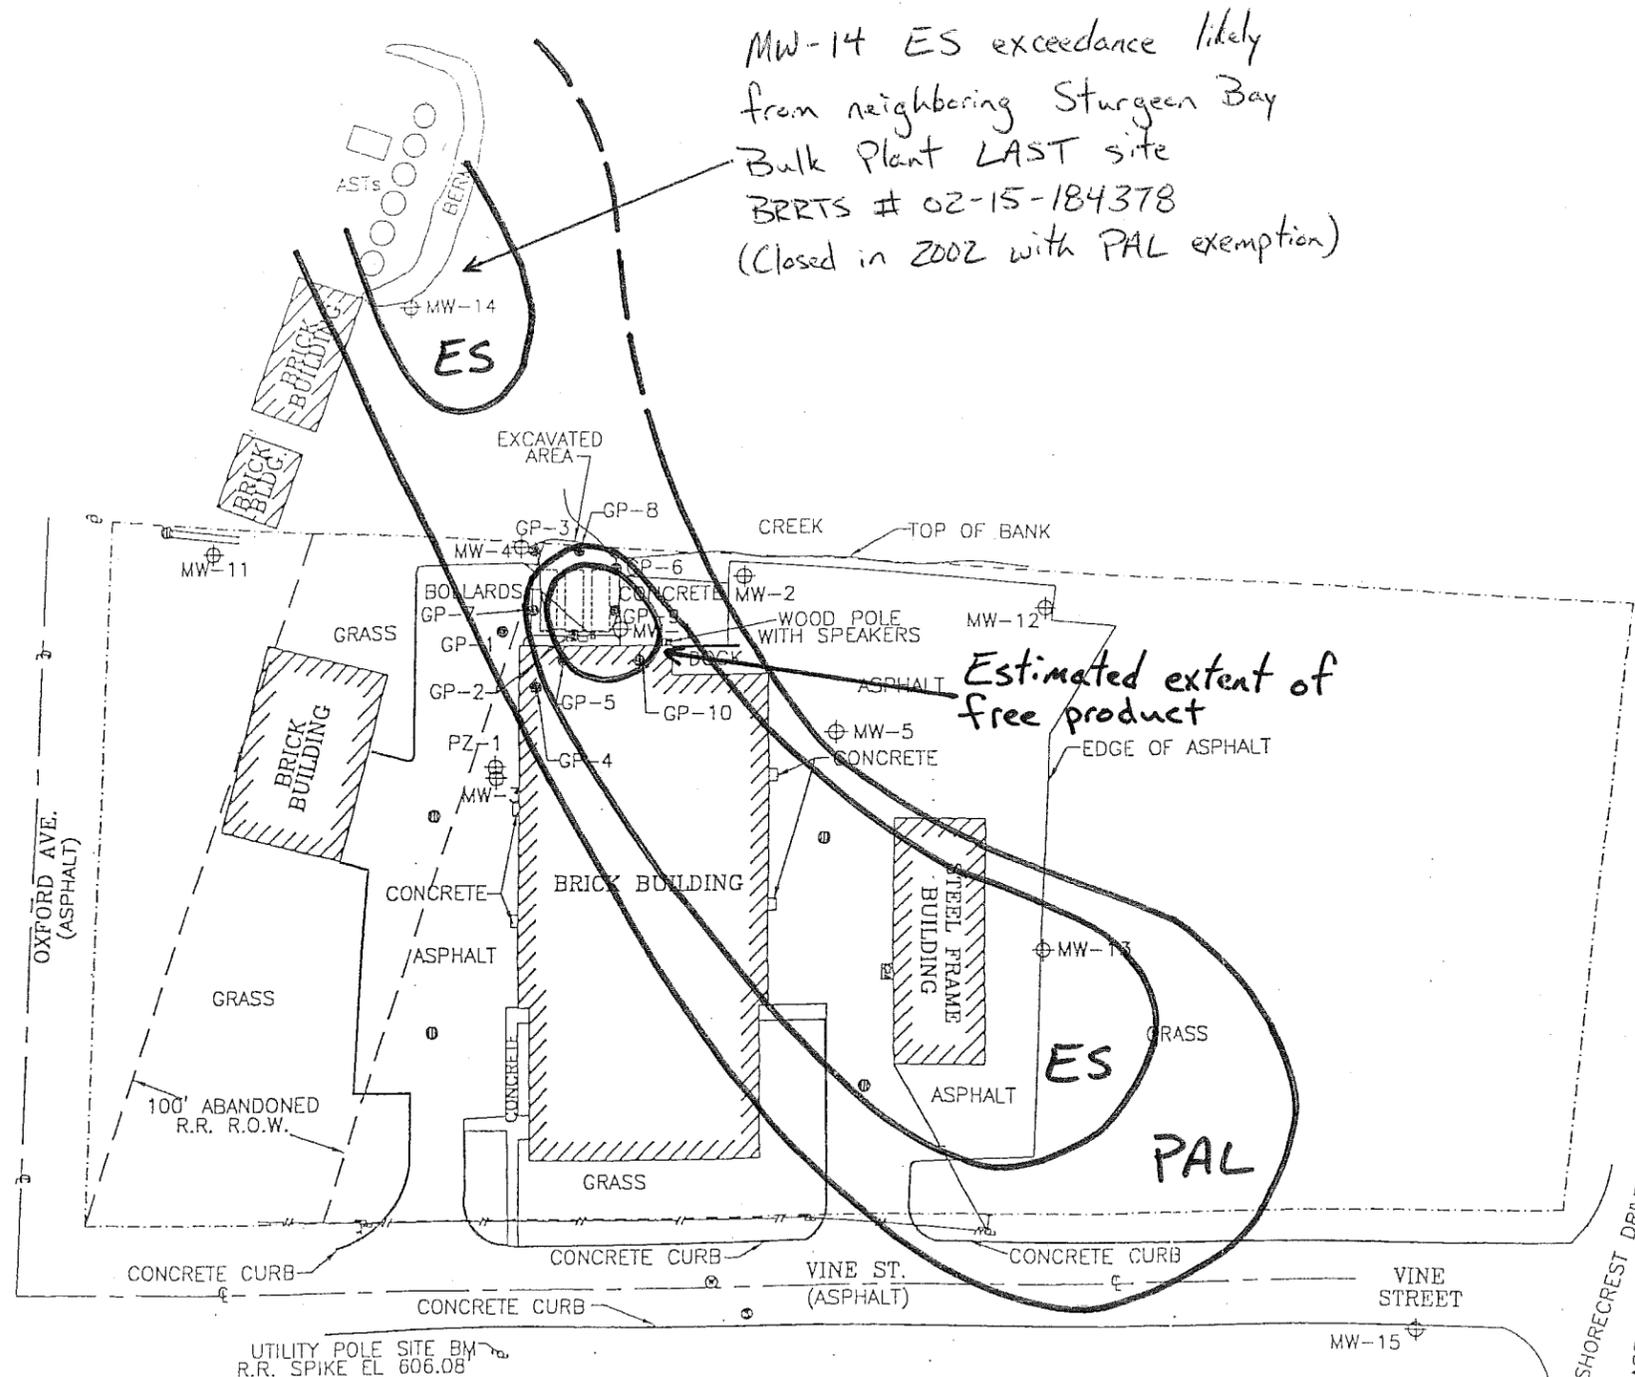
Groundwater Contamination Map  
 May 4, 2010

- LEGEND**
- APPROXIMATE BOUNDARY LINES
  - ⊕ CATCH BASIN
  - ⊕ GAS METER
  - ⊕ WATER VALVE
  - ⊕ MANHOLE
  - OVERHEAD UTILITY LINE
  - ▭ FORMER UST
  - ⊕ MONITORING WELL
  - ⊕ PIEZOMETER
  - ⊕ GEOPROBE

**Figure #:**                      **Title: Groundwater Contamination Map - May 4, 2010**

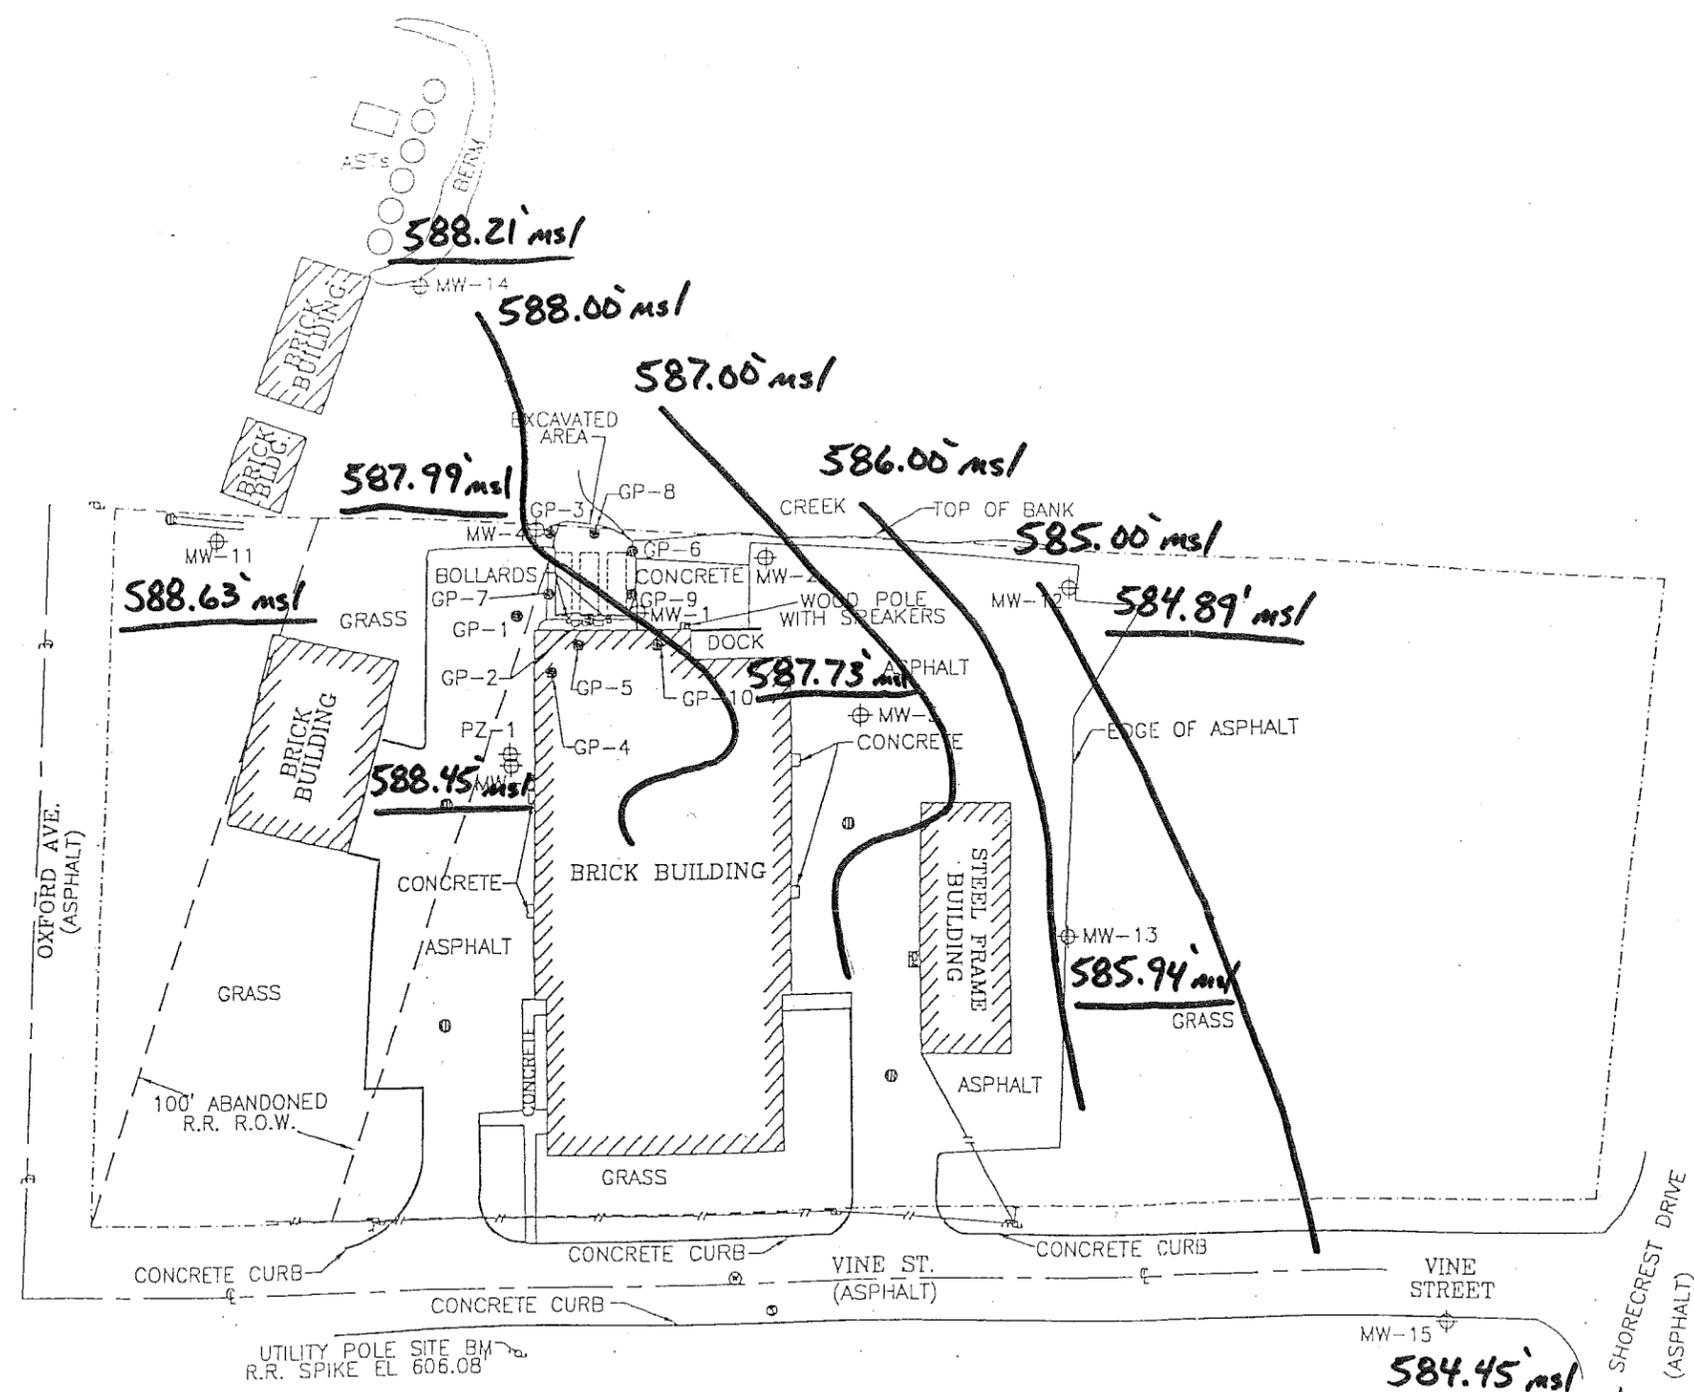
Groundwater Contour Map  
 May 4, 2010

- LEGEND**
- APPROXIMATE BOUNDARY LINES
  - ⊕ CATCH BASIN
  - ⊕ GAS METER
  - ⊕ WATER VALVE
  - ⊕ MANHOLE
  - OVERHEAD UTILITY LINE
  - FORMER UST
  - ⊕ MONITORING WELL
  - ⊕ PIEZOMETER
  - ⊕ GEOPROBE

**Figure #:**                      **Title: Groundwater Contour Map - May 4, 2010**

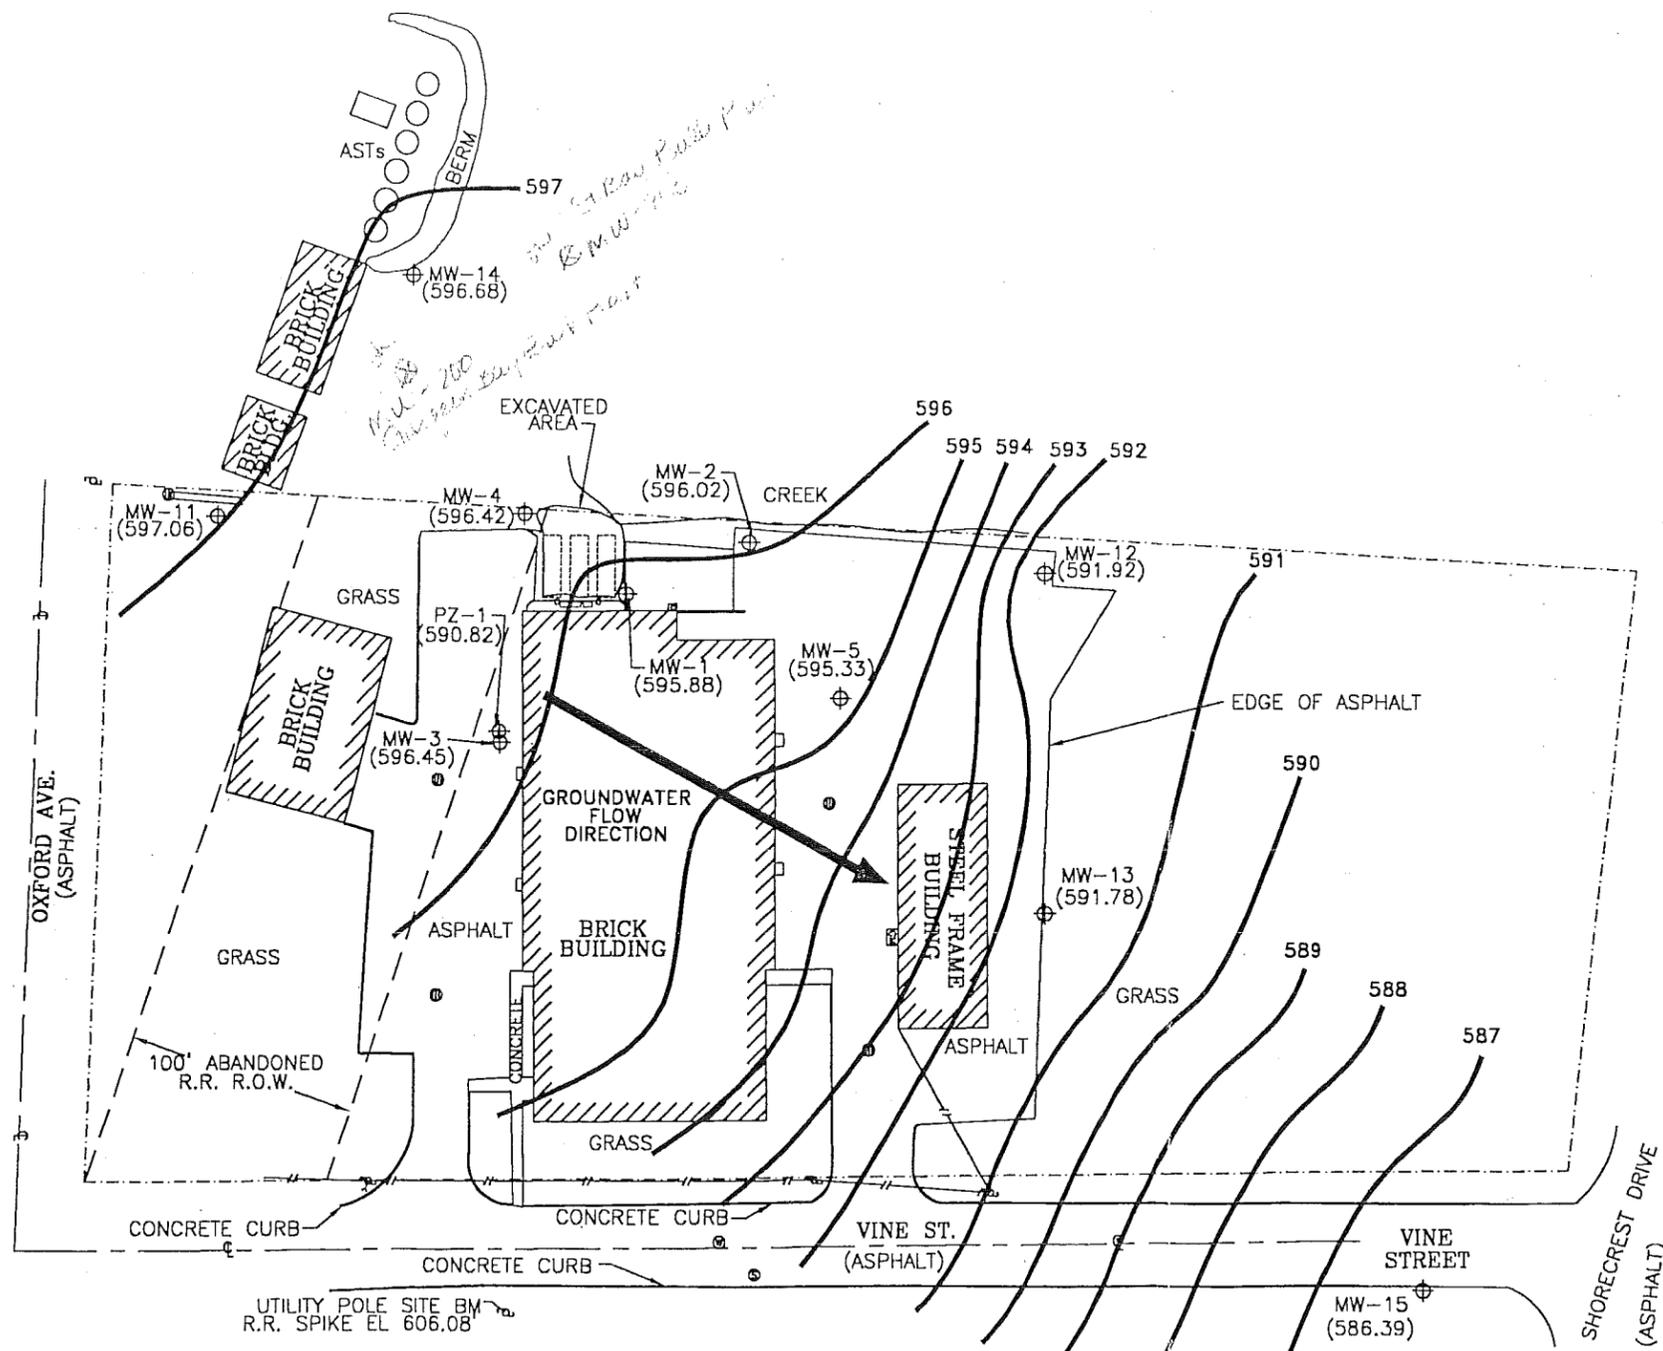
- LEGEND**
- APPROXIMATE BOUNDARY LINES
  - ⊕ CATCH BASIN
  - ⊕ GAS METER
  - ⊕ WATER VALVE
  - ⊕ MANHOLE
  - OVERHEAD UTILITY LINE
  - ▭ FORMER UST
  - ⊕ MONITORING WELL
  - ⊕ PIEZOMETER
  - ( ) GROUNDWATER ELEVATION IN FEET ABOVE MSL
  - 590 ISOELEVATION CONTOUR

NOTE: HYDRAULIC GRADIENT =  $dh/dl = 1.6 \times 10^{-2}$  ft/ft

**Figure #: 9**                      **Title: Potentiometric Surface (04-07-98)**
