# GIS REGISTRY

ACTIVITY NAME: Sturgeon Bay Utilities

PROPERTY ADDRESS: 230 E Vine St

Cap Maintenance Plan Map

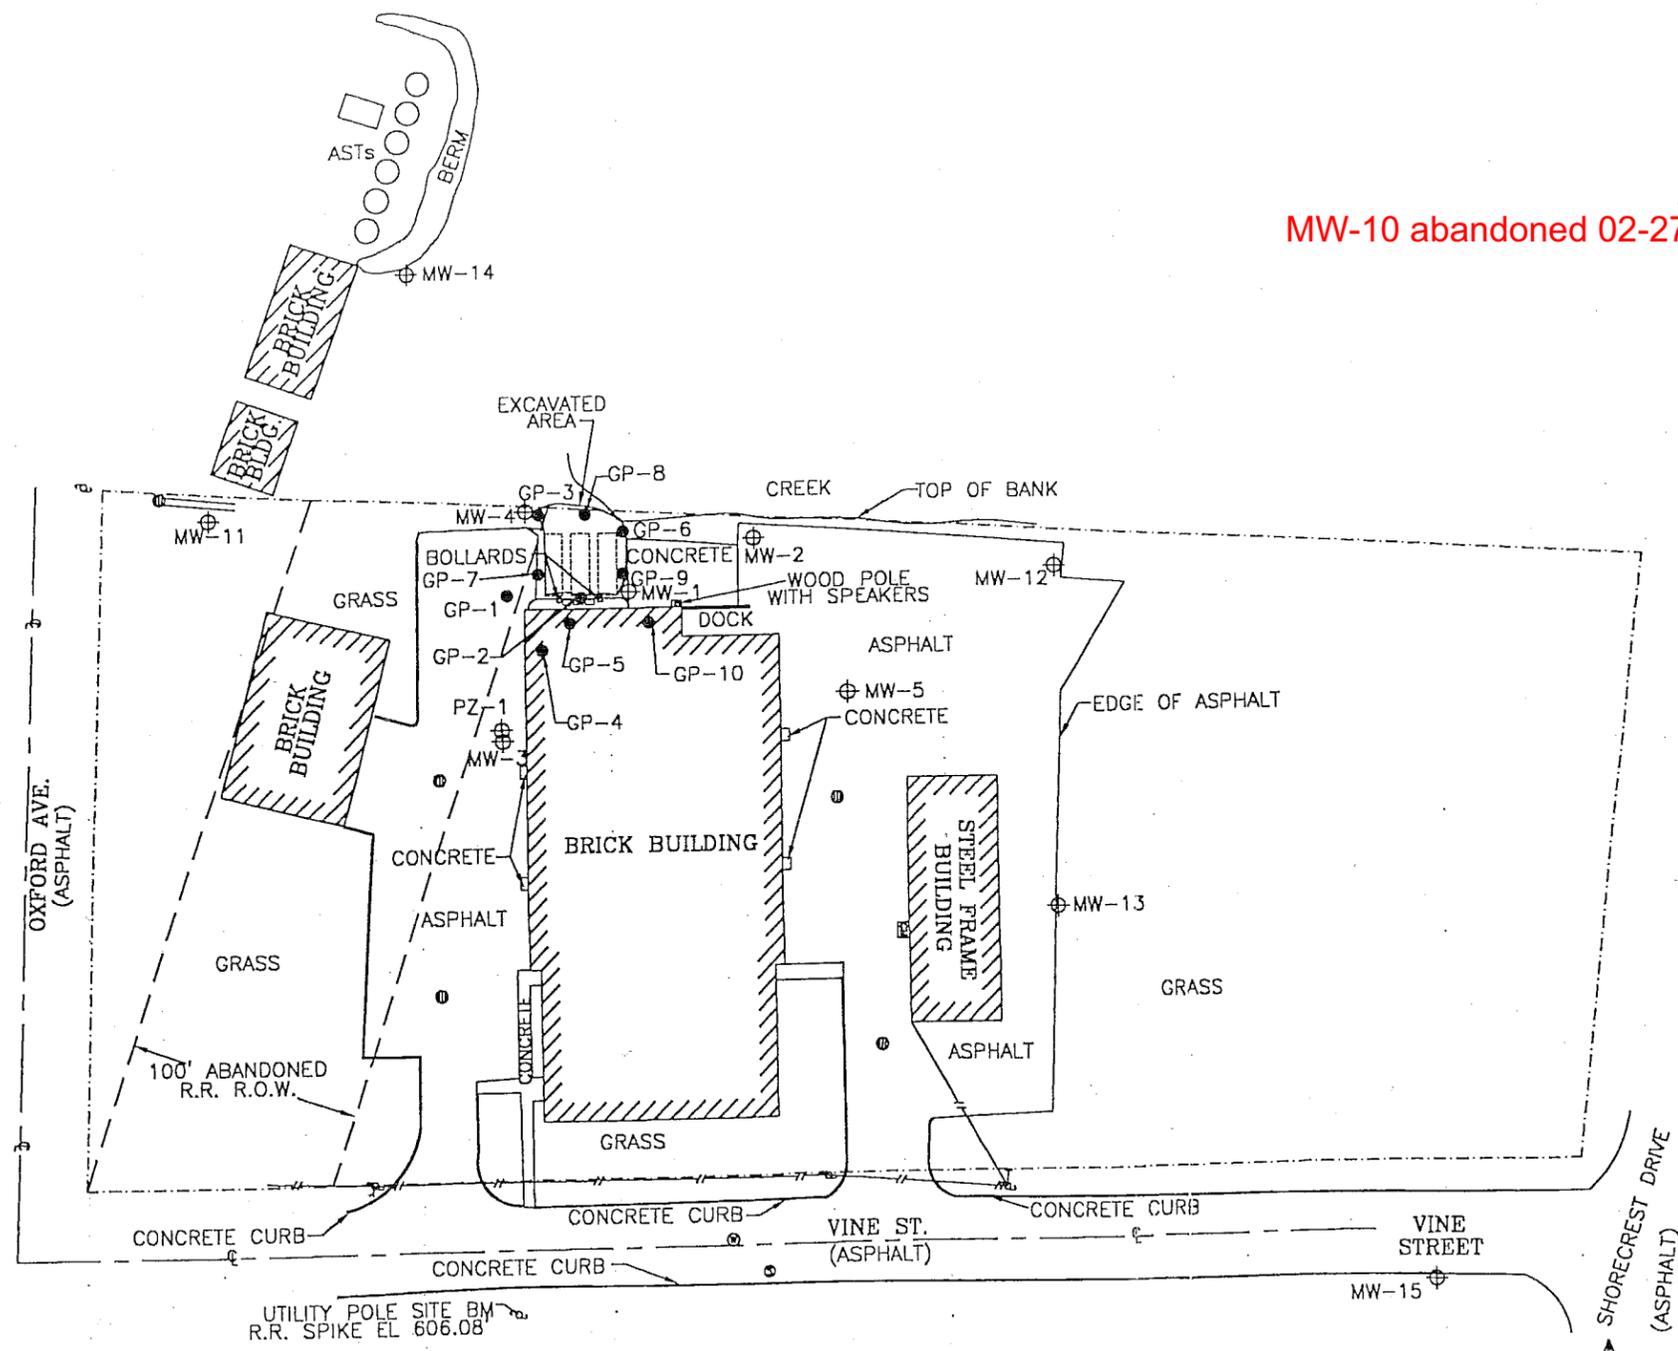
IMPROPERLY ABANDONED  
 MONITORING WELL

MW-10 abandoned 02-27-98 but unlocatable.

- - - - - APPROXIMATE BOUNDARY LINES
- ⊙ CATCH BASIN
- ⊕ GAS METER
- ⊕ WATER VALVE
- ⊕ MANHOLE
- OVERHEAD UTILITY LINE
- ▭ FORMER UST
- ⊕ MONITORING WELL
- ⊕ PIEZOMETER
- GEOPROBE

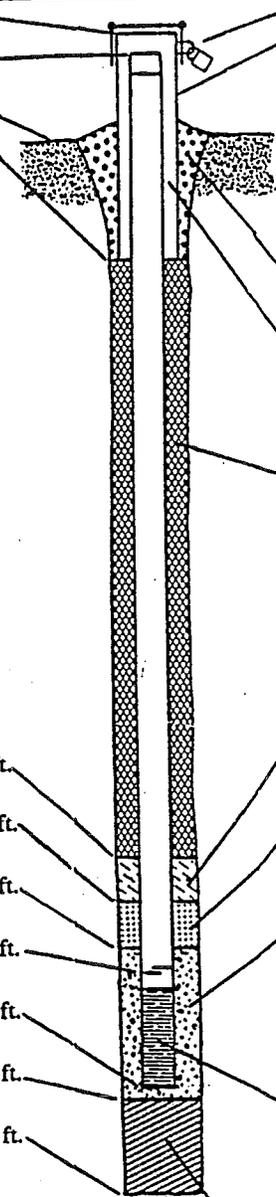
Well Name: MW-10  
 Wis. Unique Well Number \_\_\_\_\_ DNR Well Number \_\_\_\_\_  
 Date Well Installed 10/17/97  
 Well Installed By: (Person's Name and Firm)  
 EDS-Craig

1. Cap and lock?  Yes  No
2. Protective cover pipe:
  - a. Inside diameter: 6.0 in.
  - b. Length: 7.0 ft.
  - c. Material: Steel  04  
Other
  - d. Additional protection?  Yes  No  
If yes, describe: \_\_\_\_\_

3. Surface seal:
  - Bentonite  30
  - Concrete  01
  - Other
4. Material between well casing and protective pipe:
  - Bentonite  30
  - Annular space seal
  - Other
