Source Property Information

BRRTS #: 02-20-297826
ACTIVITY NAME: Canadian National Railway - Storehouse
PROPERTY ADDRESS: 2 Harrison Street
MUNICIPALITY: North Fond du Lac
PARCEL ID #: V05-16-17-33-77-777-00

WISCONSIN CENTRAL, LTD
NORTH FOND DU LAC RAIL YARD

CAP and BIOPILE MAINTENANCE PLAN

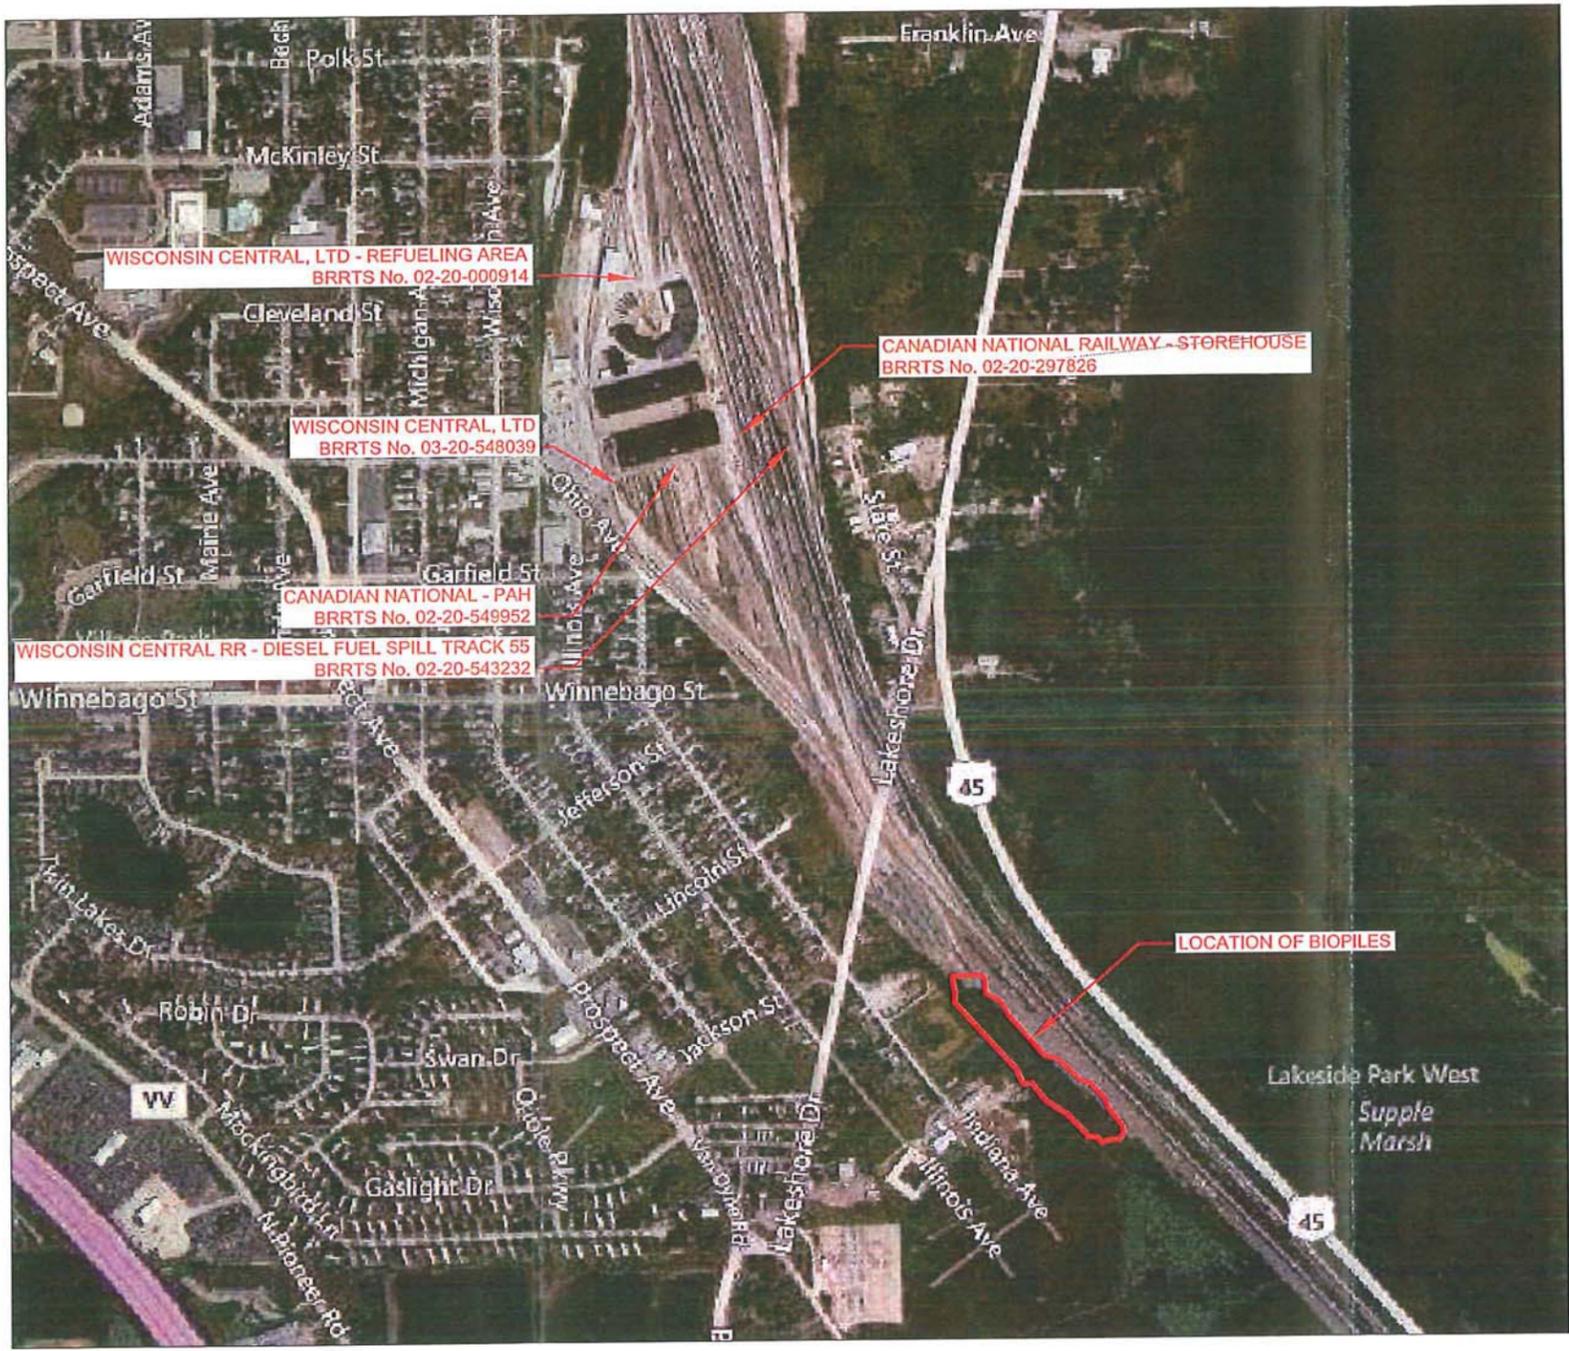
OVERVIEW OF LOCATIONS OF BRRTS CASES AND BIOPILES

Cover or Barrier (s. 292.12 (2) (a), Wis. Stats., s. NR 726.15, s. NR 727.07 Wis. Adm. Code) The coarse sand/gravel, ballast rock and asphalt surfaces that exists in the location shown on the **attached map (Figure 4)** shall be maintained in compliance with **the attached maintenance plan** in order to prevent direct contact with residual soil contamination that might otherwise pose a threat to human health.

The Cap and BioPile Maintenance Plan relates to the existing coarse sand and gravel, ballast rock, and asphalt surfaces over the area of residual lead-impacted soil. The location of the surfaces to be maintained in accordance with this Cap and BioPile Maintenance Plan is identified on the attached Figure 4.

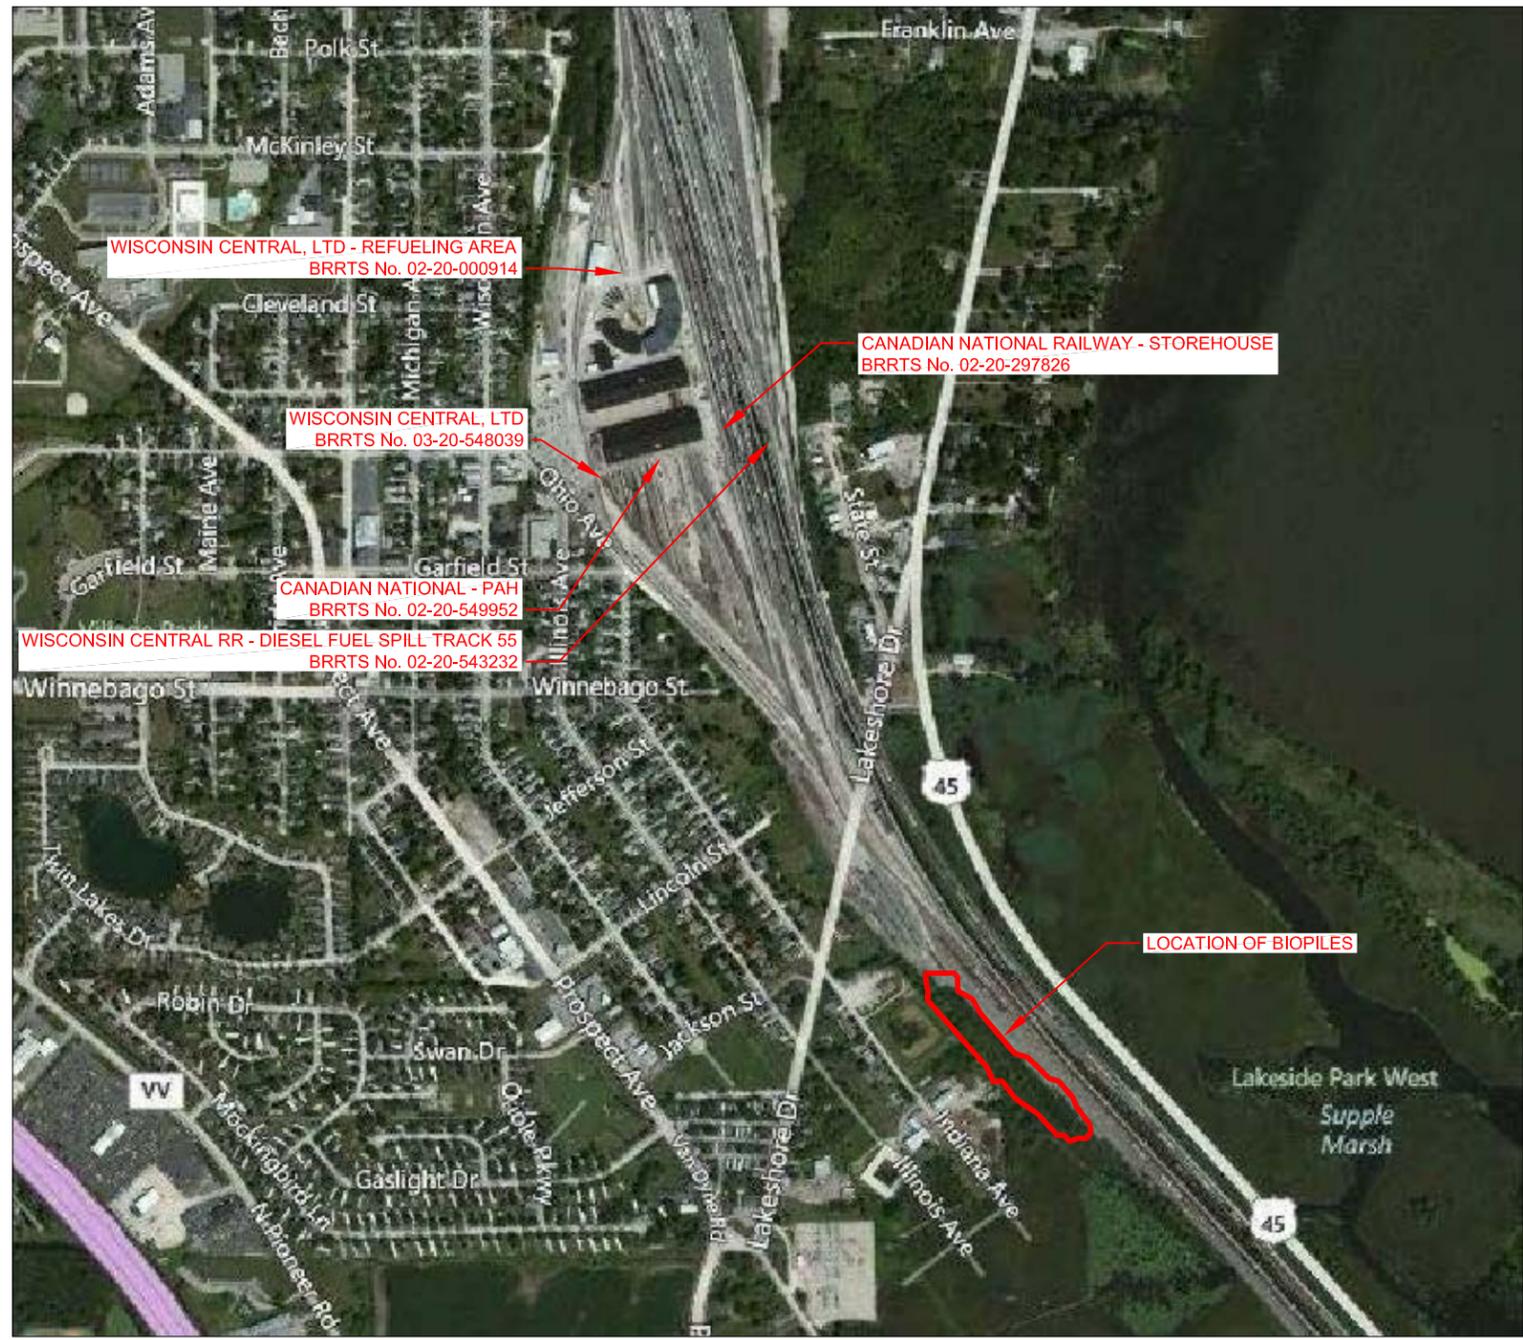
OVERVIEW OF LOCATIONS OF BRRTS CASES AND BIOPILES

WISCONSIN CENTRAL, LTD
NORTH FOND DU LAC RAIL YARD
NORTH FOND DU LAC, WISCONSIN

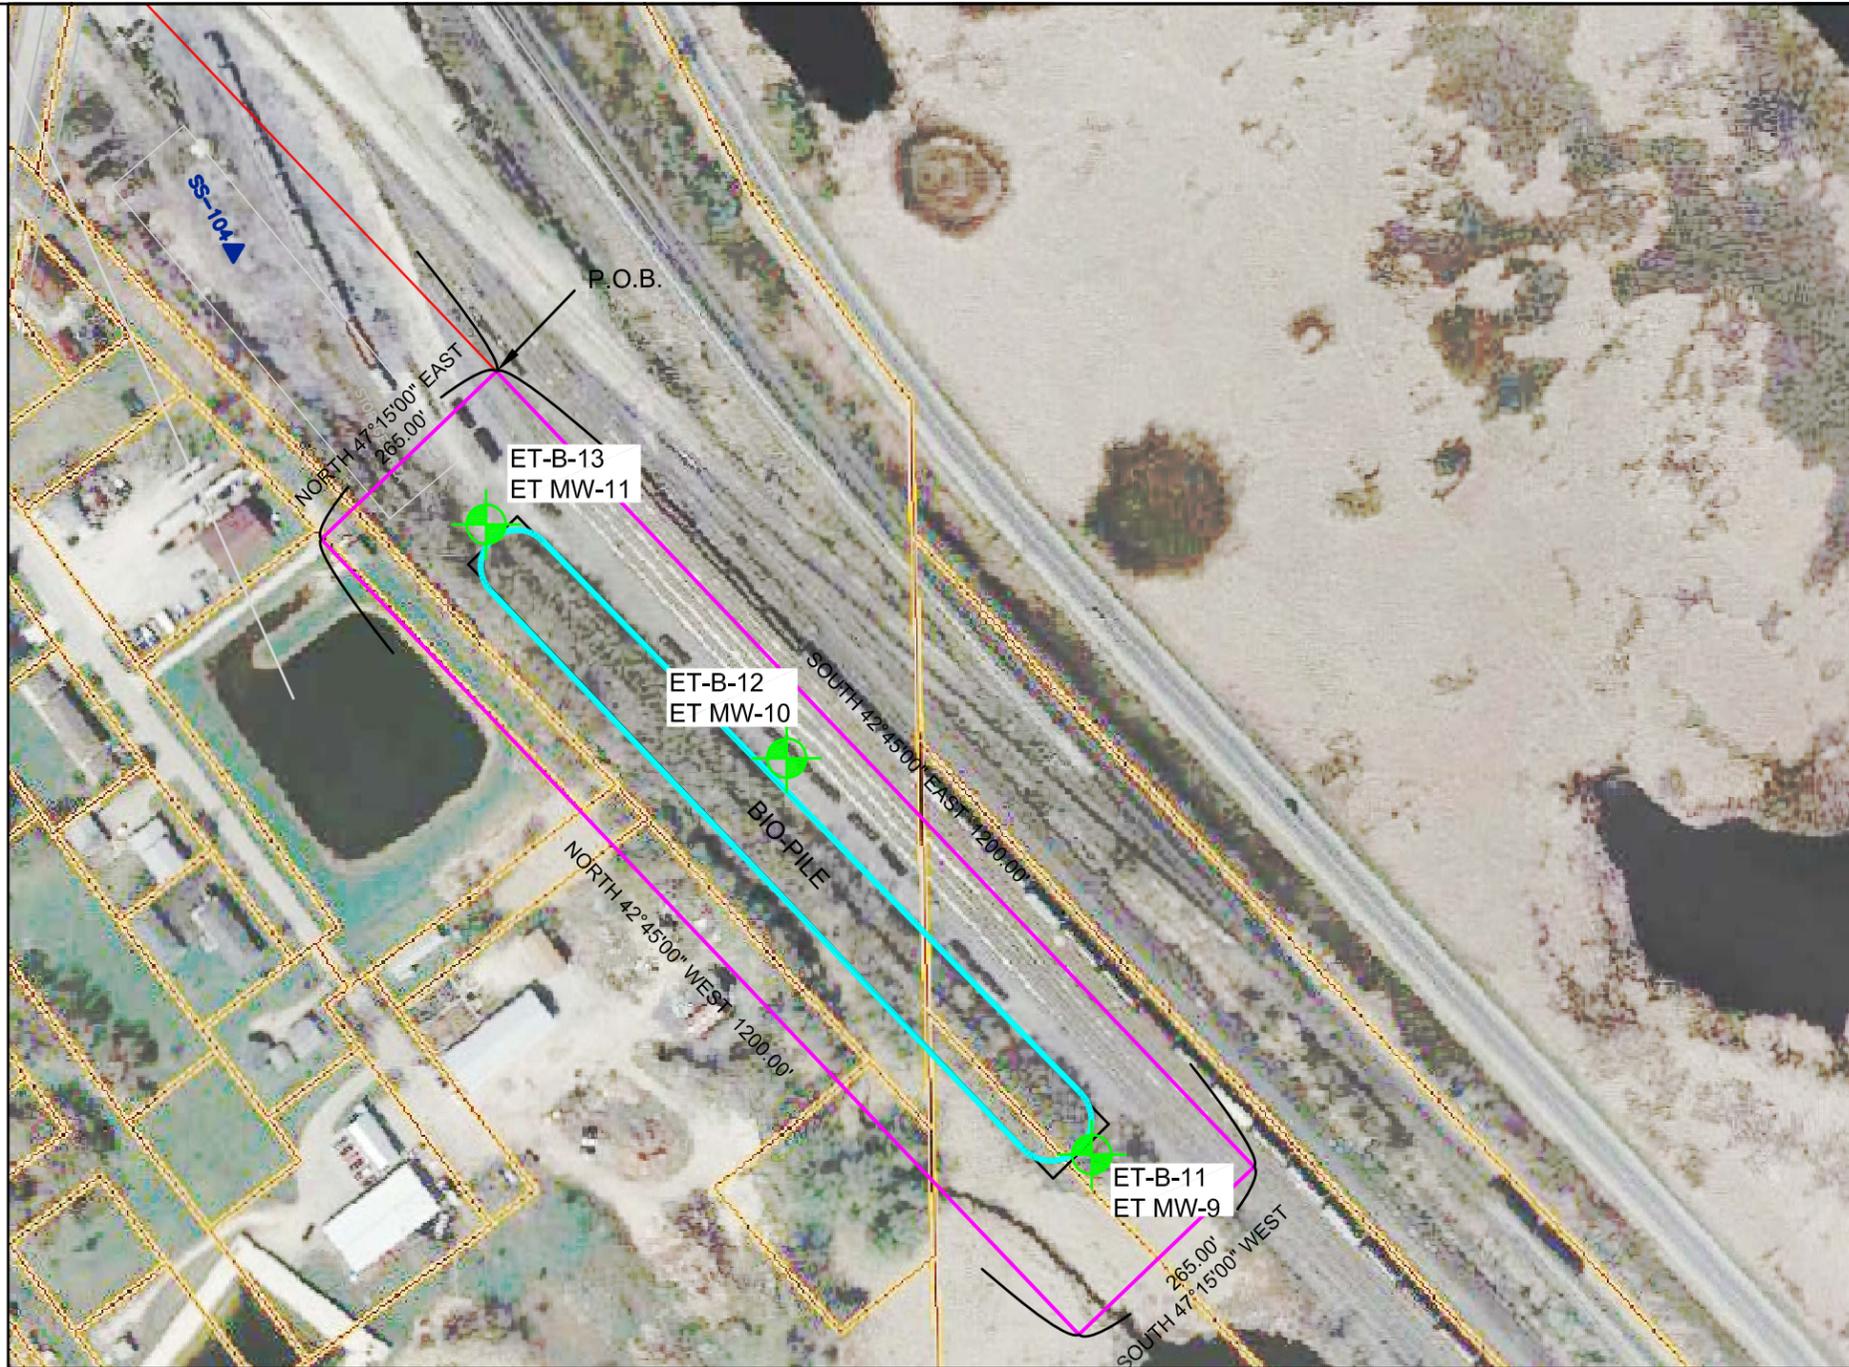
LEGAL DESCRIPTION - BIOPILE

That part of the Northeast 1/4 of Section 4, Township 15 North, Range 17 East, in the Village of North Fond du Lac, and the City of Fond du Lac, County of Fond du Lac, State of Wisconsin, more particularly described as:

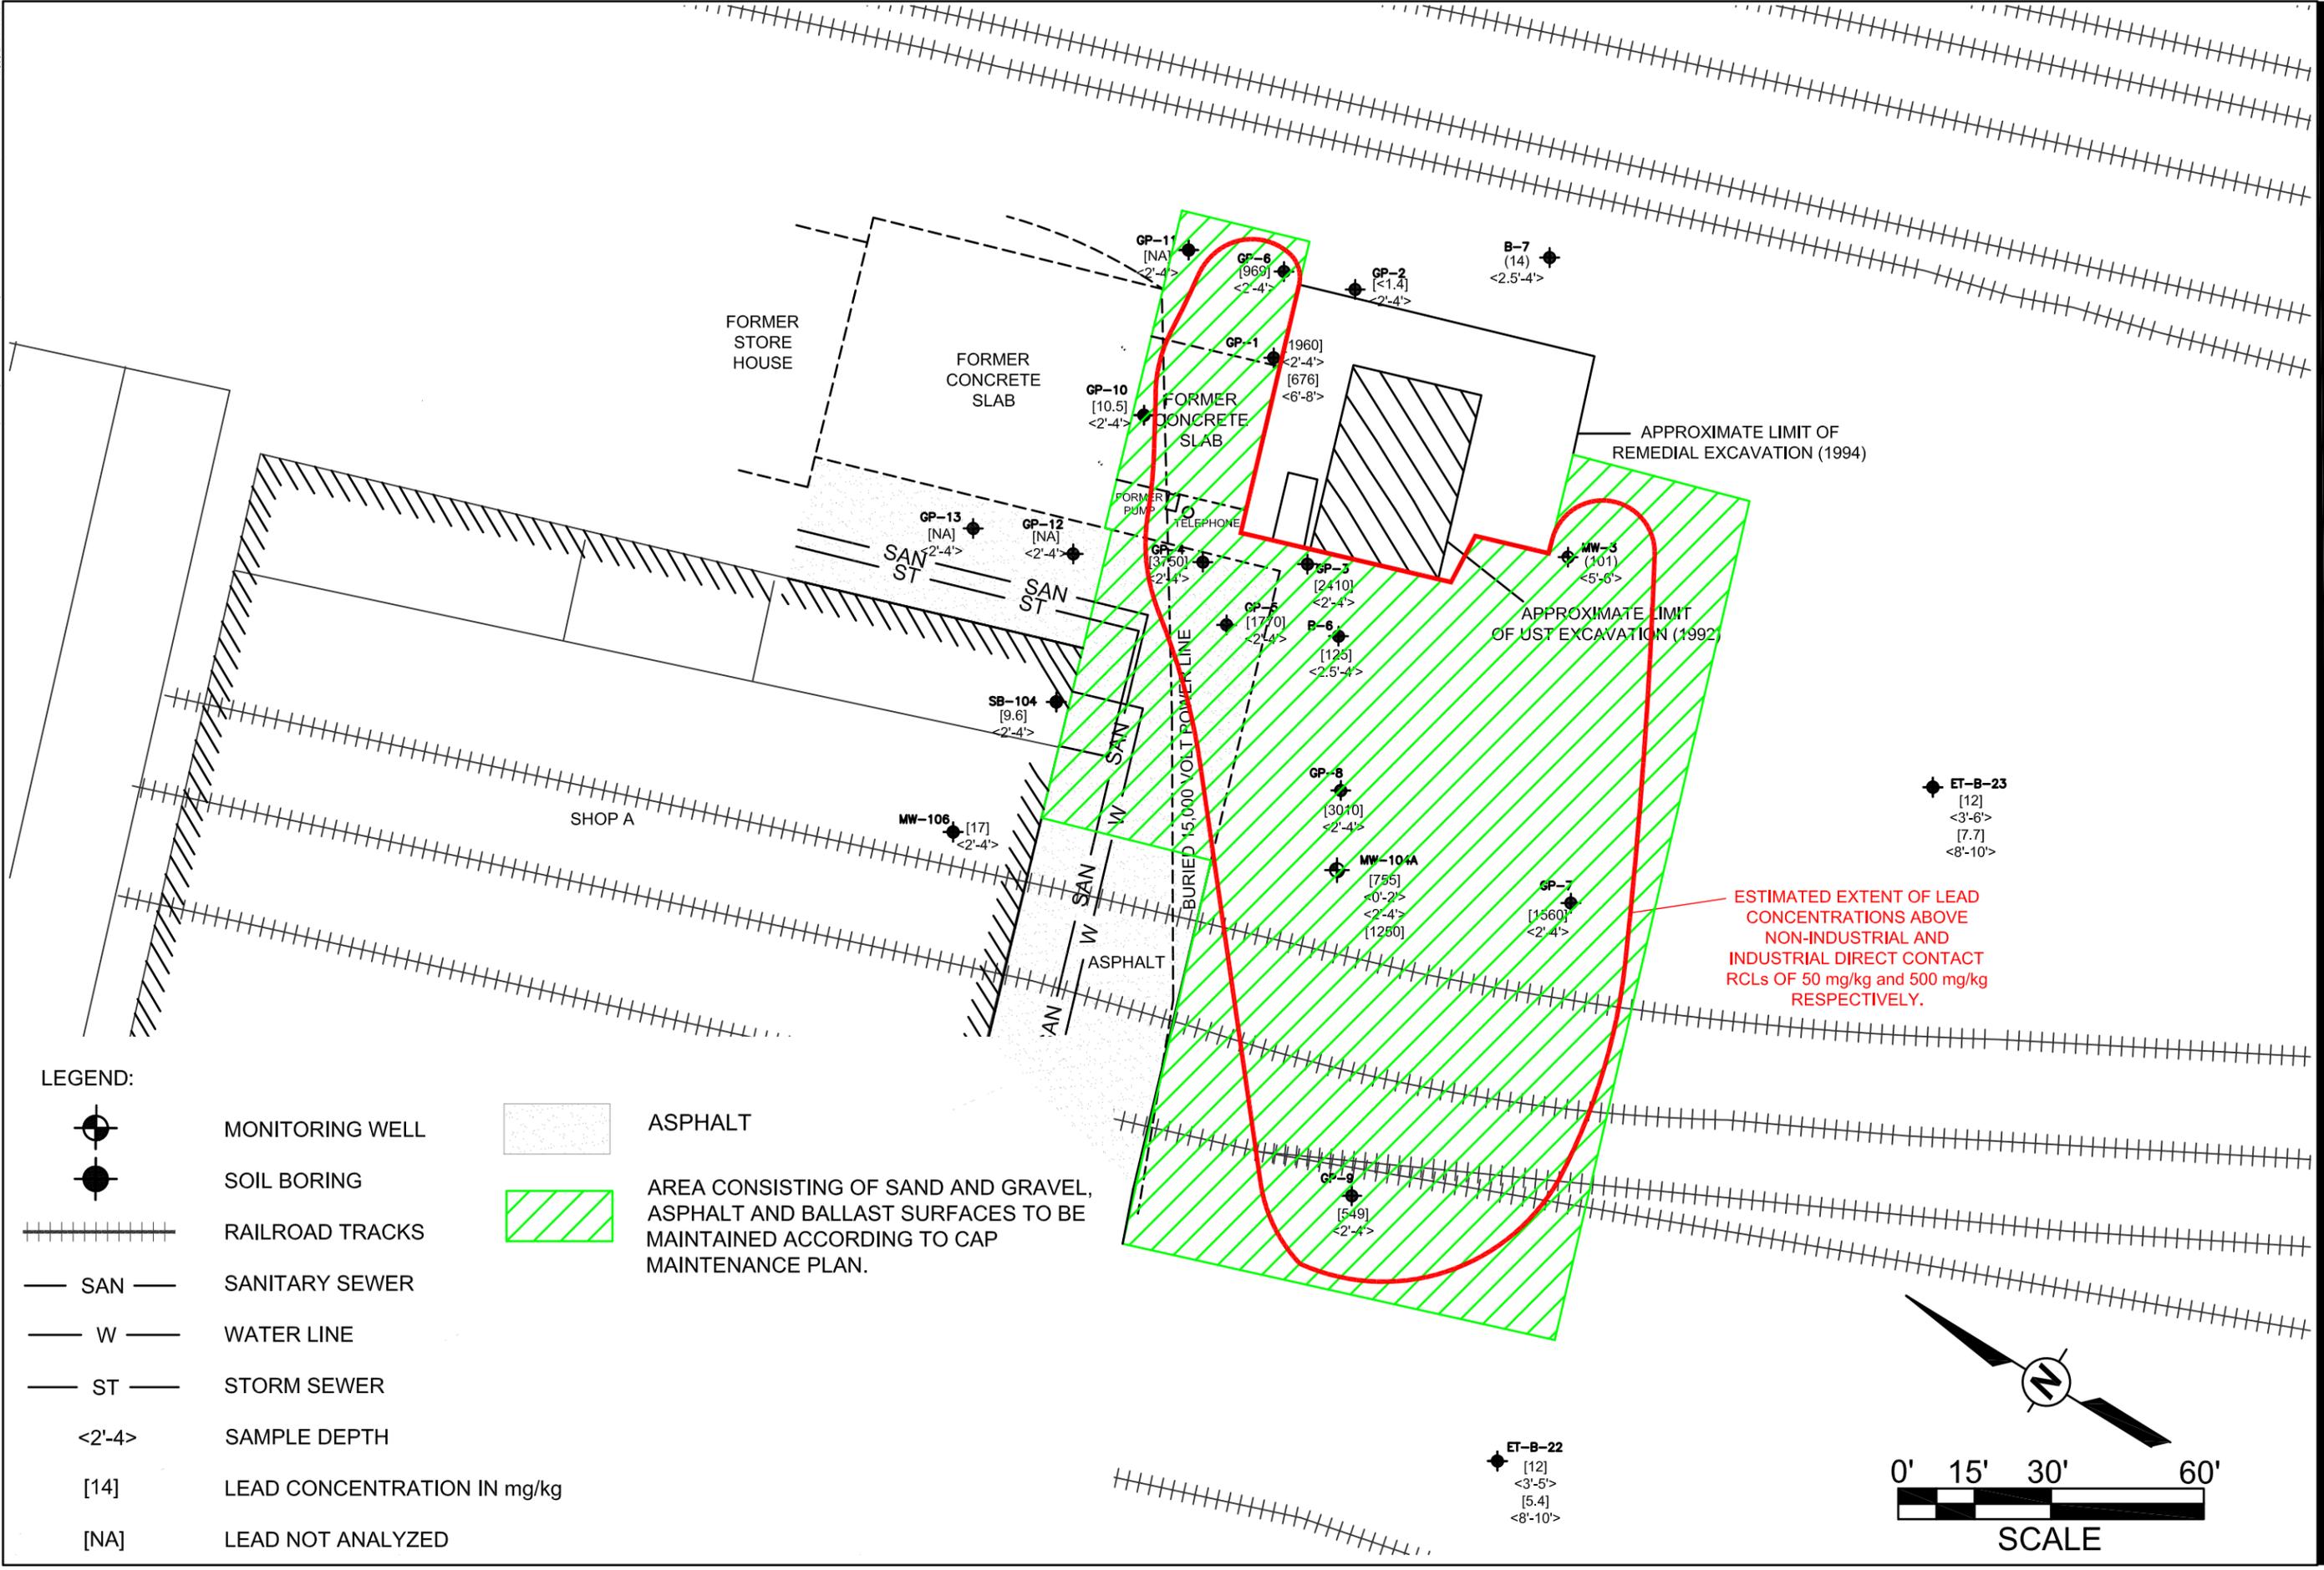
ESTIMATED EXTENT OF LEAD CONCENTRATIONS ABOVE NON-INDUSTRIAL AND INDUSTRIAL DIRECT CONTACT RCLs OF 50 mg/kg and 500 mg/kg RESPECTIVELY.

Residual Soil Contamination (ch. NR 718, chs. 500 to 536, Wis. Adm. Code or ch. 289, Wis. Stats.) Soil contamination remains as indicated on the **attached map (Figure 4)**. If any contaminated soil is excavated in the future, the property owner or right-of-way holder at the time of excavation must sample and analyze the excavated soil to determine if contamination remains. If sampling confirms that contamination is present, the property owner or right-of-way holder at the time of excavation will need to determine whether the material is considered solid or hazardous waste and ensure that any storage, treatment or disposal is in compliance with applicable standards and rules. Contaminated soil may be managed in accordance with ch. NR 718, Wis. Adm. Code, with prior DNR approval.

- remaining soil contamination map (Figure 4)
- extent of cap map (Figure 4)
- maintenance plan

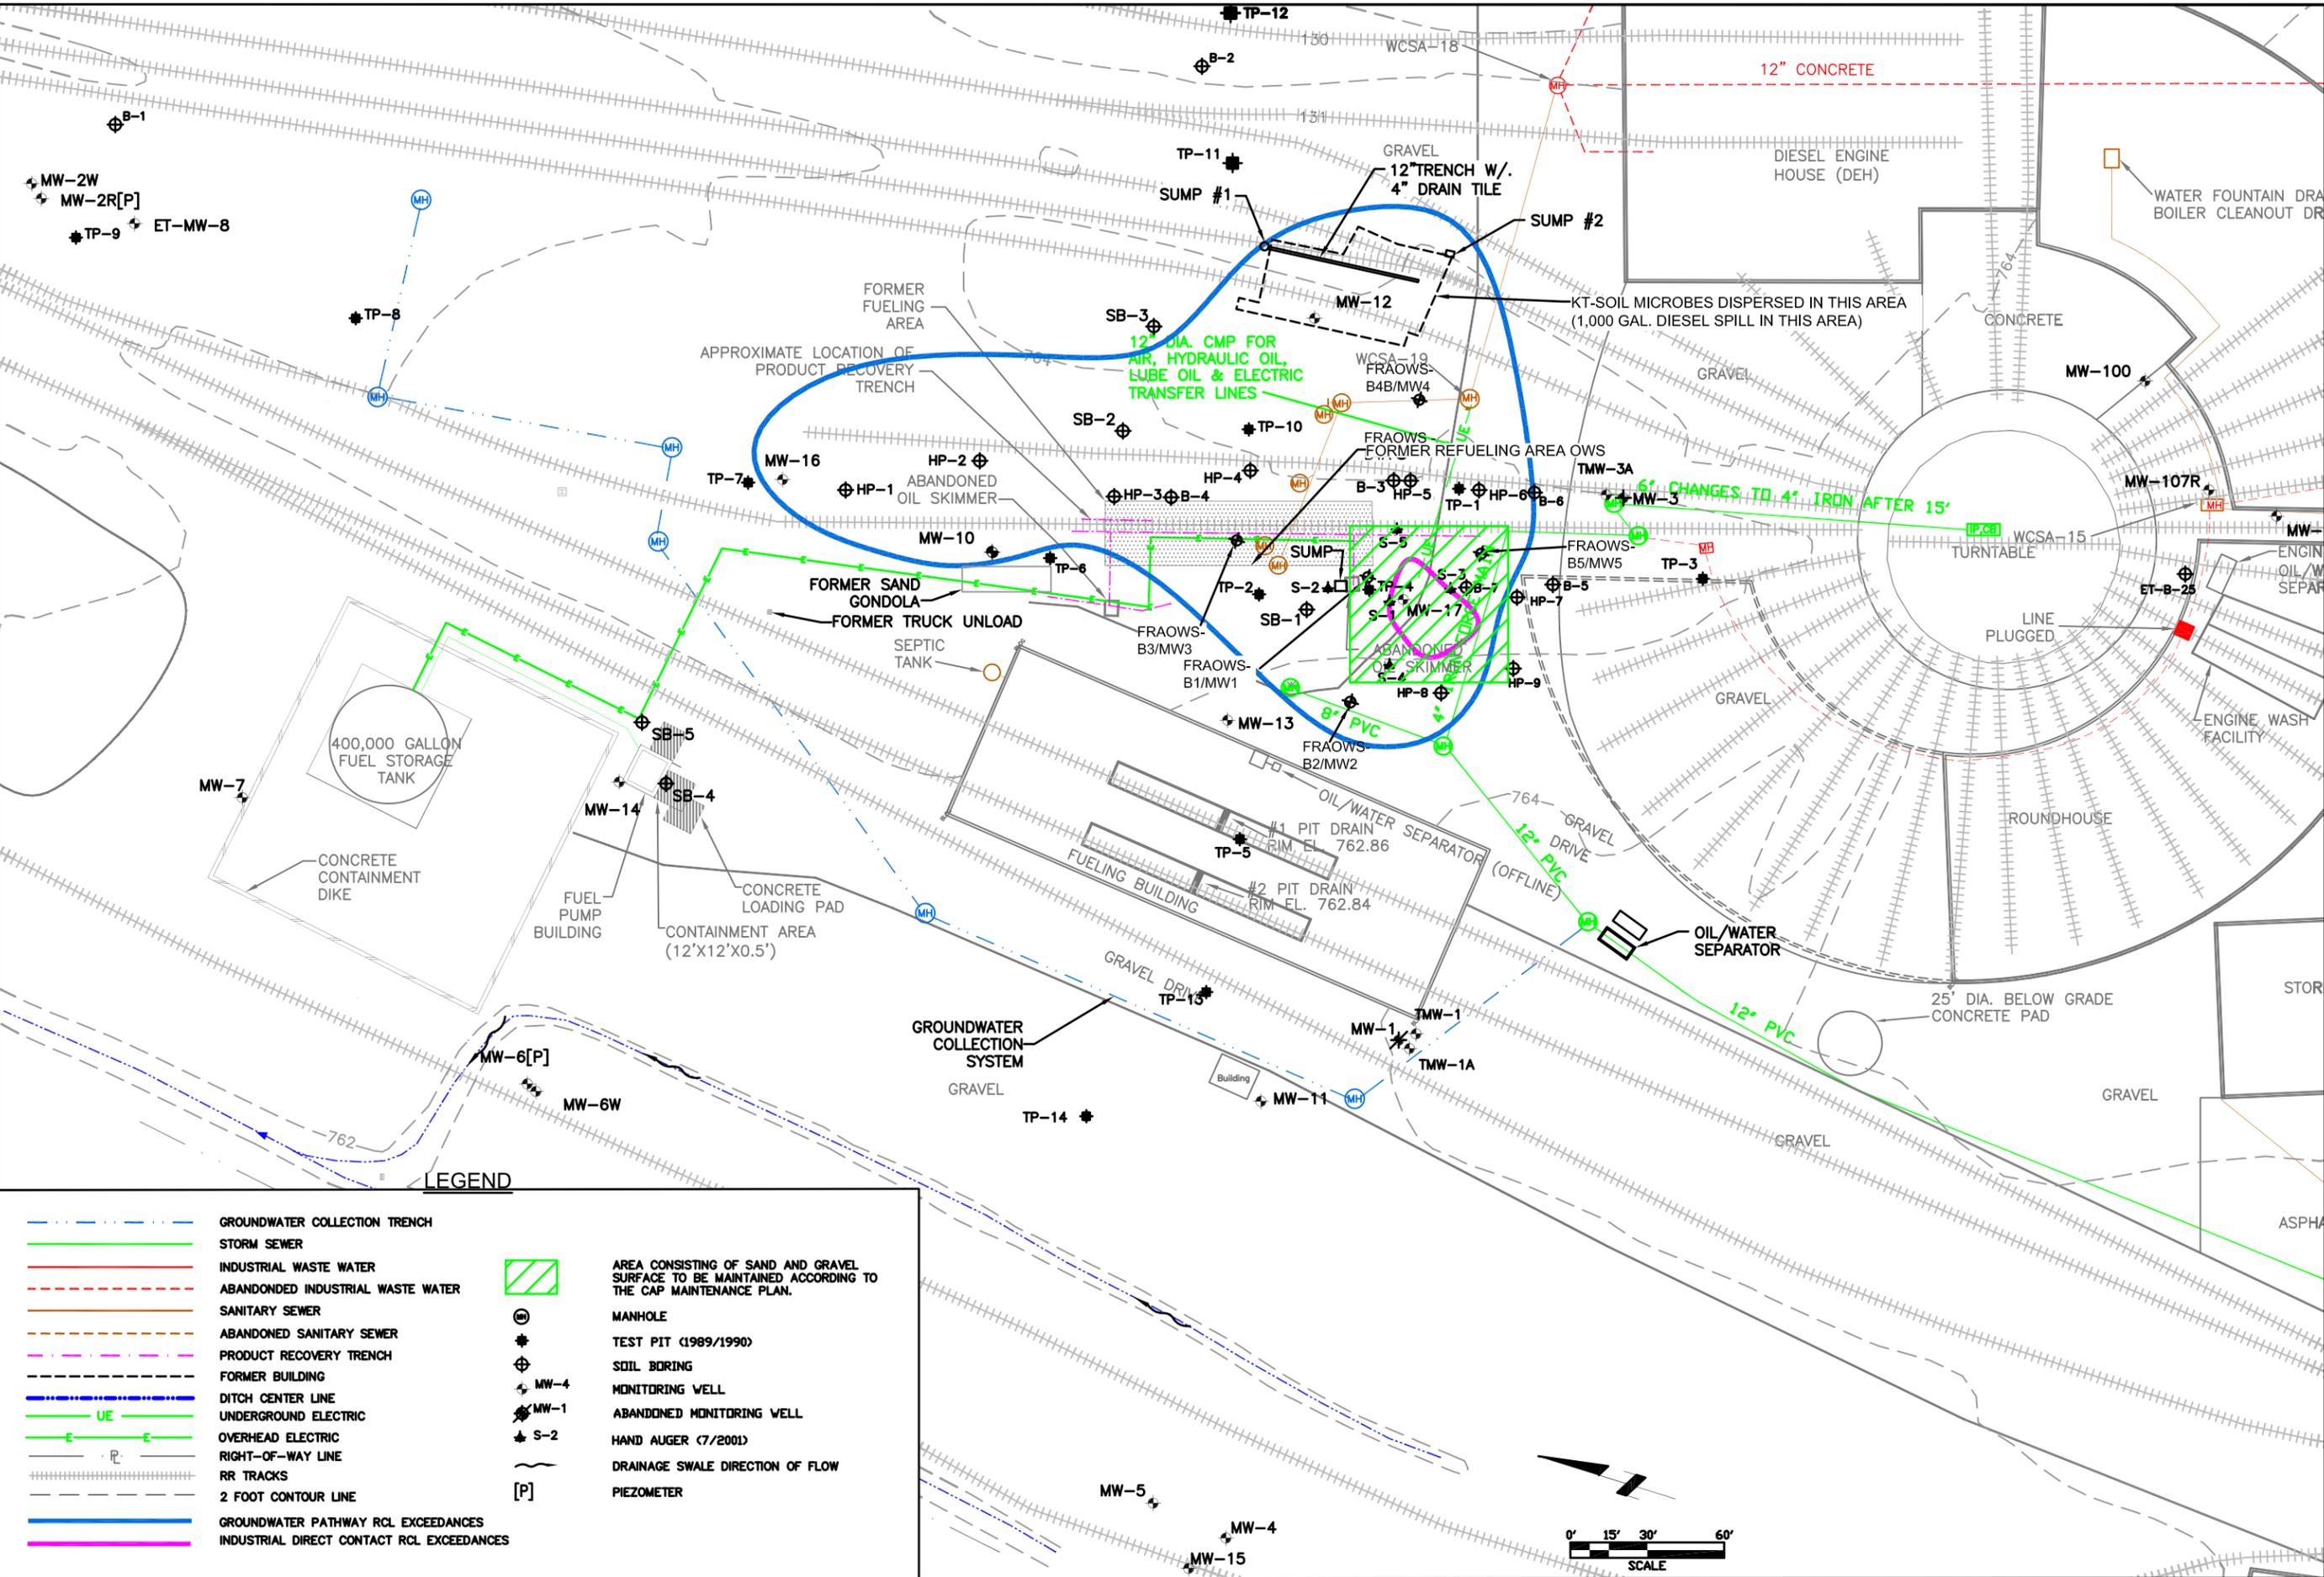
WISCONSIN CENTRAL, LTD
 NORTH FOND DU LAC RAIL YARD
 NORTH FOND DU LAC, WISCONSIN
 AECOM
 60135737
 FIGURE 6

LEGEND	
	GROUNDWATER COLLECTION TRENCH
	STORM SEWER
	INDUSTRIAL WASTE WATER
	ABANDONED INDUSTRIAL WASTE WATER
	SANITARY SEWER
	ABANDONED SANITARY SEWER
	PRODUCT RECOVERY TRENCH
	FORMER BUILDING
	DITCH CENTER LINE
	UNDERGROUND ELECTRIC
	OVERHEAD ELECTRIC
	RIGHT-OF-WAY LINE
	RR TRACKS
	2 FOOT CONTOUR LINE
	GROUNDWATER PATHWAY RCL EXCEEDANCES
	INDUSTRIAL DIRECT CONTACT RCL EXCEEDANCES
	AREA CONSISTING OF SAND AND GRAVEL SURFACE TO BE MAINTAINED ACCORDING TO THE CAP MAINTENANCE PLAN.
	MANHOLE
	TEST PIT (1989/1990)
	SOIL BORING
	MW-4 MONITORING WELL
	MW-1 ABANDONED MONITORING WELL
	S-2 HAND AUGER (7/2001)
	DRAINAGE SWALE DIRECTION OF FLOW
	PIEZOMETER

WISCONSIN CENTRAL, LTD - REFUELING AREA - BRRTS No. 02-20-000914

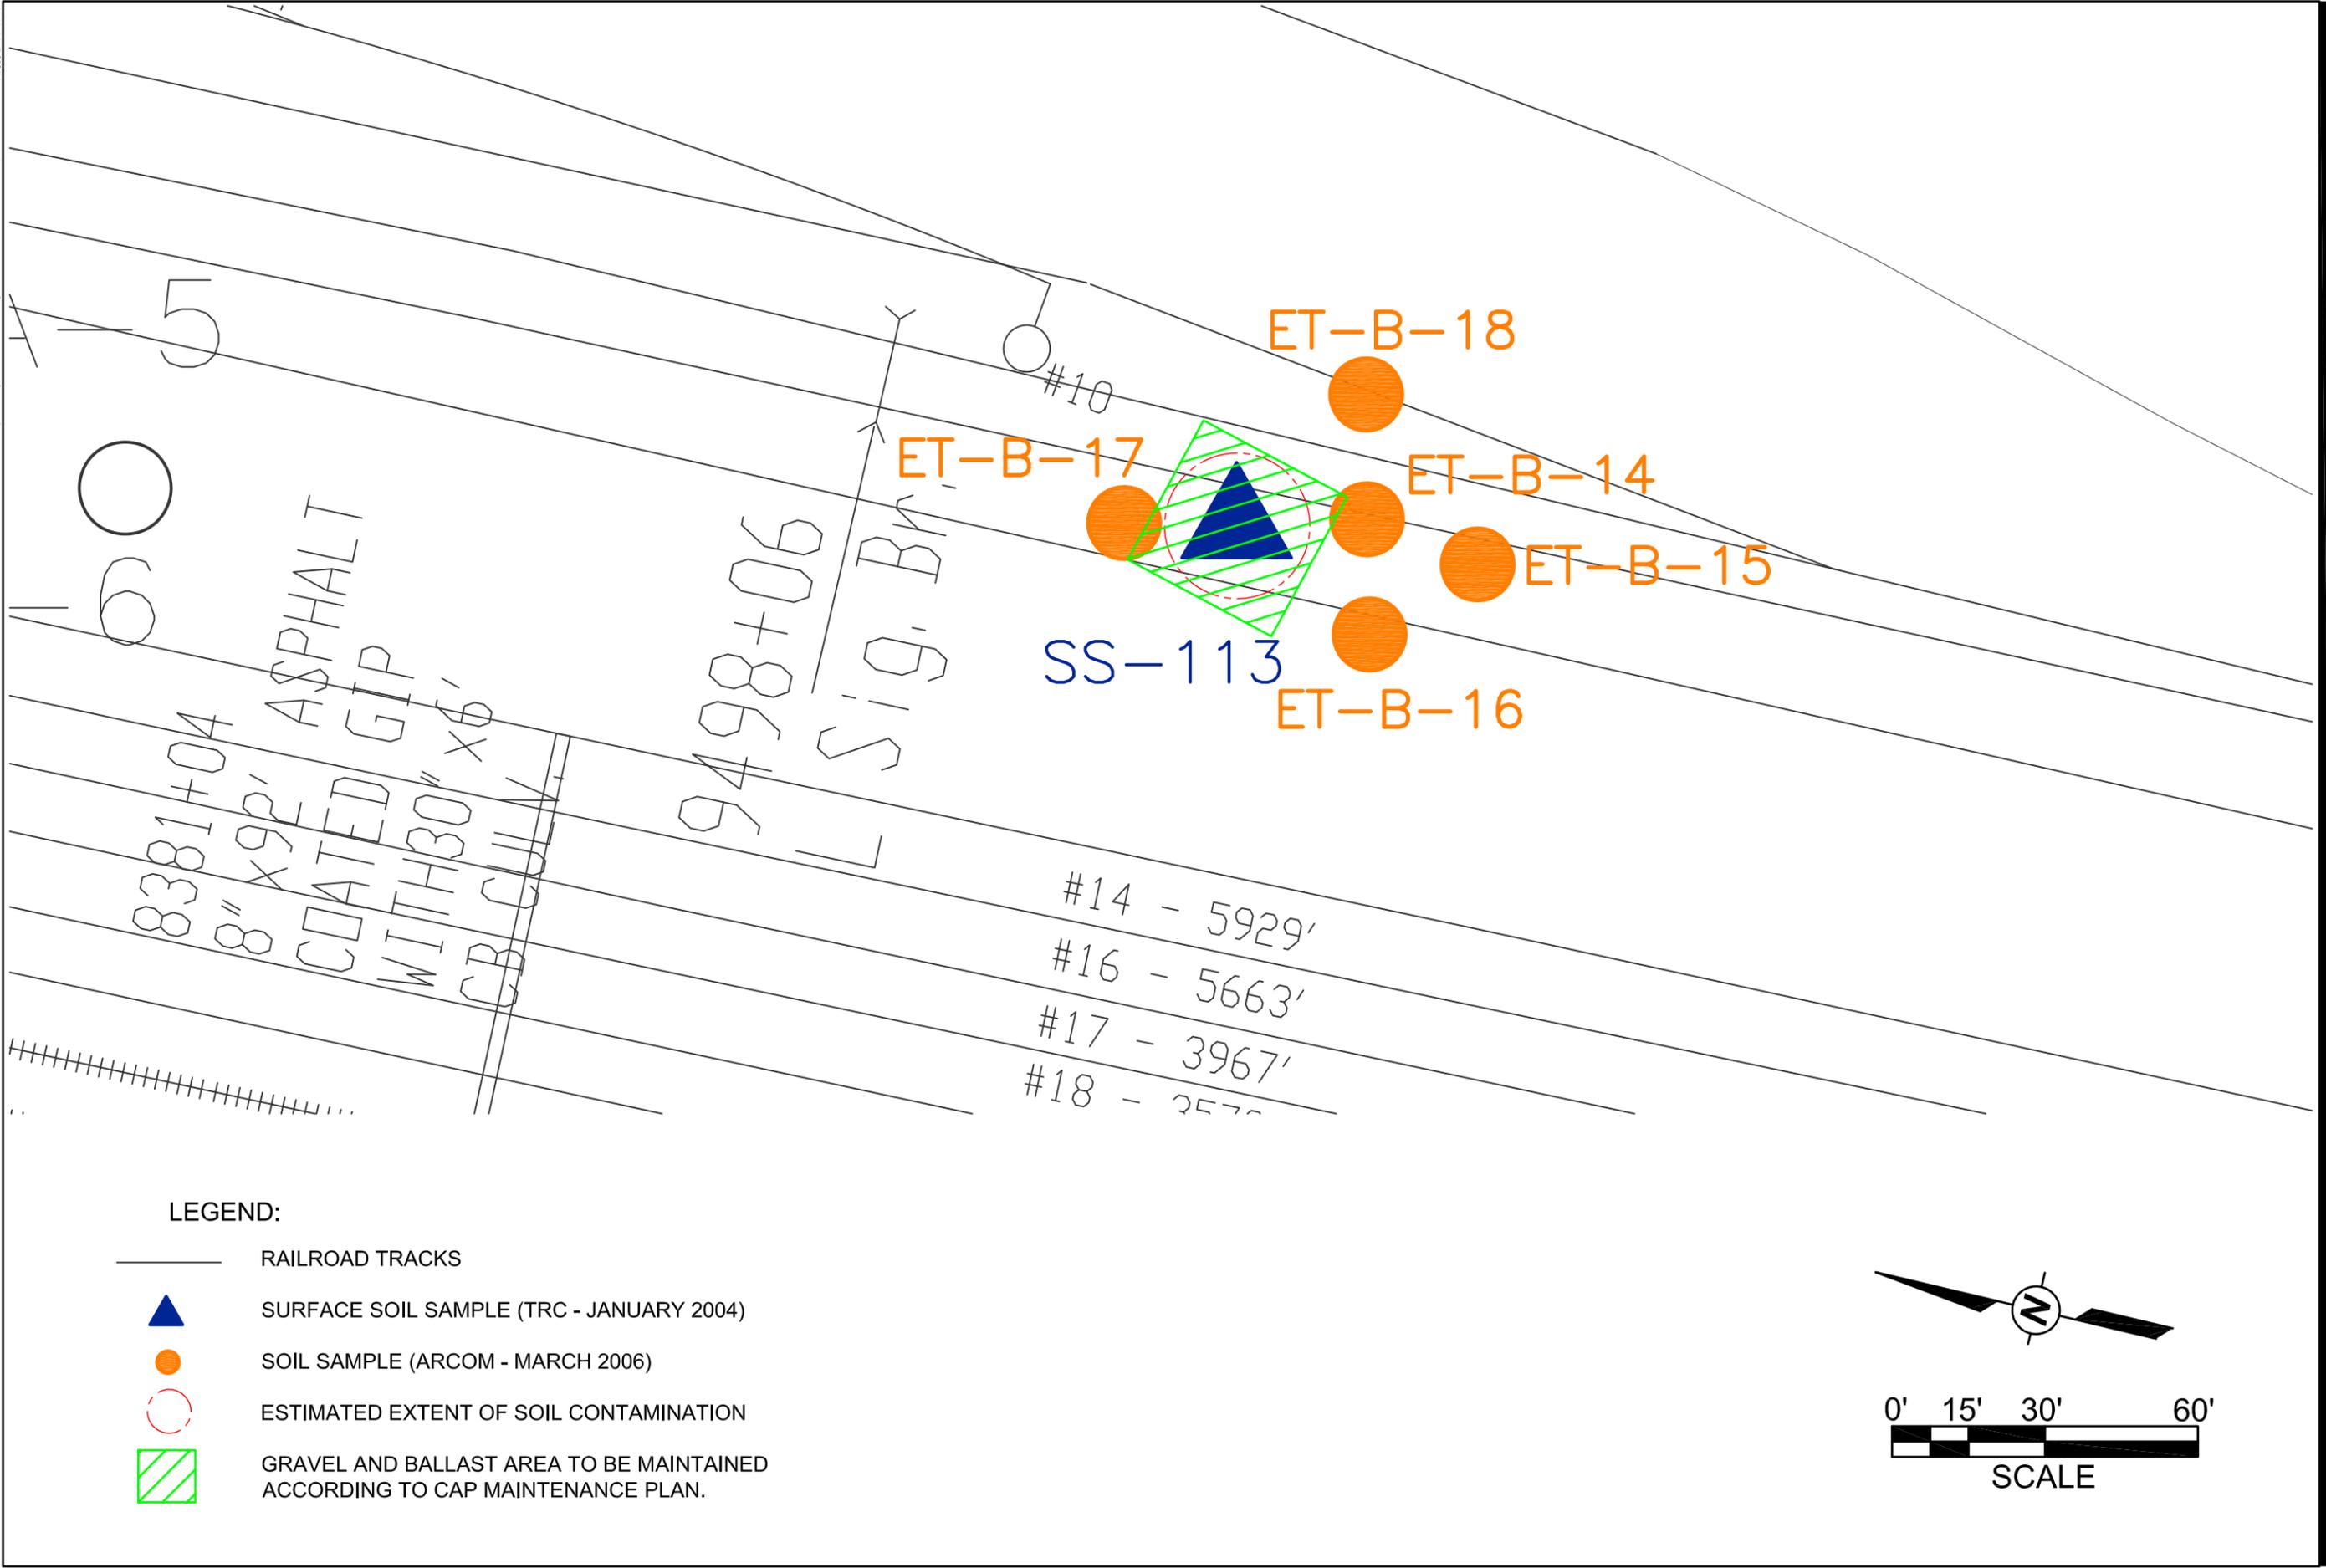
- RAILROAD TRACKS
- SURFACE SOIL SAMPLE (TRC - JANUARY 2004)
- SOIL SAMPLE (ARCOM - MARCH 2006)
- ESTIMATED EXTENT OF SOIL CONTAMINATION
- GRAVEL AND BALLAST AREA TO BE MAINTAINED ACCORDING TO CAP MAINTENANCE PLAN.

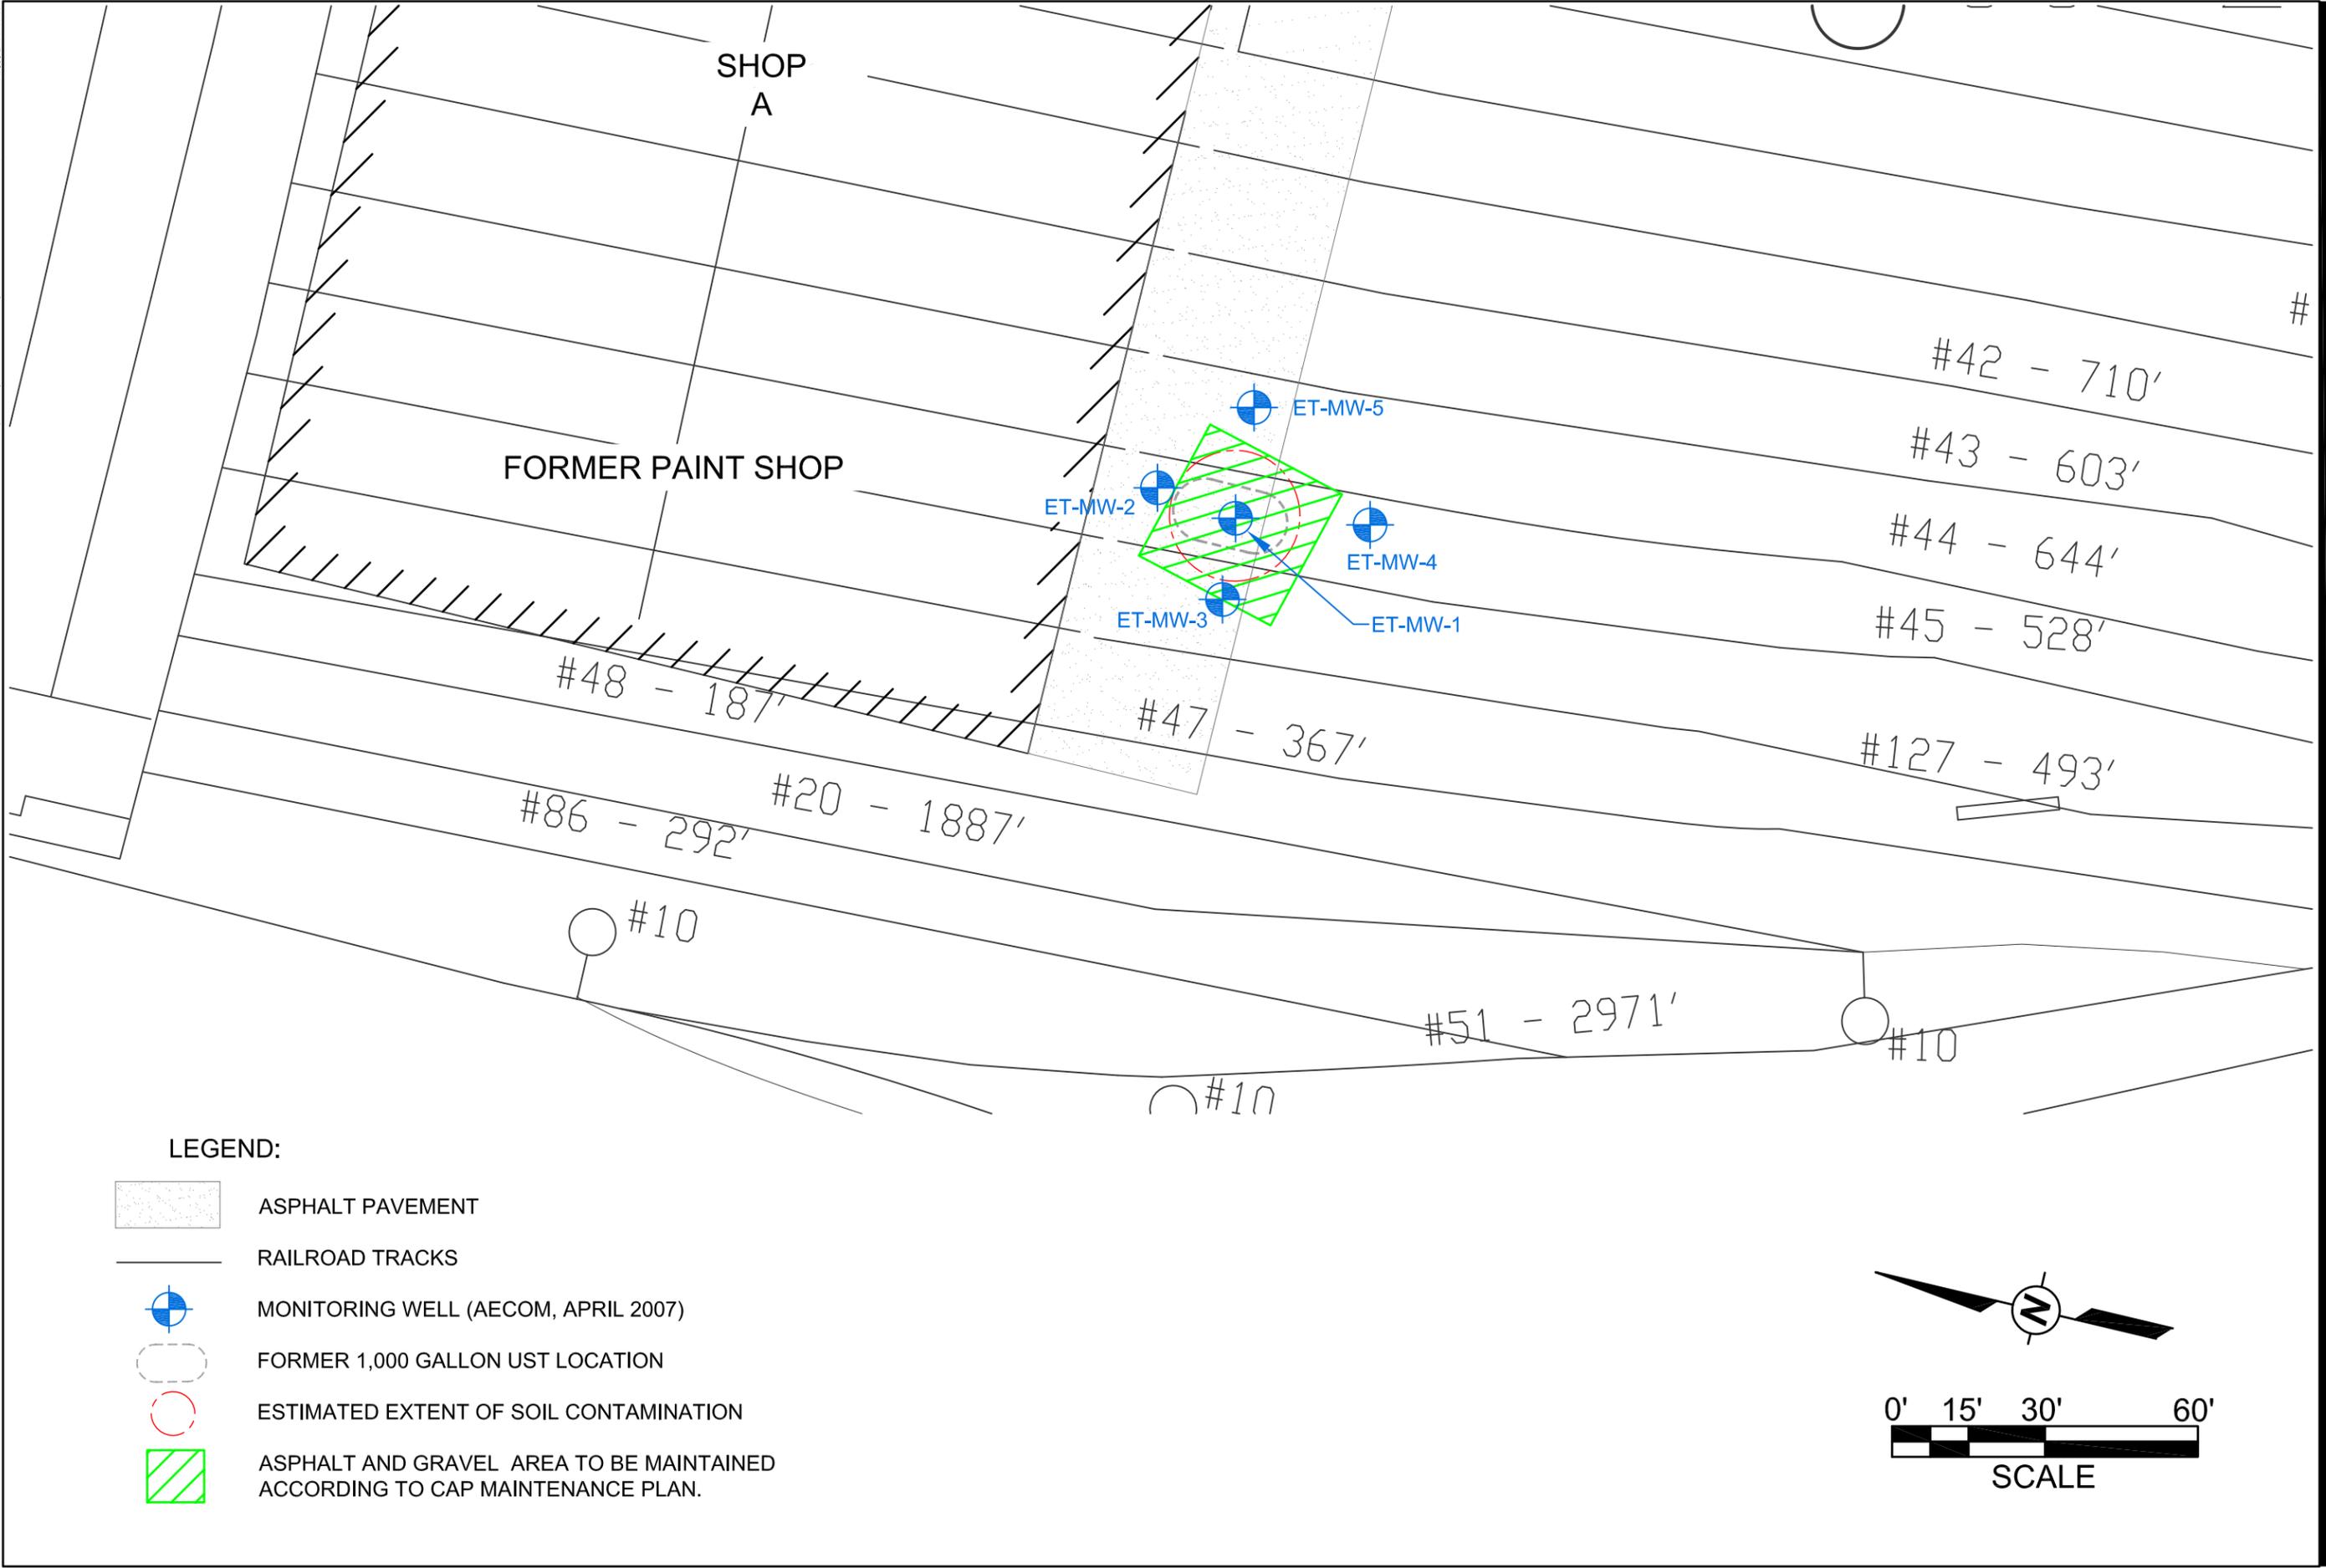
- ASPHALT PAVEMENT
- RAILROAD TRACKS
- MONITORING WELL (AECOM, APRIL 2007)
- FORMER 1,000 GALLON UST LOCATION
- ESTIMATED EXTENT OF SOIL CONTAMINATION
- ASPHALT AND GRAVEL AREA TO BE MAINTAINED ACCORDING TO CAP MAINTENANCE PLAN.
