Source Property Information

BRRTS #: 02-20-297826
ACTIVITY NAME: Canadian National Railway - Storehouse
PROPERTY ADDRESS: 2 Harrison Street
MUNICIPALITY: North Fond du Lac
PARCEL ID #: V05-16-17-33-77-777-00

WISCONSIN CENTRAL, LTD
NORTH FOND DU LAC RAIL YARD

CAP and BIOPILE MAINTENANCE PLAN

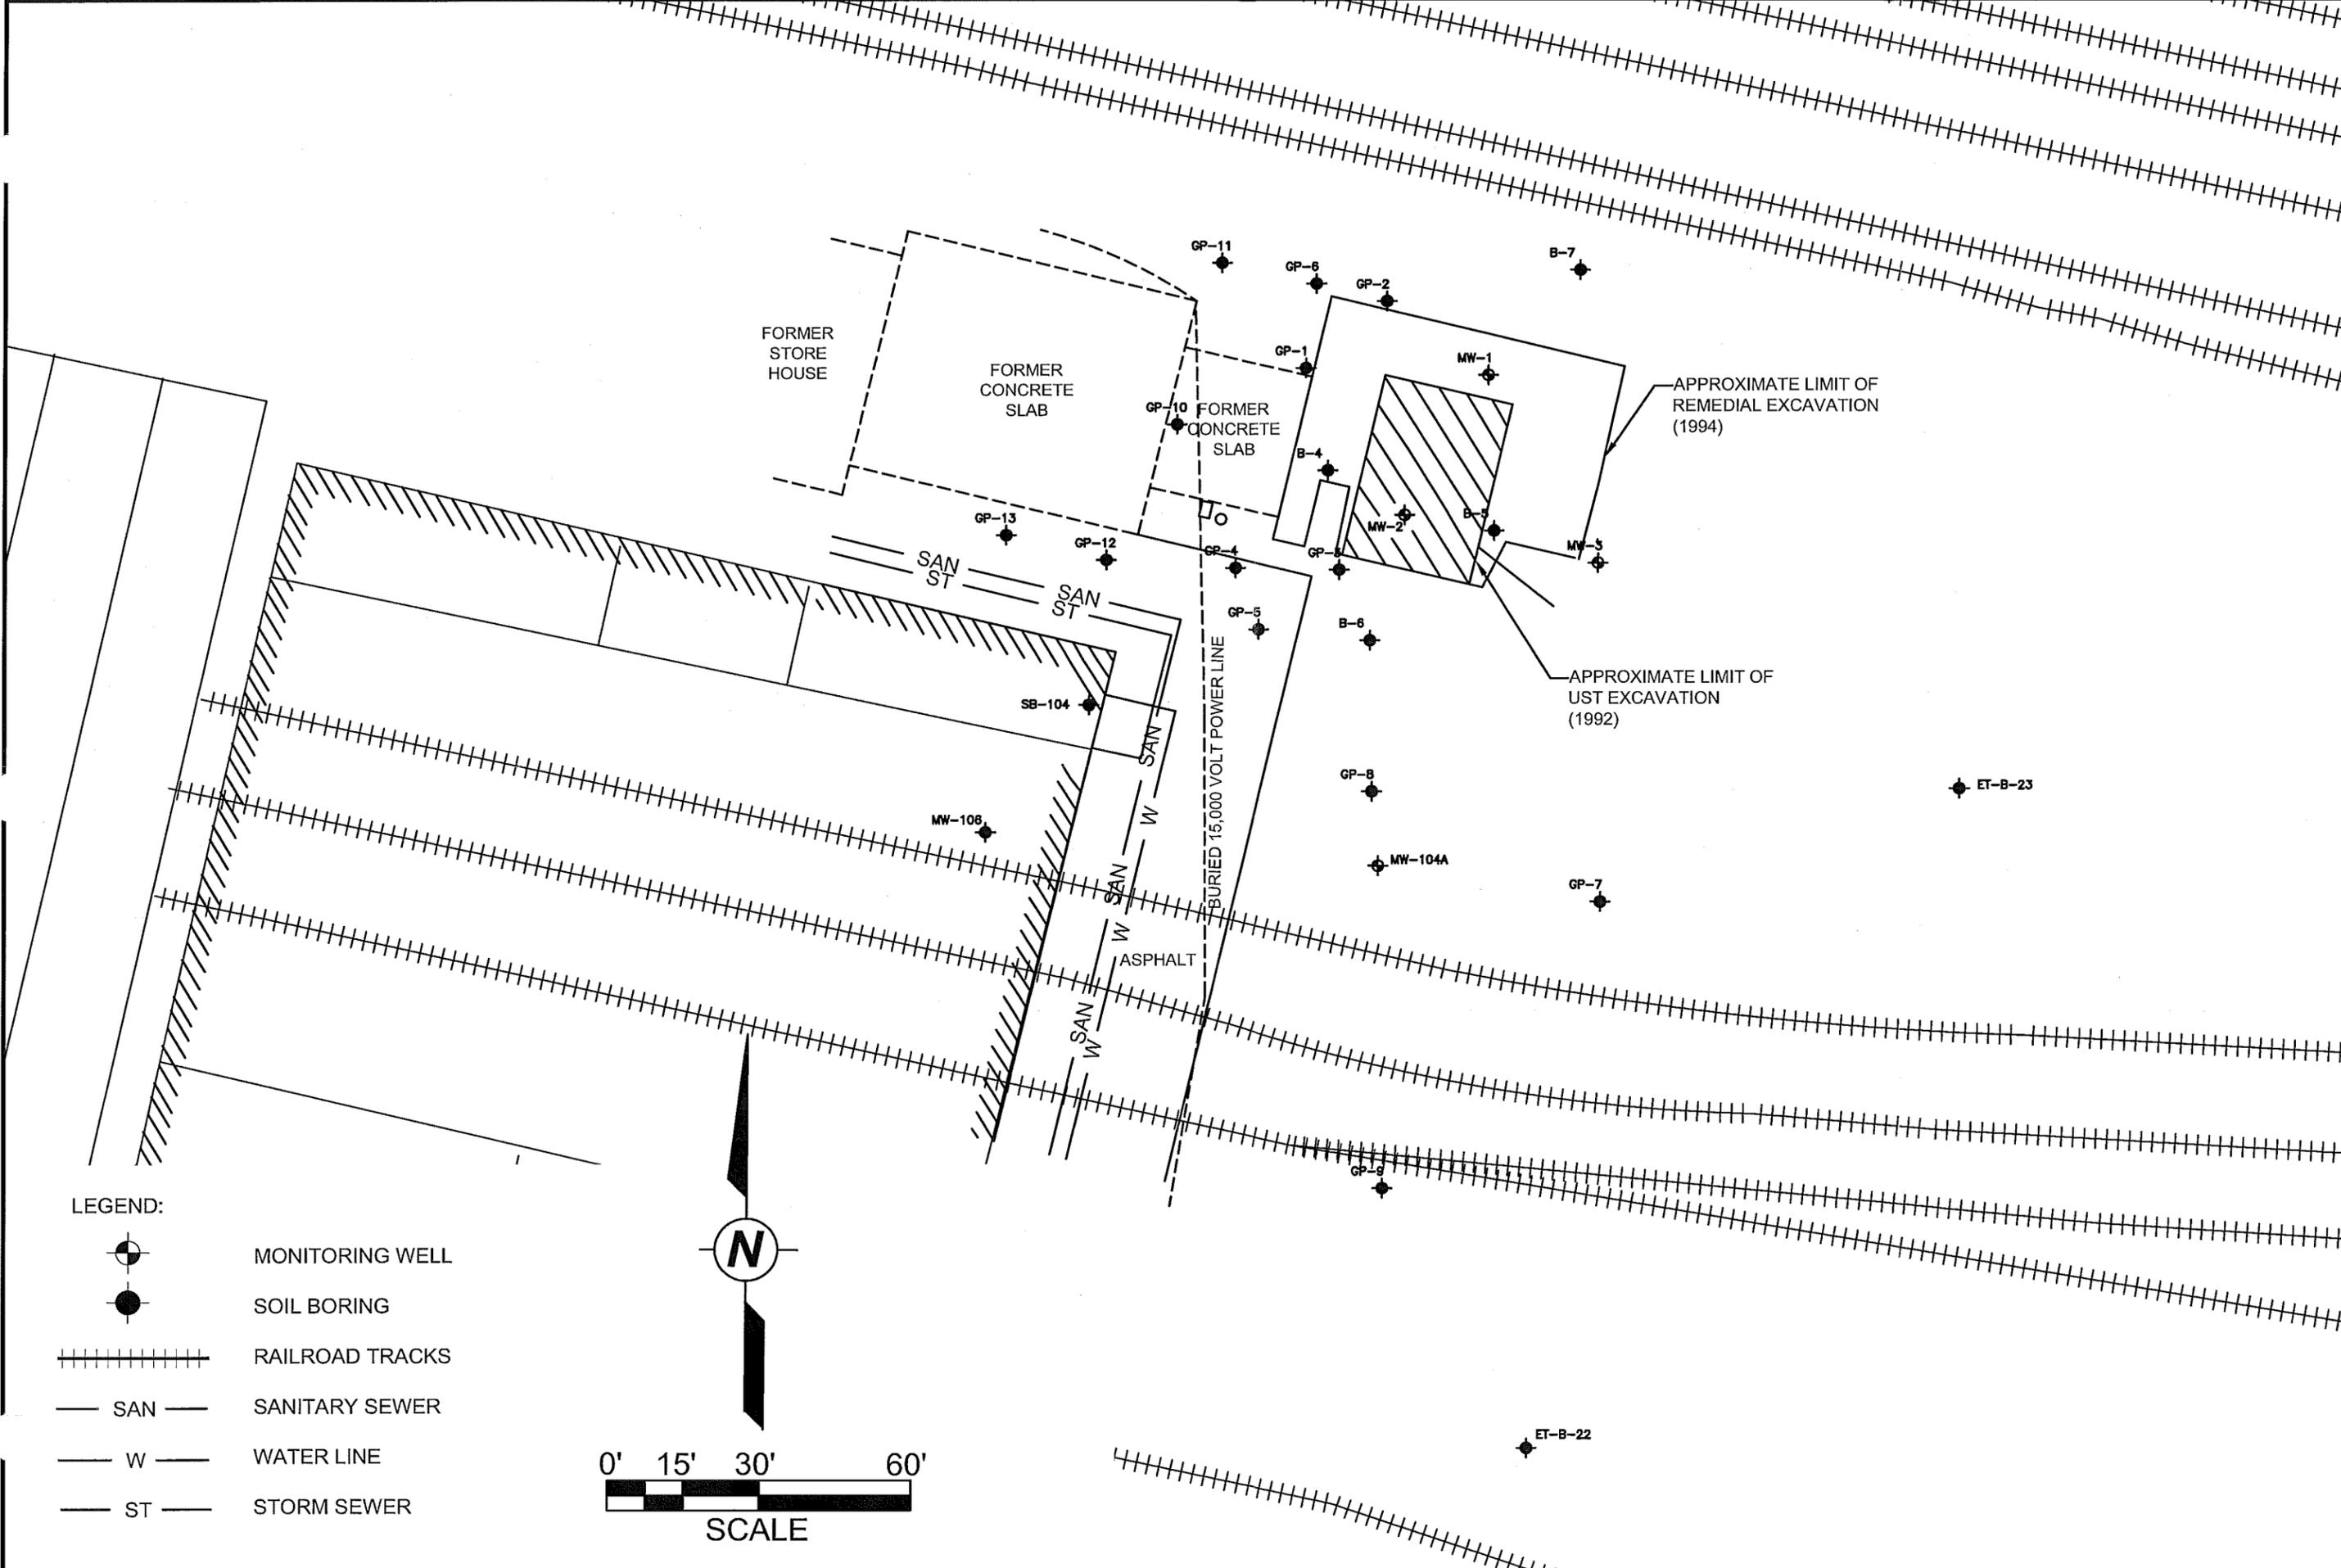
- LEGEND:**
- MONITORING WELL
 - SOIL BORING
 - RAILROAD TRACKS
 - SAN SANITARY SEWER
 - W WATER LINE
 - ST STORM SEWER

- Detailed Site Map:** A map that shows all relevant features (buildings, roads, individual property boundaries, contaminant sources, utility lines, monitoring wells and potable wells) within the contaminated area. This map is to show the location of all contaminated public streets, and highway and railroad rights-of-way in relation to the source property and in relation to the boundaries of groundwater contamination exceeding a ch. NR 140 Enforcement Standard (ES), and/or in relation to the boundaries of soil contamination exceeding a Residual Contaminant Level (RCL) or a Site Specific Residual Contaminant Levels (SSRCL) as determined under s. NR 720.09, 720.11 and 720.19.
Figure #: 3 **Title: Soil Boring and Monitoring Well Location Plan**

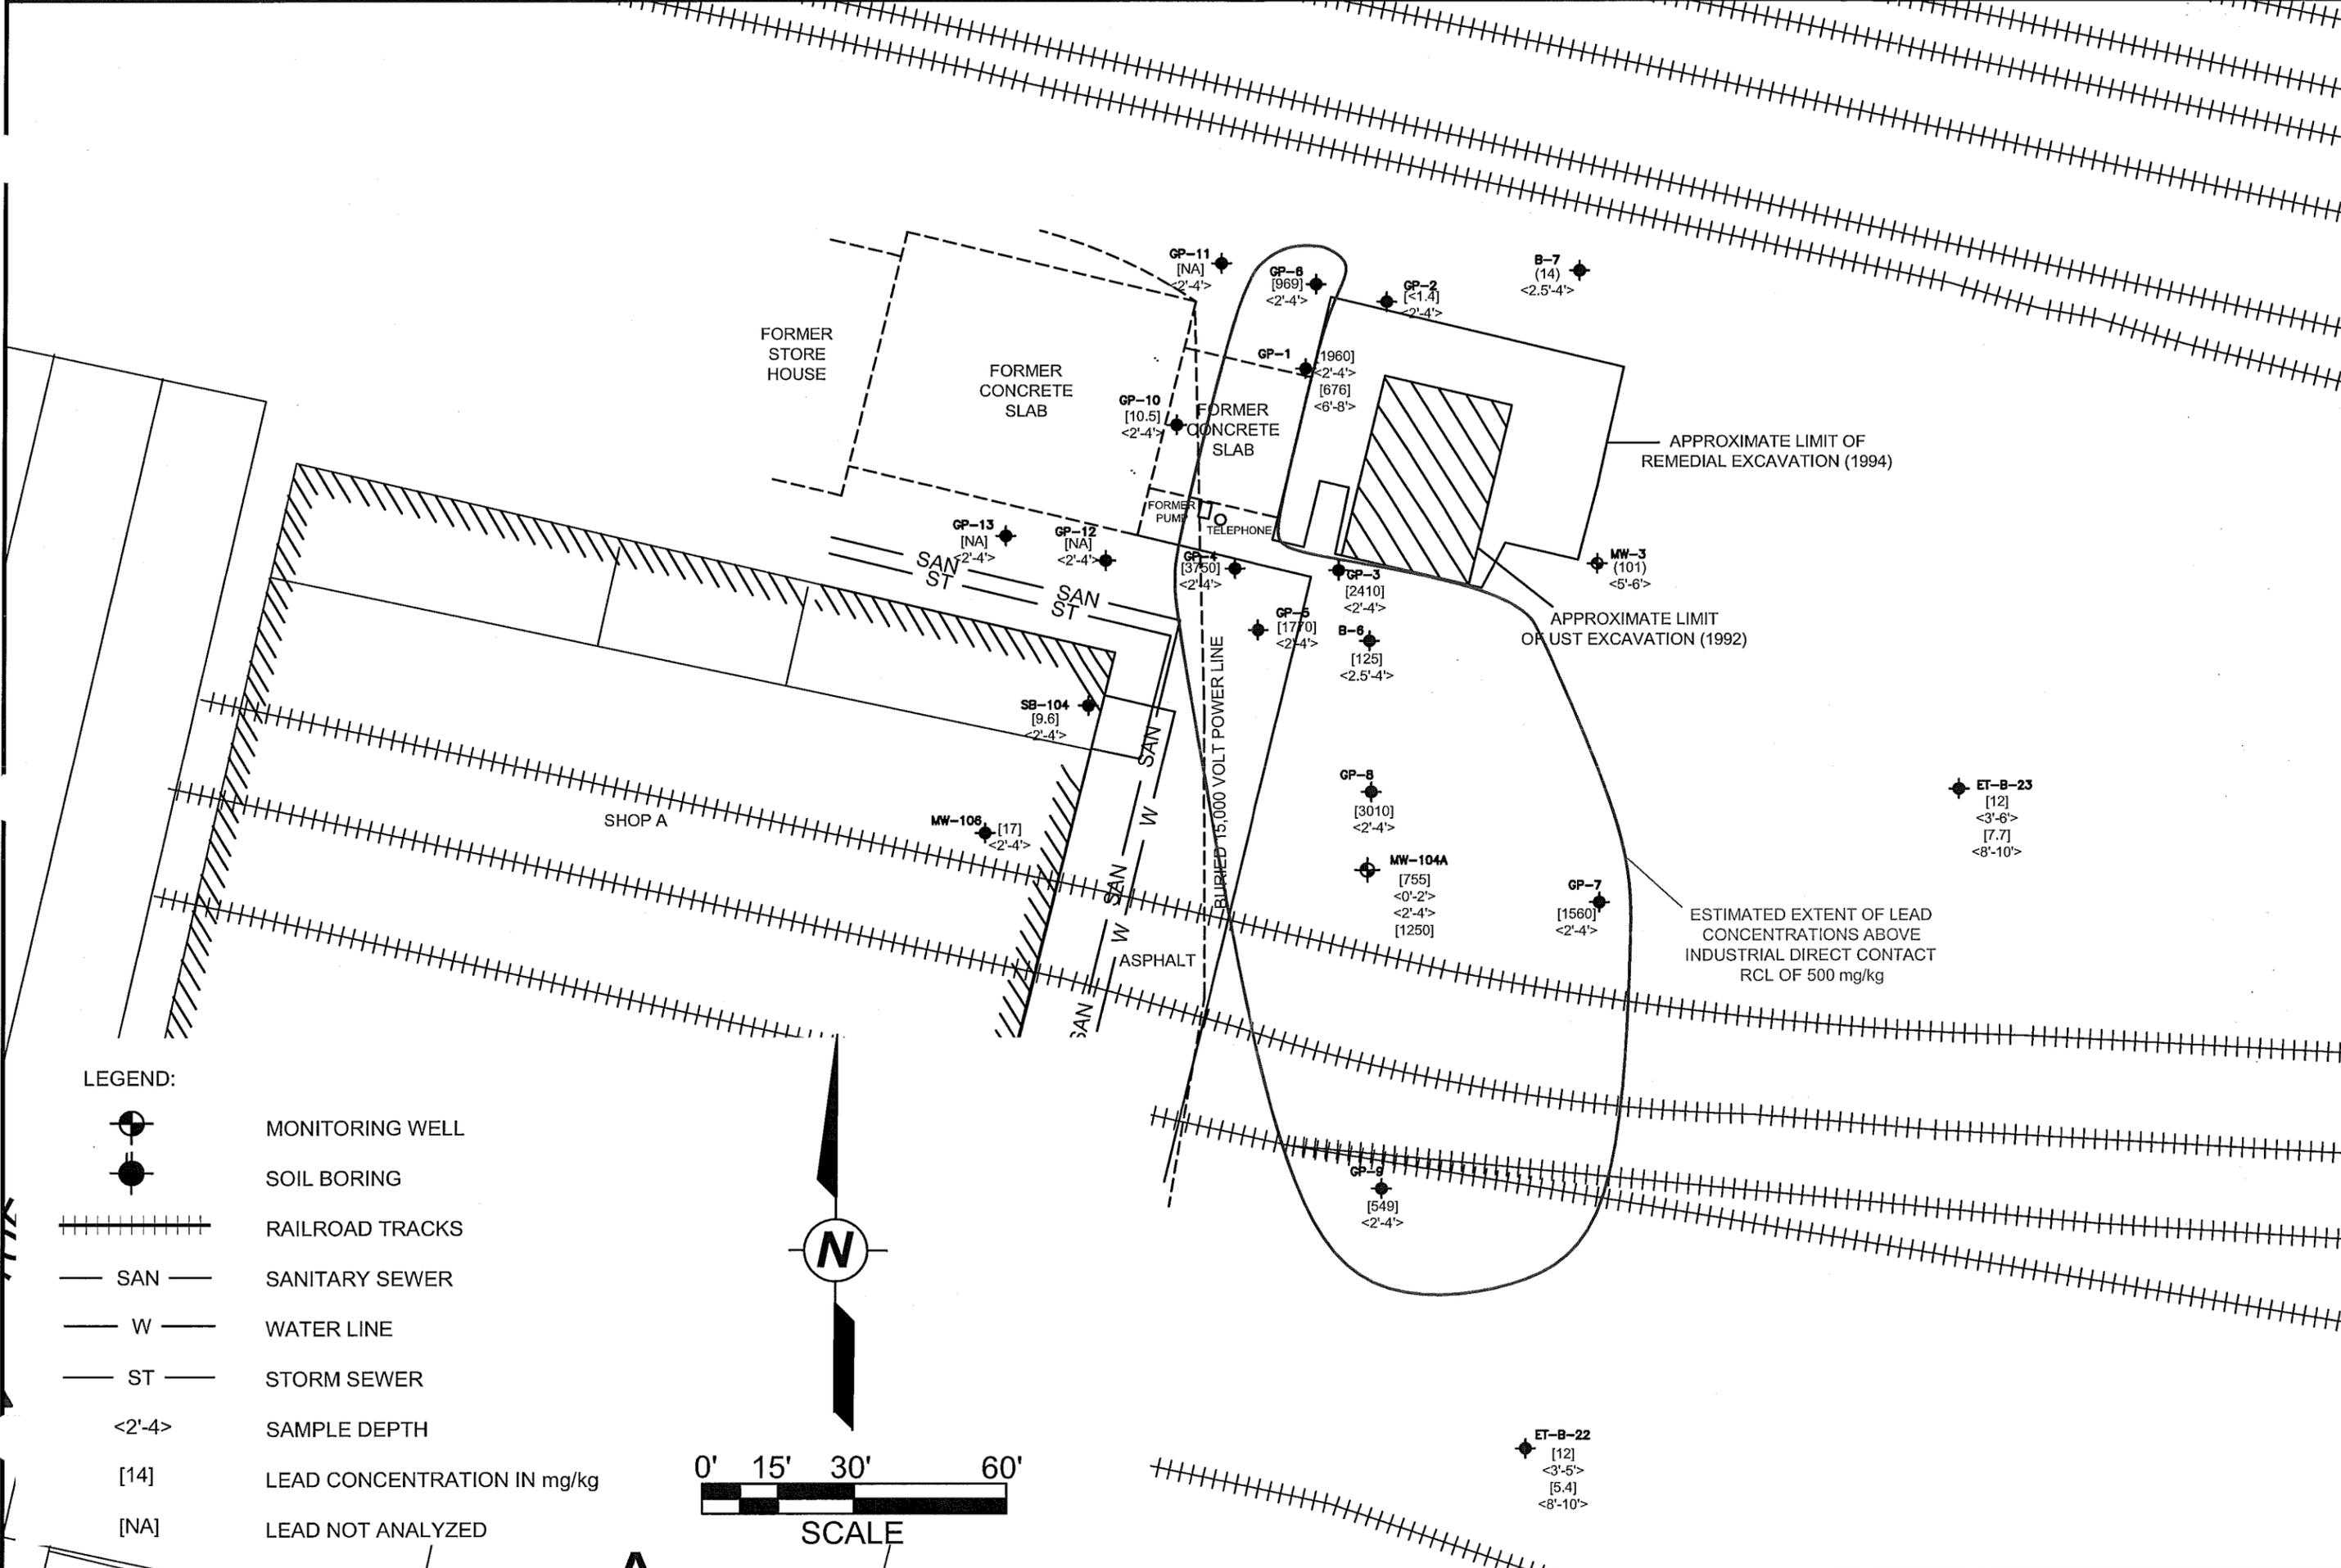
- LEGEND:**
- MONITORING WELL
 - SOIL BORING
 - RAILROAD TRACKS
 - SANITARY SEWER
 - WATER LINE
 - STORM SEWER
 - SAMPLE DEPTH
 - LEAD CONCENTRATION IN mg/kg
 - LEAD NOT ANALYZED

- Soil Contamination Contour Map:** For sites closing with residual soil contamination, this map is to show the location of all contaminated soil and a single contour showing the horizontal extent of each area of contiguous residual soil contamination that exceeds a Residual Contaminant Level (RCL) or a Site Specific Residual Contaminant Level (SSRCL) as determined under s. NR 720.09, 720.11 and 720.19.
Figure #: 5 **Title: Soil Results (Post-Excavation)**
