# GIS REGISTRY

## Cover Sheet

### Source Property Information

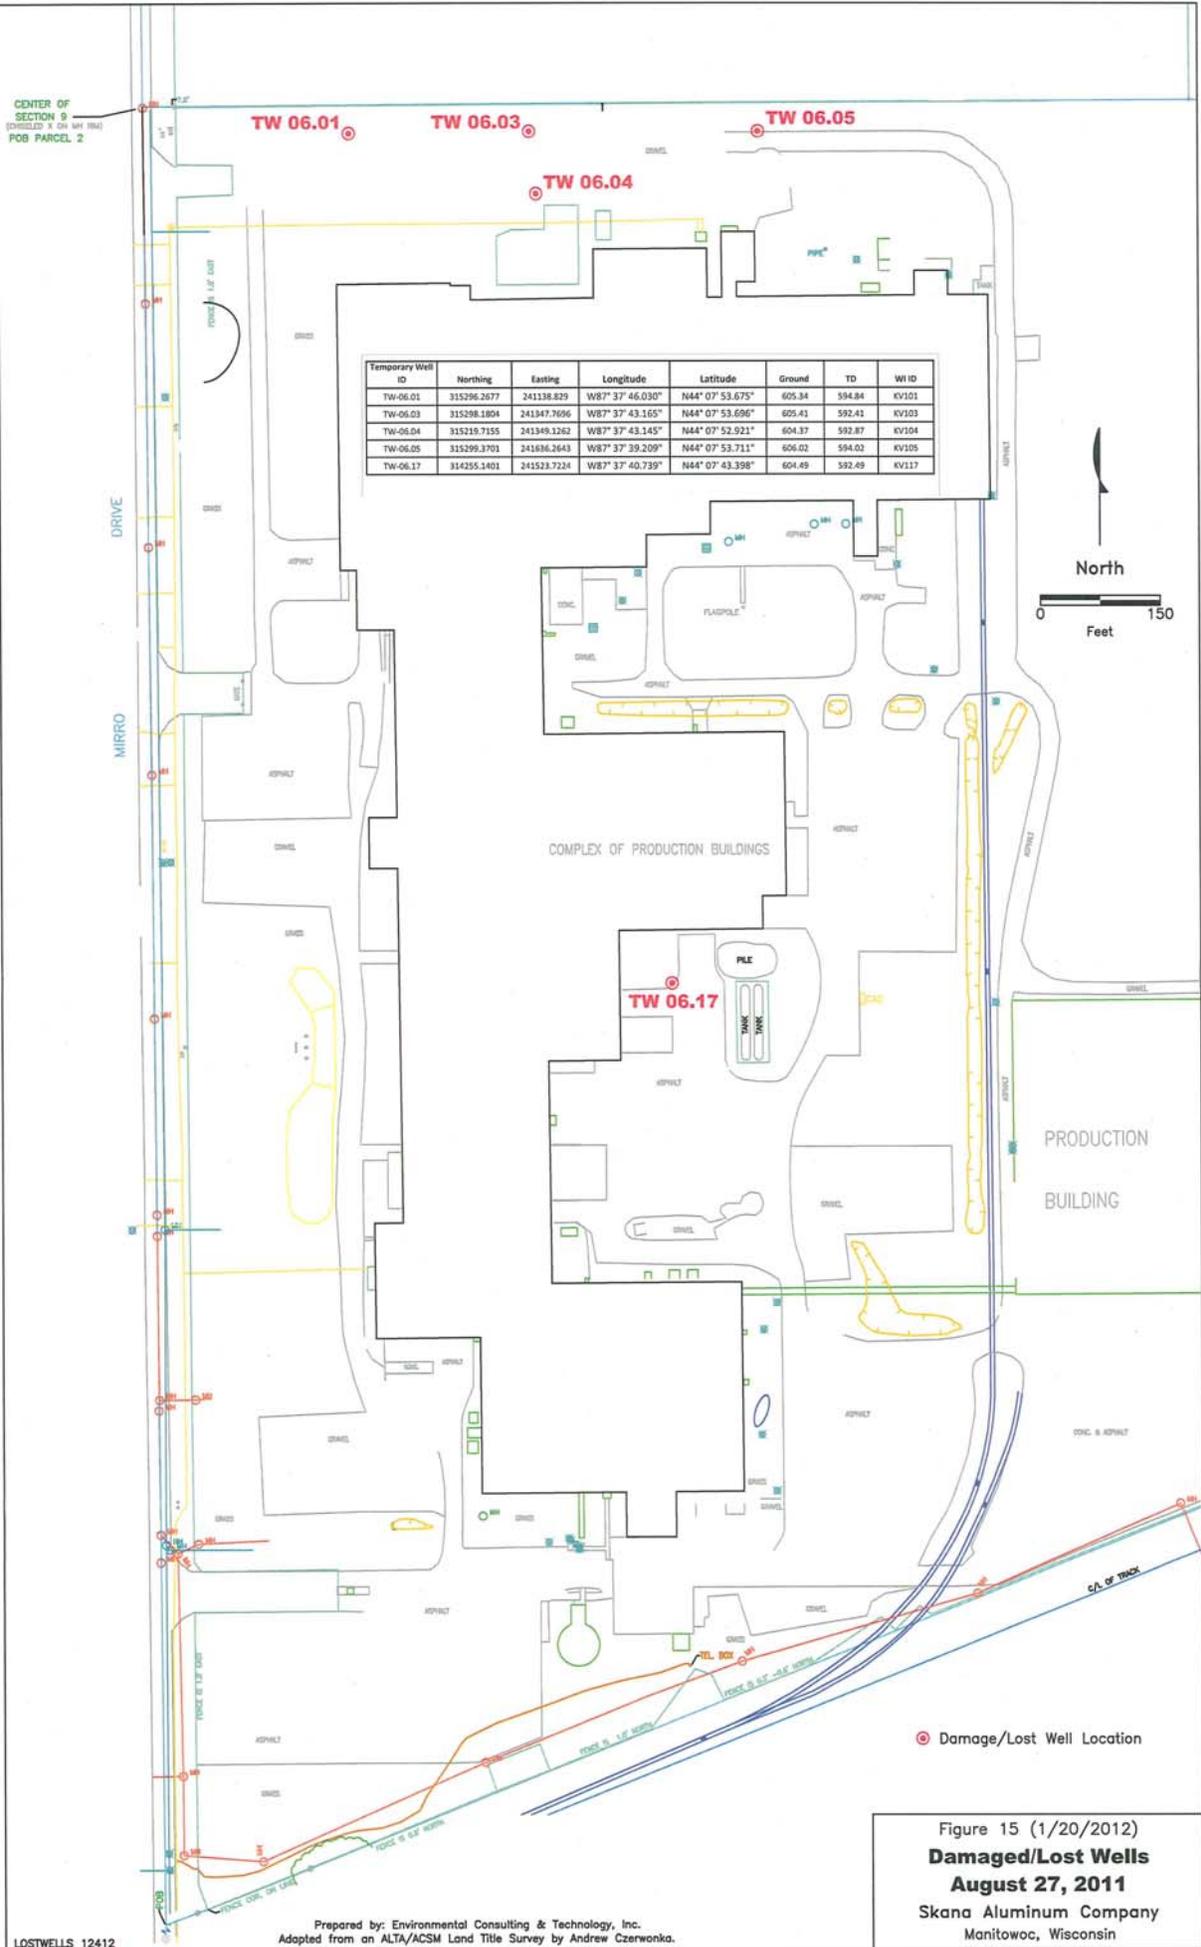
Figure 15 (1/20/2012)  
**Damaged/Lost Wells**  
**August 27, 2011**  
Skana Aluminum Company  
Manitowoc, Wisconsin

Temporary monitoring well(s) TW-06.01, TW-06.03 TW-06.04, TW-06.05, TW06.11, TW-06.17 located on the Skana Aluminum property as shown on the attached map, could not be properly filled and sealed because they could not be found. Your consultant made a reasonable effort to locate the wells and to determine whether they were properly filled and sealed, but was unsuccessful. You may be held liable for any problems associated with the monitoring wells if they create a conduit for contaminants to enter groundwater. If any of the groundwater monitoring wells are found, the then current owner of the property on which the well is located is required to notify the DNR, to properly fill and seal the wells and to submit the required documentation to the DNR.

**Figure #: 15 Title: Damaged/Lost Wells August 27, 2011**

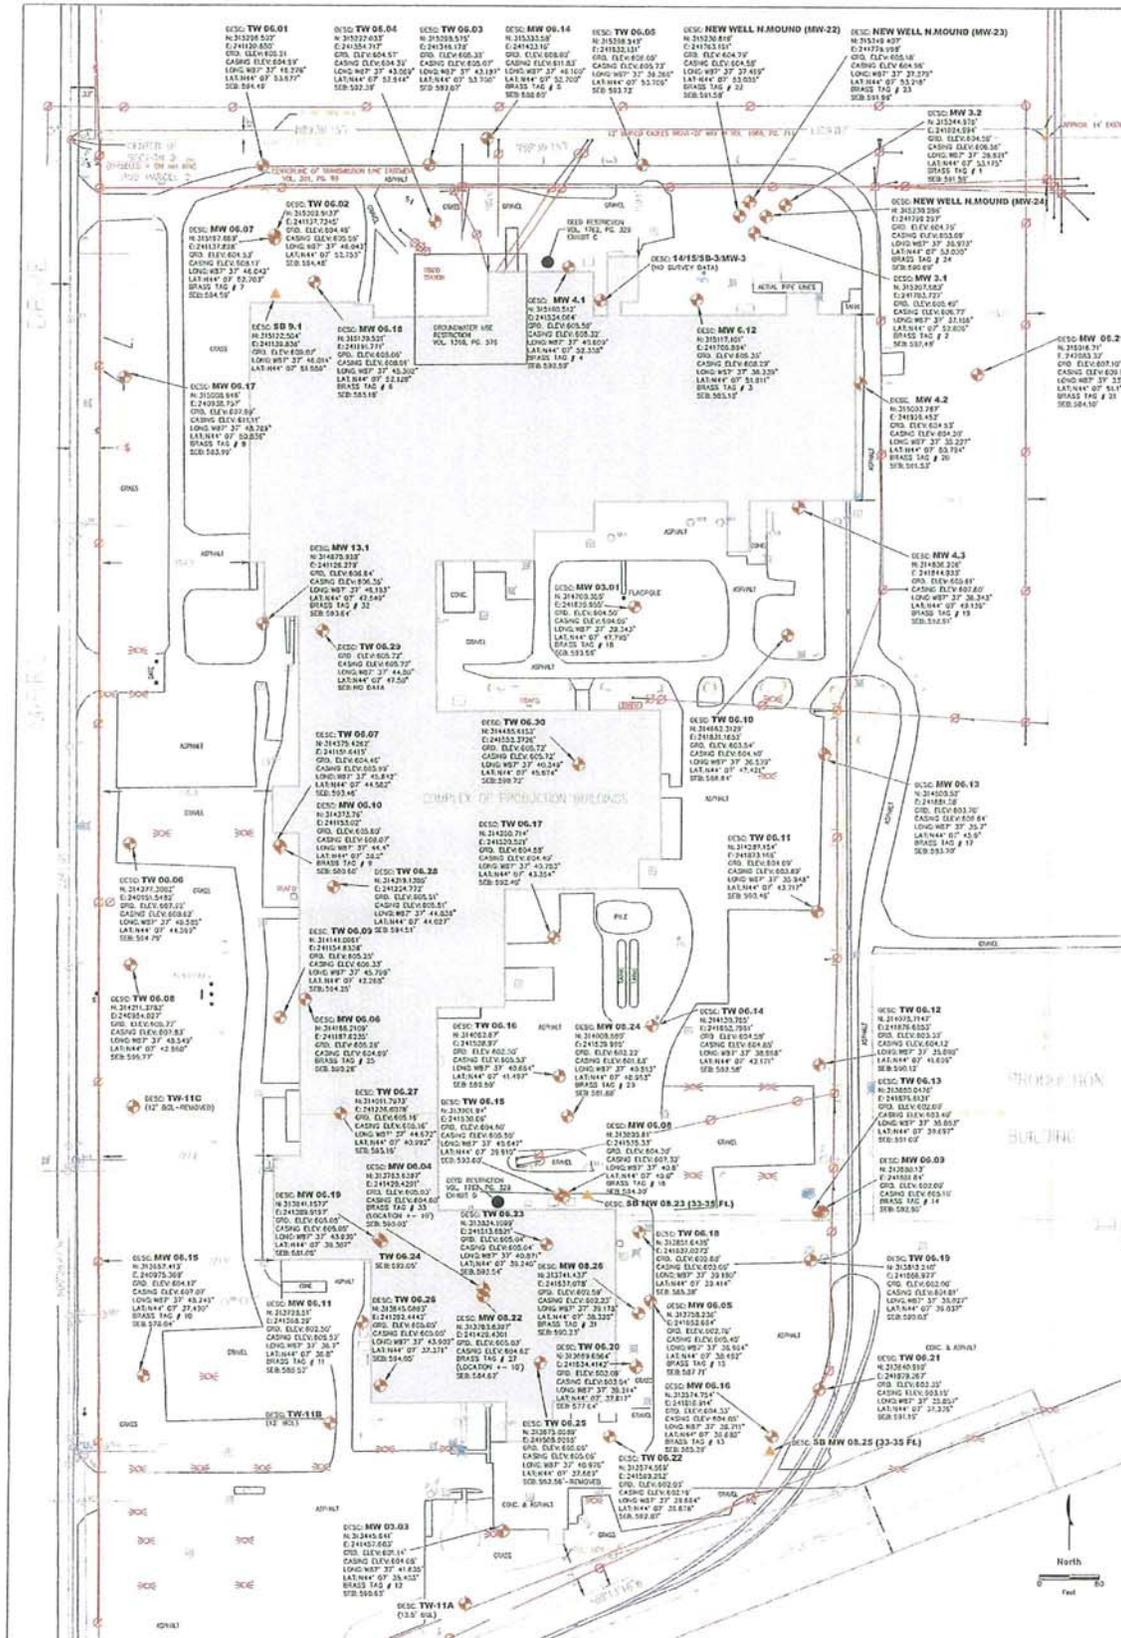
**Well Locations, Screen Depths & Soil Sample Locations (SB MW 08.23 & SB MW 08.25)**  
 Skana Aluminum Company  
 Manitowoc, Wisconsin  
 (Nov 2011)

MONITORING WELL DATA ACQUIRED BY STERNBERGER & MENAUE, INC., DECEMBER 3, 2010.  
 NOTE: THE LATITUDE AND LONGITUDE SHOWN IS BASED ON A COORDINATION FROM THE MANITOWOC COUNTY COORDINATE. THE ELEVATION DATUM IS USGS (NAVD83).  
 SOL BORING LOCATION (SB MW 08.23, SB MW 08.25) (SAMPLE DEPTH IN FEET)  
 SB - WELL SCREEN BOTTOM ELEVATION  
 Prepared by: Environmental Consulting & Technology, Inc.  
 Adapted from an ALTA/ACSM Land Title Survey by Andrew Czerwanka.

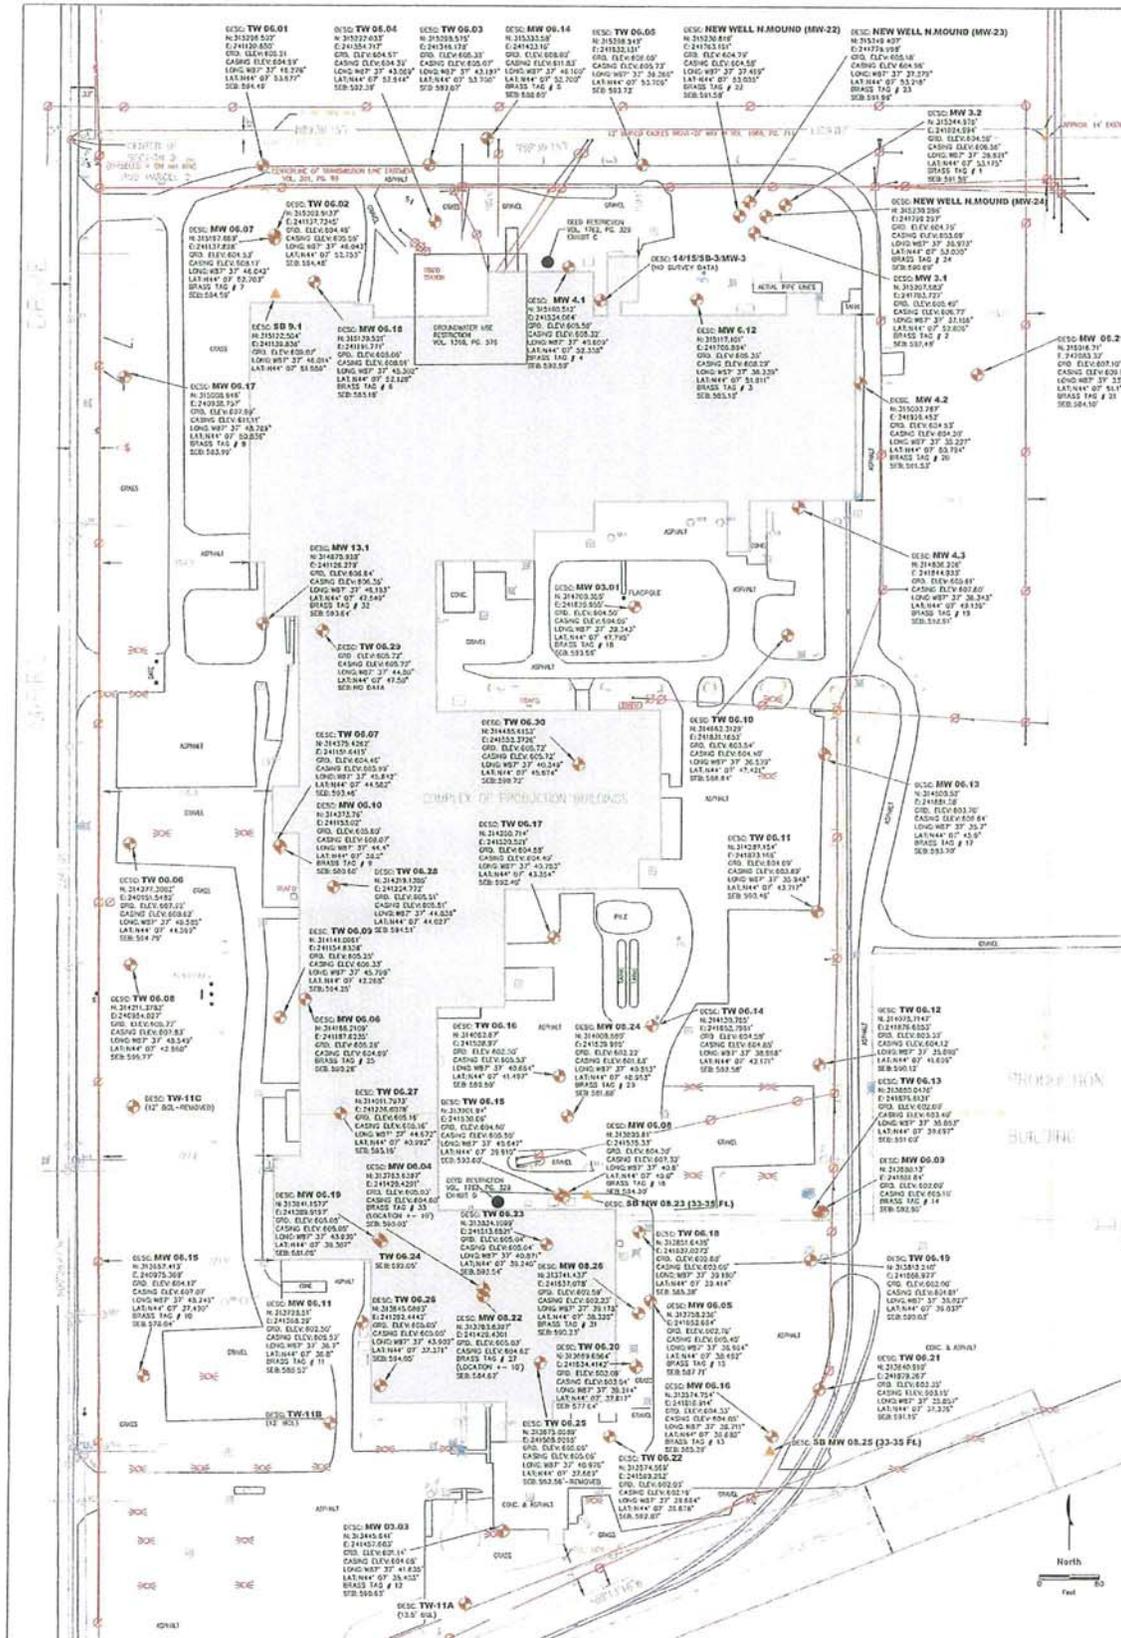
**Well Locations, Screen Depths & Soil Sample Locations (SB MW 08.23 & SB MW 08.25)**  
 Skana Aluminum Company  
 Manitowoc, Wisconsin  
 (Nov 2011)

MONITORING WELL DATA ACQUIRED BY STERNBERGER & MENAUE, INC., DECEMBER 3, 2010.  
 NOTE: THE LATITUDE AND LONGITUDE SHOWN IS BASED ON A CONVERSION FROM THE MANITOWOC COUNTY COORDINATE. THE ELEVATION DATUM IS USGS (NAVD83).  
 SOL BORING LOCATION (SB MW 08.23, SB MW 08.25) (SAMPLE DEPTH IN FEET)  
 SB - WELL SCREEN BOTTOM ELEVATION

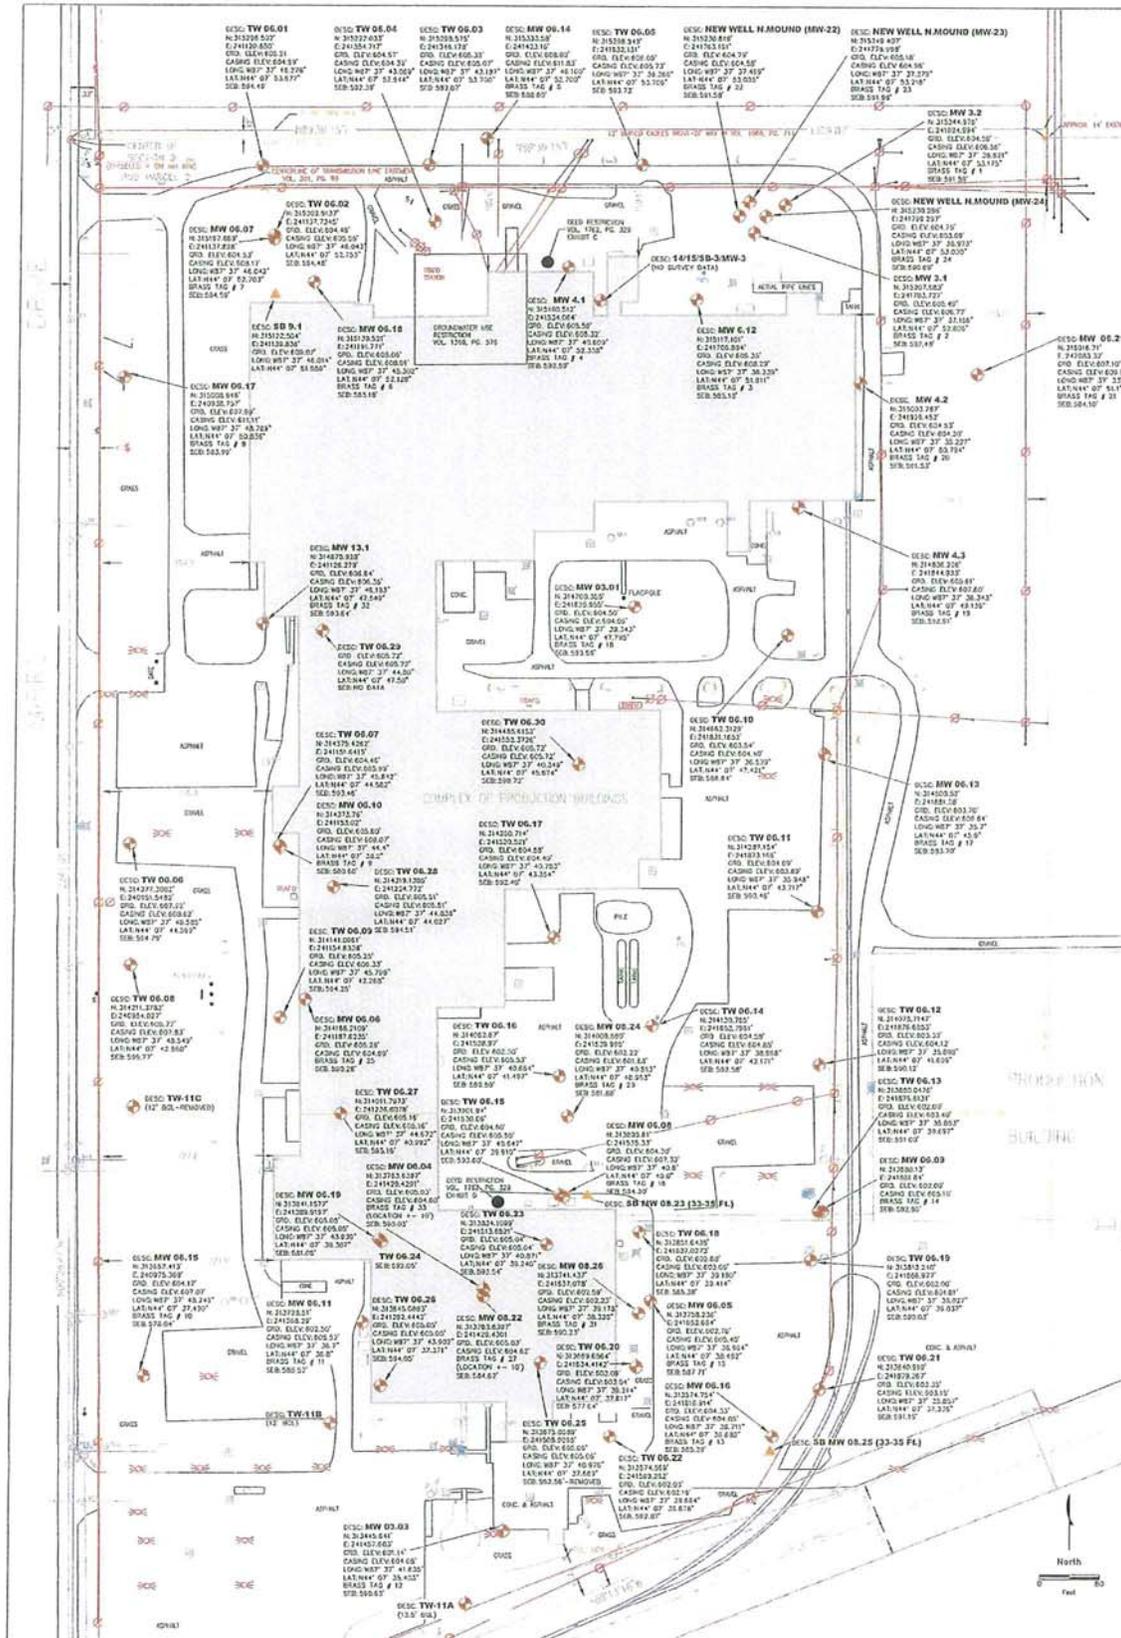
**Well Locations, Screen Depths & Soil Sample Locations (SB MW 08.23 & SB MW 08.25)**  
 Skana Aluminum Company  
 Manitowoc, Wisconsin  
 (Nov 2011)

MONITORING WELL DATA ACQUIRED BY STERNBERGER & MENAUE, INC., DECEMBER 3, 2010.  
 NOTE: THE LATITUDE AND LONGITUDE SHOWN IS BASED ON A COORDINATION FROM THE MANITOWOC COUNTY COORDINATE. THE ELEVATION DATUM IS USGS (NAVD83).  
 SOL BORING LOCATION (SB MW 08.23, SB MW 08.25) (SAMPLE DEPTH IN FEET)  
 SB - WELL SCREEN BOTTOM ELEVATION

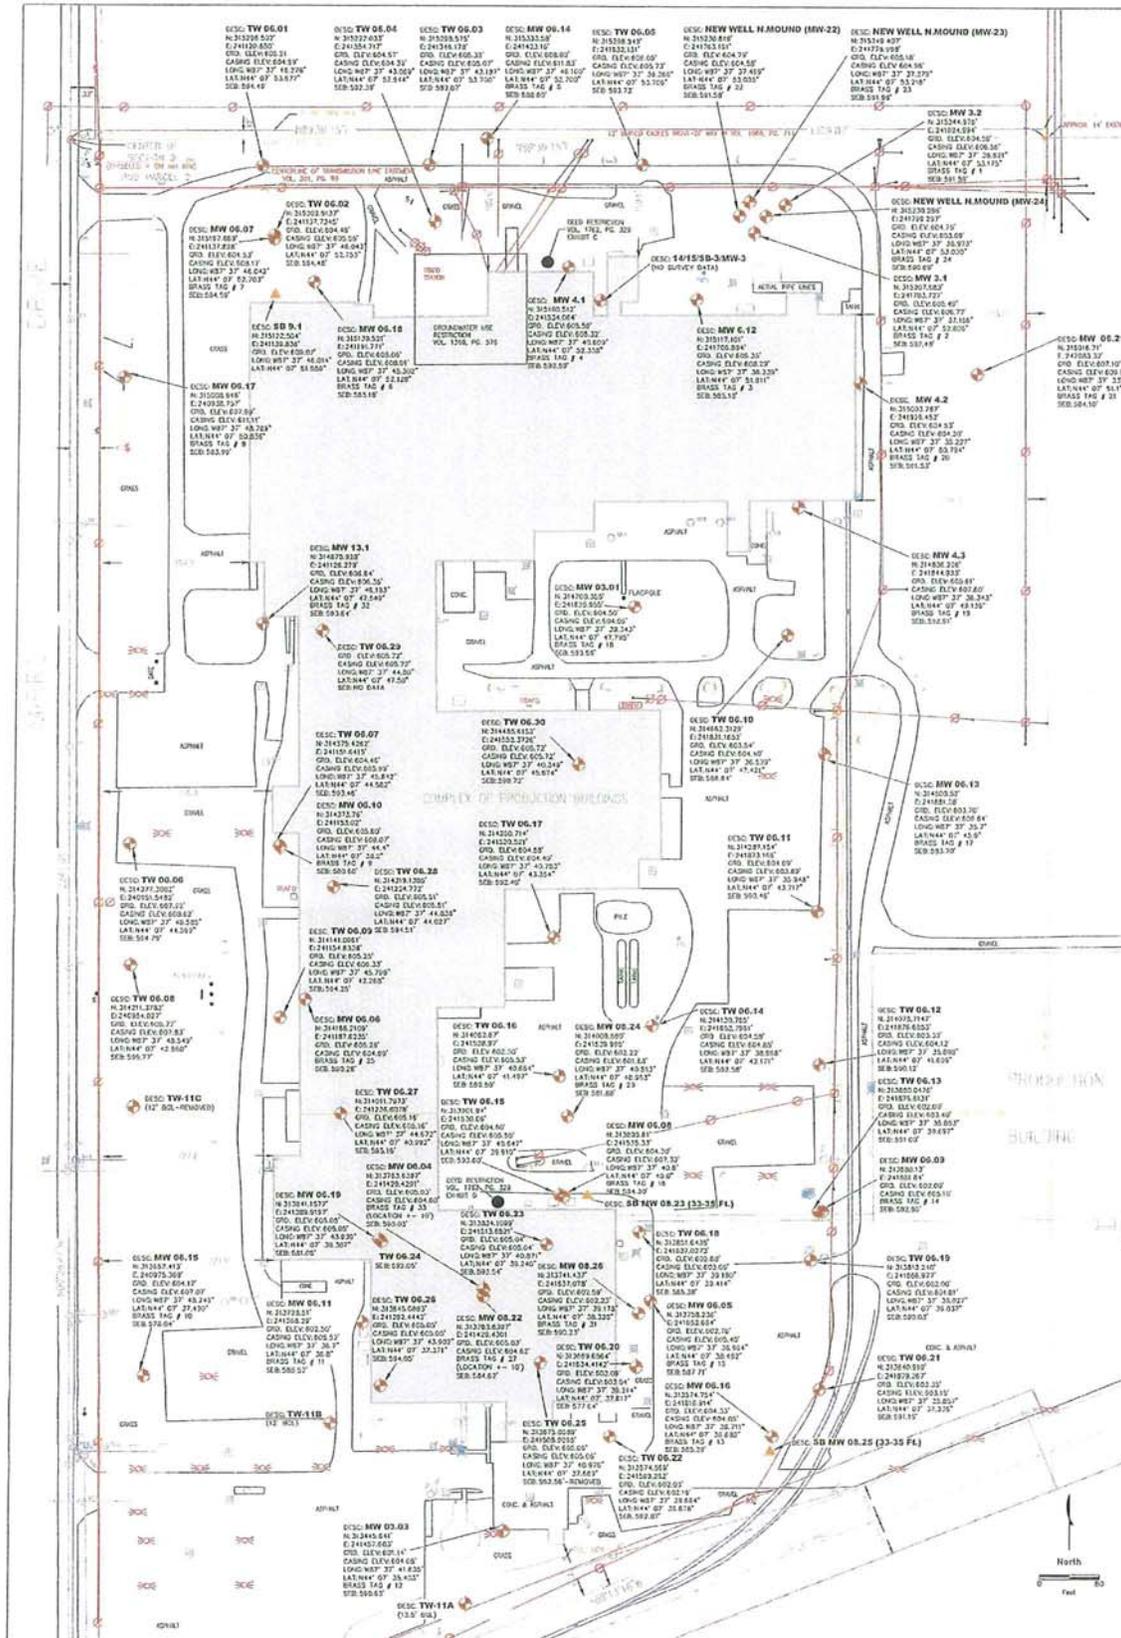
**Well Locations, Screen Depths & Soil Sample Locations (SB MW 08.23 & SB MW 08.25)**  
 Skana Aluminum Company  
 Manitowoc, Wisconsin  
 (Nov 2011)

MONITORING WELL DATA ACCORD TO: STERNBERGER & MENAULT, INC., DECEMBER 3, 2010.  
 NOTE: THE LATITUDE AND LONGITUDE SHOWN IS BASED ON A COORDINATION FROM THE MANITOWOC COUNTY COORDINATE. THE ELEVATION DATUM IS USGS (NAVD83).  
 SOL BORING LOCATION (SB MW 08.23, SB MW 08.25) (SAMPLE DEPTH IN FEET)  
 SB - WELL SCREEN BOTTOM ELEVATION  
 Prepared by: Environmental Consulting & Technology, Inc.  
 Adapted from an ALTA/ACSM Land Title Survey by Andrew Czerwanka.

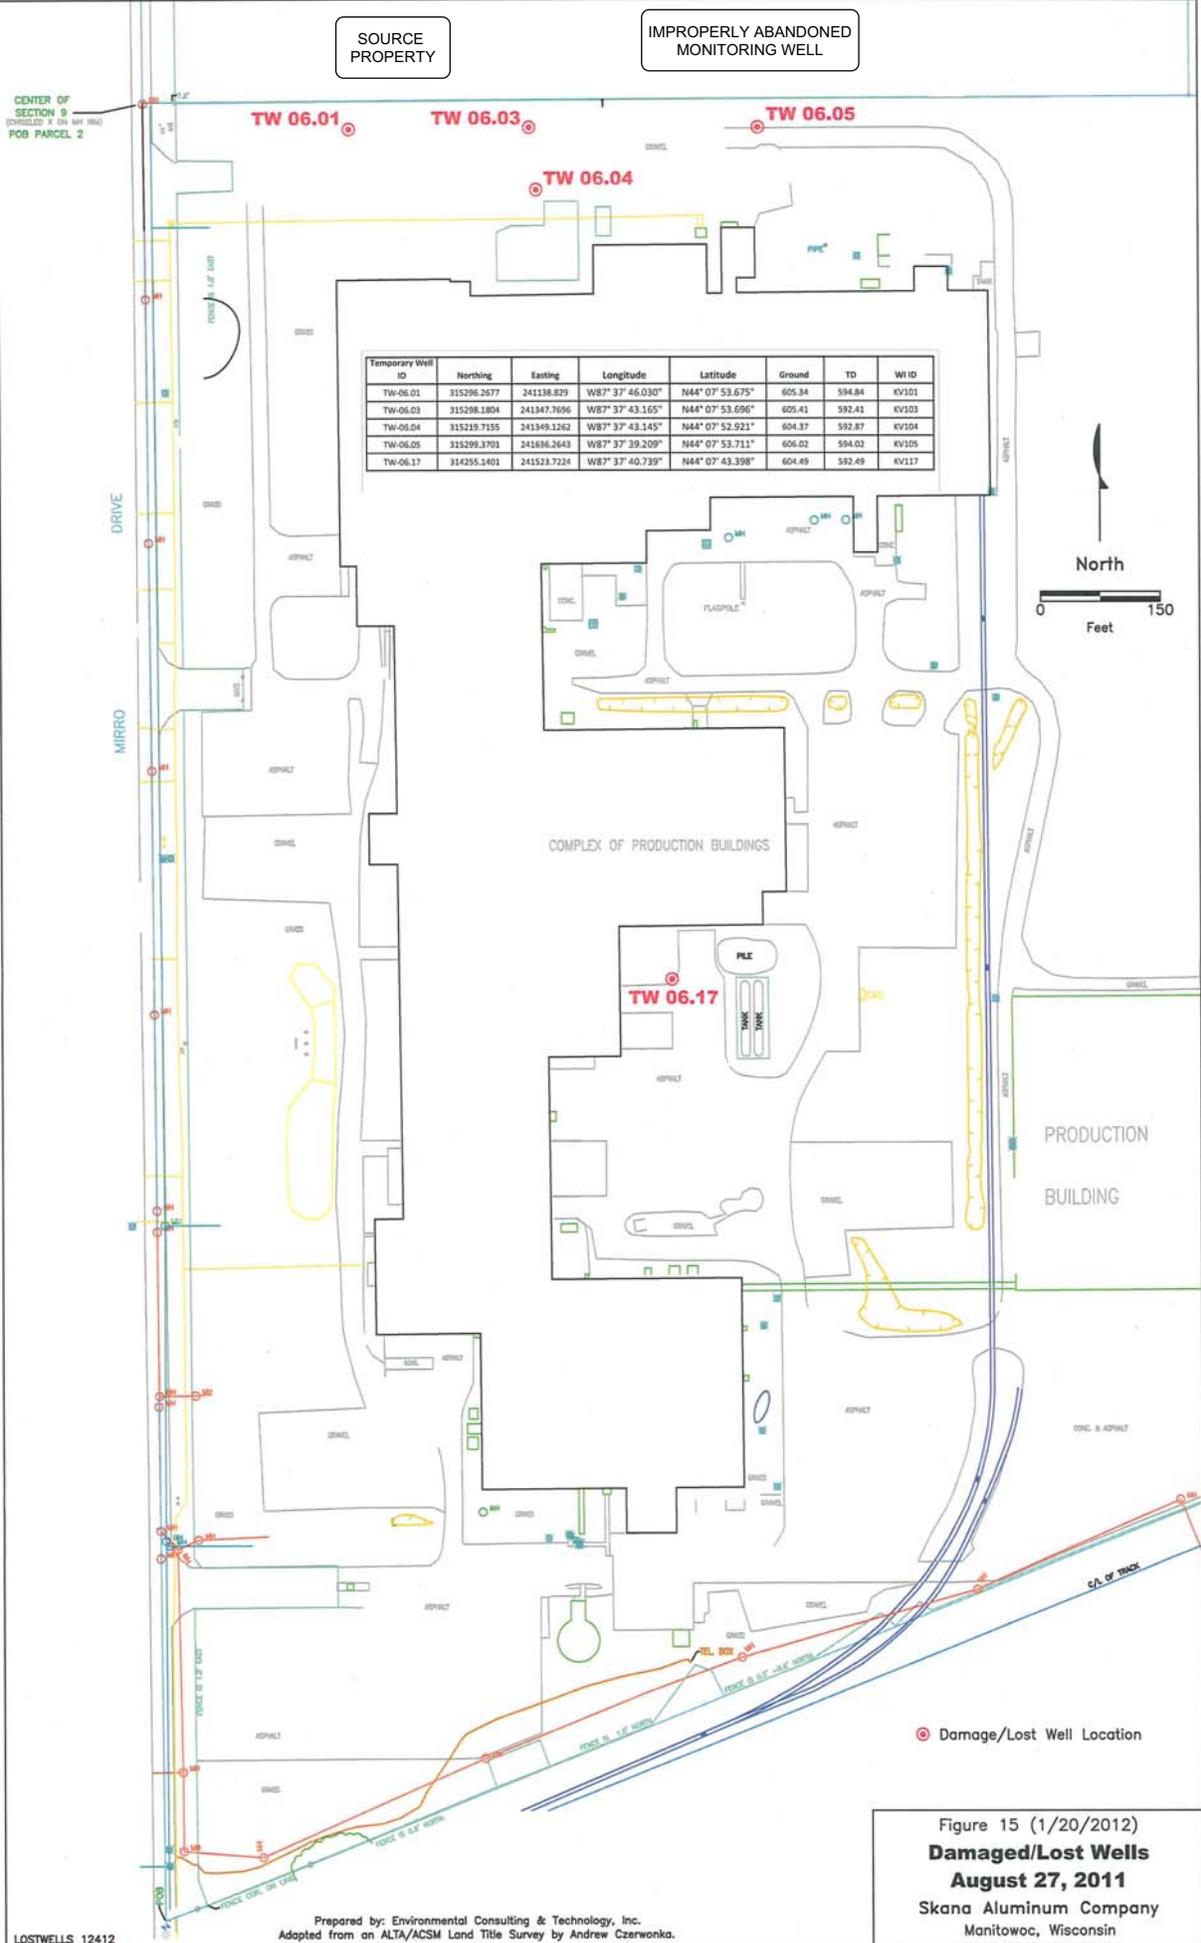
IMPROPERLY ABANDONED MONITORING WELL

SOURCE PROPERTY

Temporary Well ID	Northing	Easting	Longitude	Latitude	Ground	TD	WI ID
TW-06.01	315296.2677	241138.829	W87° 37' 46.030"	N44° 07' 53.675"	605.34	594.84	KV101
TW-06.03	315298.1804	241347.7696	W87° 37' 43.165"	N44° 07' 53.696"	605.41	592.41	KV103
TW-06.04	315219.7155	241349.1262	W87° 37' 43.145"	N44° 07' 52.921"	604.37	592.87	KV104
TW-06.05	315299.3701	241686.2641	W87° 37' 39.209"	N44° 07' 53.711"	606.02	594.02	KV105
TW-06.17	314255.1401	241523.7224	W87° 37' 40.739"	N44° 07' 43.398"	604.49	592.49	KV117

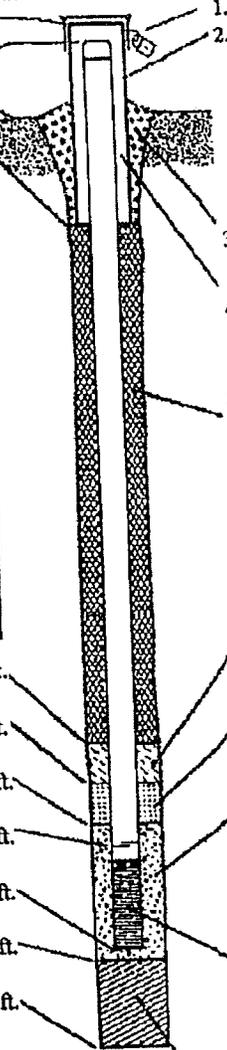
- 1. Cap and lock?  Yes  No
- 2. Protective cover pipe:
  - a. Inside diameter: 6 in.
  - b. Length: --- ft.
  - c. Material: Fluoromant Cover Steel  04 Other

- d. Additional protection?  Yes  No If yes, describe: ---
- 3. Surface seal:
  - Bentonite  30
  - Concrete  01
  - Other
- 4. Material between well casing and protective pipe:

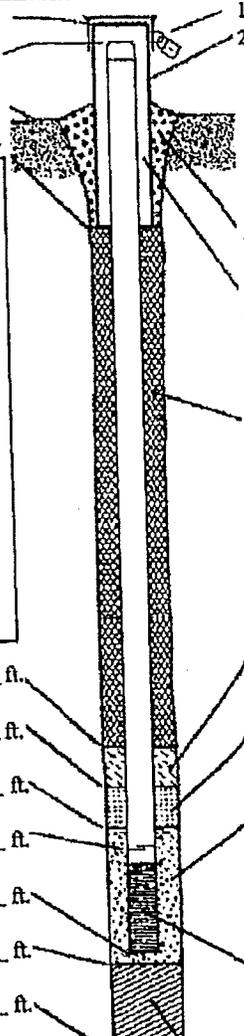
- 1. Cap and lock?  Yes  No
- 2. Protective cover pipe:
  - a. Inside diameter: 6 in.
  - b. Length: 1 ft.
  - c. Material: Steel  04  
Flush mount Other
  - d. Additional protection?  Yes  No  
 If yes, describe: \_\_\_\_\_

- 3. Surface seal: Bentonite  30  
 Concrete  01  
 Other
- 4. Material between well casing and protective pipe: Bentonite  30  
Cement Other
- 5. Annular space seal:

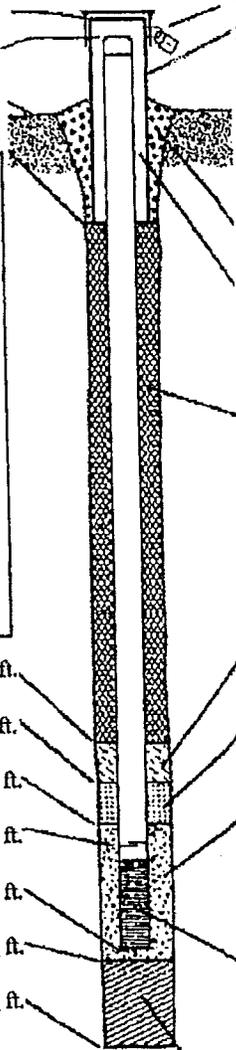
- 1. Cap and lock?  Yes  No
- 2. Protective cover pipe:
  - a. Inside diameter: 6 in.
  - b. Length: 1 ft.
  - c. Material: Steel  04  
Flashed Cover Other
  - d. Additional protection?  Yes  No  
 If yes, describe: \_\_\_\_\_

- 3. Surface seal:
  - Bentonite  30
  - Concrete  01
  - Other
- 4. Material between well casing and protective pipe:
  - Bentonite  30
  - Other  Cement
- 5. Annular space seal:
