SUBJECT: Final Case Closure with Continuing Obligations  
Enbridge Energy – Tank 23, Superior, WI  
WDNR BRRTS Activity #: 02-16-558989

**ENBRIDGE SUPERIOR TERMINAL**

**TANK 23 PRE/POST REMAINING SOIL CONTAMINATION SUPERIOR TERMINAL**  
Enbridge Energy, L.P.  
Superior, Wisconsin

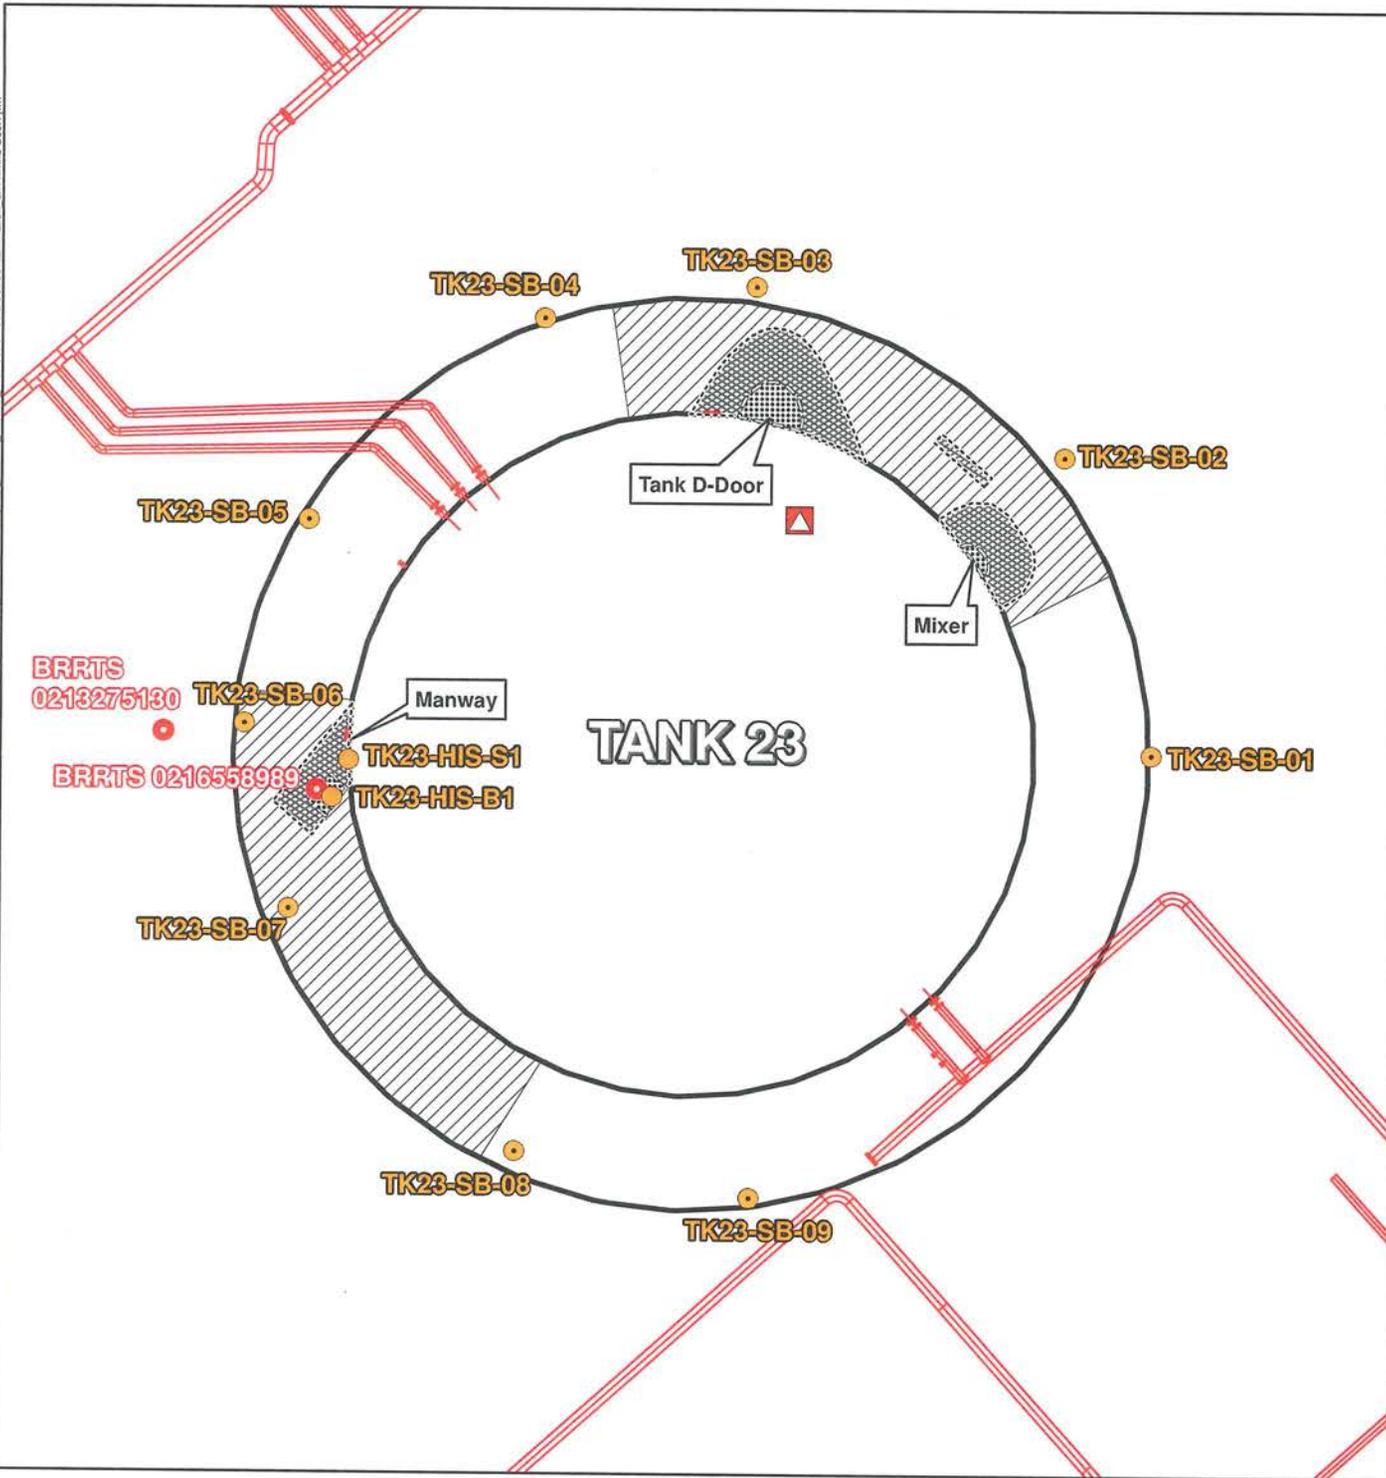
1 Inch = 50 Feet  
Figure B.2.c.

Residual Soil Contamination (ch. NR 718, chs. 500 to 536, Wis. Adm. Code or ch. 289, Wis. Stats.)  
Soil contamination remains beneath Tank 23, near the tank foundation, and beneath the tank ring road, as indicated on the attached map (Figure B.2.c – Tank 23 Pre/Post Remaining Soil Contamination, June 2013). If soil in the specific locations described above is excavated in the future, the property owner at the time of excavation must sample and analyze the excavated soil to determine if contamination remains. If sampling confirms that contamination is present, the property owner at the time of excavation will need to determine whether the material is considered solid or hazardous waste and ensure that any storage, treatment or disposal is in compliance with applicable standards and rules. Contaminated soil may be managed in accordance with ch. NR 718, Wis. Adm. Code, with prior DNR approval.

Industrial Soil Standards (s. NR 726.15, s. NR 727.07, Wis. Adm. Code)  
Soil contamination remains beneath Tank 23, near the tank foundation, and beneath the tank ring road, as shown on the attached map (Figure B.2.c – Tank 23 Pre/Post Remaining Soil Contamination, June 2013). Sample Tk23-HIS-B1 contained benzo(a)pyrene in concentrations which exceeded non-industrial (residential) soil standards, but which met industrial soil standards.

1) Tank 23 road construction: Crude oil contaminated soil (headspace > 10 ppm or crude oil staining or odor) excavated during the road construction work was segregated from uncontaminated soil. A total of 540 tons of contaminated soil was hauled to the Shamrock Landfill in Cloquet, MN (Attachment C.2; profile # CL12-0023). The road construction excavation extents were field screened by Barr and additional contaminated soil was removed beyond the planned road grade when doing so did not threaten the tank infrastructure. The approximate pre and post contaminated soil areas are illustrated in Figure B.2.c.

- 1) Tank 23 road construction: The ring road construction excavation was approximately 30 feet wide by 2 feet deep (Figure B.2.1). 540 cubic yards of crude oil contaminated soil (headspace > 10 ppm or crude oil staining or odor) was segregated and hauled to the Shamrock Landfill in Cloquet, MN. Most of the crude oil contaminated soil identified during the road excavation was excavated during the construction work however some contaminated soil remains below each tank port next to the foundation as shown in Figures B.2.b. and B.2.c.

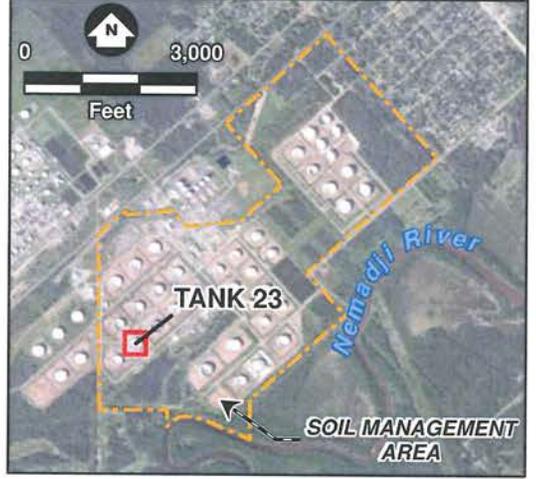
- Geoprobe Borings
- Analytical Samples
- ▲ Approximate Tank Bottom Cut Out Location
- Documented Historical Releases
- Field Screened Area
- Impacted Soil - Post-Remedial Excavation
- Impacted Soil - Pre-Remedial Excavation
- Road Boundary
- Pipeline Infrastructure
- Terminal Property Boundary

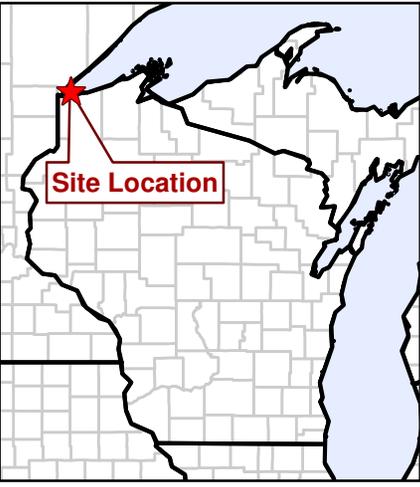
- Tank 23
- Terminal Property Boundary

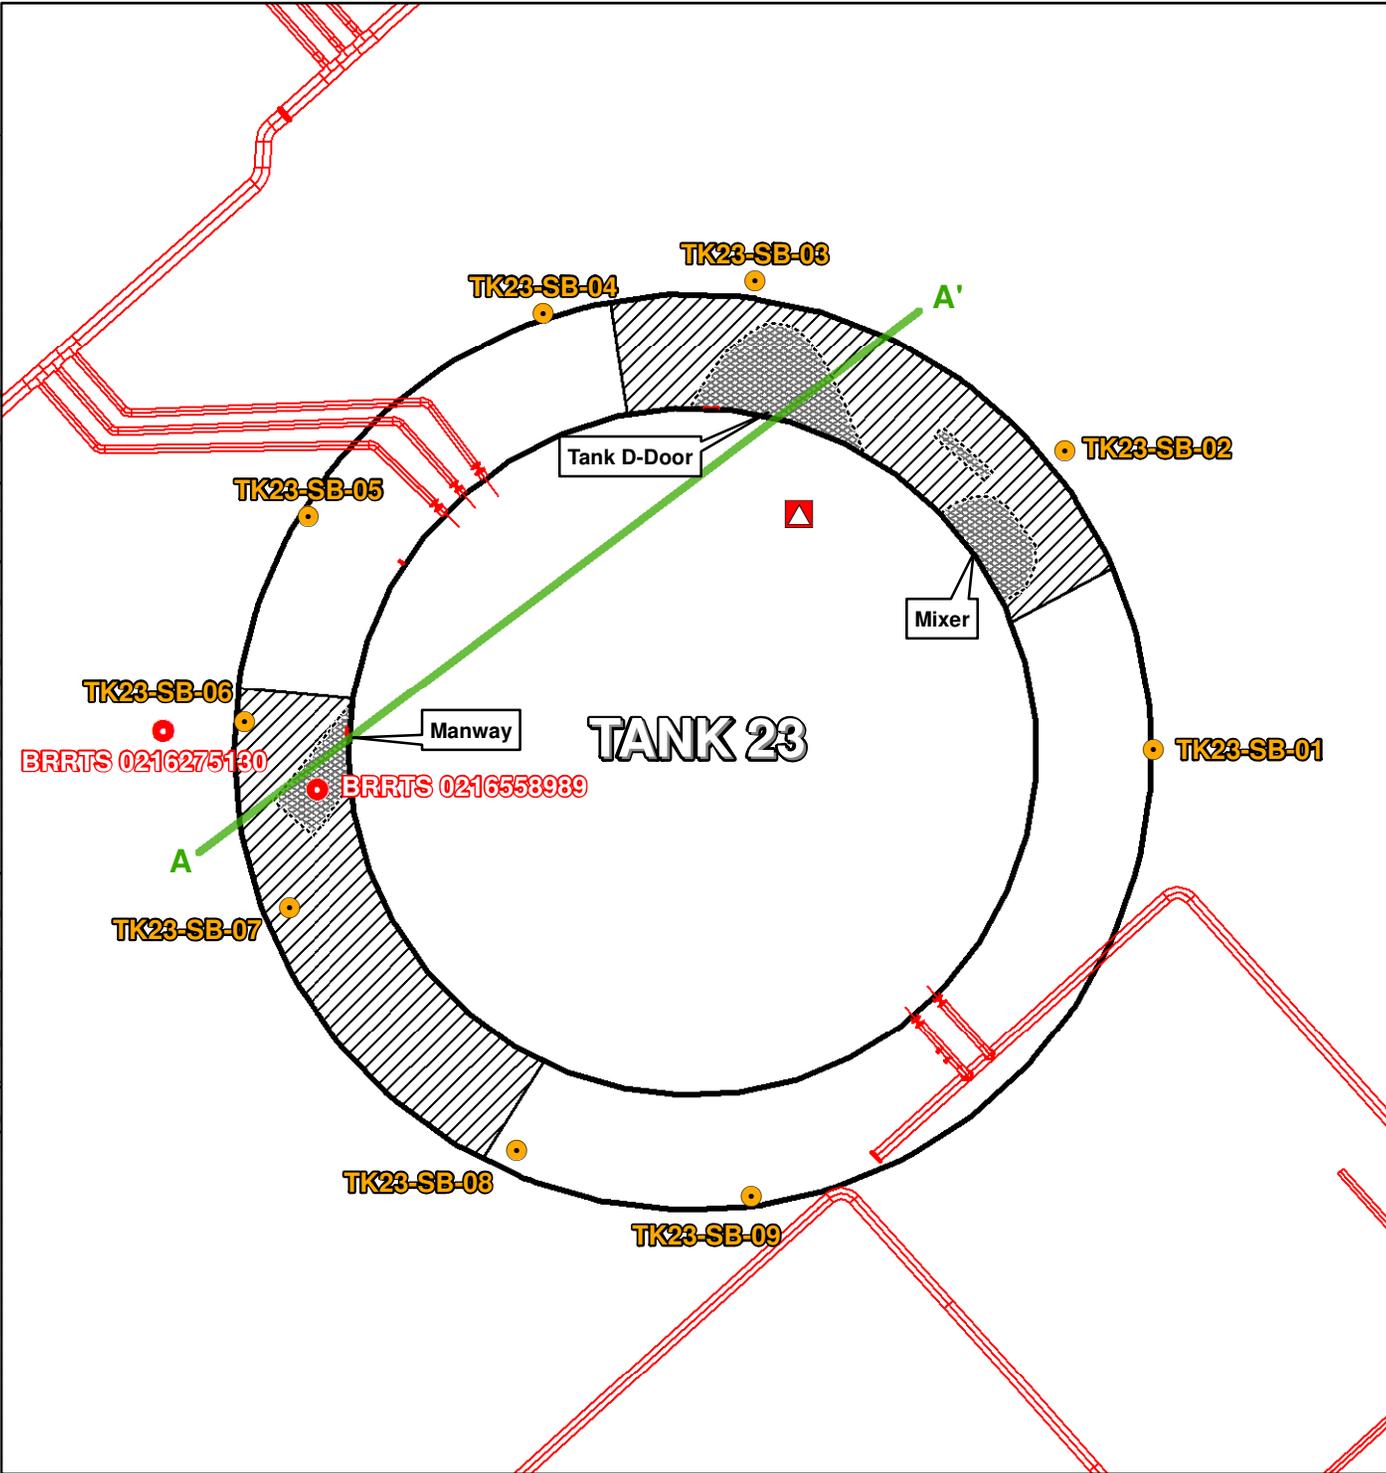
0 50 100  
 Feet  
 1 Inch = 50 Feet  
 Figure B.2.a.

1) Tank 23 road construction: Historical crude oil contaminated soil was identified in three locations around the perimeter of Tank 23 adjacent to tank ports (manway, D-door, mixer) during the ring road construction as shown in Figure B.2.a. Contamination depth varied but was generally between 0 and 2 feet bgs. Contamination immediately below the D-door was observed to 7 feet bgs but was shallower further away from the tank. During the road excavation, crude oil contaminated soil was observed up to 25 feet out from the tank but never exceeded the width of the road excavation. The road excavation provided an excellent opportunity to identify the lateral extent of contamination from these release points. Vertical definition was not achieved in the areas with residual impacts (Figure B.2.b) because the excavation depth was typically limited by construction objectives and safety concerns associated with buried infrastructure. Enbridge indicated that the crude oil contaminated soil originated from releases from the tank ports during historical tank maintenance projects.

**TANK 23 PRE-REMEDIATION  
SOIL CONTAMINATION  
SUPERIOR TERMINAL**  
 Enbridge Energy, L.P.  
 Superior, Wisconsin

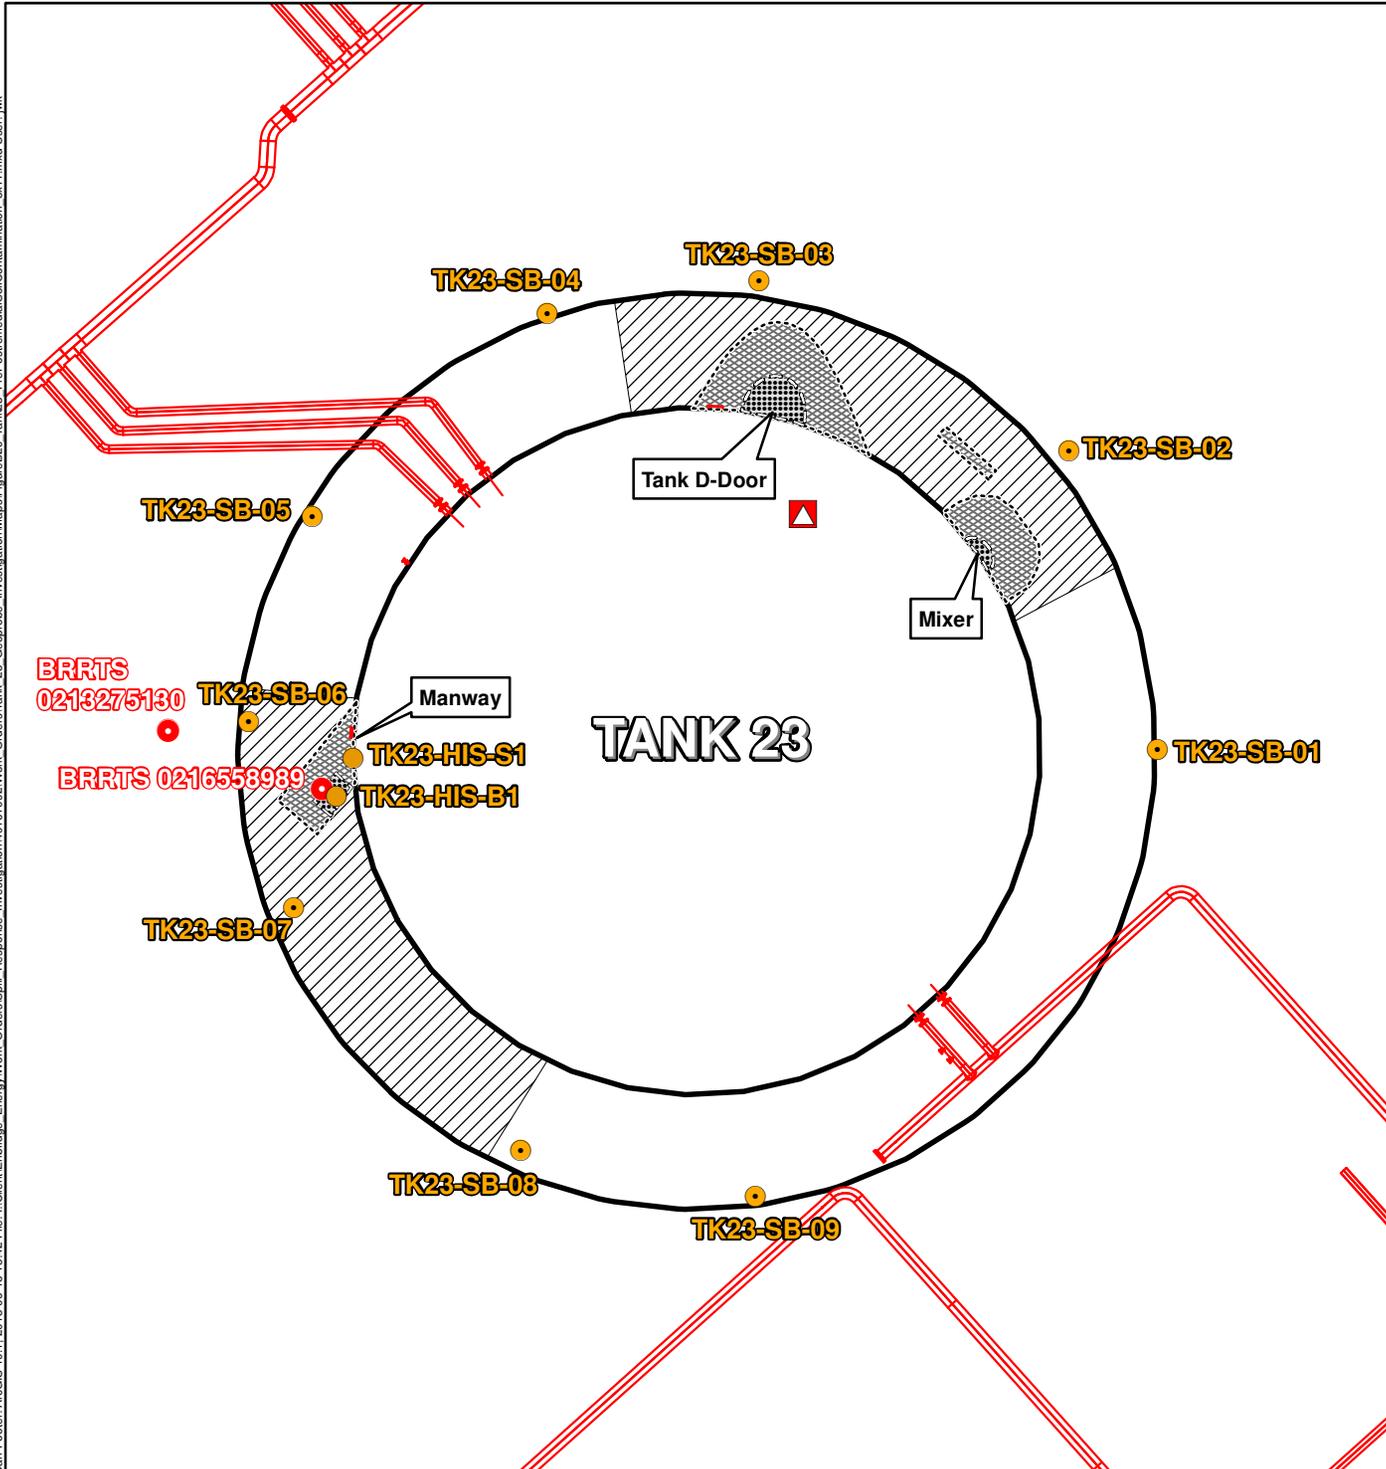
**TANK 23 PRE/POST REMAINING SOIL CONTAMINATION SUPERIOR TERMINAL**  
 Enbridge Energy, L.P.  
 Superior, Wisconsin

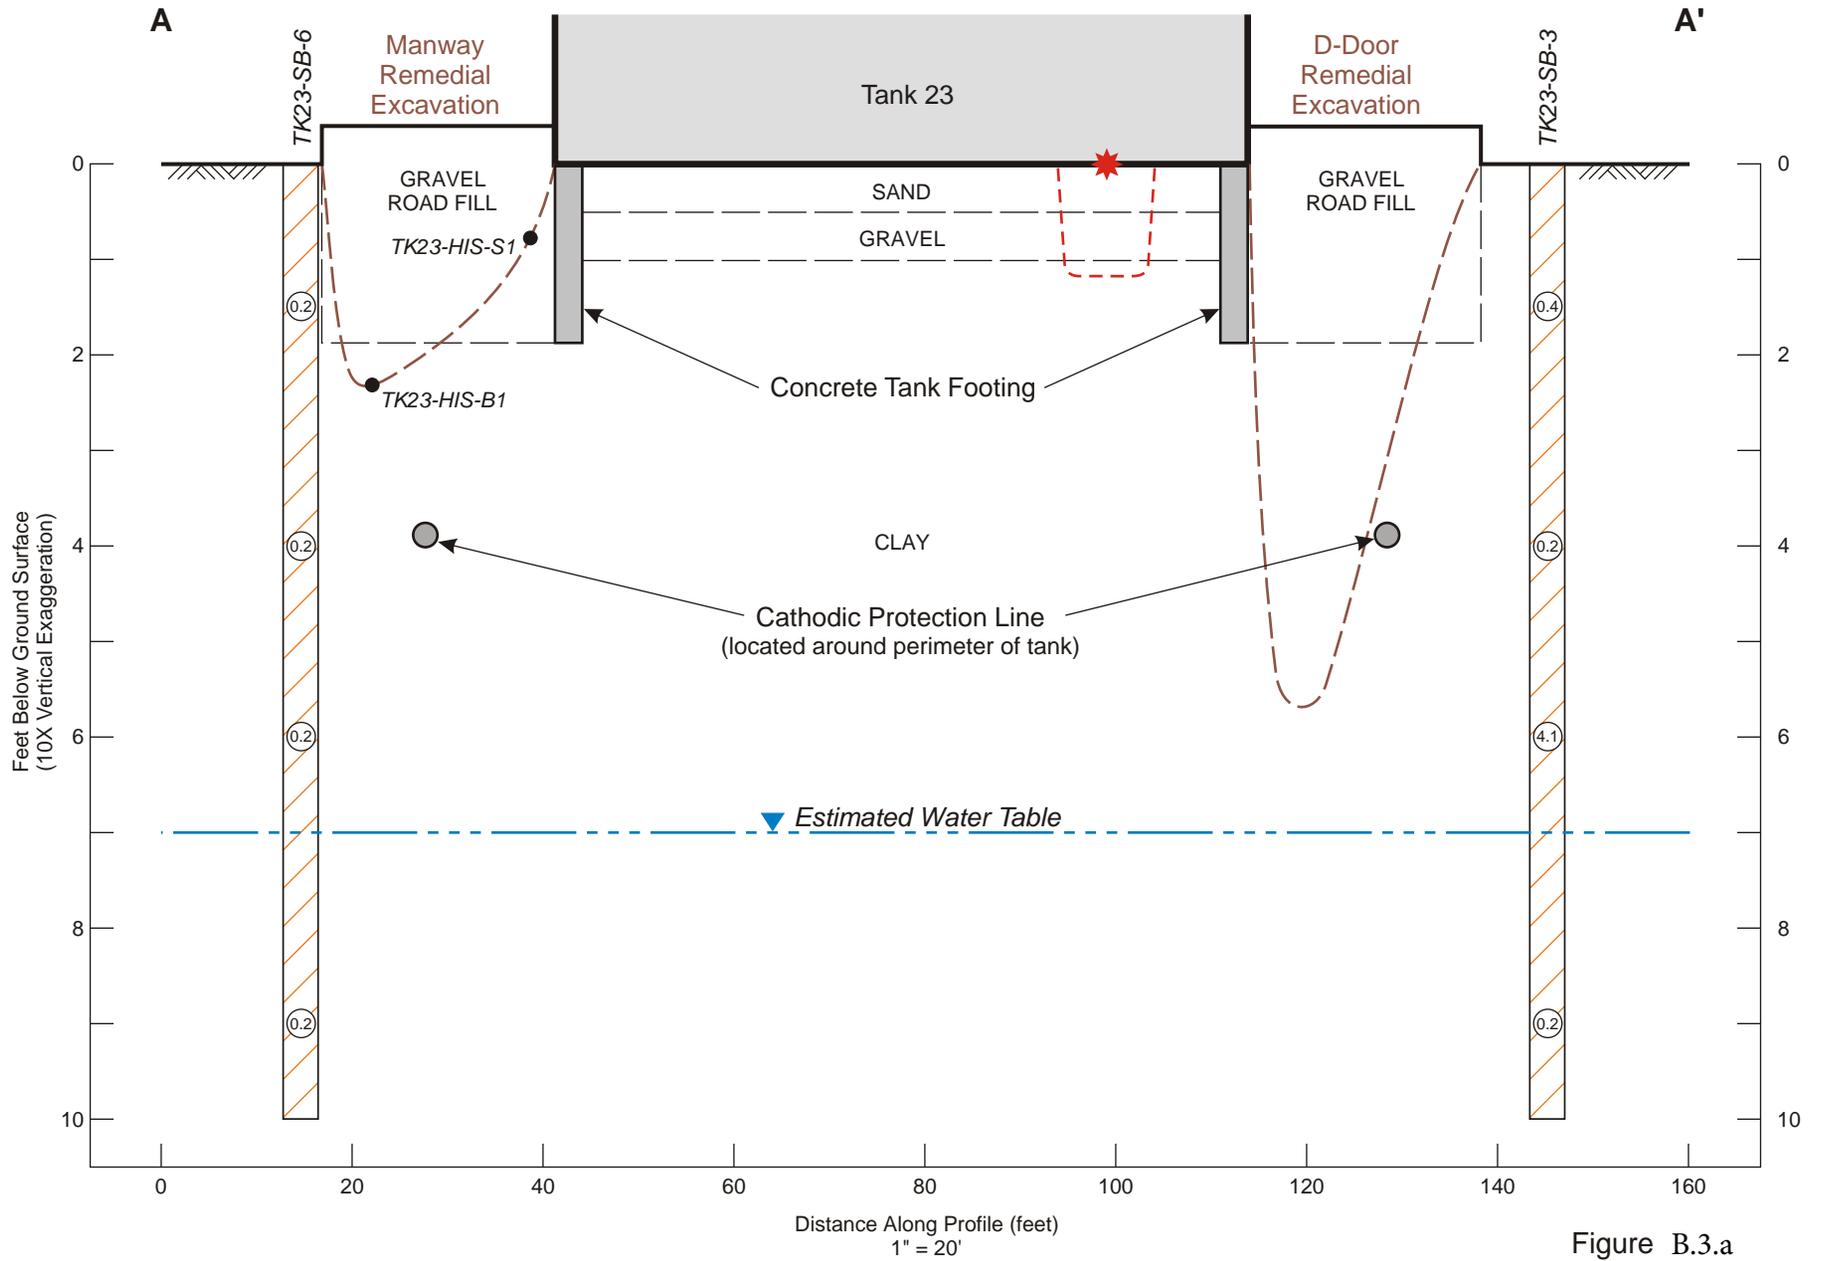
Figure B.3.a

- Excavation Extent
- ★ Approximate Location of Known Diesel Impacts
- PID (ppm)
- Sample Location

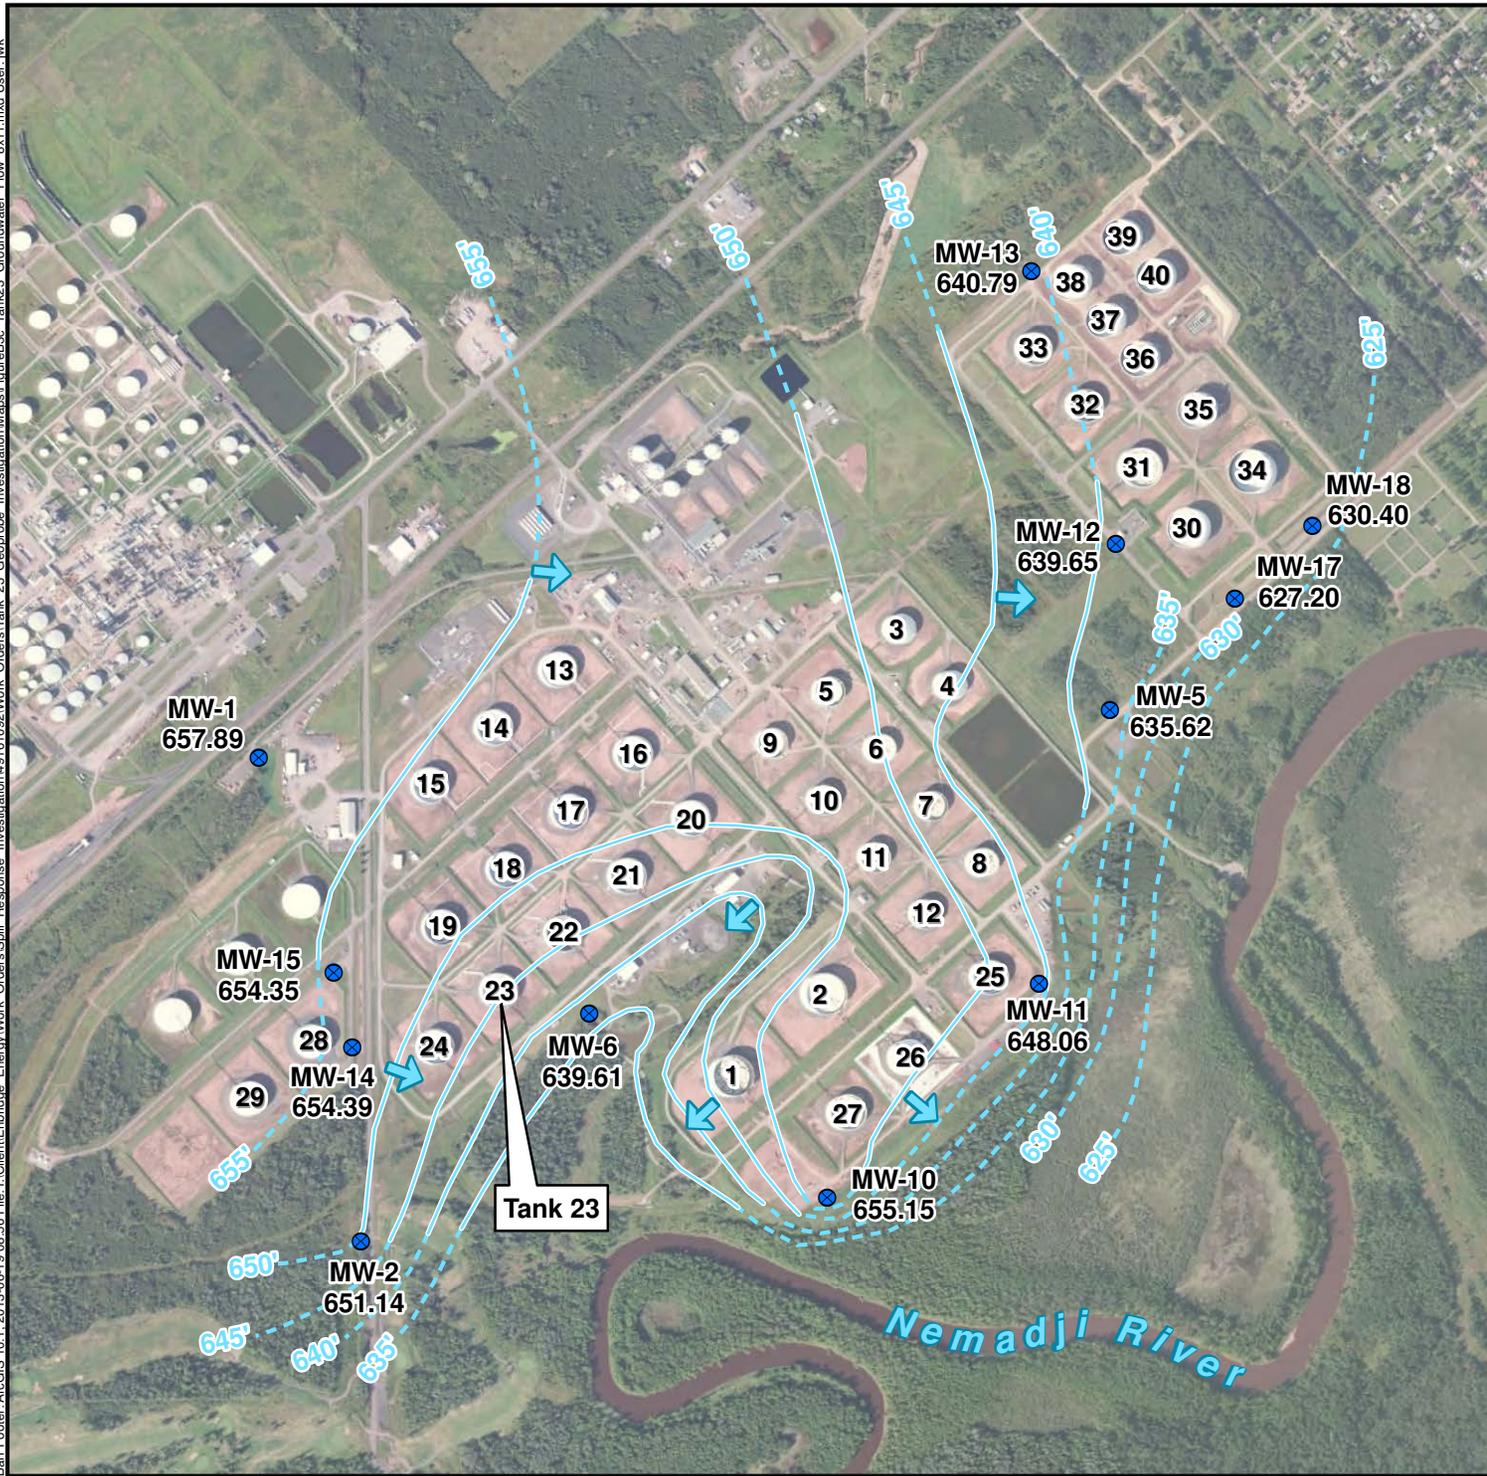
- ⊕ **630.40** Monitoring Well Location and Groundwater Elevation (ft)
- Groundwater Contour  
Dashed where inferred  
(Contour Interval = 5.0 ft)
- ➔ Inferred Groundwater Flow Direction

Monitoring well groundwater elevations were measured on September 26, 2012

**TANK 23 GROUNDWATER FLOW DIRECTION SUPERIOR TERMINAL**  
Enbridge Energy, L.P.  
Superior, Wisconsin

The estimated groundwater depth in the Tank 23 containment basin area varies between 7 and 9 feet bgs based on groundwater measurements taken during periodic sampling of monitoring well MW-6. MW-6 is located downgradient of Tank 23 (Figure B.3.c). No water or product were observed in the 10-15 foot deep Tank 23 Geoprobe borings. The water table is located in a fat glacial/lacustrine clay.
- ii. Discuss groundwater flow direction(s), shallow and deep. Describe and explain flow variations, including fracture flow if present.
