The following site is being submitted for inclusion into the Groundwater GIS registry:

This is a:	New Submittal
BRRTS ID (no dashes):	0349000982
Comm # (no dashes):	54858902996
County:	Polk
Region:	Northern
Site name:	Bumper to Bumper/Rapid Repair
Street Address:	96 E Main St
City:	Milltown
Final Closure Date	2002-10-24
Closure Conditions:	met
Off-source property contamination? (If yes, attach locational data and deed information on pg. 2)	No
Right-of-way contamination?	No
Contaminated media:	Groundwater
GPS Coordinates (meters in the WTM91 projection)	
Easting (X):	324561
Northing (Y):	564487
Collection Method:	DNR Web Site
Scale or Resolution:	1:3,839
(1:24,000 scale or finer)	
Prepared by:	Shawn Wenzel
Submitted by:	Cheryl Nelson

Commerce # 54858-9029-96 **WDNR BRRTS # 03-49-000982**
Bumper To Bumper/Rapid Repair, 96 E Main St, Milltown

NOTICE OF CONTAMINATION TO PROPERTY

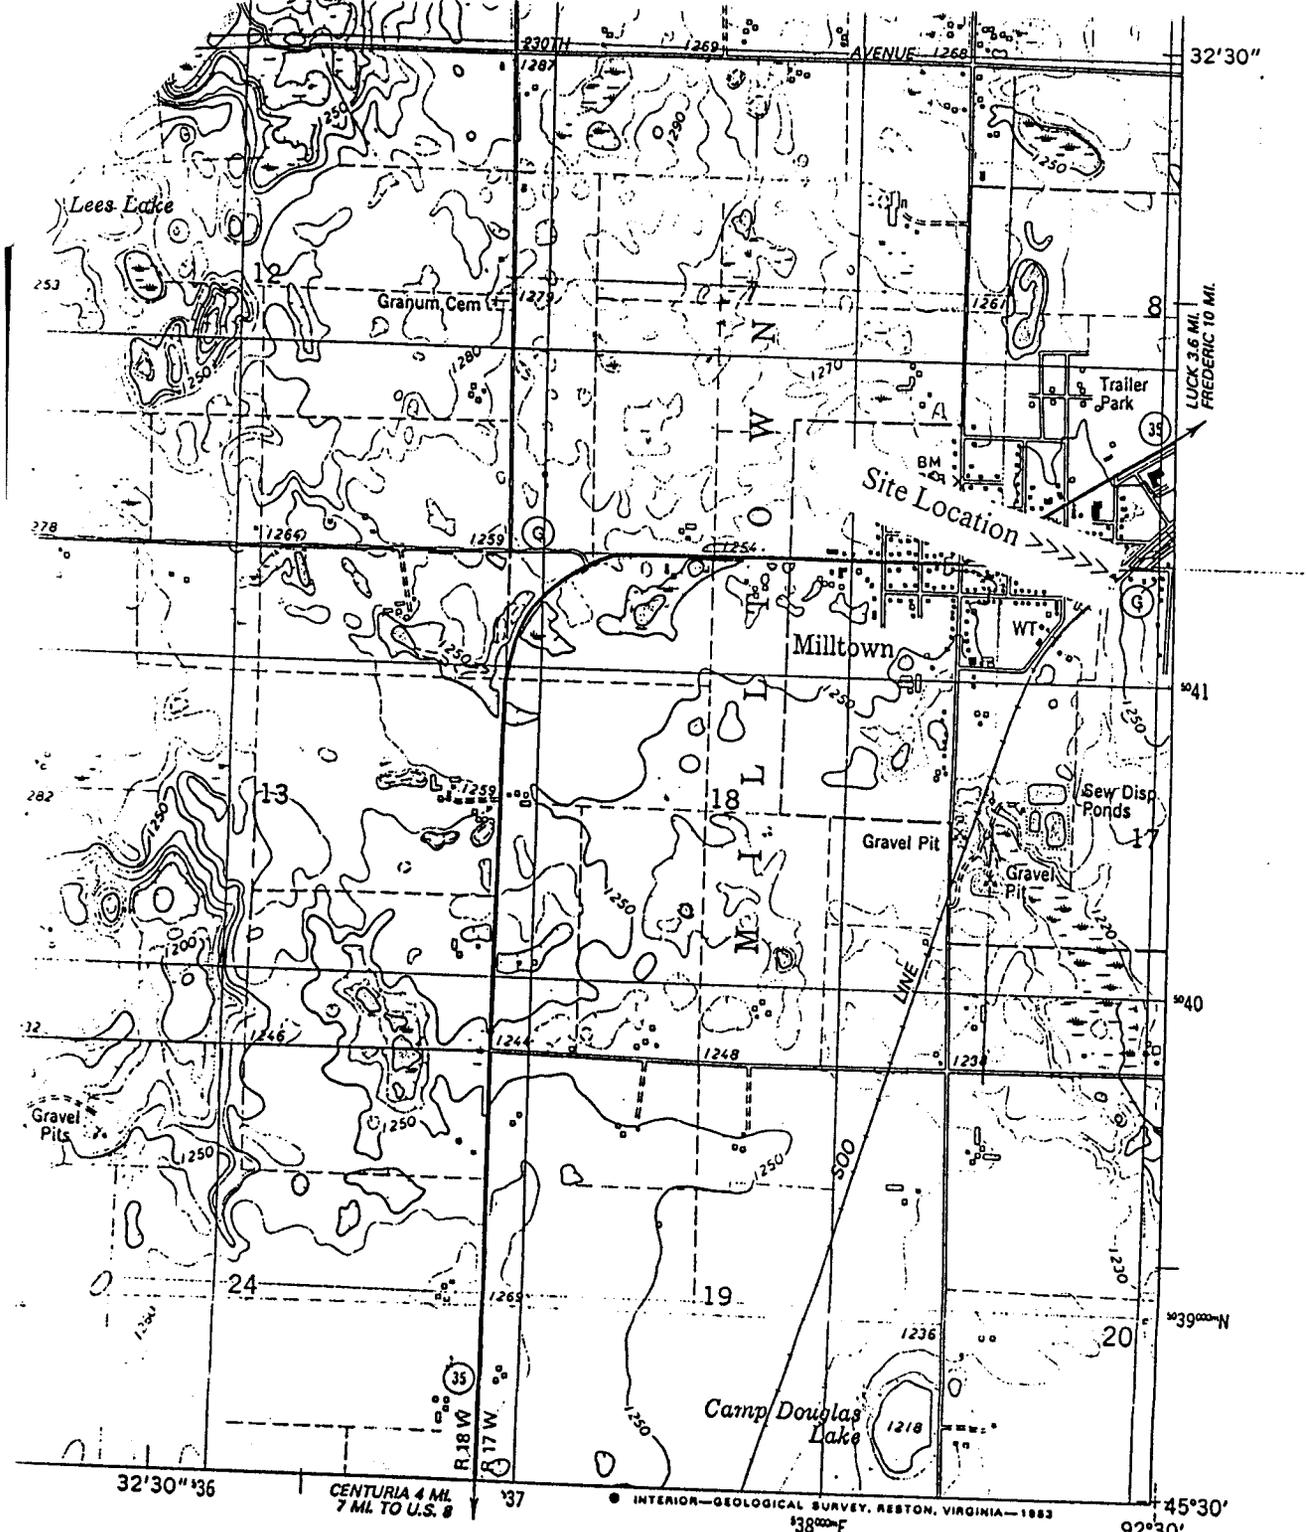
FIGURE ONE; SITE LOCATION MAP

MILLTOWN, WIS.
 SE/4 MILLTOWN 15' QUADRANGLE
 N4530-W9230/7.5

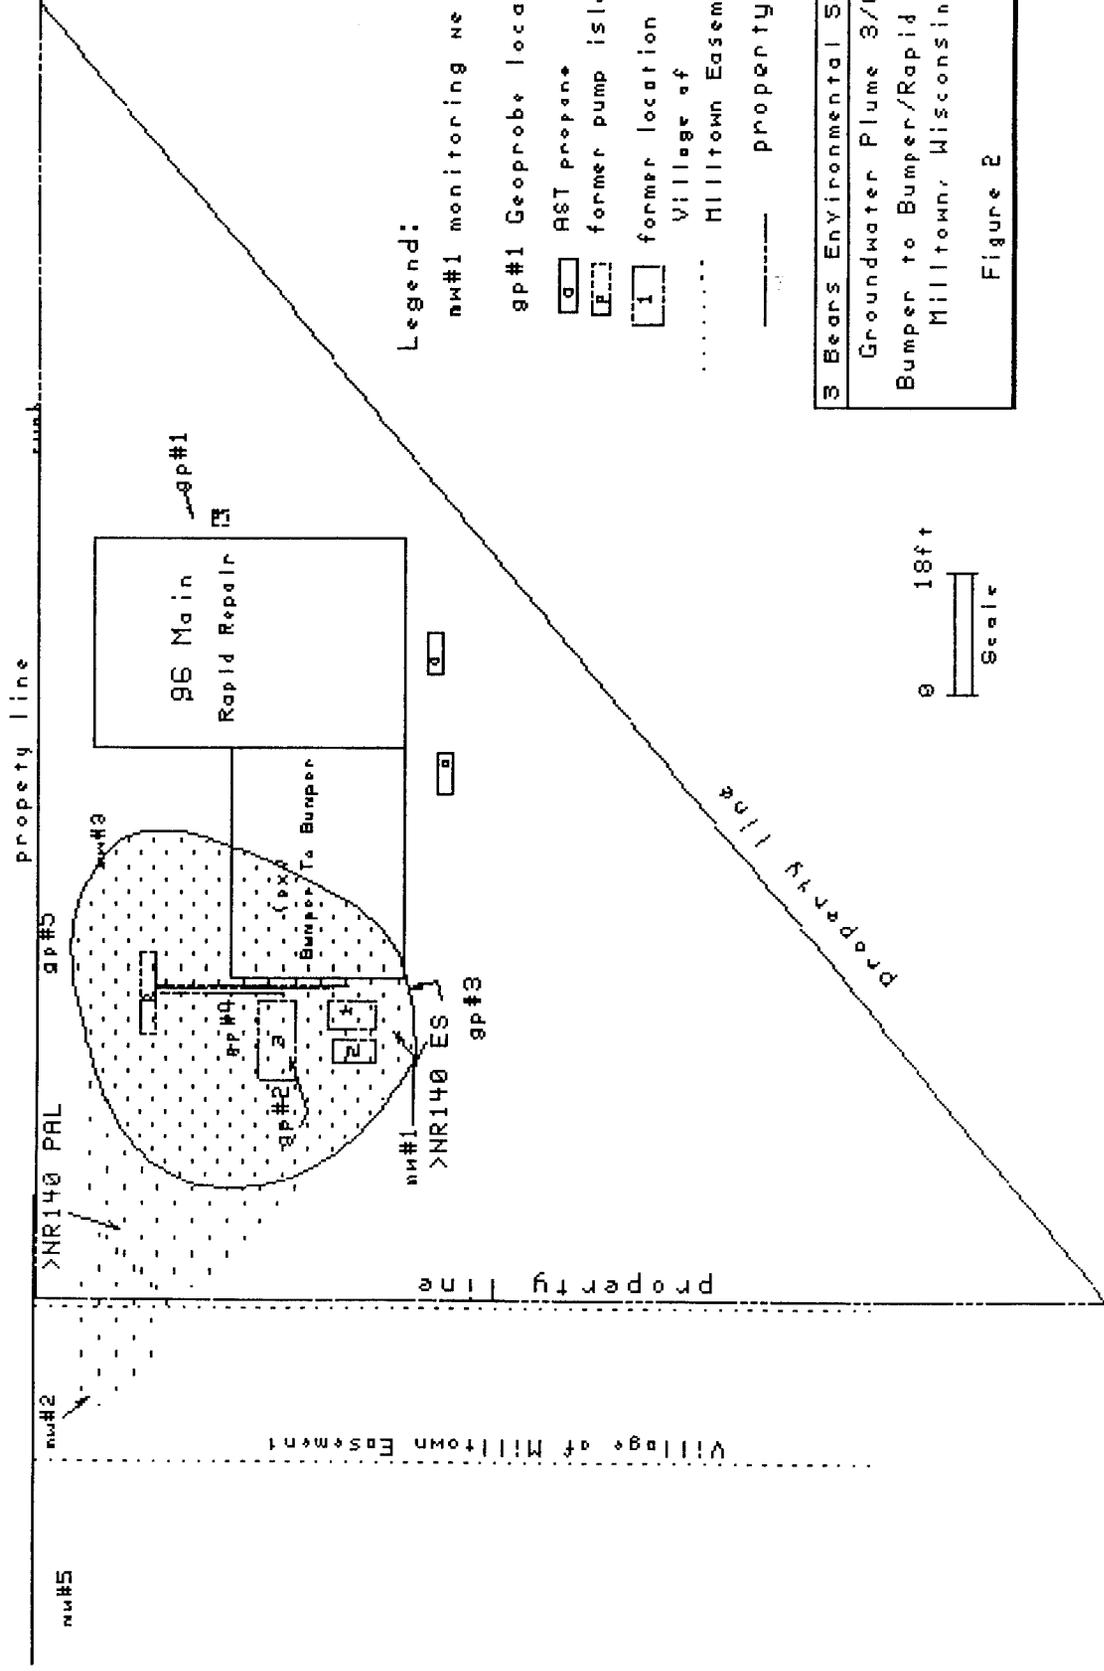
Figure 2

- nm#1 monitoring well
- gp#1 Geoprobe location
- ASST propane
- former pump island
- former location of UST
- Village of Milwaukee Easement
- property line

3 Bears Environmental Services
 Groundwater Plume 3/00
 Bumper to Bumper/Rapid Repair
 Milltown, Wisconsin

Residual groundwater contamination above NR 720 enforcement standards remains on site and is located beneath the former UST basin located to the west of the former Bumper to Bumper building and extends to near Main Street making up the northern property line of the site. Natural attenuation is the approved remedial alternative for this site. Anyone who proposes to construct or reconstruct a well on this property is required to contact the Department of Natural Resources' Bureau of Drinking Water and Groundwater, or its successor agency, to determine what specific prohibitions or requirements are applicable, prior to constructing or reconstructing a well on this property. No well may be constructed or be constructed on this property unless applicable requirements are met.

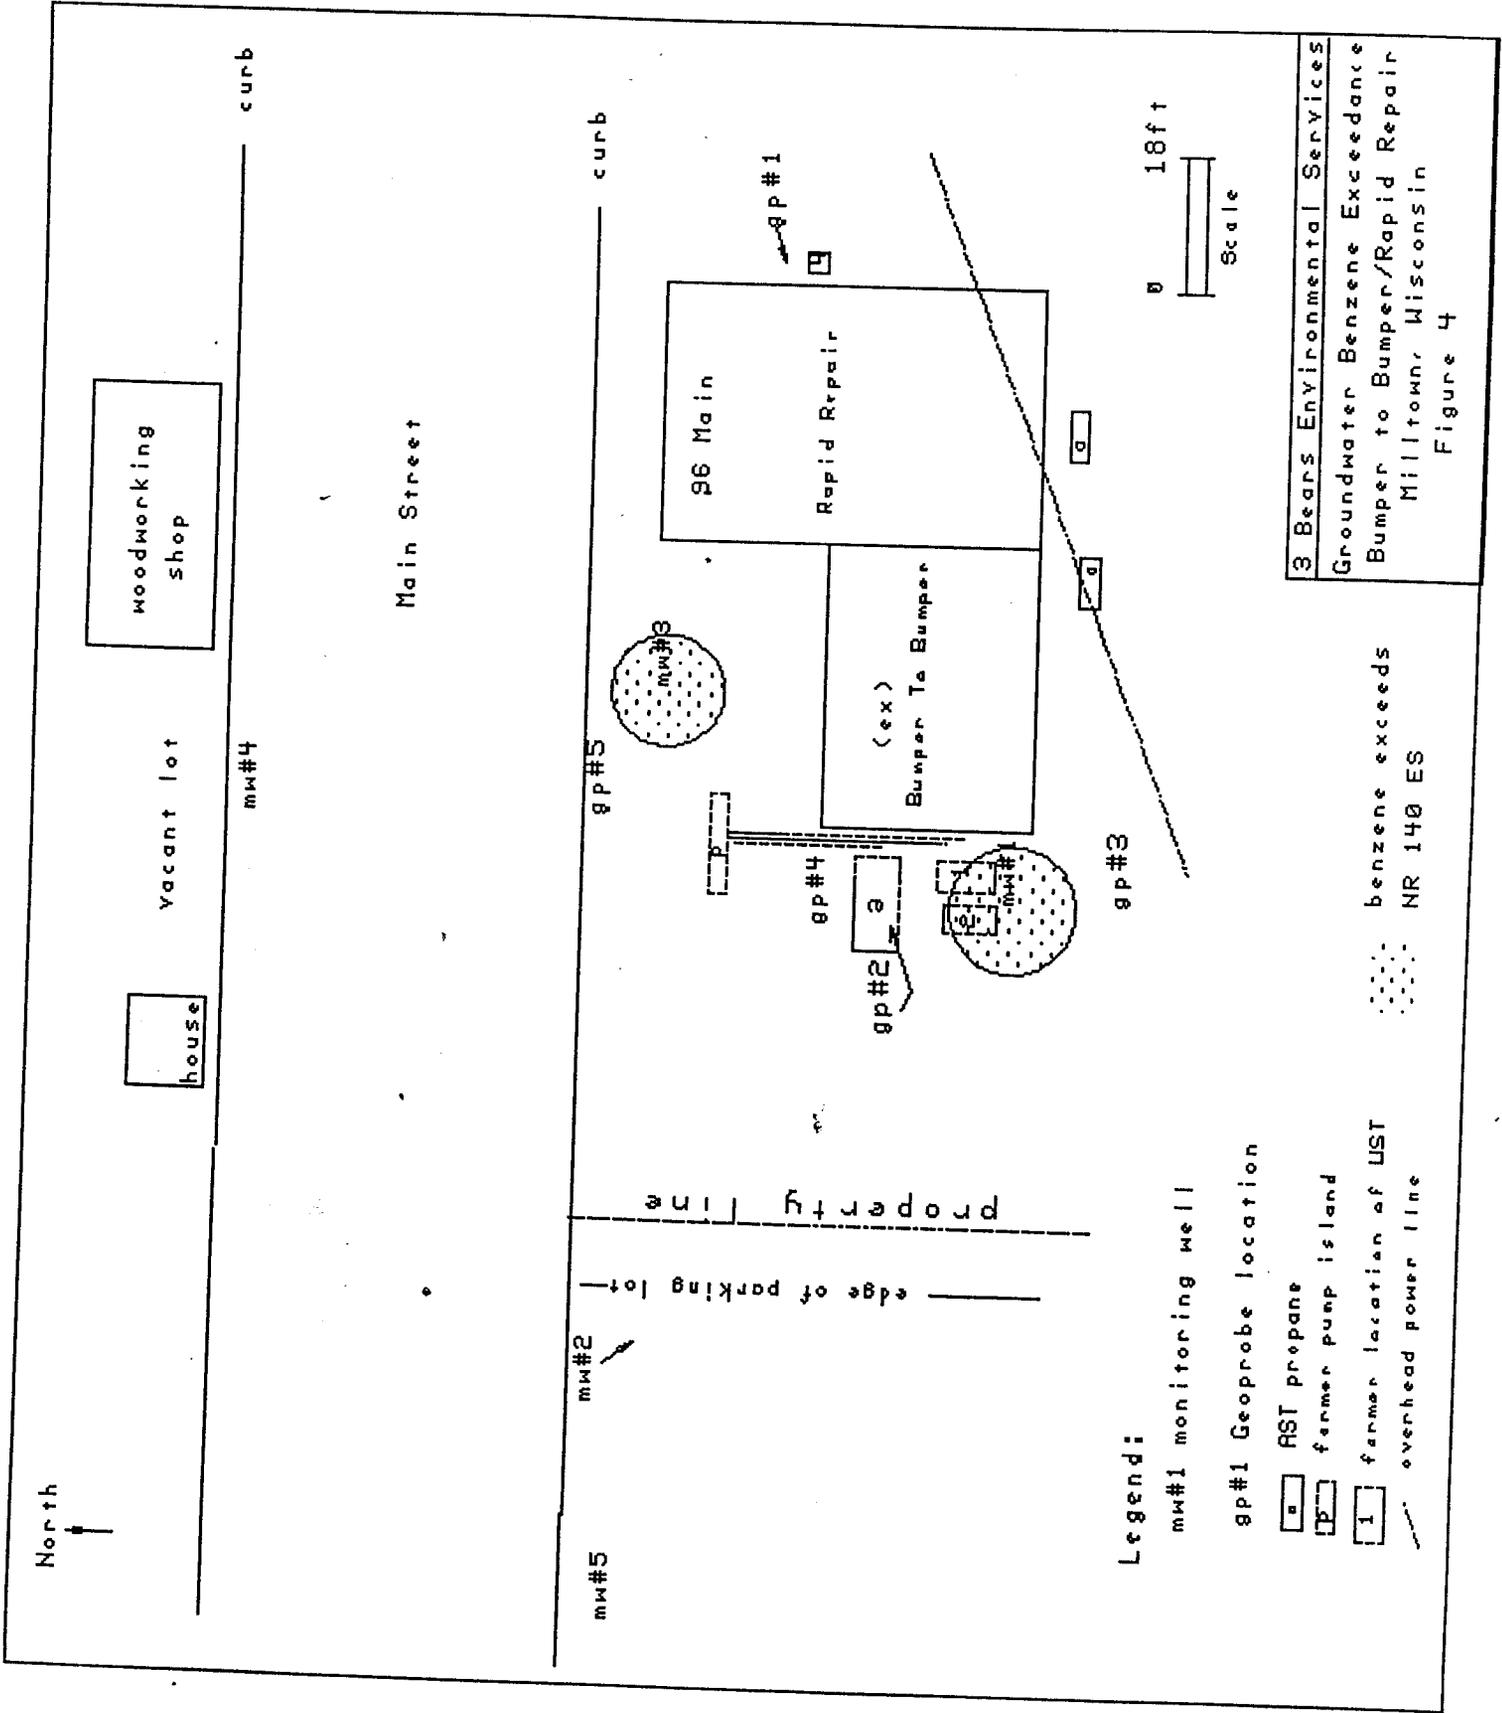
3 Bears Environmental Services
 Groundwater Benzene Exceedance
 Bumper to Bumper/Rapid Repair
 Milltown, Wisconsin
 Figure 4

benzene exceeds
 NR 140 ES
