GIS REGISTRY INFORMATION

SITE NAME:	Phillips Service Center								
BRRTS #:	03-51-000692			FID #	(if appropriate):				
COMMERCE # (if appropriate):	54555-1421-15								
CLOSURE DATE:	July 11, 2003								
STREET ADDRESS:	515 S Lake Ave								
CITY:	Phillips								
SOURCE PROPERTY GPS COORDINATES (meters in WTM91 projection):	X =	489528			Y =	579003			
CONTAMINATED MEDIA:	Groundwater	<input type="checkbox"/>	Soil	<input type="checkbox"/>	Both	<input checked="" type="checkbox"/>			
OFF-SOURCE GW CONTAMINATION >ES:	Yes	<input type="checkbox"/>	No	<input checked="" type="checkbox"/>

Commerce # 54555-1421-15 **WDNR BRRTS # 03-51-000692**
Phillips Service Center, 515 S Lake Ave, Phillips

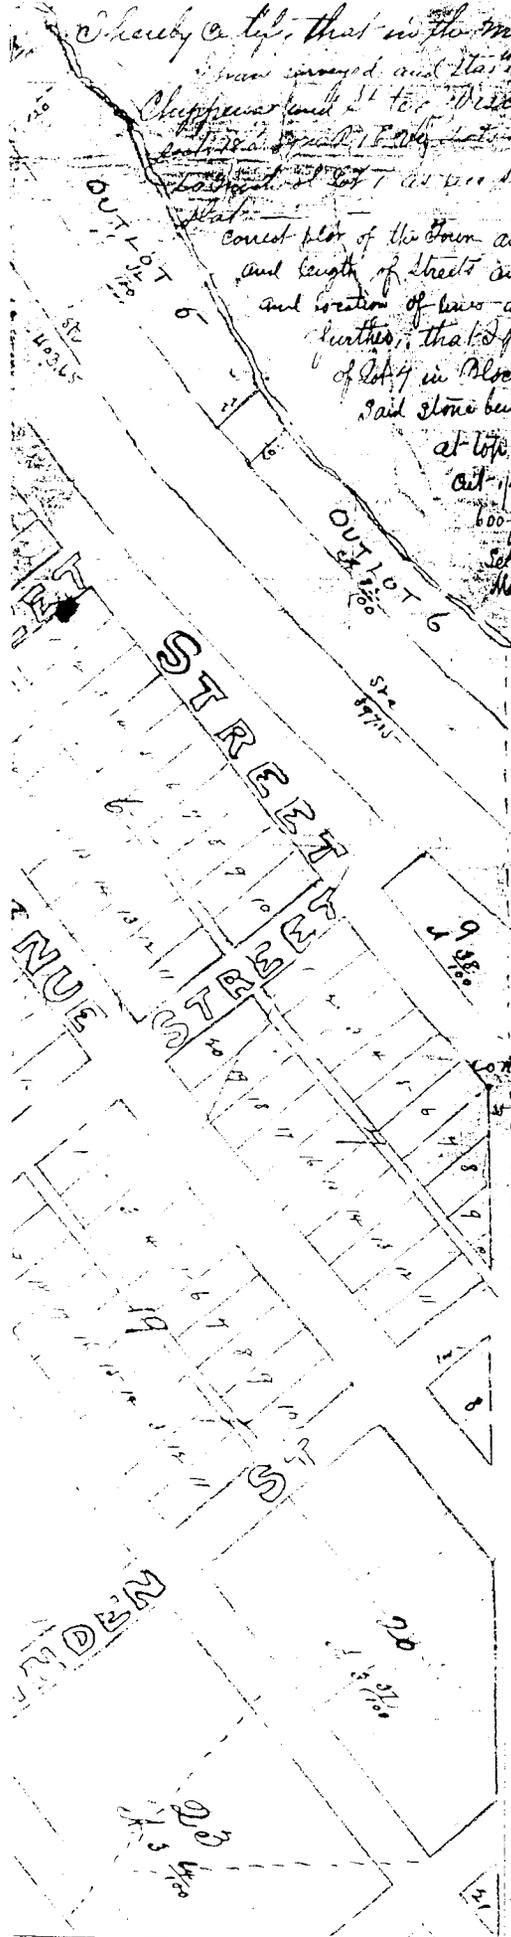
Phillips Service Center - Phillips, WI
 Figure 1
 Portion of Plat Map Showing Property Site
 (Block 8)

Whereby it is to be seen that in the month of Sept, 1876
 was conveyed and that at the village of Phillips in the
 Cheppewa land of the Wisconsin Territory and in the
 and further that this is a
 corner plot of the town as so surveyed that the width
 and length of streets and alleys, top of lots, directions
 and location of lines are as herein described
 further, that is placed a stone (granite) at the corner
 of Lot 4 in Block 8 on Lake St. as a corner
 said stone being 9 in at bottom, and 9 in
 at top, 2.5 inches length marked at that point
 cut in it 1/2 inch deep, and said stone being
 600 ft south and 400 ft west of main street
 set where the east boundary
 No 2 intersects purey Lake

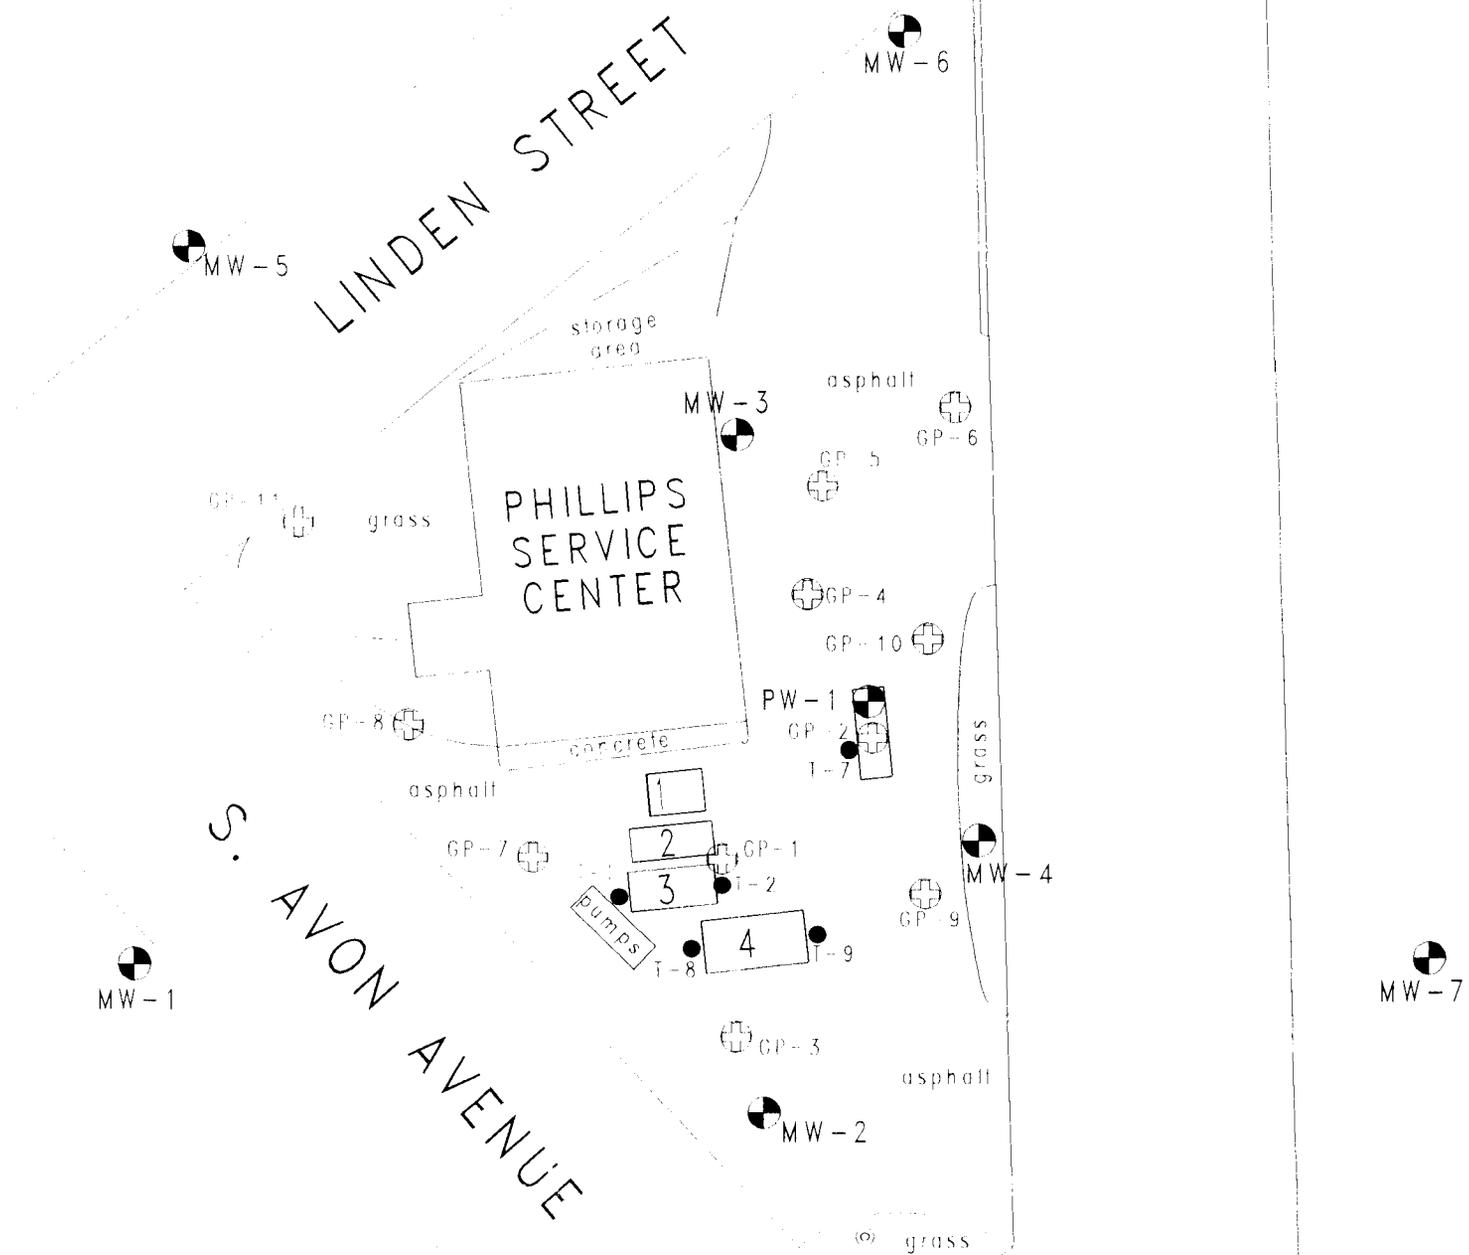
TANK INFORMATION

- Tank 1: 1,000-gallon diesel fuel
- Tank 2: 2,000-gallon unleaded gas
- Tank 3: 4,000-gallon unleaded gas
- Tank 4: 6,000-gallon unleaded gas

LEGEND

- Approx. former tank locations.
- Soil boring/Monitoring well location.
- Geoprobe boring.
- Tank closure assessment soil sample location.
- Buried natural gas line.
- Fire hydrant.
- Fencing.

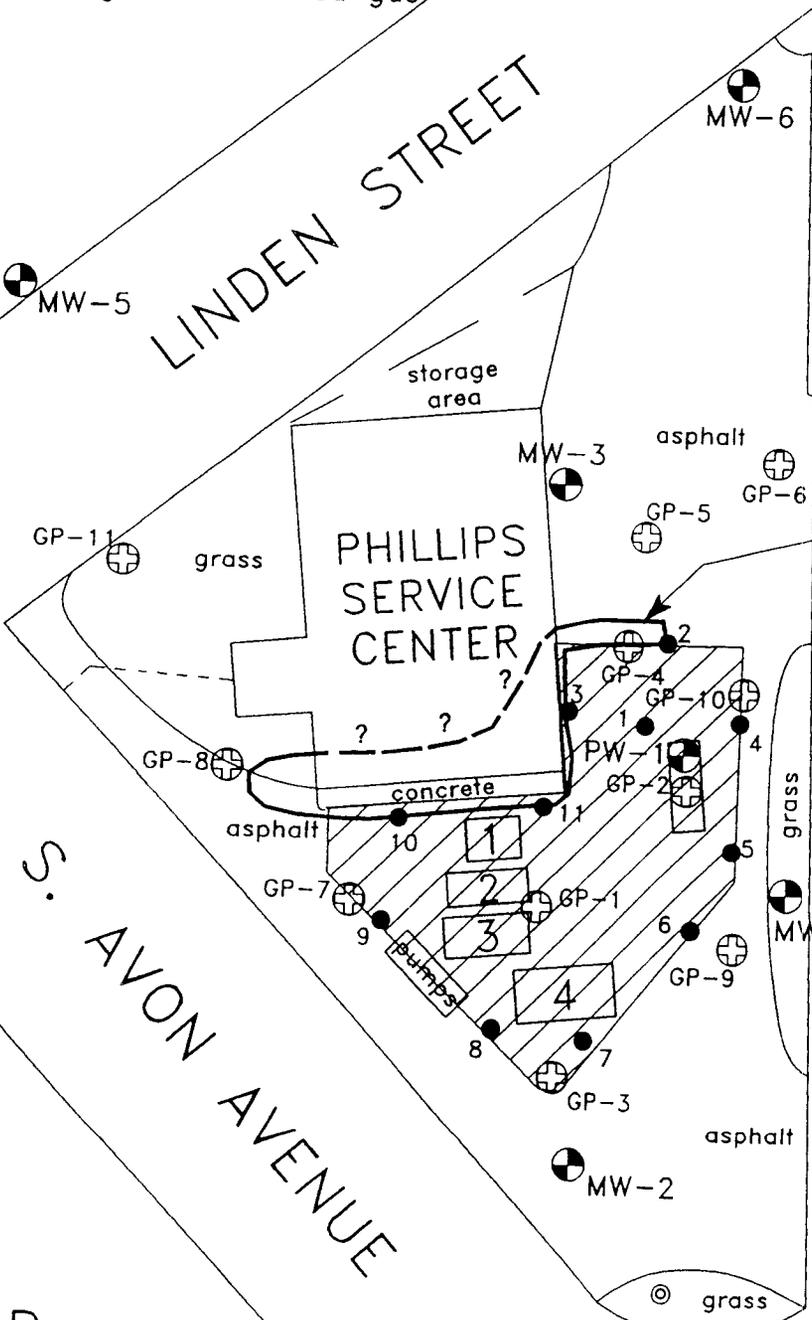
Phillips Service Center - Phillips, WI	
FIGURE 6 Horizontal Extent of Soil Excavation and Soil Excavation Sample Locations	
SCALE: 1" = 30'	DATE: 1/17/00
Environmental Compliance Consultants, Inc.	BY: B. KORB

ESTIMATED
POST-REMEDIATION
EXTENT OF REMAINING VADOSE
ZONE SOIL CONTAMINATION
EXCEEDING NR 720
GRCL'S

- 1 Approx. former tank locations.
- Excavation soil sample locations.
- Extent of excavation.
- MW-3 Monitoring well.
- Geoprobe boring.
- GP-3 Geoprobe boring.
- - - Buried natural gas line.
- ⊙ Fire hydrant.
- Fencing.

TABLE 1
SOIL EXCAVATION ANALYTICAL RESULTS
PHILLIPS SERVICE CENTER

TABLE 1 (cont.)
SOIL EXCAVATION ANALYTICAL RESULTS
PHILLIPS SERVICE CENTER

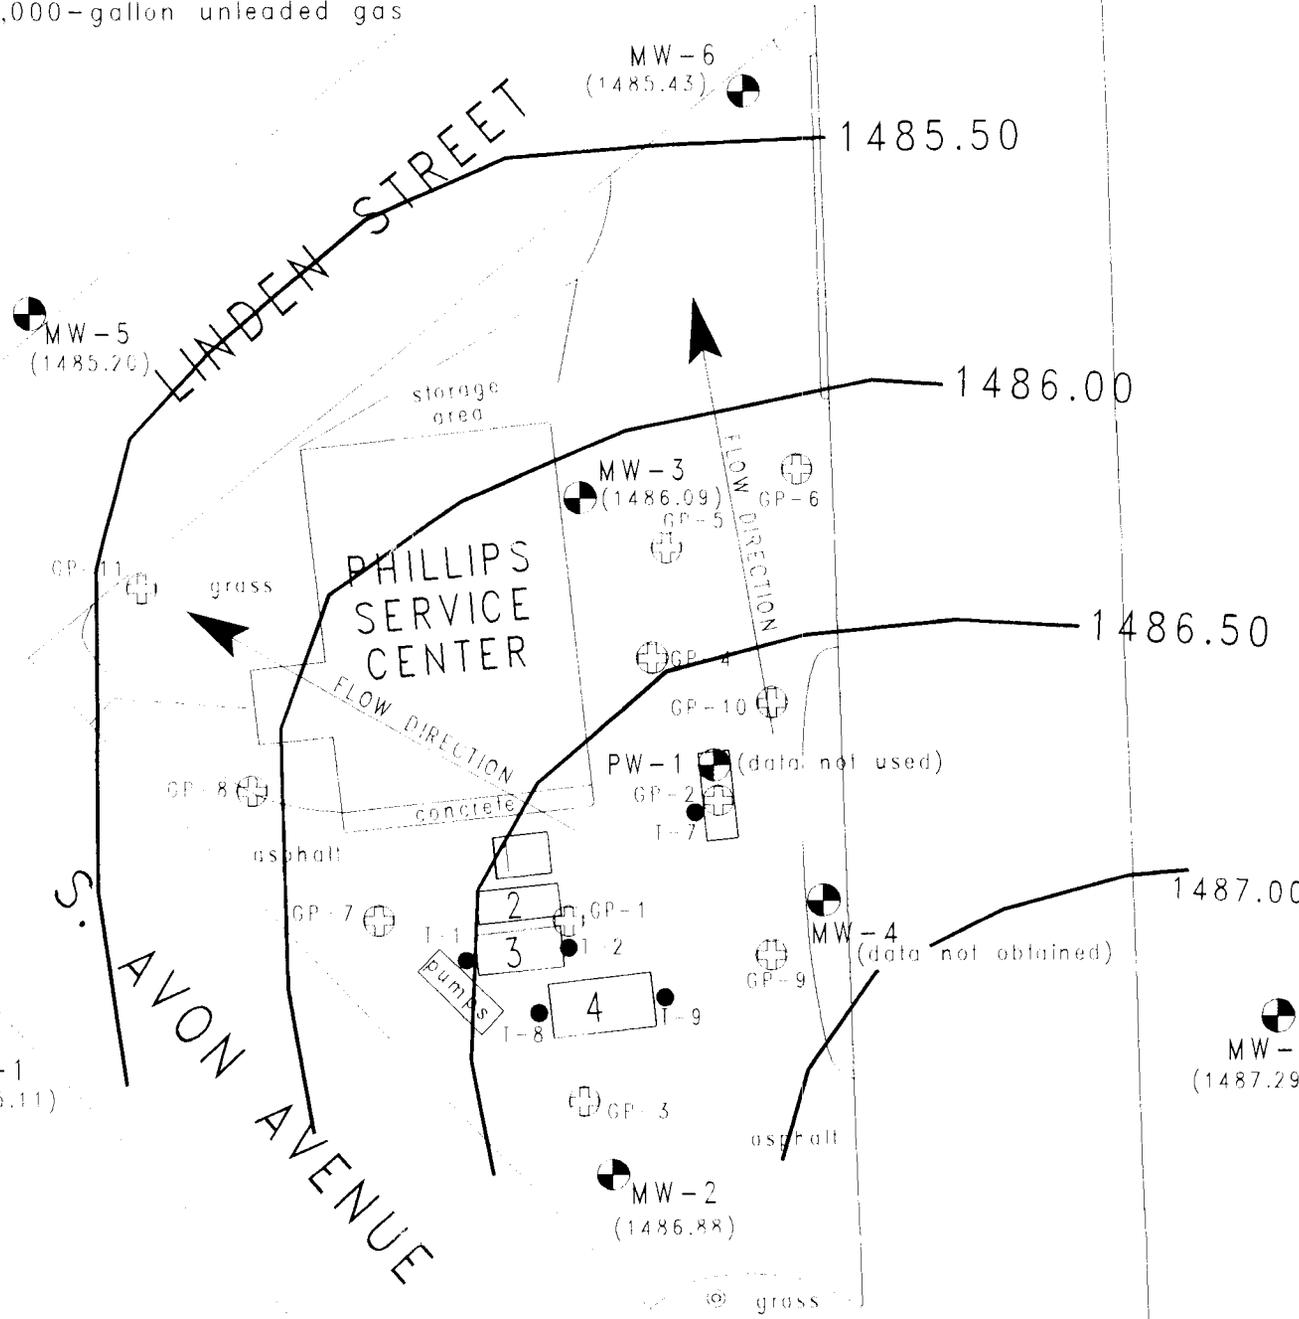
Phillips Service Center Phillips, WI
 FIGURE 2
 Groundwater Flow Direction
 11/11/98
 state
 date
 Environmental Compliance Consultants Co. F. KORB

- Approx. former tank locations.
- Soil boring/Monitoring well location.
- Geoprobe boring.
- Tank closure assessment soil sample location.
- Buried natural gas line.
- Fire hydrant.
- Fencing.

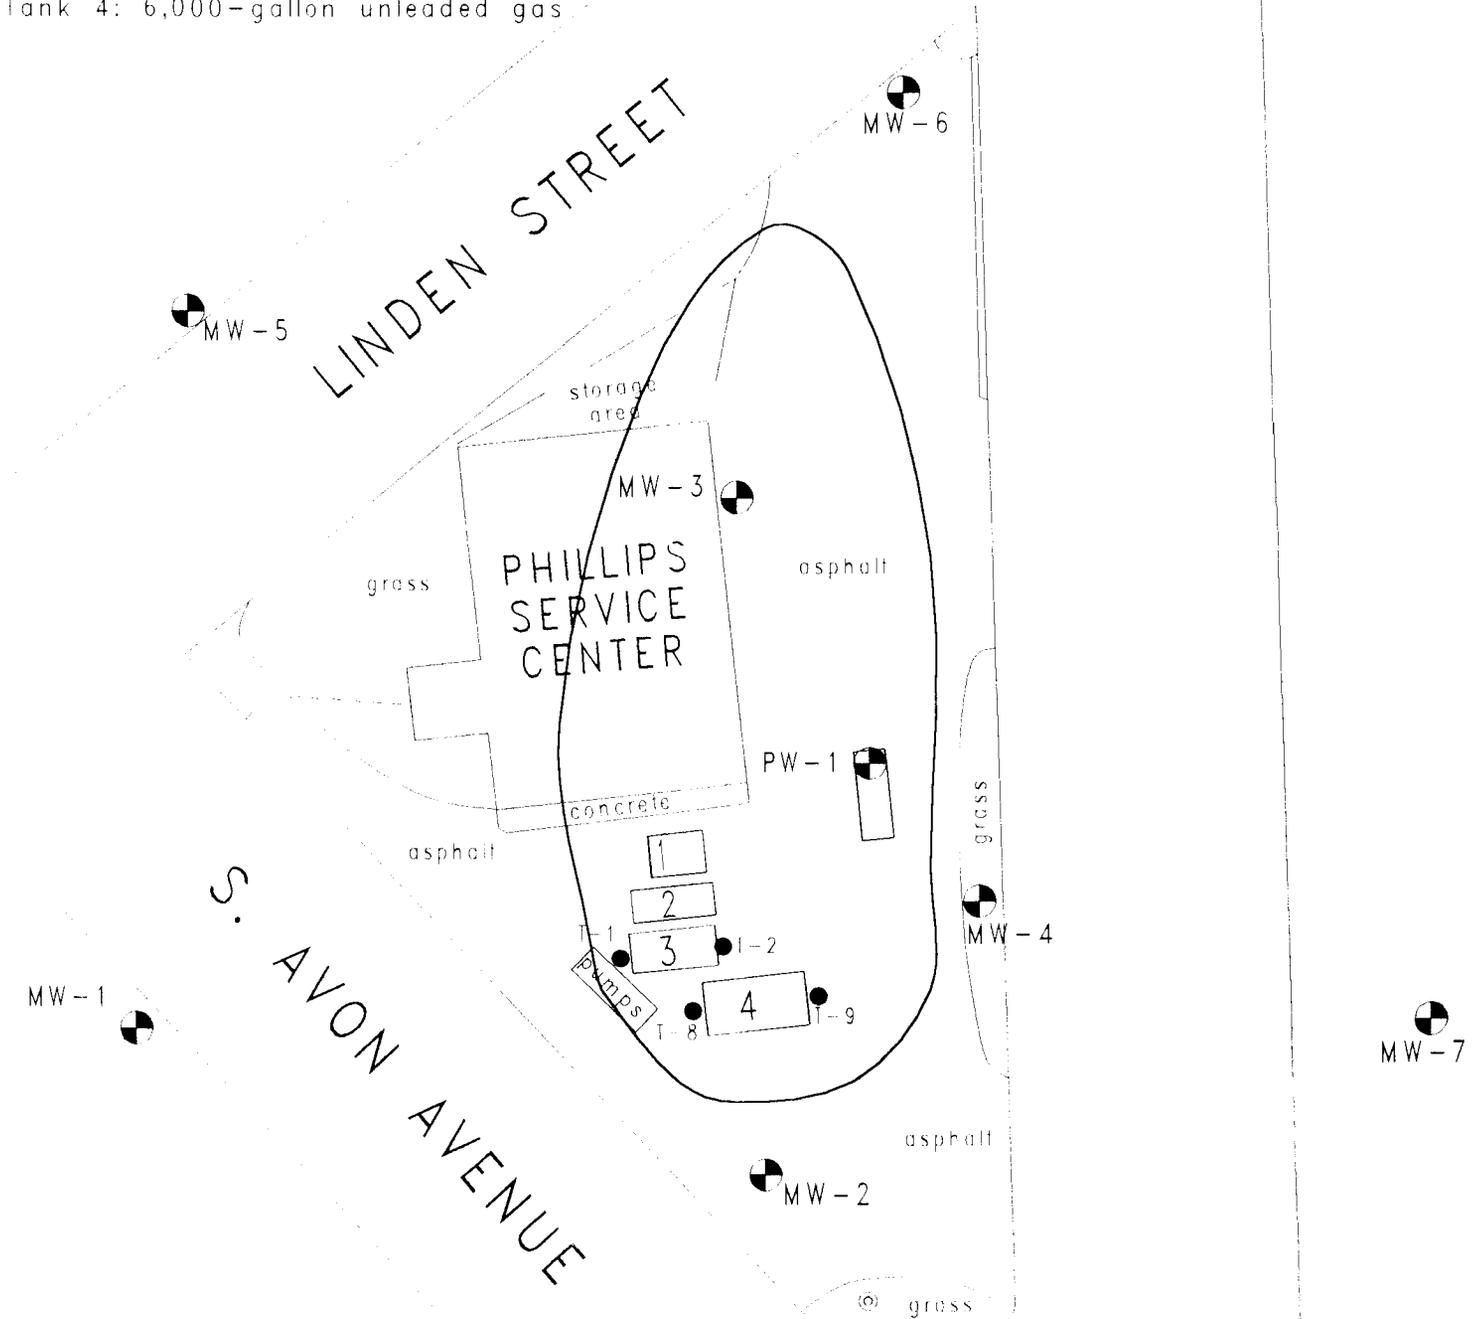
FIGURE 4

Extent of groundwater impact at site

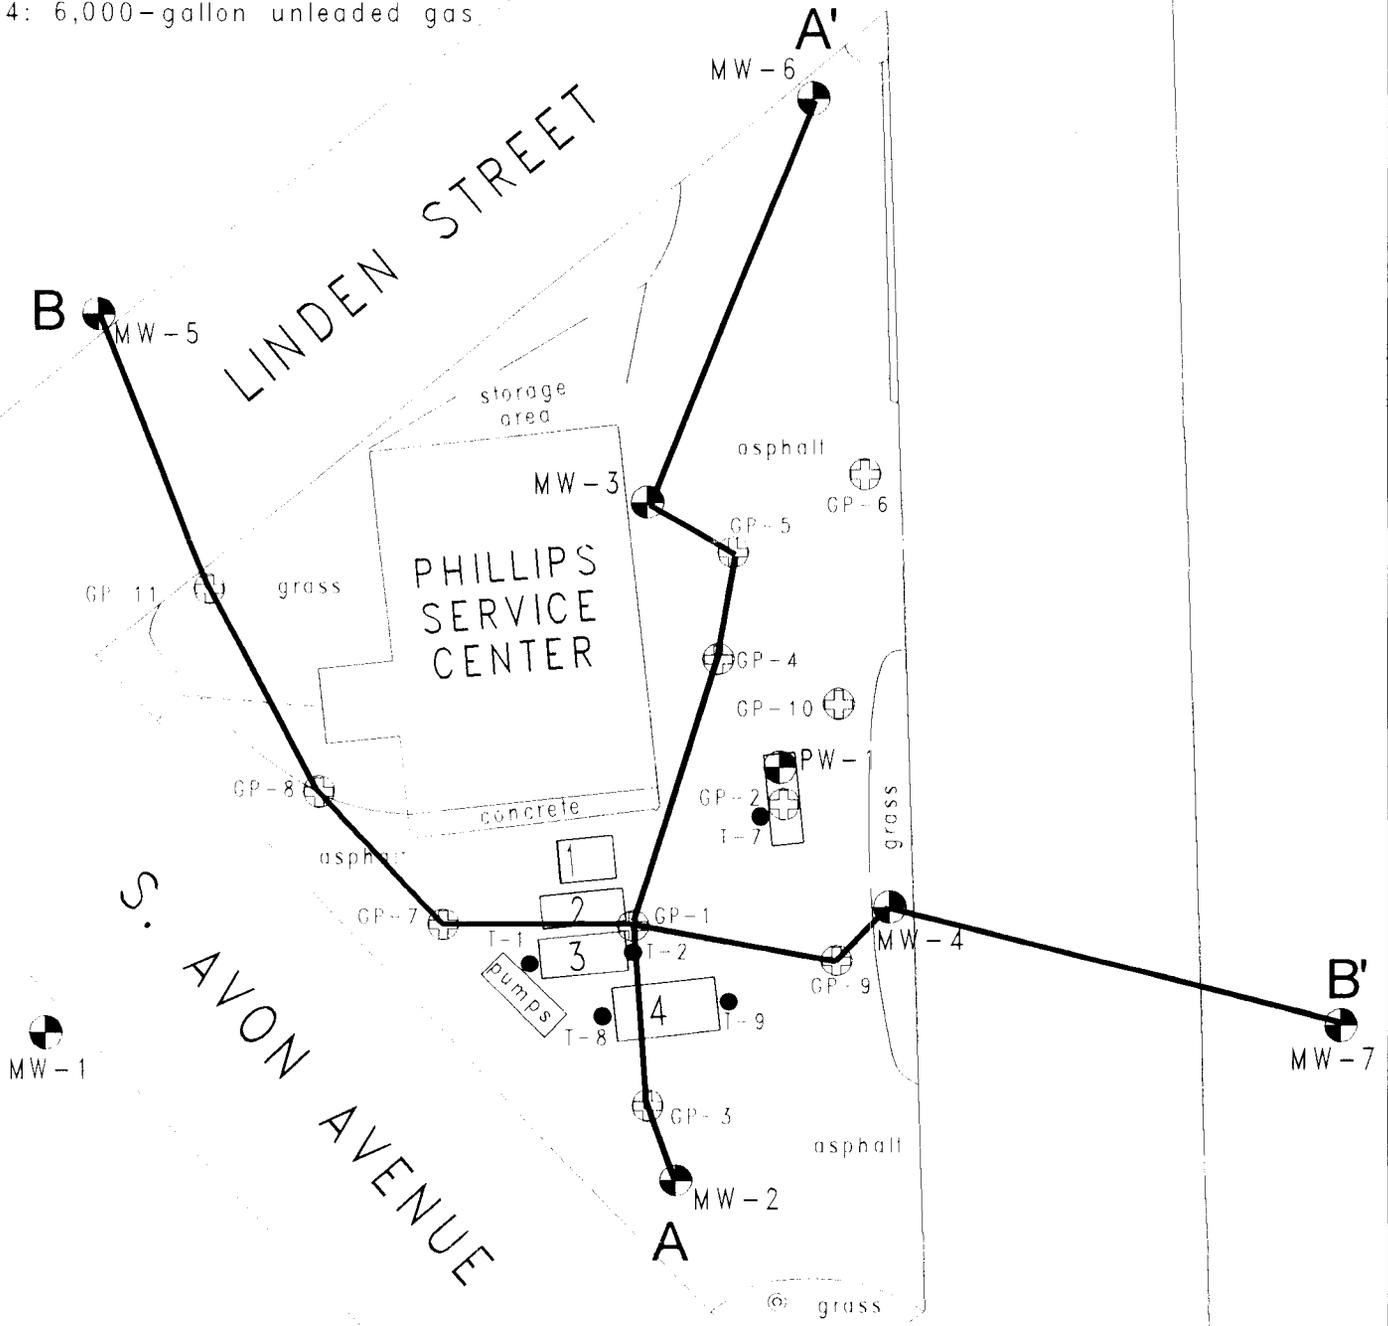
Phillips Service Center Phillips, WI
FIGURE 1
 Cross Section Overview
 scale 1" = 10' DATE 1/18/97
 Environmental Compliance Consultants, Inc. SP-10-0008

- Approx. former tank locations.
- Soil boring/Monitoring well location.
- Geoprobe boring.
- Tank closure assessment soil sample location.
- Buried natural gas line.
- Fire hydrant.
- Fencing.

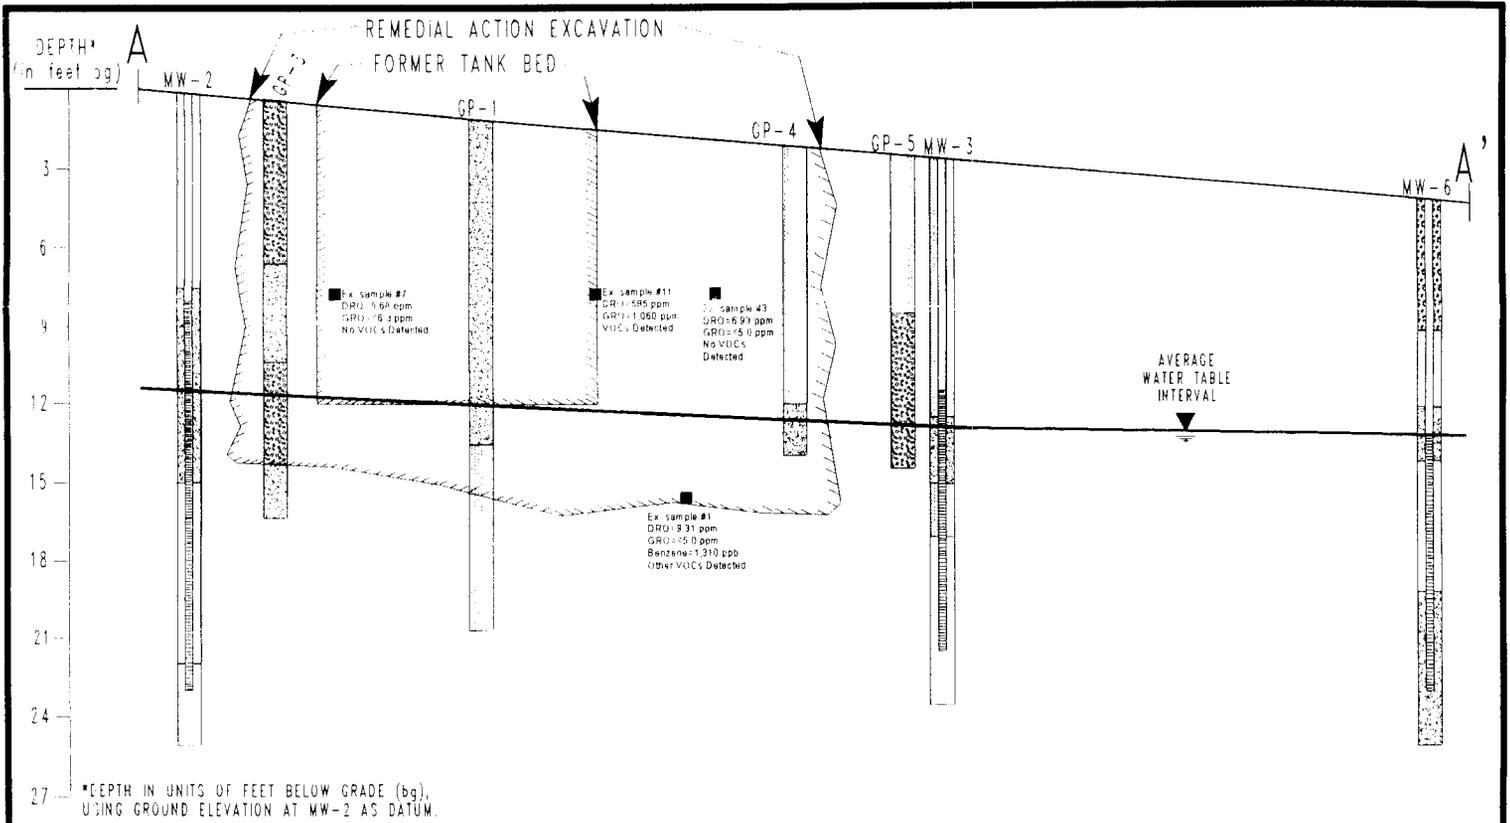
Phillips Service Center - Phillips, WI	
FIGURE 10 CROSS SECTION A-A' (Post-remediation)	
SCALE: SEE GRAPHIC SCALE	DATE: 2/27/00
Environmental Compliance Consultants, Inc.	BY: B. KORB

- VARIABLE MIX OF BROWNISH GRAVEL, SAND, SILT, AND CLAY, POSSIBLY REPRESENTING FILL MATERIAL OR DISTURBED SOILS.
- BROWN FINE TO COARSE SAND, AND SILTY SAND WITH 0-20% GRAVEL, 0-5% CLAY, AND INTERMITTENT SILT LENSES.
- RED BROWN TO BROWN TO ORANGE BROWN SILT WITH 0-15% CLAY, 5-15% SAND, 0-15% GRAVEL, AND INTERMITTENT SANDY AND CLAYEY LENSES.
- NO DATA AVAILABLE, INTERVAL NOT CLASSIFIED
- MONITORING WELL AND SCREENED INTERVAL
- LOCATION AND LABORATORY RESULTS OF EXCAVATION SOIL SAMPLES
- ESTIMATED EXTENT OF SOIL CONTAMINATION
- ESTIMATED EXTENT OF GROUNDWATER CONTAMINATION

VERTICAL EXAGGERATION = 3.33X

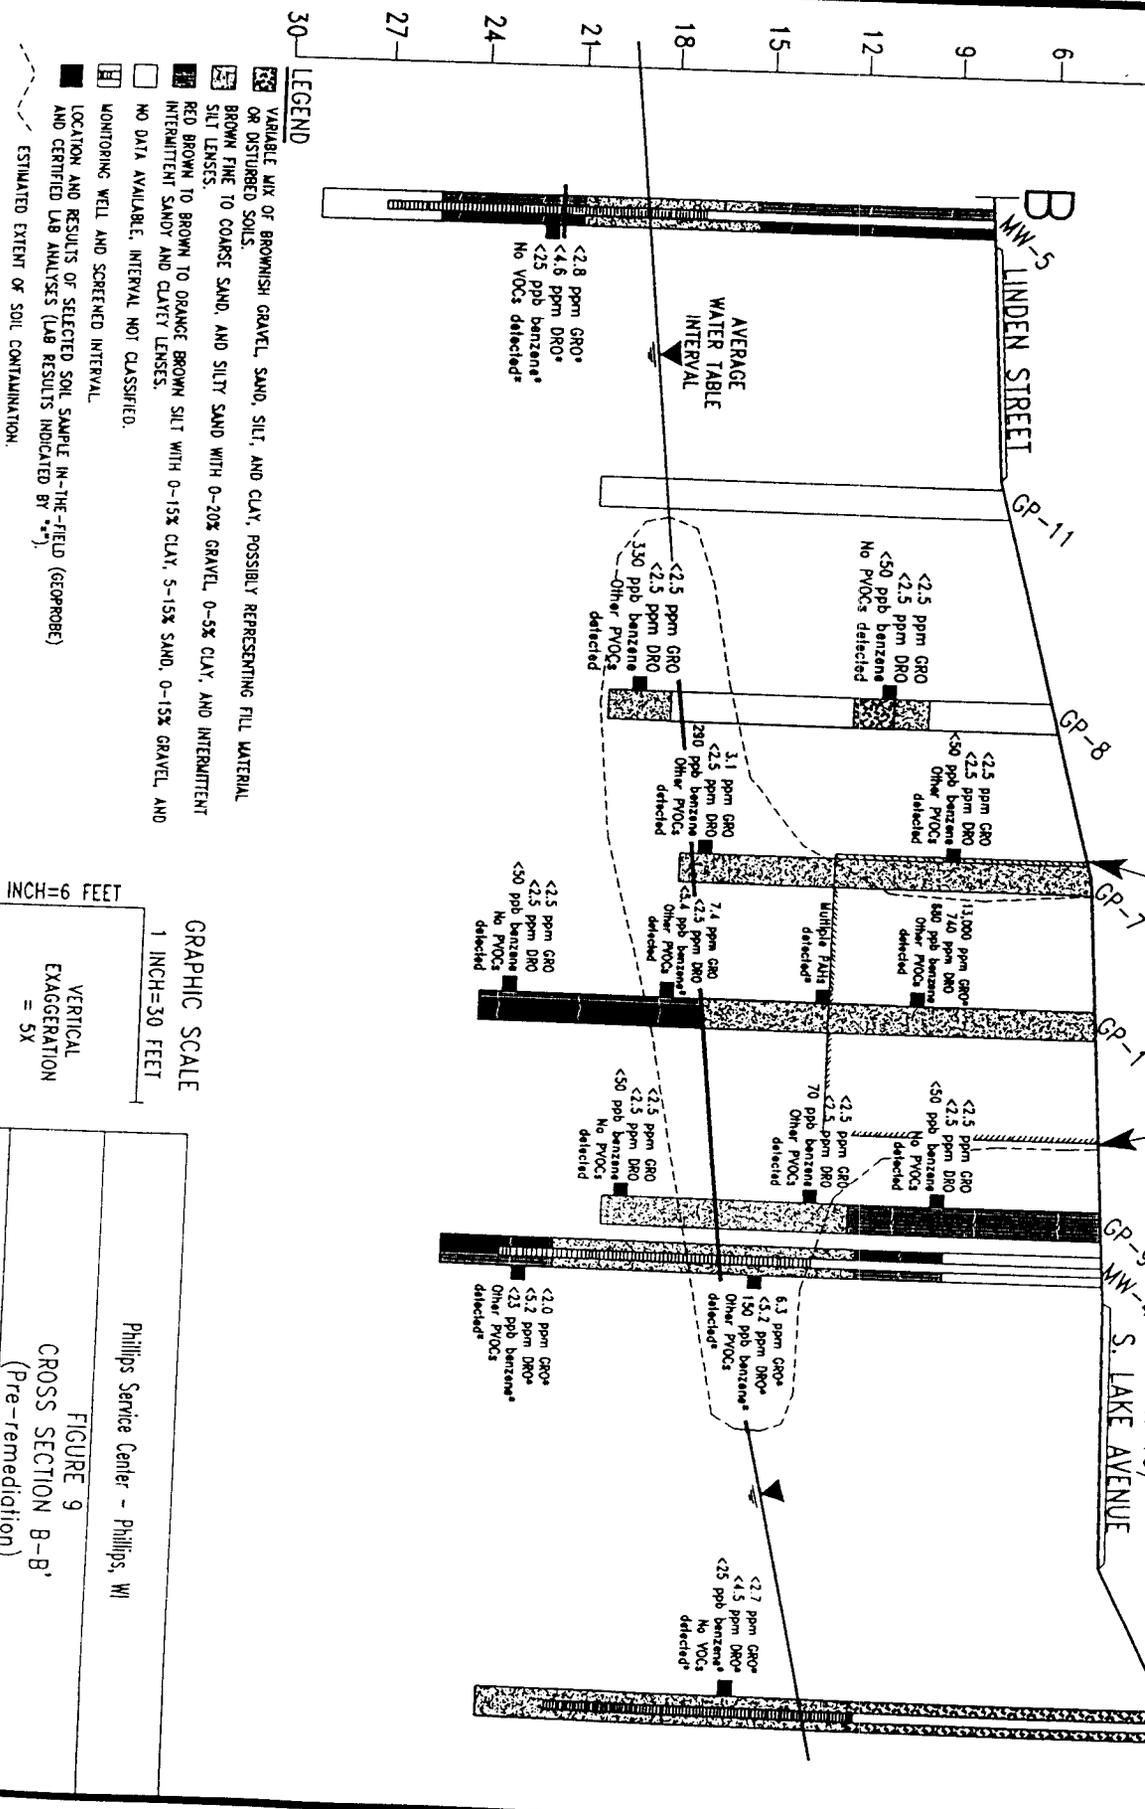
FIGURE 9
CROSS SECTION B-B'
(Pre-remediation)

- LEGEND**
- ▨ VARIABLE MIX OF BROWNISH GRAVEL, SAND, SILT, AND CLAY, POSSIBLY REPRESENTING FILL MATERIAL OR DISTURBED SOILS.
 - ▨ BROWN FINE TO COARSE SAND, AND SILTY SAND WITH 0-20% GRAVEL, 0-5% CLAY, AND INTERMITTENT SILT LENSES.
 - ▨ RED BROWN TO BROWN TO ORANGE BROWN SILT WITH 0-15% CLAY, 5-15% SAND, 0-15% GRAVEL, AND INTERMITTENT SANDY AND CLAYEY LENSES.
 - NO DATA AVAILABLE, INTERVAL NOT CLASSIFIED.
 - ▨ MONITORING WELL AND SCREENED INTERVAL.
 - ▨ LOCATION AND RESULTS OF SELECTED SOIL SAMPLE IN-THE-FIELD (GEOPROBE) AND CERTIFIED LAB ANALYSES (LAB RESULTS INDICATED BY *+*), ESTIMATED EXTENT OF SOIL CONTAMINATION.

VERTICAL EXAGGERATION = 5X
1 INCH=6 FEET

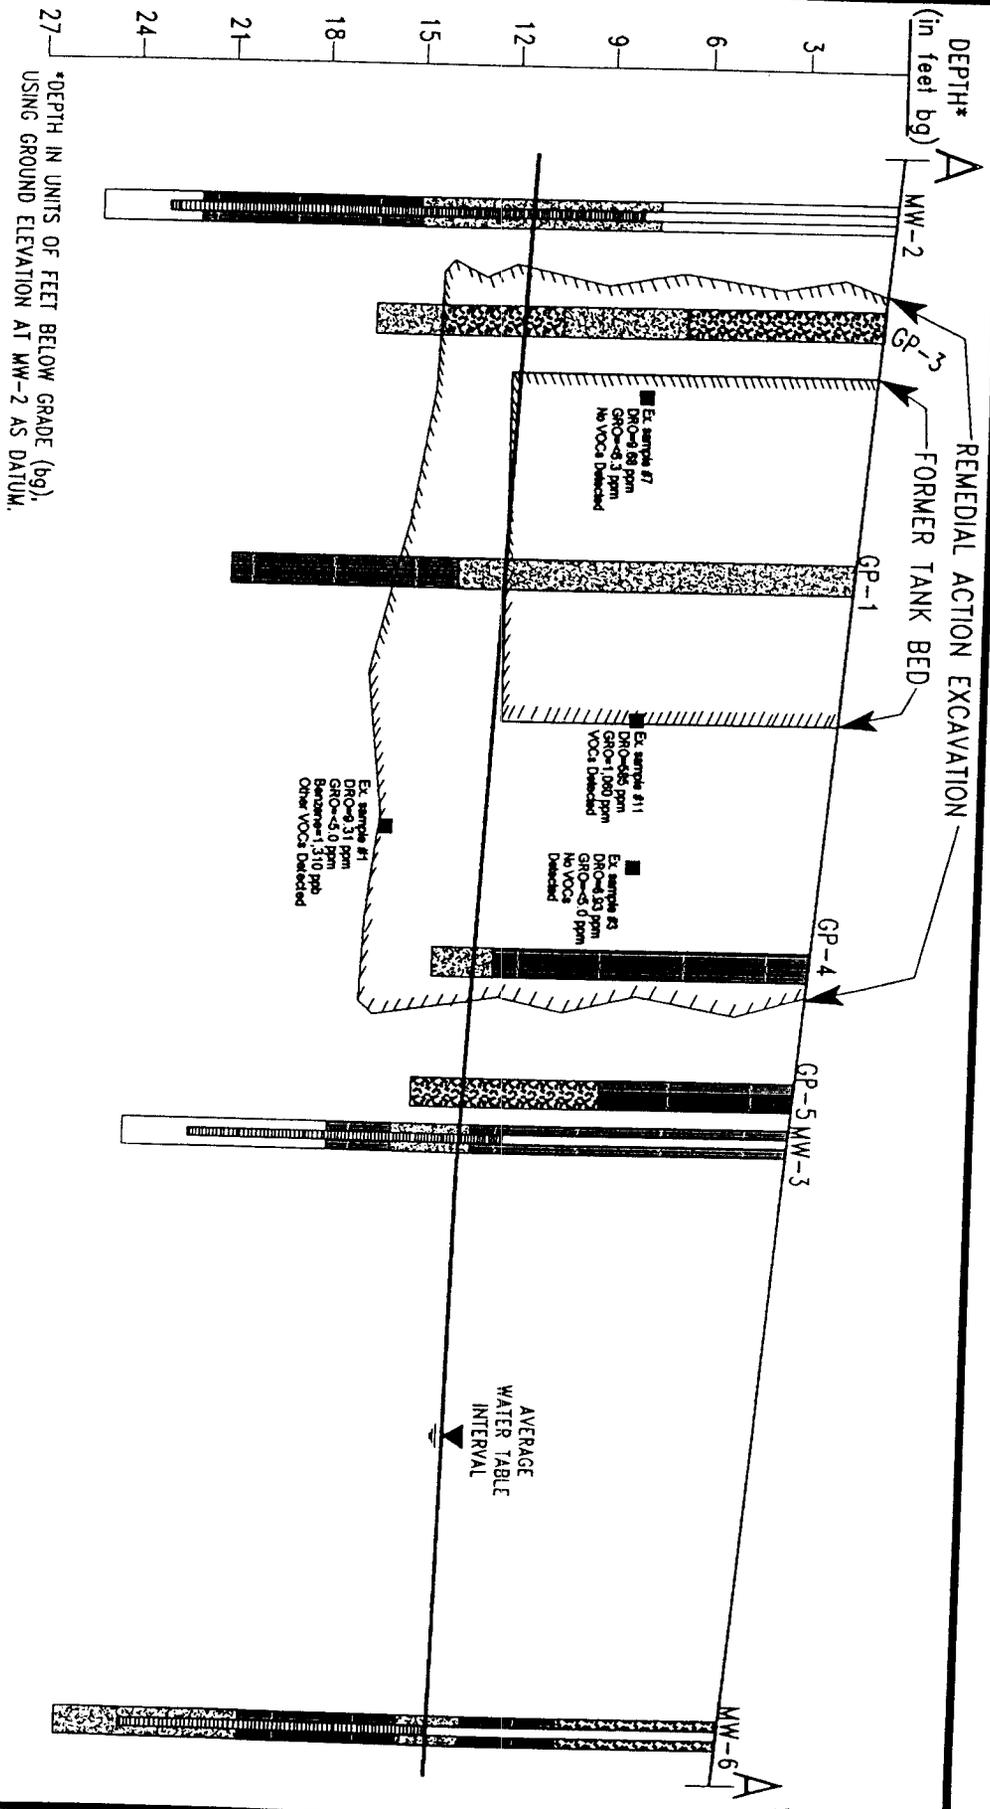
Phillips Service Center - Phillips, WI	
FIGURE 10	
CROSS SECTION A-A'	
(Post-remediation)	
SCALE: SEE GRAPHIC SCALE	DATE: 2/27/00
Environmental Compliance Consultants, Inc.	
BY: B. KORB

- VARIABLE MIX OF BROWNISH GRAVEL, SAND, SILT, AND CLAY, POSSIBLY REPRESENTING FILL MATERIAL OR DISTURBED SOILS.
- BROWN FINE TO COARSE SAND, AND SILTY SAND WITH 0-20% GRAVEL, 0-5% CLAY, AND INTERMITTENT SILT LENSES.
- RED BROWN TO BROWN TO ORANGE BROWN SILT WITH 0-15% CLAY, 5-15% SAND, 0-15% GRAVEL, AND INTERMITTENT SANDY AND CLAYEY LENSES.
- NO DATA AVAILABLE, INTERVAL NOT CLASSIFIED.
- MONITORING WELL AND SCREENED INTERVAL.
- LOCATION AND LABORATORY RESULTS OF EXCAVATION SOIL SAMPLES.
- ESTIMATED EXTENT OF SOIL CONTAMINATION.
- ESTIMATED EXTENT OF GROUNDWATER CONTAMINATION.

VERTICAL EXAGGERATION = 3.33X

*DEPTH IN UNITS OF FEET BELOW GRADE (bg),
USING GROUND ELEVATION AT MW-7 AS DATUM.

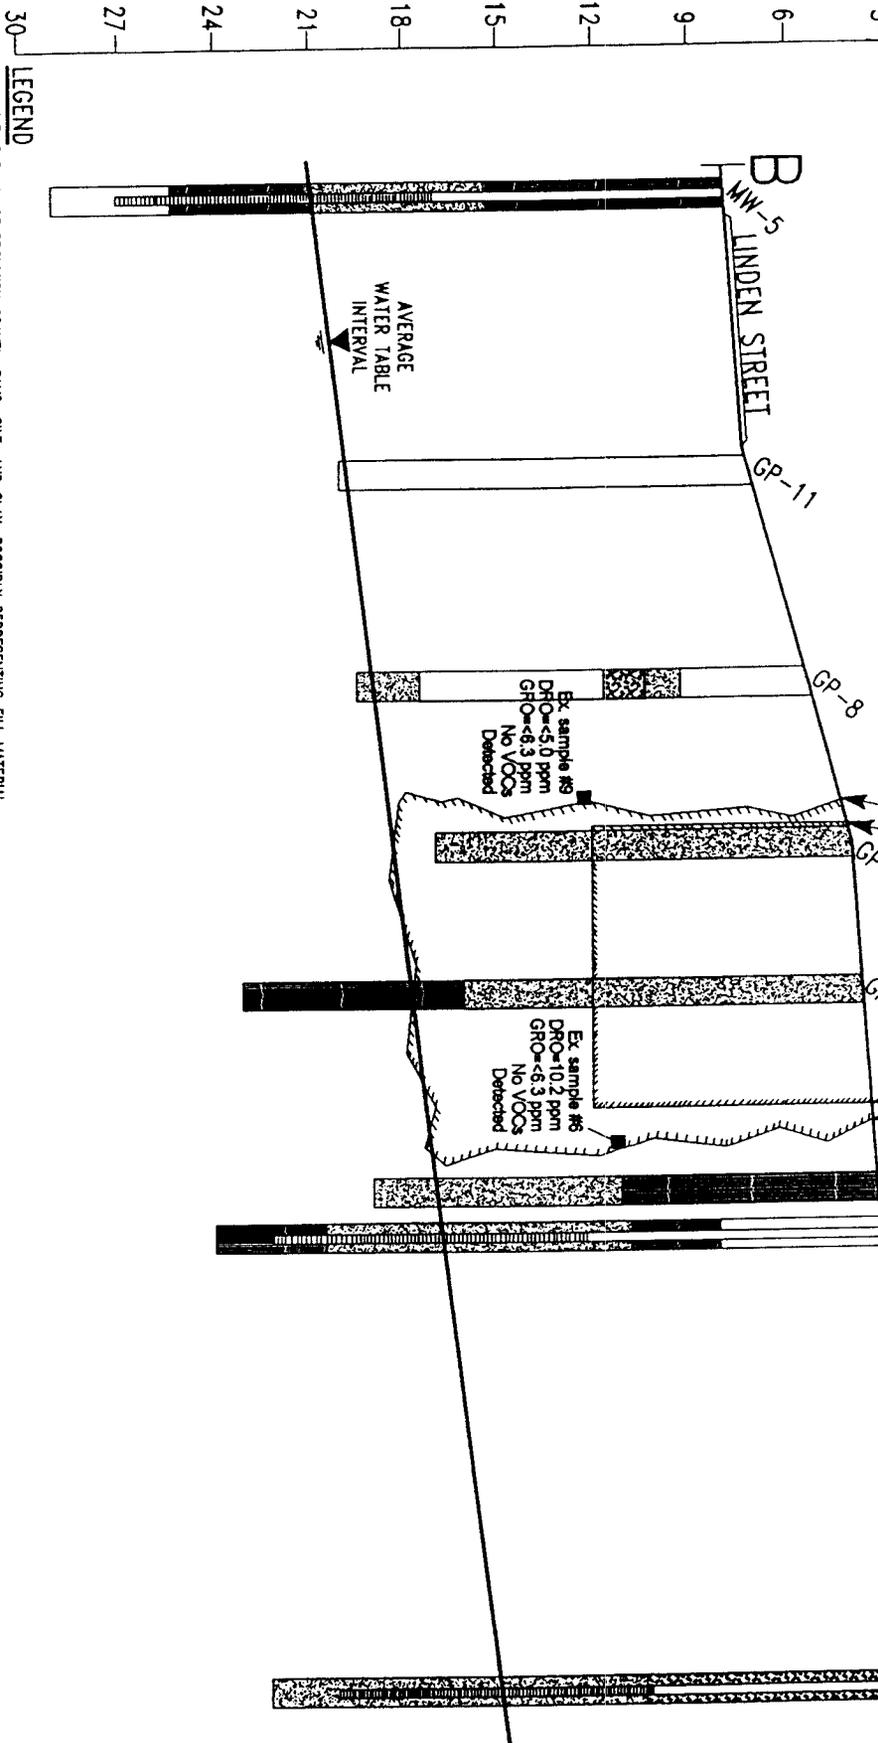
Philips Service Center - Phillips, WI	
FIGURE 11	
CROSS SECTION B-B' (Post-remediation)	
SCALE: SEE GRAPHIC SCALE	DATE: 3/17/00
Environmental Compliance Consultants, Inc.	
BY: B. KORB

- LEGEND**
- VARIABLE MIX OF BROWNISH GRAVEL, SAND, SILT, AND CLAY, POSSIBLY REPRESENTING FILL MATERIAL OR DISTURBED SOILS.
 - BROWN FINE TO COARSE SAND, AND SILTY SAND WITH 0-20% GRAVEL, 0-5% CLAY, AND INTERMITTENT SILT LENSES.
 - RED BROWN TO BROWN TO ORANGE BROWN SILT WITH 0-15% CLAY, 5-15% SAND, 0-15% GRAVEL, AND INTERMITTENT SANDY AND CLAYEY LENSES.
 - NO DATA AVAILABLE; INTERVAL NOT CLASSIFIED.
 - MONITORING WELL AND SCREENED INTERVAL.
 - LOCATION AND LABORATORY RESULTS OF EXCAVATION SOIL SAMPLES.
 - ESTIMATED EXTENT OF SOIL CONTAMINATION.

VERTICAL EXAGGERATION = 5X
1 INCH=6 FEET
