GOLATS PHILLIPS 66

SUBJECT: Final Case Closure with Continuing Obligations
Golats Phillips 66, 212E. Arthur Avenue, Bruce, Wisconsin
WDNR BRRTS Activity # 03-55-236132

Subject: Conditional Closure Decision,
With Requirements to Achieve Final Closure
Golats Phillips 66, 212E. Arthur Avenue, Bruce, Wisconsin
WDNR BRRTS Activity # 03-55-236132

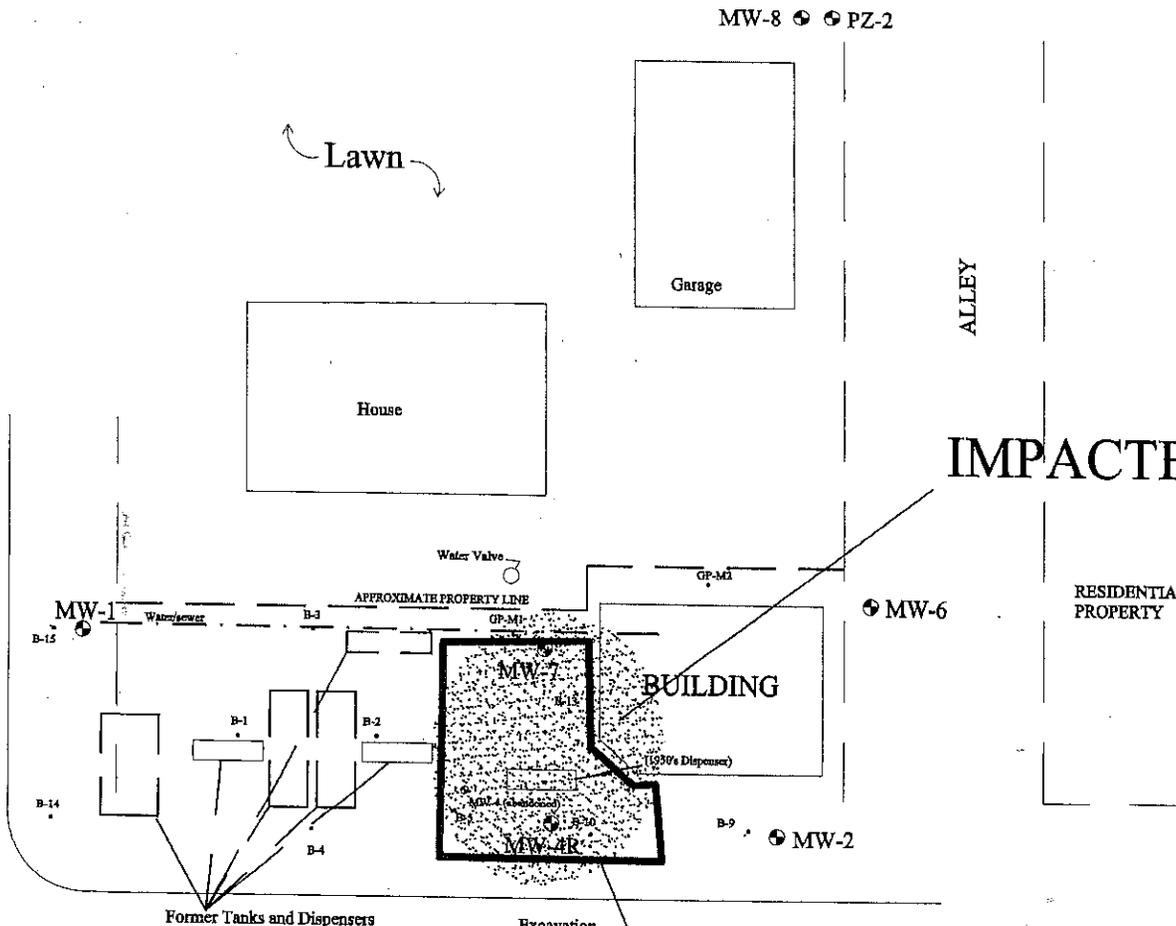
Figure B.3.b
Estimated Extent of Impacted Ground Water
Golaf's Gas N Grocery
Bruce, WI

Groundwater contamination greater than enforcement standards is present on this contaminated property as shown on the attached map, "Estimated Extent of Impacted Ground Water", labeled Figure B.3.b, submitted by Meridian Environmental on February 18, 2013. If you intend to construct a new well, or reconstruct an existing well, you'll need prior DNR approval.

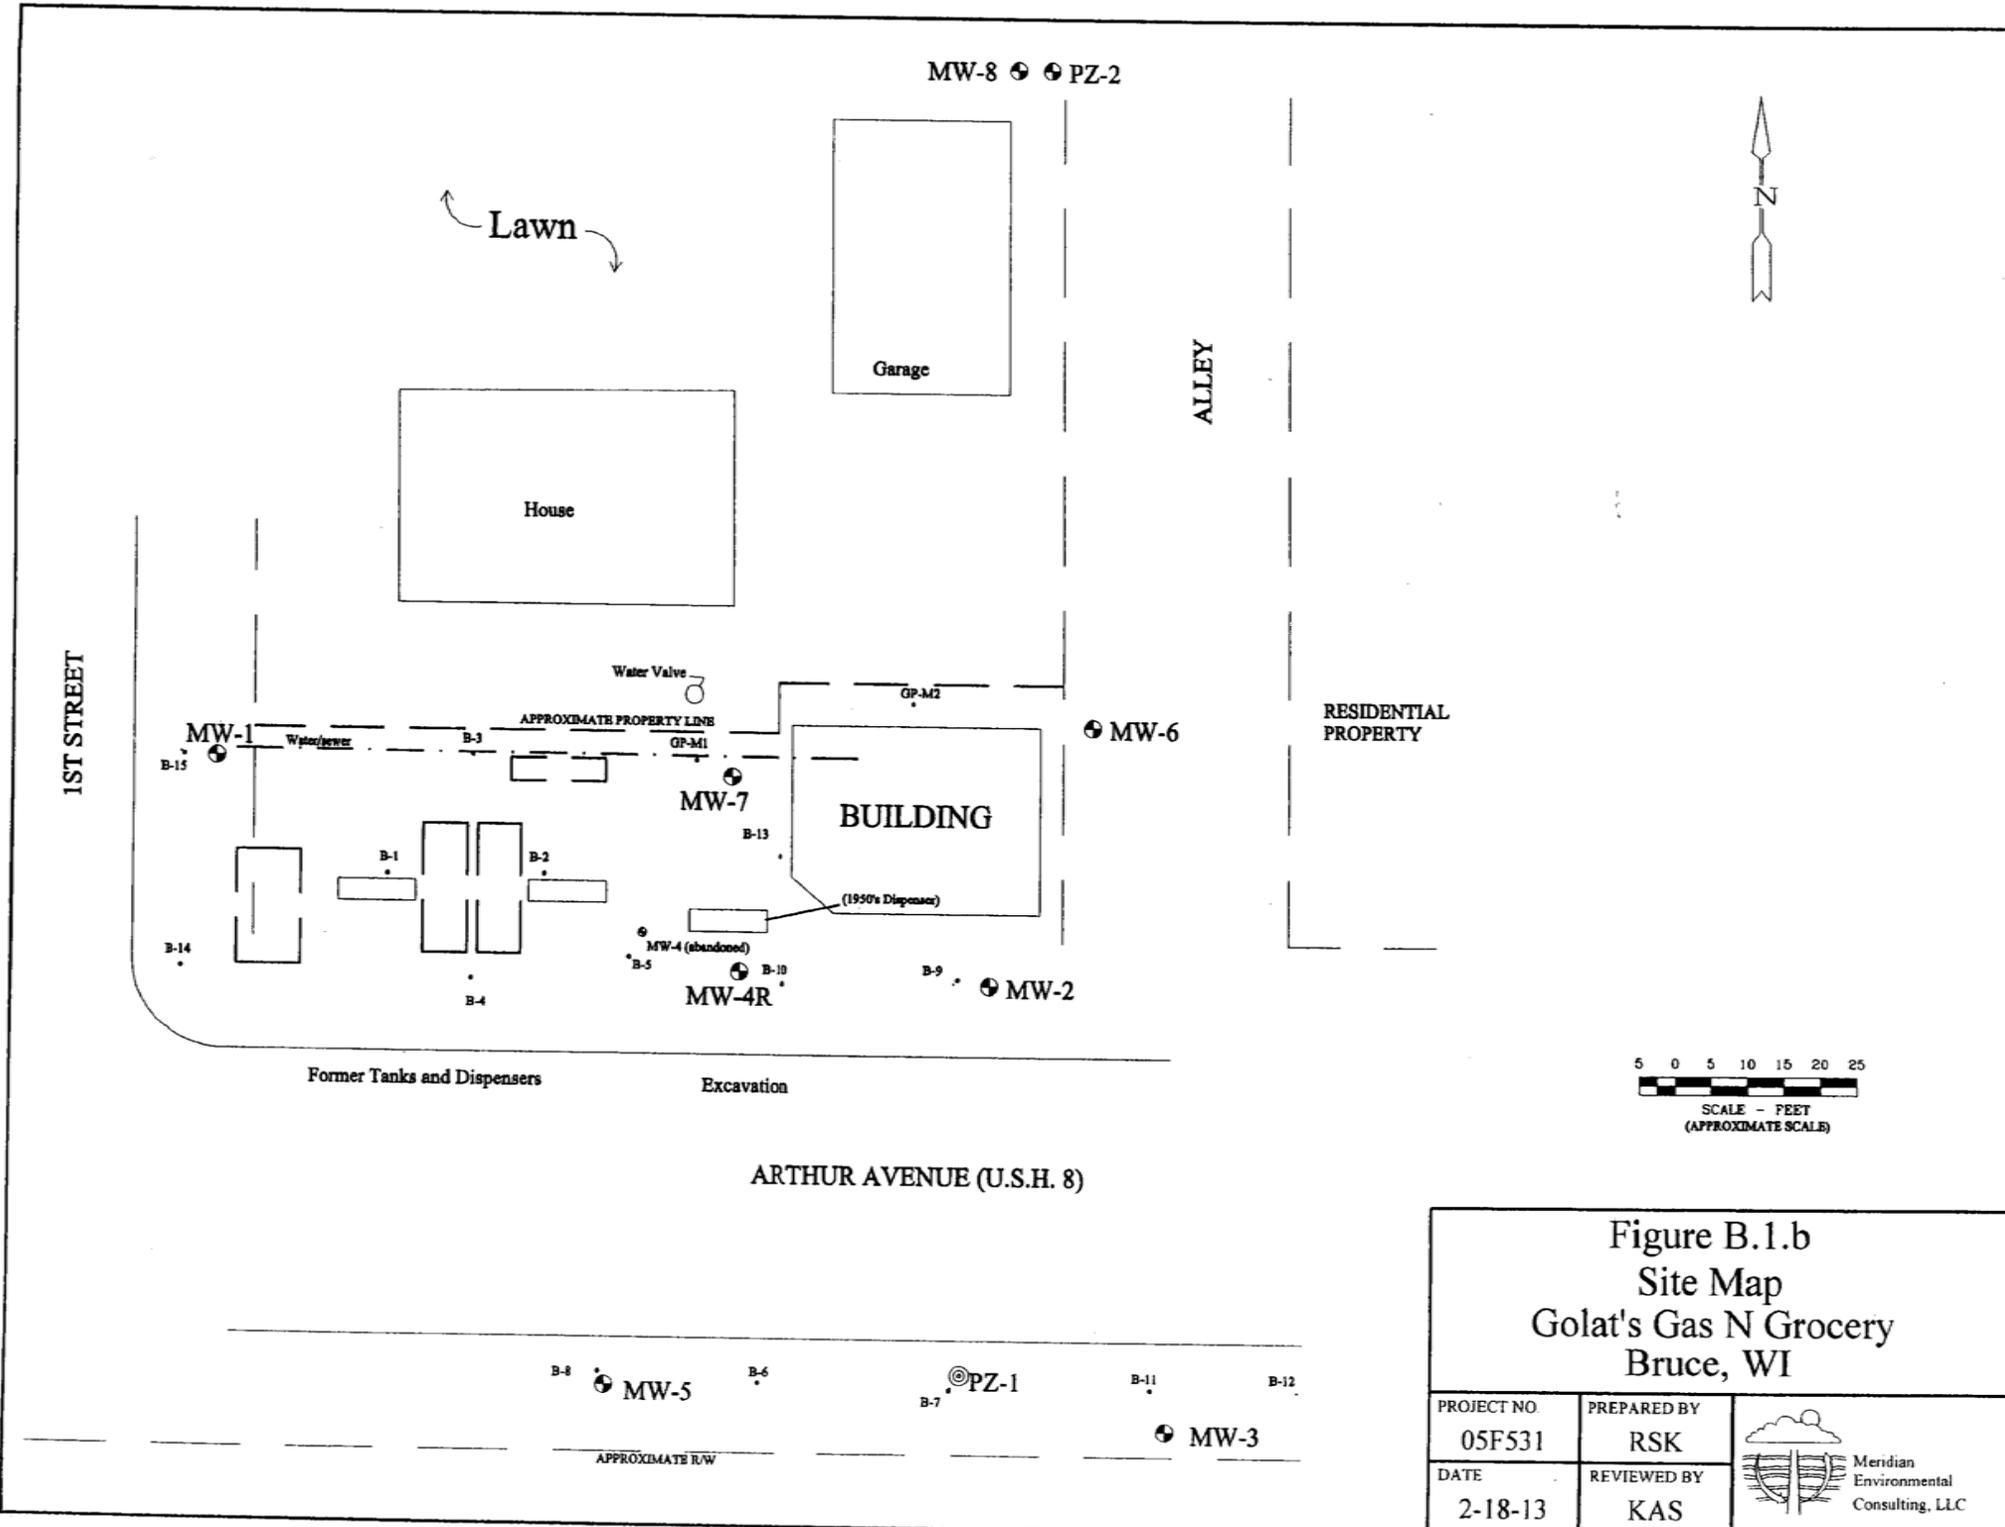
Figure B.1.b
 Site Map
 Golat's Gas N Grocery
 Bruce, WI

Site is former gas station located at corner of Highway 8 (Arthur Avenue) and 1st Street. Property is small (approximately 25 x 120 ft) and consists of small building and parking space. Property is located on edge of commercial and residential properties. Wetland is located across Hwy. 8 (south).

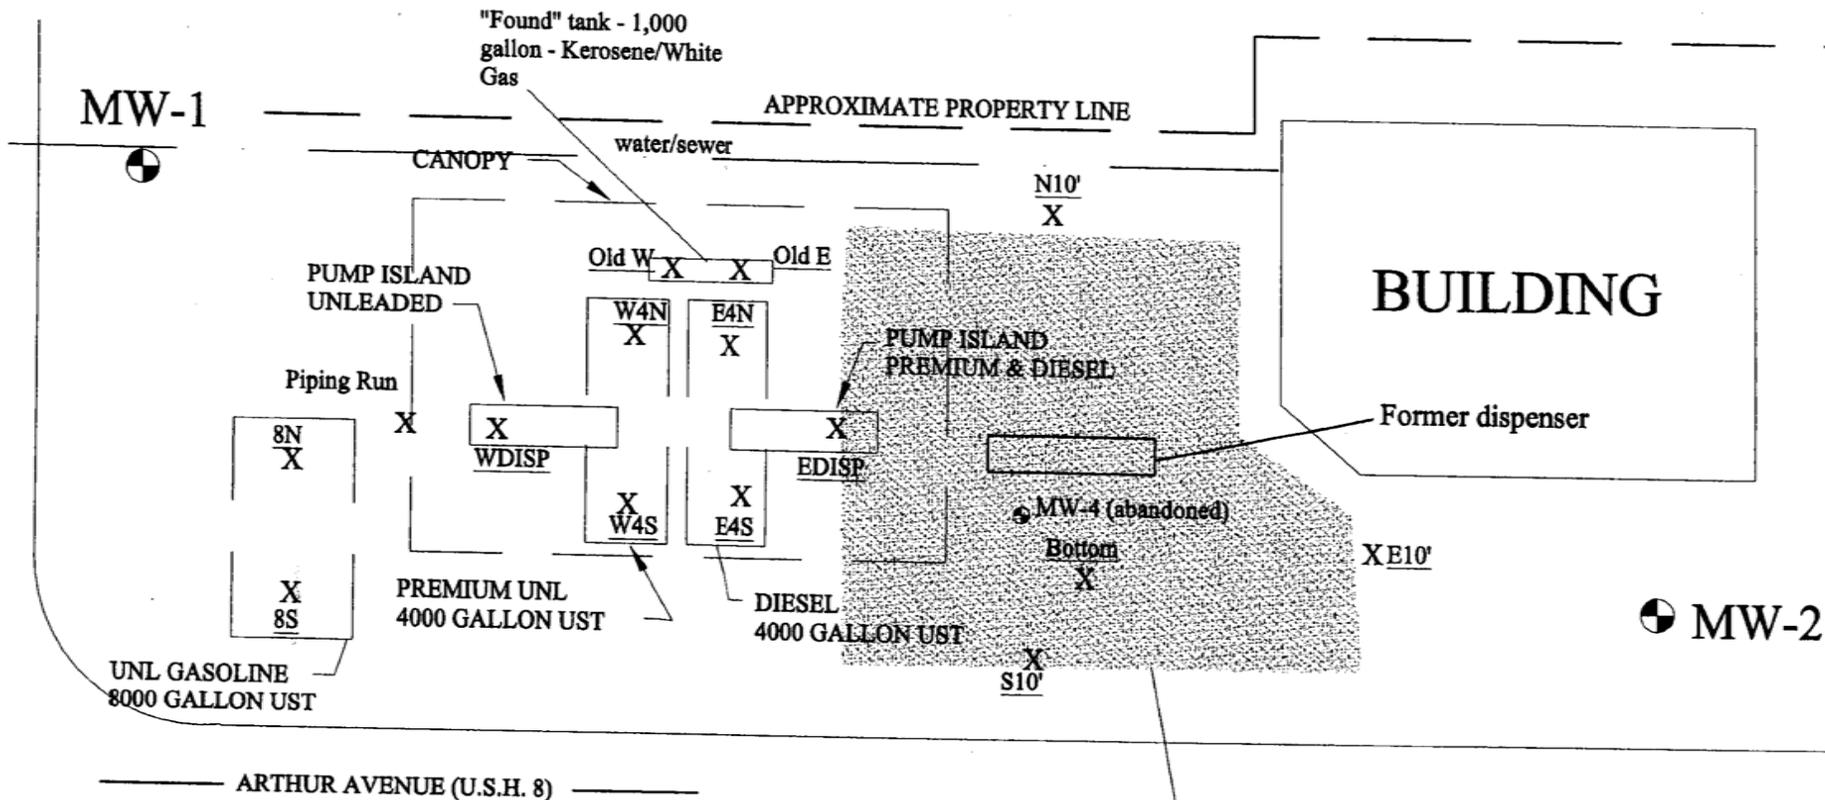
Excavation

X 8S - Tank Closure Sample Location

Free product was bailed from MW-4 from 2003 to 2007. Approximately 766 tons of source soils were excavated in December 2008. Remedial excavation removed all contaminated soil and smear zone impacts in free product area (MW-4). Confirmation sampling indicates no soil contamination. Ground water monitoring indicates stable plume and no free product is found at the site. See Figure B.2.b for location of excavation and Table A.3 for summary of post-remedial soil sampling

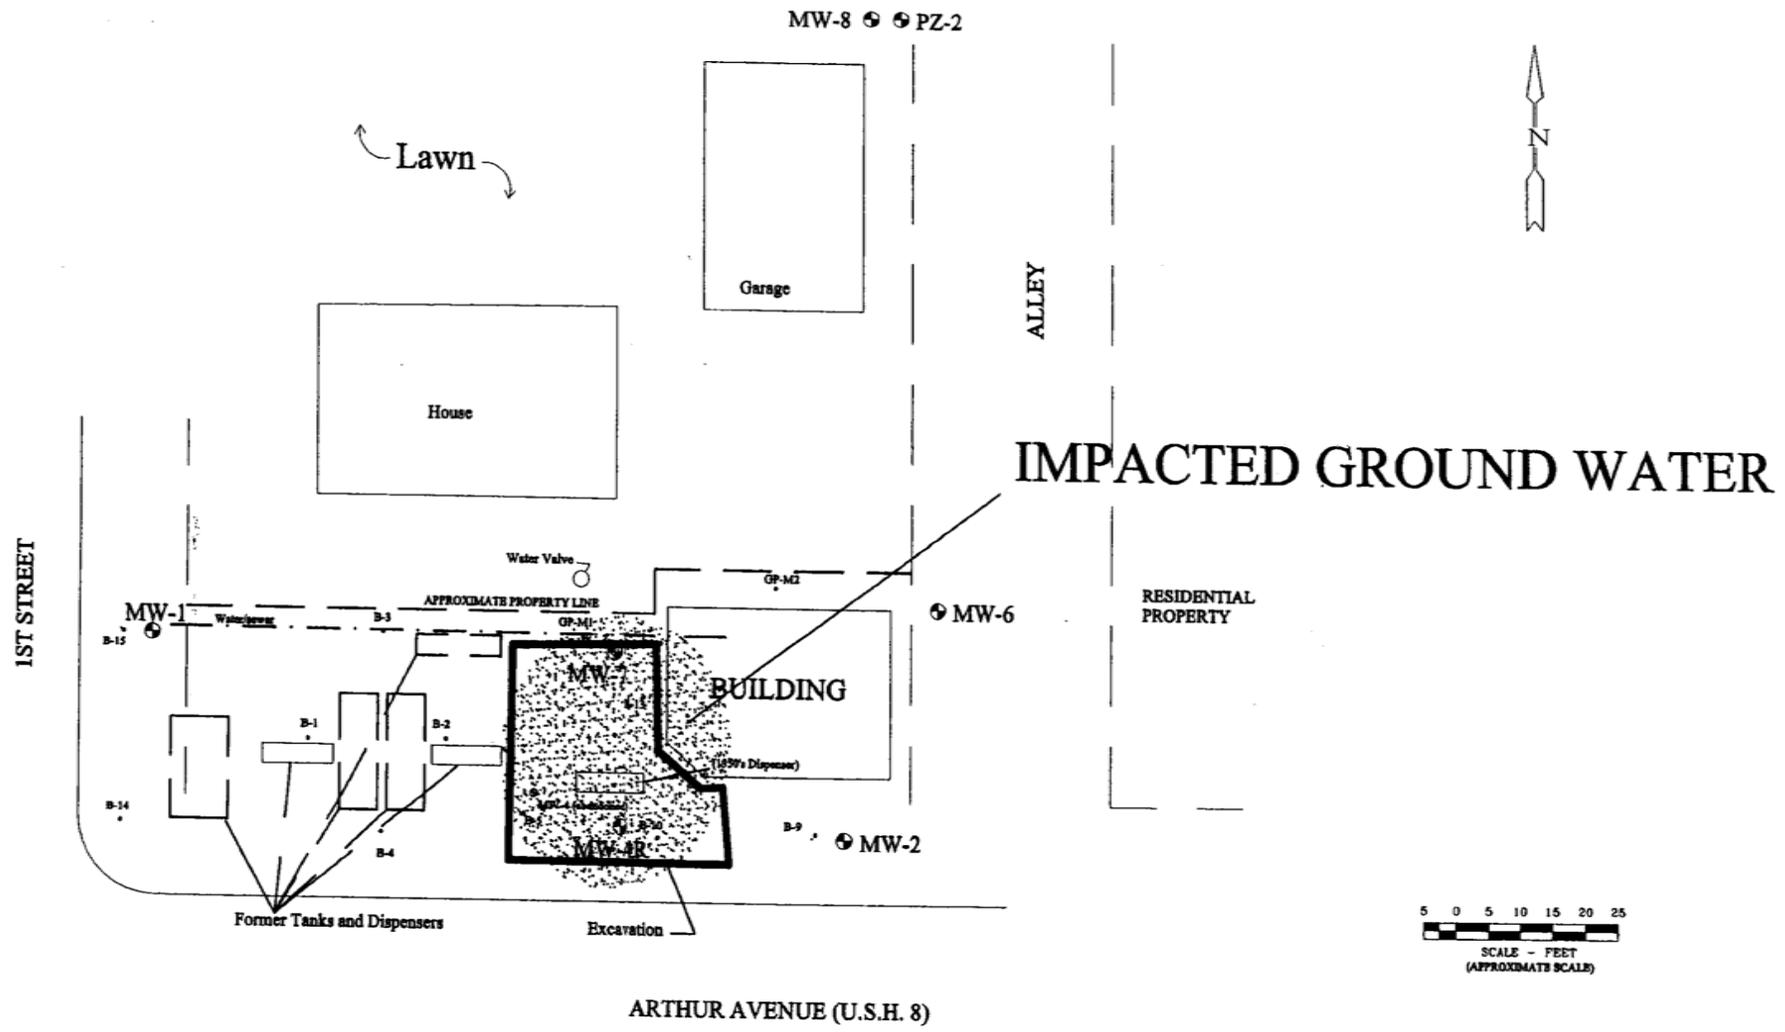
Figure B.3.b
Estimated Extent of Impacted Ground Water
Golat's Gas N Grocery
Bruce, WI

Petroleum impacted ground water is found beneath the former source area.
