GIS REGISTRY INFORMATION

SITE NAME: Hillboro Farmers Coop - Yuba
BRRTS #: 03-53-001966 **FID # (if appropriate):**
COMMERCE # (if appropriate): 54634-9313-07
CLOSURE DATE: 06-Feb-2007
STREET ADDRESS: County Road C
CITY: Yuba

SUBJECT: Final Case Closure with Land Use Limitations or Conditions
Hillsboro Farmer's Coop, Yuba, Wisconsin
WDNR BRRTS Activity #: 03-53-001966

SOILS MANAGEMENT PLAN
Hillsboro Farmers Cooperative Warehouse Site
County Highway C, Yuba, WI 54634
6/30/2005

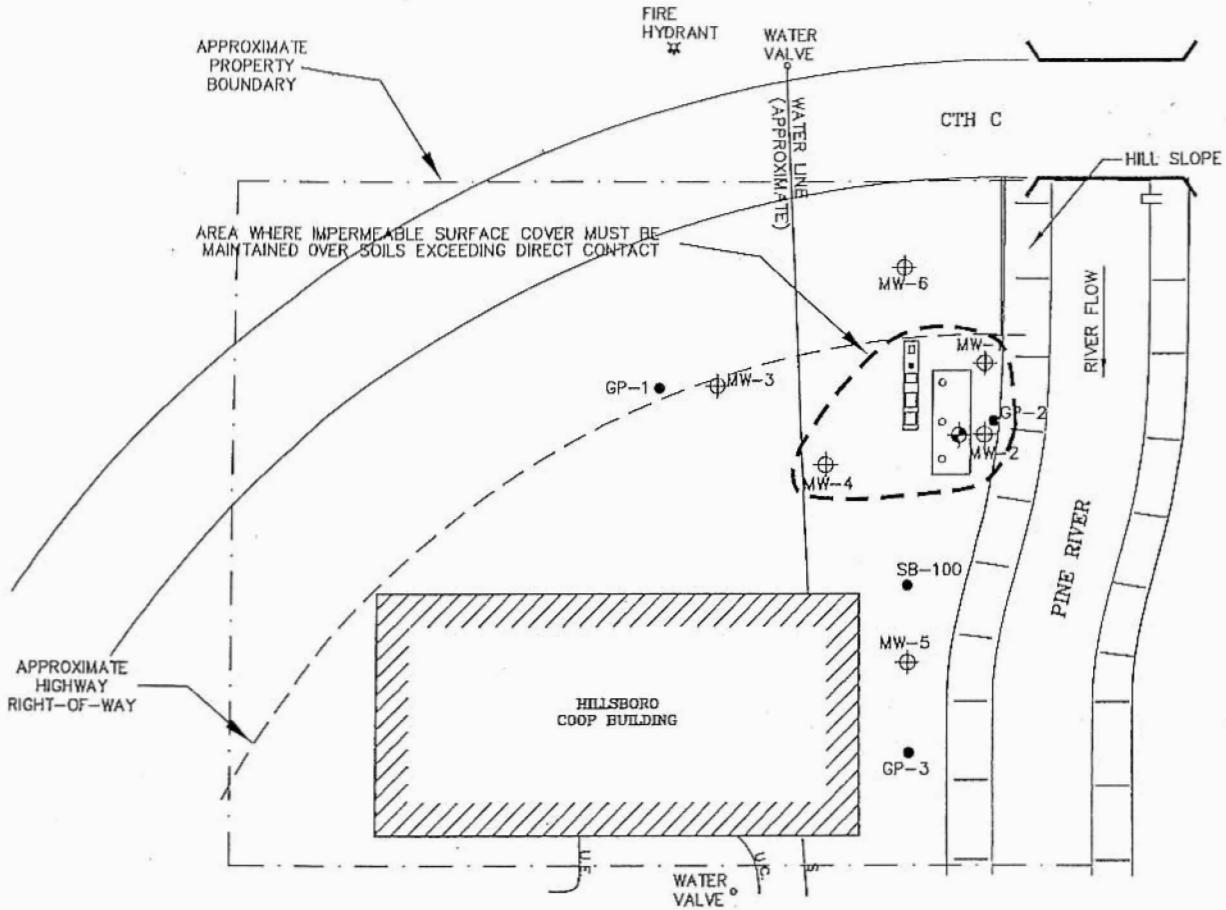
8

IMPERMEABLE SURFACE CAP
HILLSBORO FARMERS COOPERATIVE YUBA, WISCONSIN

Pursuant to s. 292.12(2)(a), Wis. Stats., the pavement that currently exists in the location shown on the attached map shall be maintained in compliance with the attached maintenance plan (Attachment A) in order to prevent direct contact with residual soil contamination that might otherwise pose a threat to human health. If soil in the specific locations described above is excavated in the future, the property owner at the time of excavation must sample and analyze the excavated soil to determine if residual contamination remains. If sampling confirms that contamination is present the property owner at the time of excavation will need to determine whether the material would be considered solid or hazardous waste and ensure that any storage, treatment or disposal is in compliance with applicable statutes and rules. In addition, all current and future owners and occupants of the property need to be aware that excavation of

The following activities are prohibited on any portion of the property where pavement is required as shown on the attached map, unless prior written approval has been obtained from the Wisconsin Department of Natural Resources: 1) removal of the existing barrier; 2) replacement with another barrier; 3) excavating or grading of the land surface; 4) filling on capped or paved areas; 5) plowing for agricultural cultivation; or 6) construction or placement of a building or other structure.

Figure 4 depicts the locations with such soils. The capped area, shown on Figure 8, will be inspected annually in the spring. Any cracks or other defects in the impermeable surface or fill material will be repaired at the time of inspection or shortly thereafter, to ensure that there will be no risk to human health from direct contact with petroleum contaminated soils. If the asphalt cap develops manageable cracks, a sealer will be applied to fill the area of the crack. If the cap is damaged beyond repair, the affected area will be recapped with a new layer of asphalt. The property owner or owner representative will document 1) the date of each inspection, 2) the condition of the impermeable surface or fill material, and 3) any repairs made to the impermeable surface or fill material. Inspection and maintenance records will be kept by the property owner or owner representative and will be made readily available to the WDNR, if necessary.

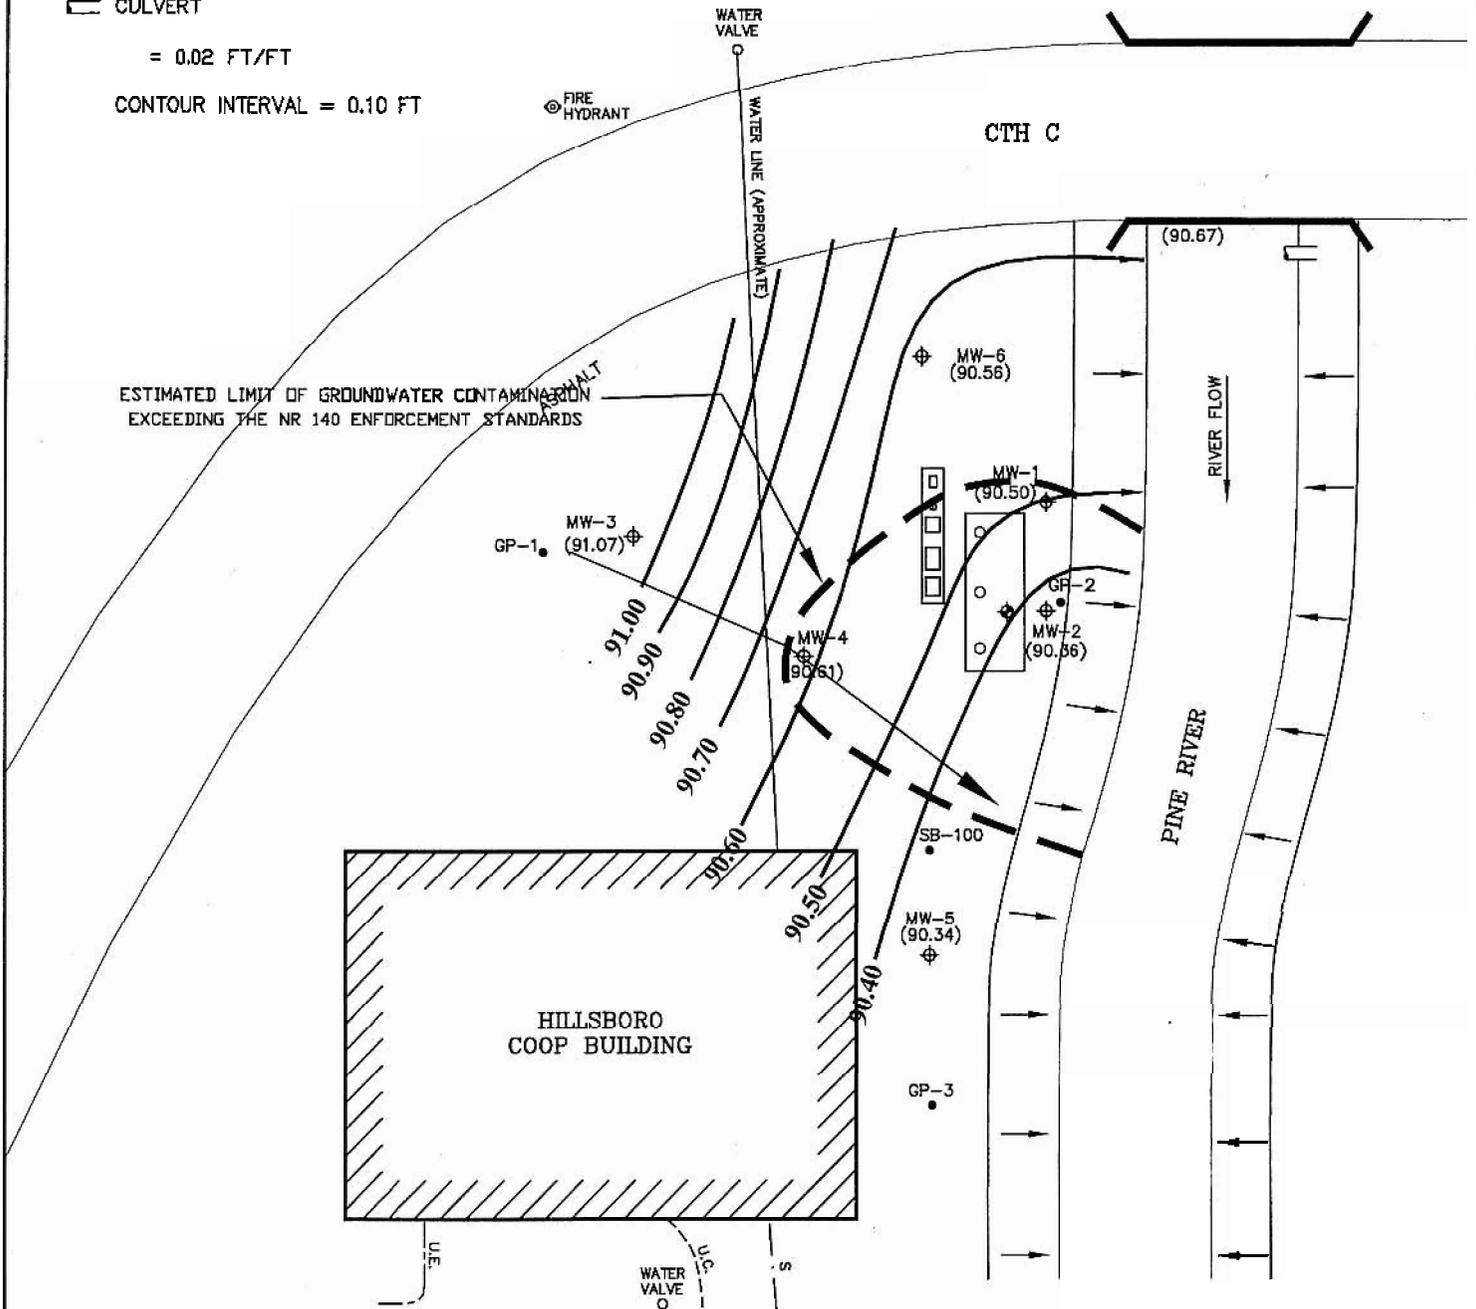
Shaw E & I, Inc.
 PREPARED FOR
 HILLSBORO FARMERS COOPERATIVE
 YUBA, WI
 FIGURE 10B
 GROUNDWATER CONTAMINANT DISTRIBUTION
 AND POTENTIOMETRIC SURFACE MAP
 (03/02/06)

= 0.02 FT/FT

CONTOUR INTERVAL = 0.10 FT

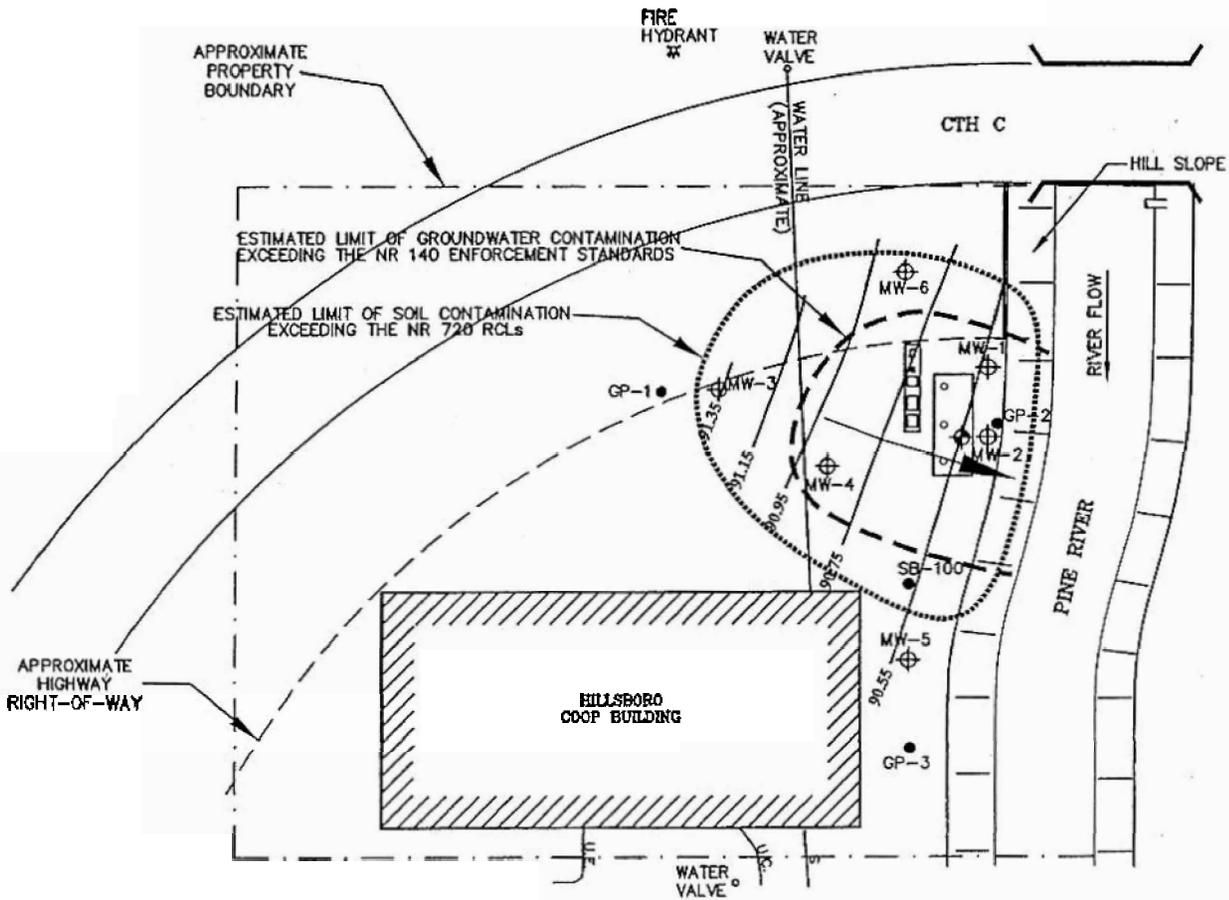
SITE PLAN VIEW
AND CONTAMINANT DISTRIBUTION
HILLSBORO FARMERS COOPERATIVE
YUBA, WISCONSIN

Figure 2 Site Plan View and Extent of Contamination
Natural Attenuation Fact Sheet
