ACTIVITY NAME: Uptown Radiator

PROPERTY ADDRESS: 3405 60th St

SUBJECT: Final Case Closure with Continuing Obligations
Uptown Radiator, 3405 60th St, Kenosha WI 53144
DNR BRRTS Activity #: 03-30-208770
FID #: 230186330 PECFA 53144-4145-05

Subject: Conditional Closure Decision,
With Requirements to Achieve Final Closure
Uptown Radiator 3405 60th St Kenosha, Wisconsin
WDNR BRRTS Activity # 03-30-208770

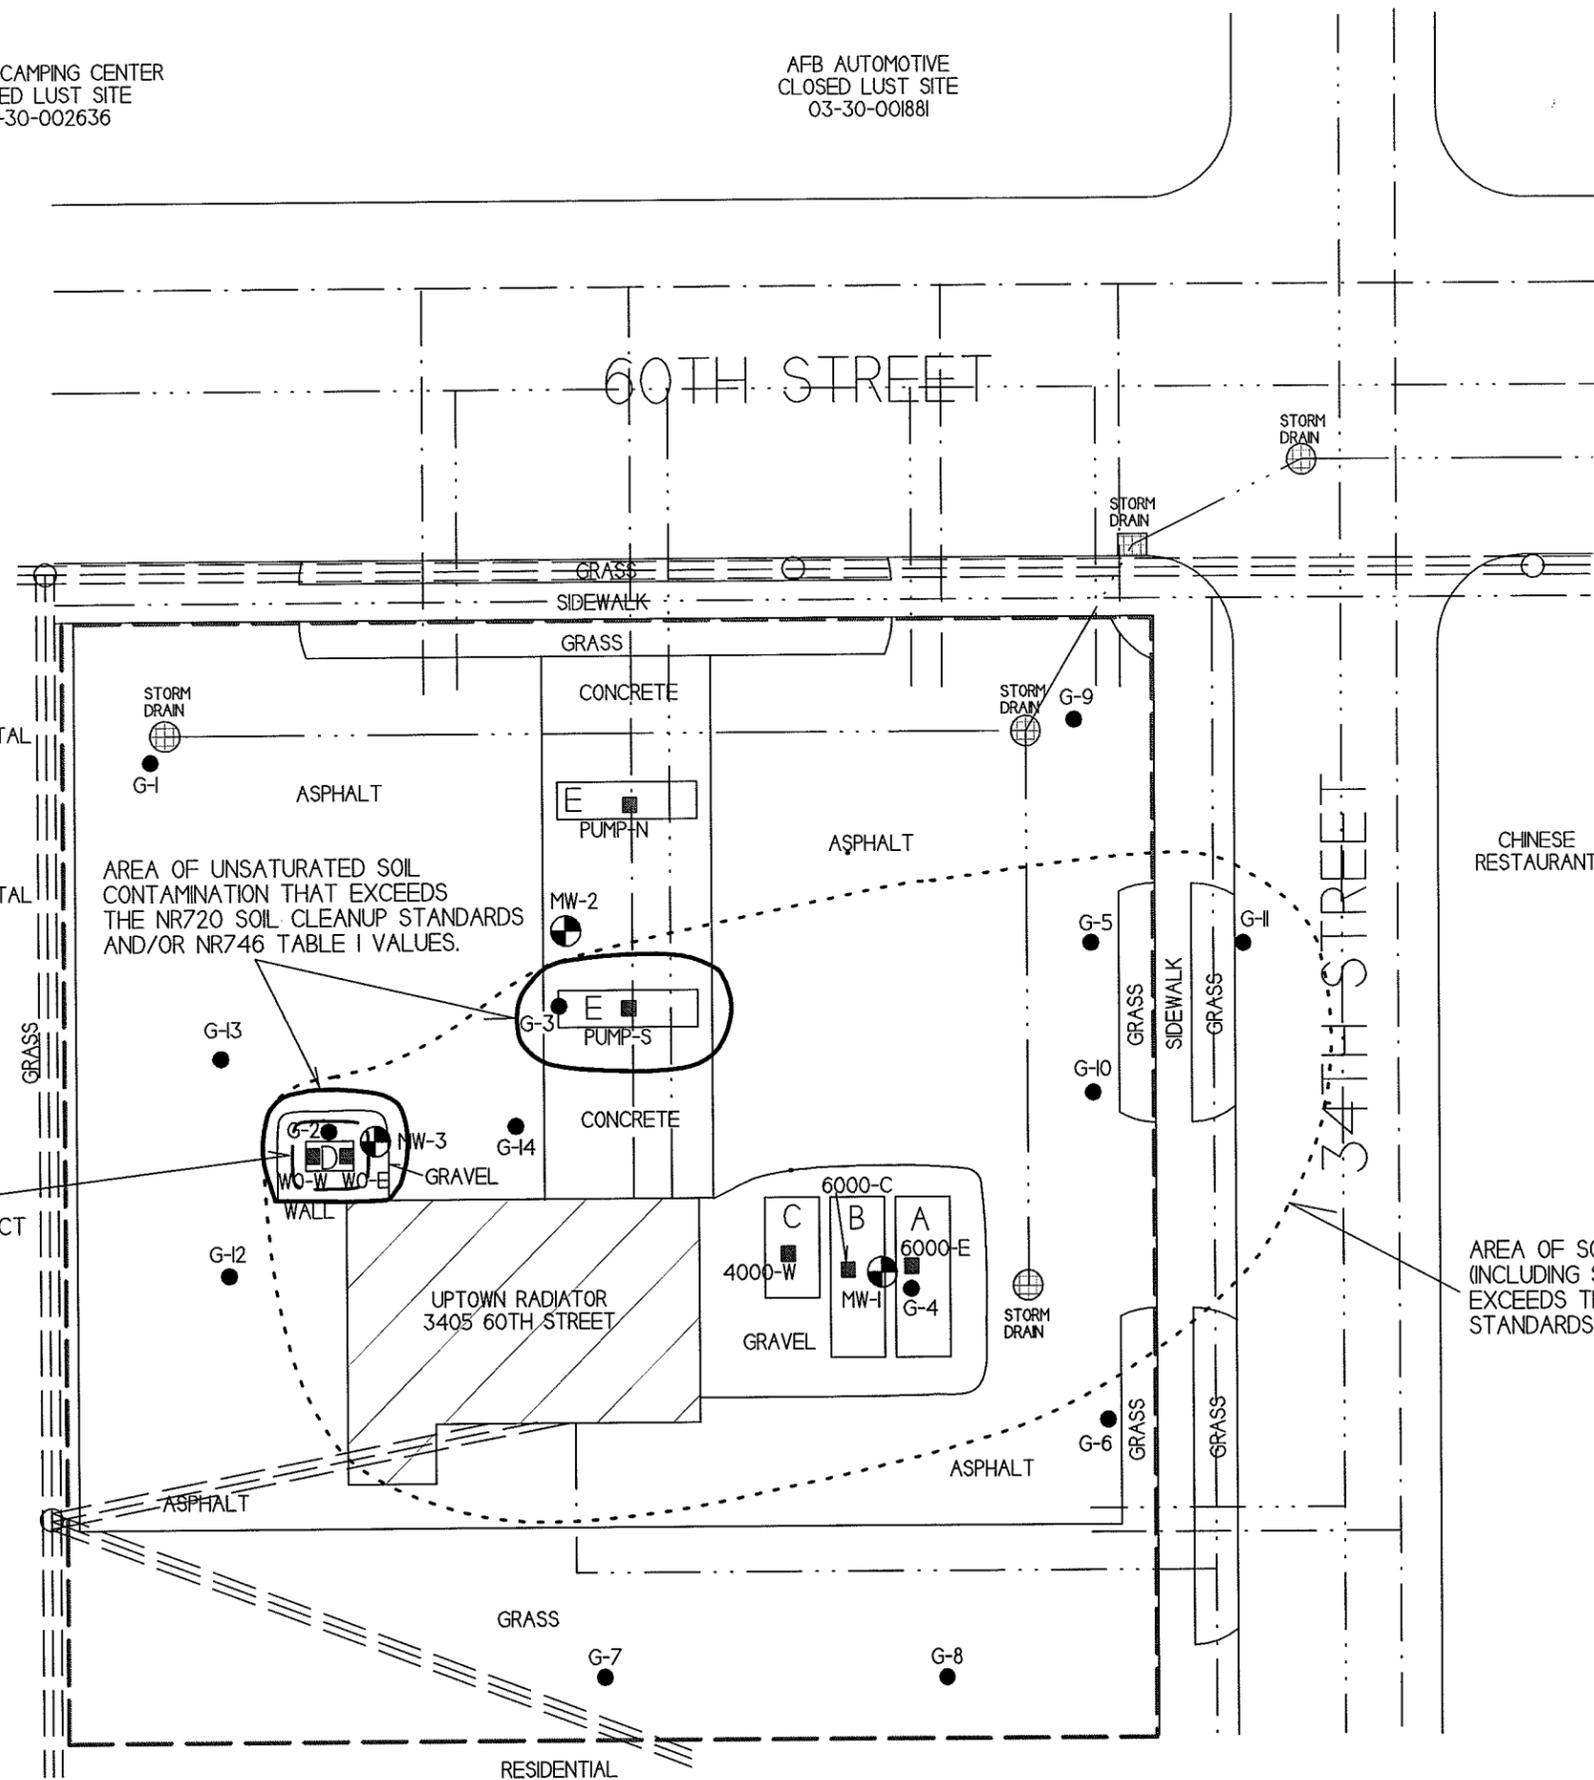
UPTOWN RADIATOR

AREA OF UNSATURATED SOIL CONTAMINATION THAT EXCEEDS THE NR720 SOIL CLEANUP STANDARDS AND/OR NR746 TABLE I VALUES.

AREA OF SOIL CONTAMINATION (INCLUDING SMEAR ZONE) THAT EXCEEDS THE NR720 SOIL CLEANUP STANDARDS AND/OR NR746 TABLE I VALUES.

Soil contamination remains in the area of the former waste oil tank on the northwest side of the building as indicated on the **attached map**. If soil in the specific locations described above is excavated in the future, the property owner or right-of-way holder at the time of excavation must sample and analyze the excavated soil to determine if contamination remains. If sampling confirms that contamination is present, the property owner or right-of-way holder at the time of excavation will need to determine whether the material is considered solid or hazardous waste and ensure that any storage, treatment or disposal is in compliance with applicable standards and rules. Contaminated soil may be managed in accordance with ch. NR 718, Wis. Adm. Code, with prior DNR approval.

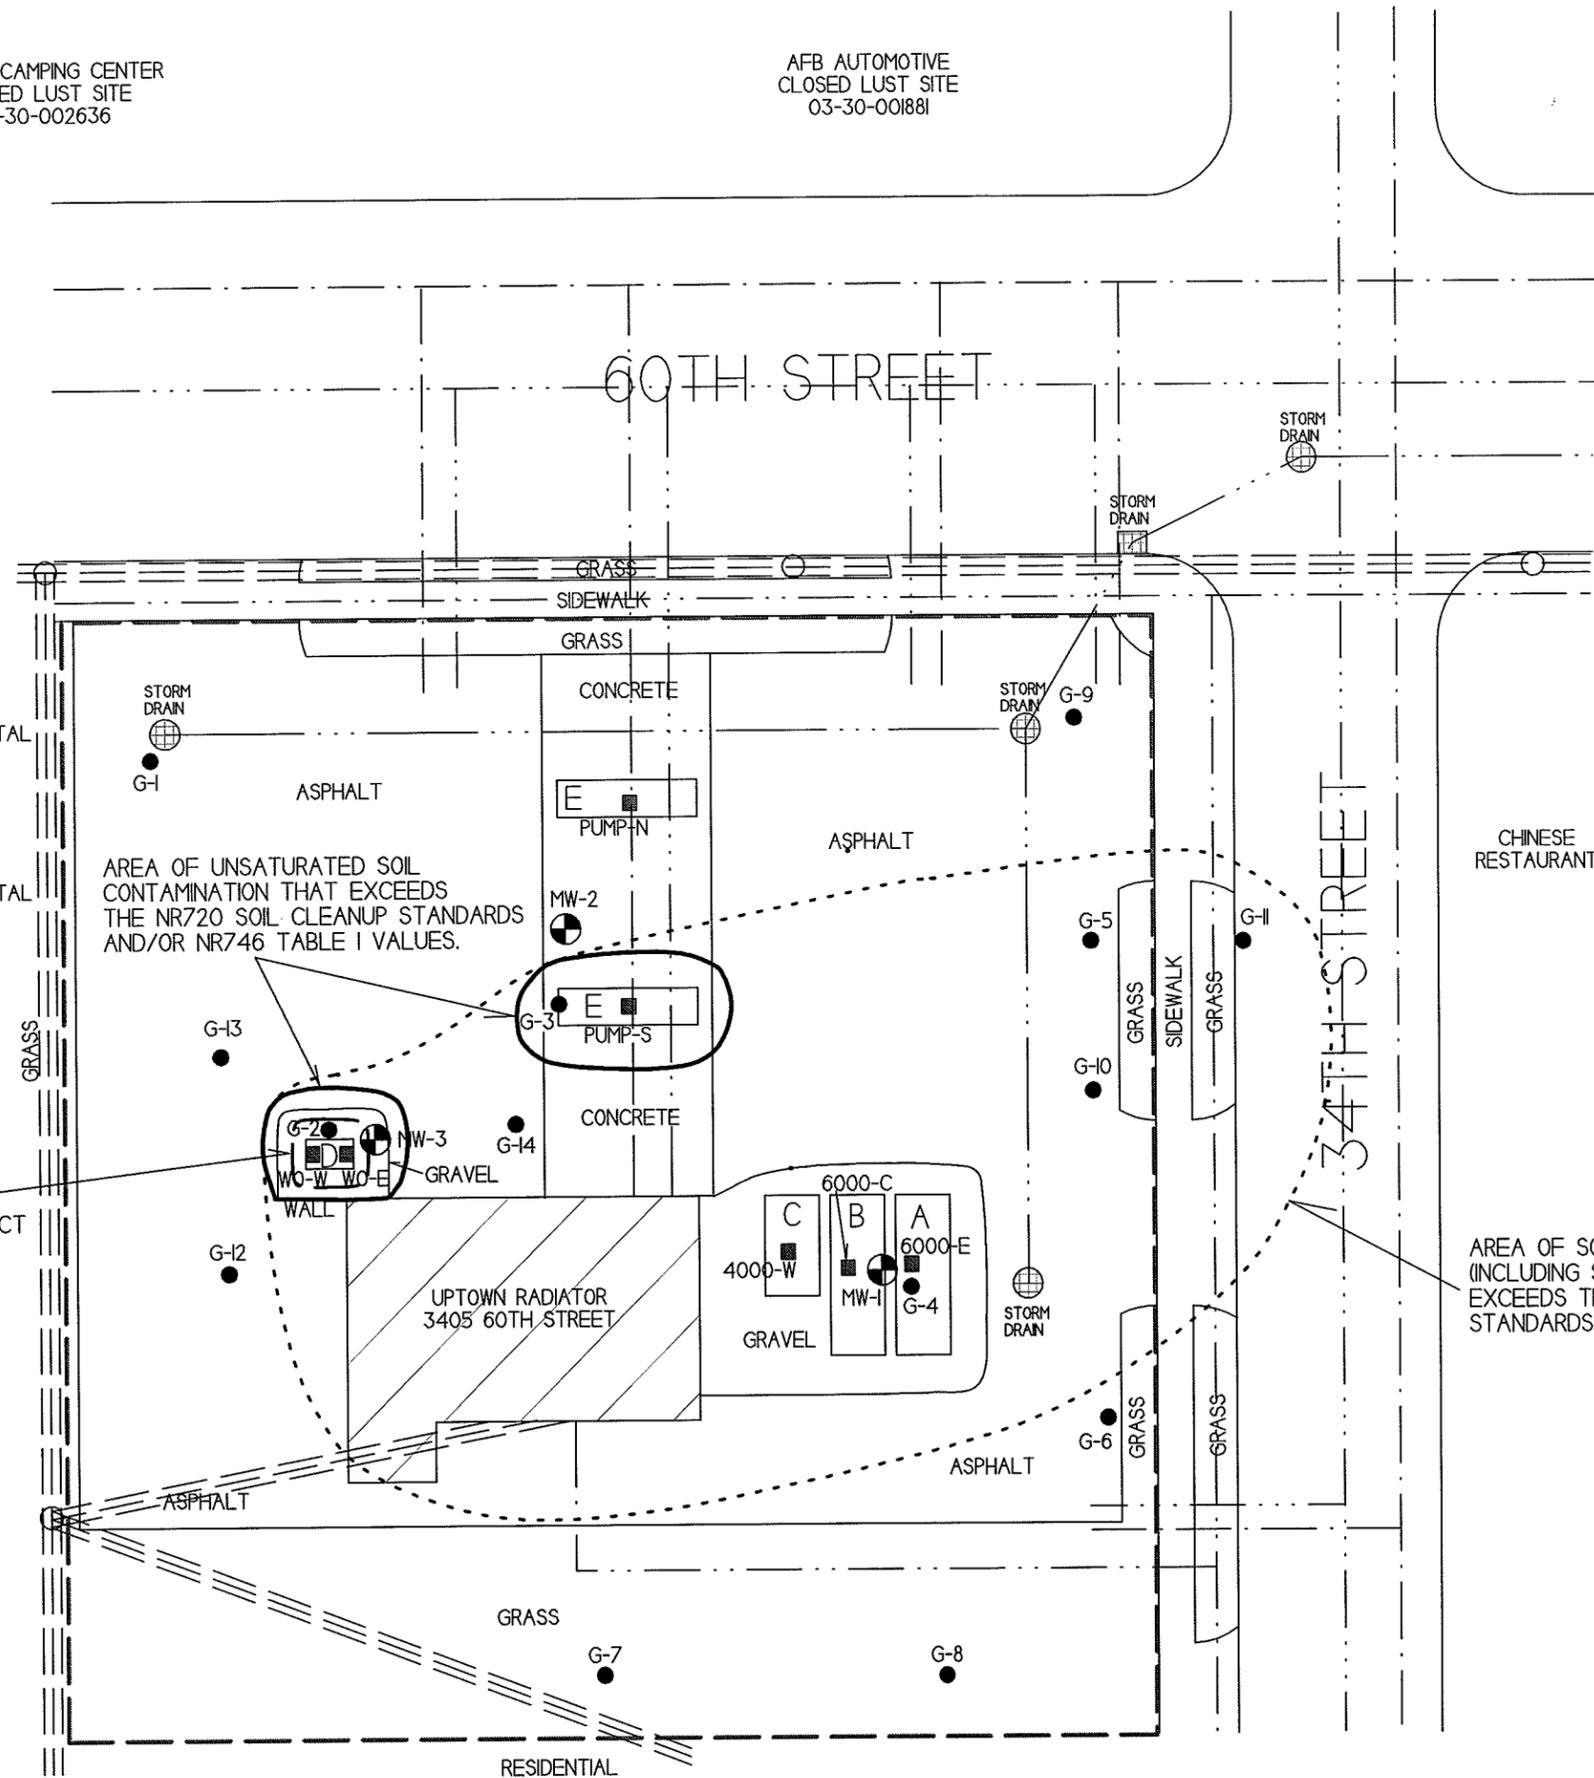
AREA OF UNSATURATED SOIL
CONTAMINATION THAT EXCEEDS
THE NR720 SOIL CLEANUP STANDARDS
AND/OR NR746 TABLE I VALUES.

AREA OF SOIL CONTAMINATION
(INCLUDING SMEAR ZONE) THAT
EXCEEDS THE NR720 SOIL CLEANUP
STANDARDS AND/OR NR746 TABLE I VALUES.

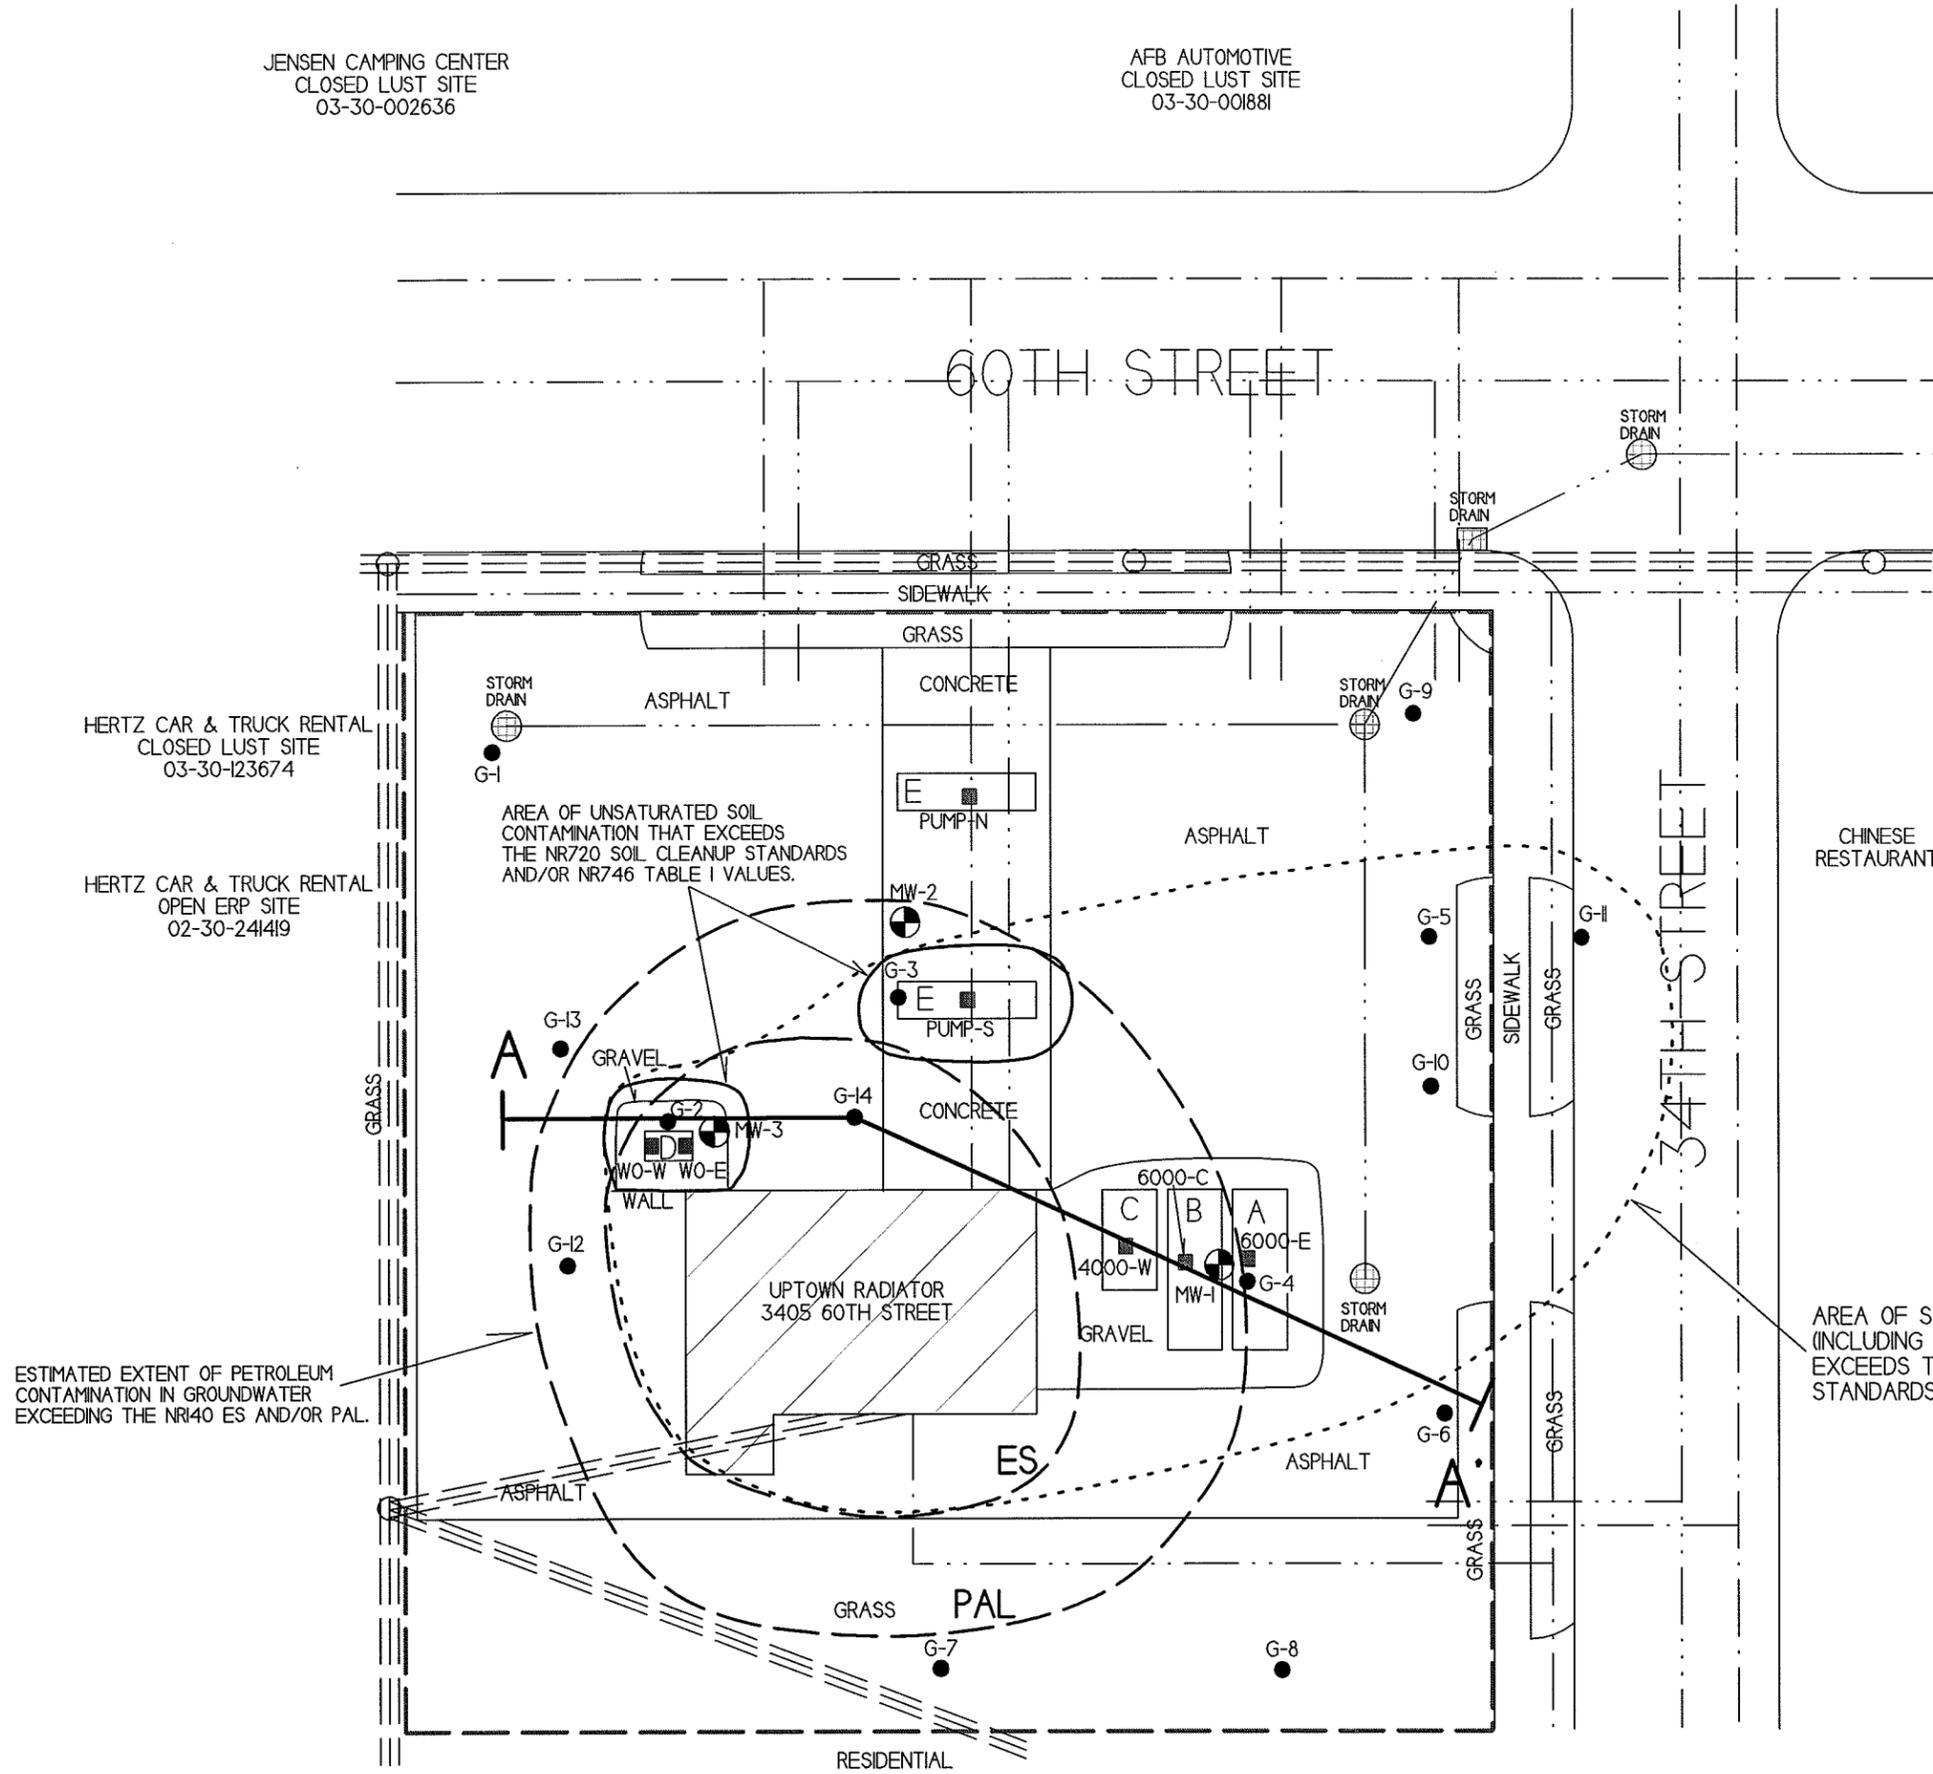
ESTIMATED EXTENT OF PETROLEUM
CONTAMINATION IN GROUNDWATER
EXCEEDING THE NR140 ES AND/OR PAL.

AREA OF SOIL CONTAMINATION
(INCLUDING SMEAR ZONE) THAT
EXCEEDS THE NR720 SOIL CLEANUP
STANDARDS AND/OR NR746 TABLE I VALUES.

The NR140 ES and PAL plume does exist under the on-site building, however due to the depth to groundwater in these areas, interception with building foundation drain systems appear unlikely (no known drain systems are known to be present).

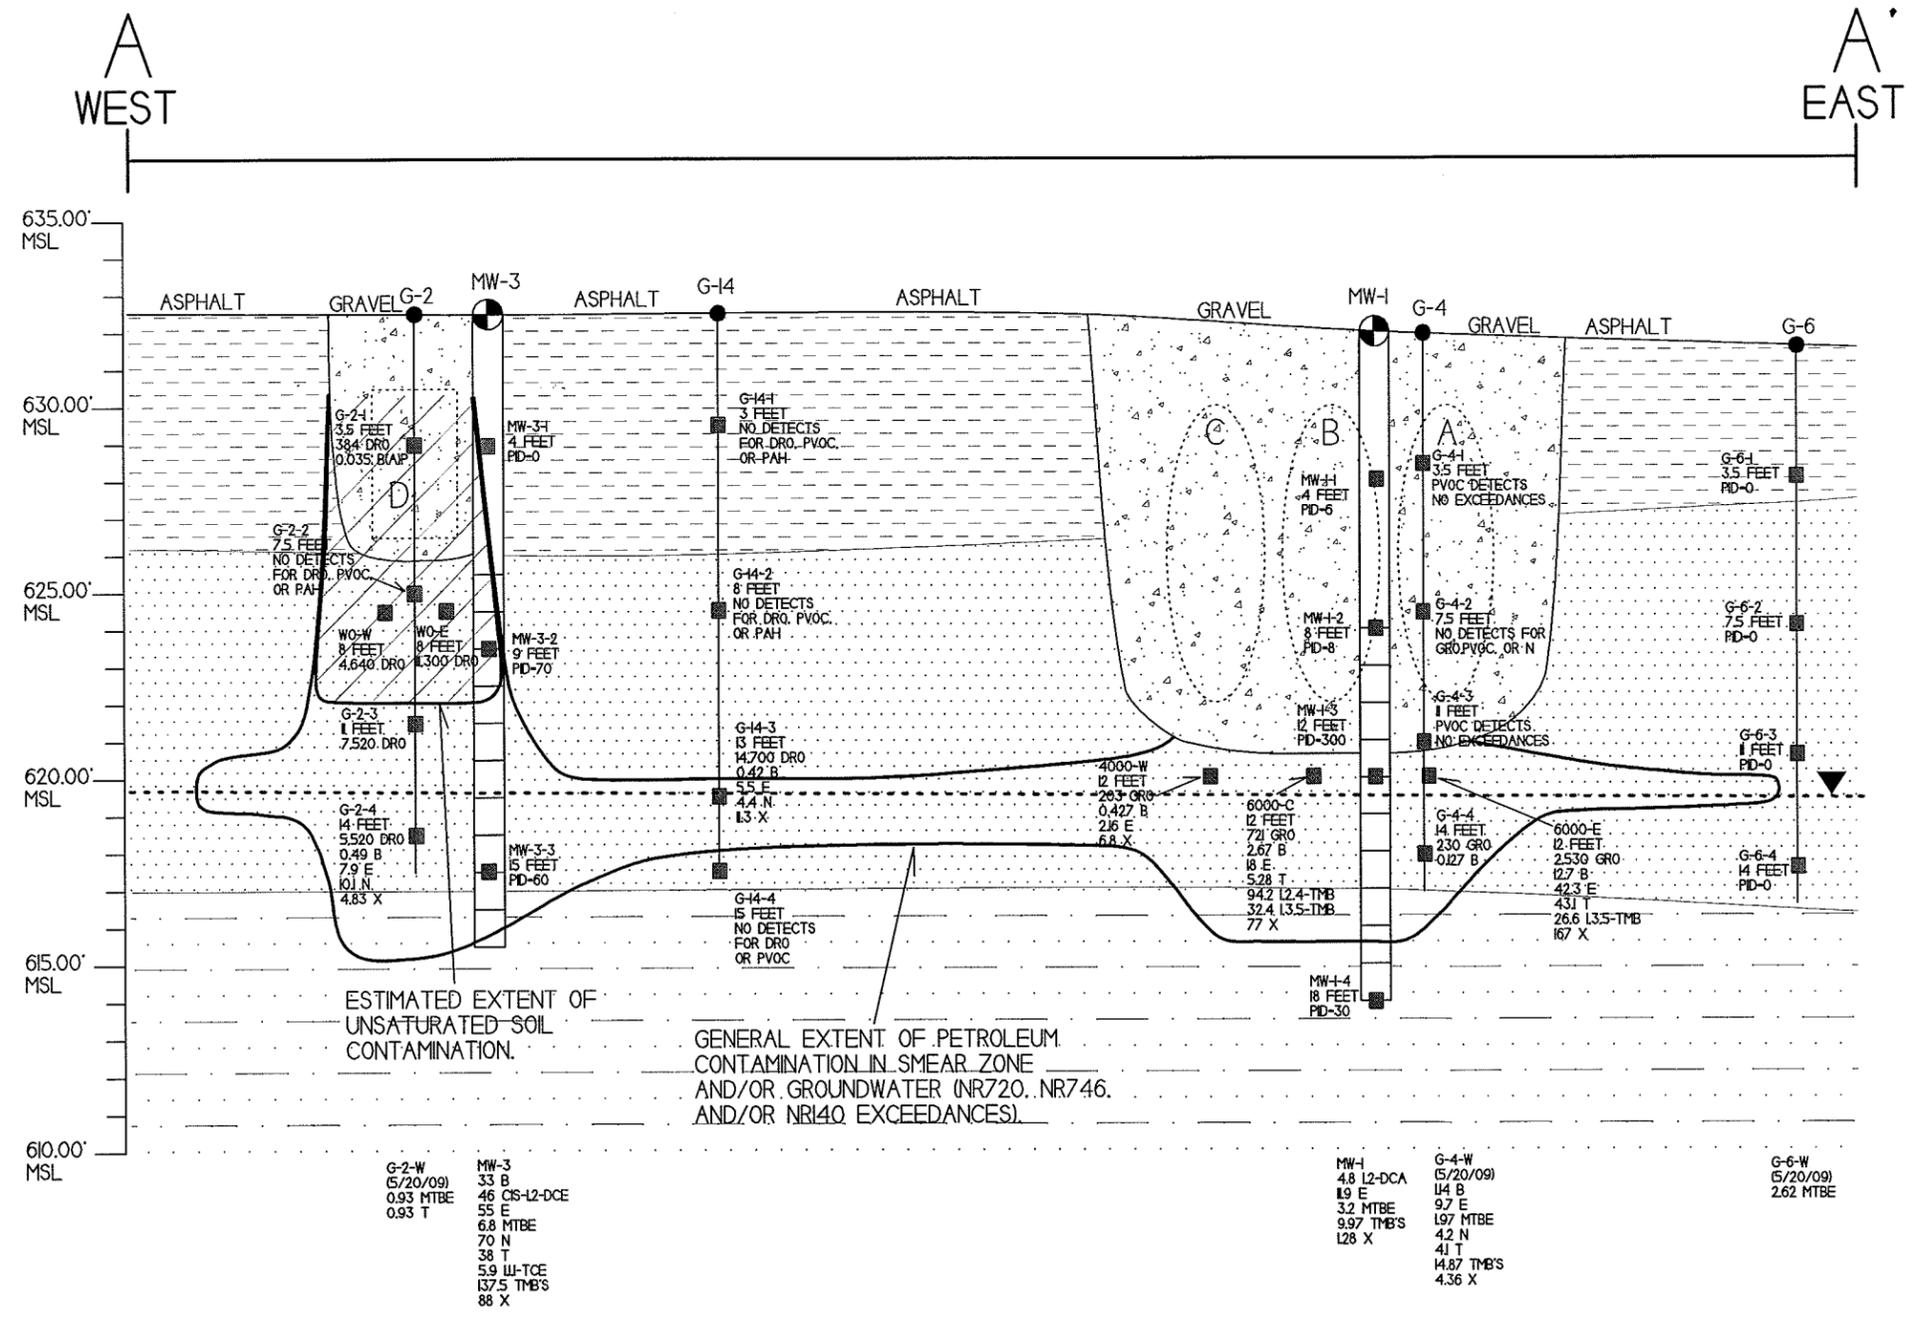
B.3.a.
GEOLOGIC CROSS SECTION
UPTOWN RADIATOR

- UST CLOSURE SITE ASSESSMENT (3/21/00)
- GEOPROBE PROJECT (5/20/09)
- DRILLING/GEOPROBE PROJECT (12/1/09)
- DRILLING PROJECT (2/26/10)
- ROUND 7 GROUNDWATER SAMPLING
(11/06/12)

- B - BENZENE
 - B(A)P - BENZO(A)PYRENE
 - CIS-1,2-DCE - CIS-1,2-DICHLOROETHENE
 - 1,2-DCA - 1,2-DICHLOROETHANE
 - DRO - DIESEL RANGE ORGANICS
 - E - ETHYLBENZENE
 - GRO - GASOLINE RANGE ORGANICS
 - MTBE - METHYL-TERT-BUTYL-ETHER
 - PAH - POLYNUCLEAR AROMATIC HYDROCARBONS
 - PID - PHOTO IONIZATION DETECTOR
 - PVOC - PETROLEUM VOLATILE ORGANIC COMPOUNDS
 - N - NAPHTHALENE
 - T - TOLUENE
 - 1,1,1-TCE - 1,1,1-TRICHLOROETHANE
 - TMB - TRIMETHYLBENZENE
 - VC - VINYL CHLORIDE
 - X - XYLENE
- KEY TO UST SYSTEMS
- A - REMOVED 6,000 GALLON UNLEADED GASOLINE
 - B - REMOVED 6,000 GALLON UNLEADED GASOLINE
 - C - REMOVED 4,000 GALLON UNLEADED GASOLINE
 - D - REMOVED 500 GALLON WASTE OIL

Depth to groundwater during the investigation ranged from 11.13 to 12.52 feet bgs (or 619.63-620.75 feet msl). Free product has been encountered in monitoring well MW-3, during the two most recent sampling events, however, free product thickness could not be measured due to the viscosity of the product (waste oil). Due to the existence of this thick product, water levels were unable to be collected from the well. The stratigraphic unit where the water table is found is in sand.

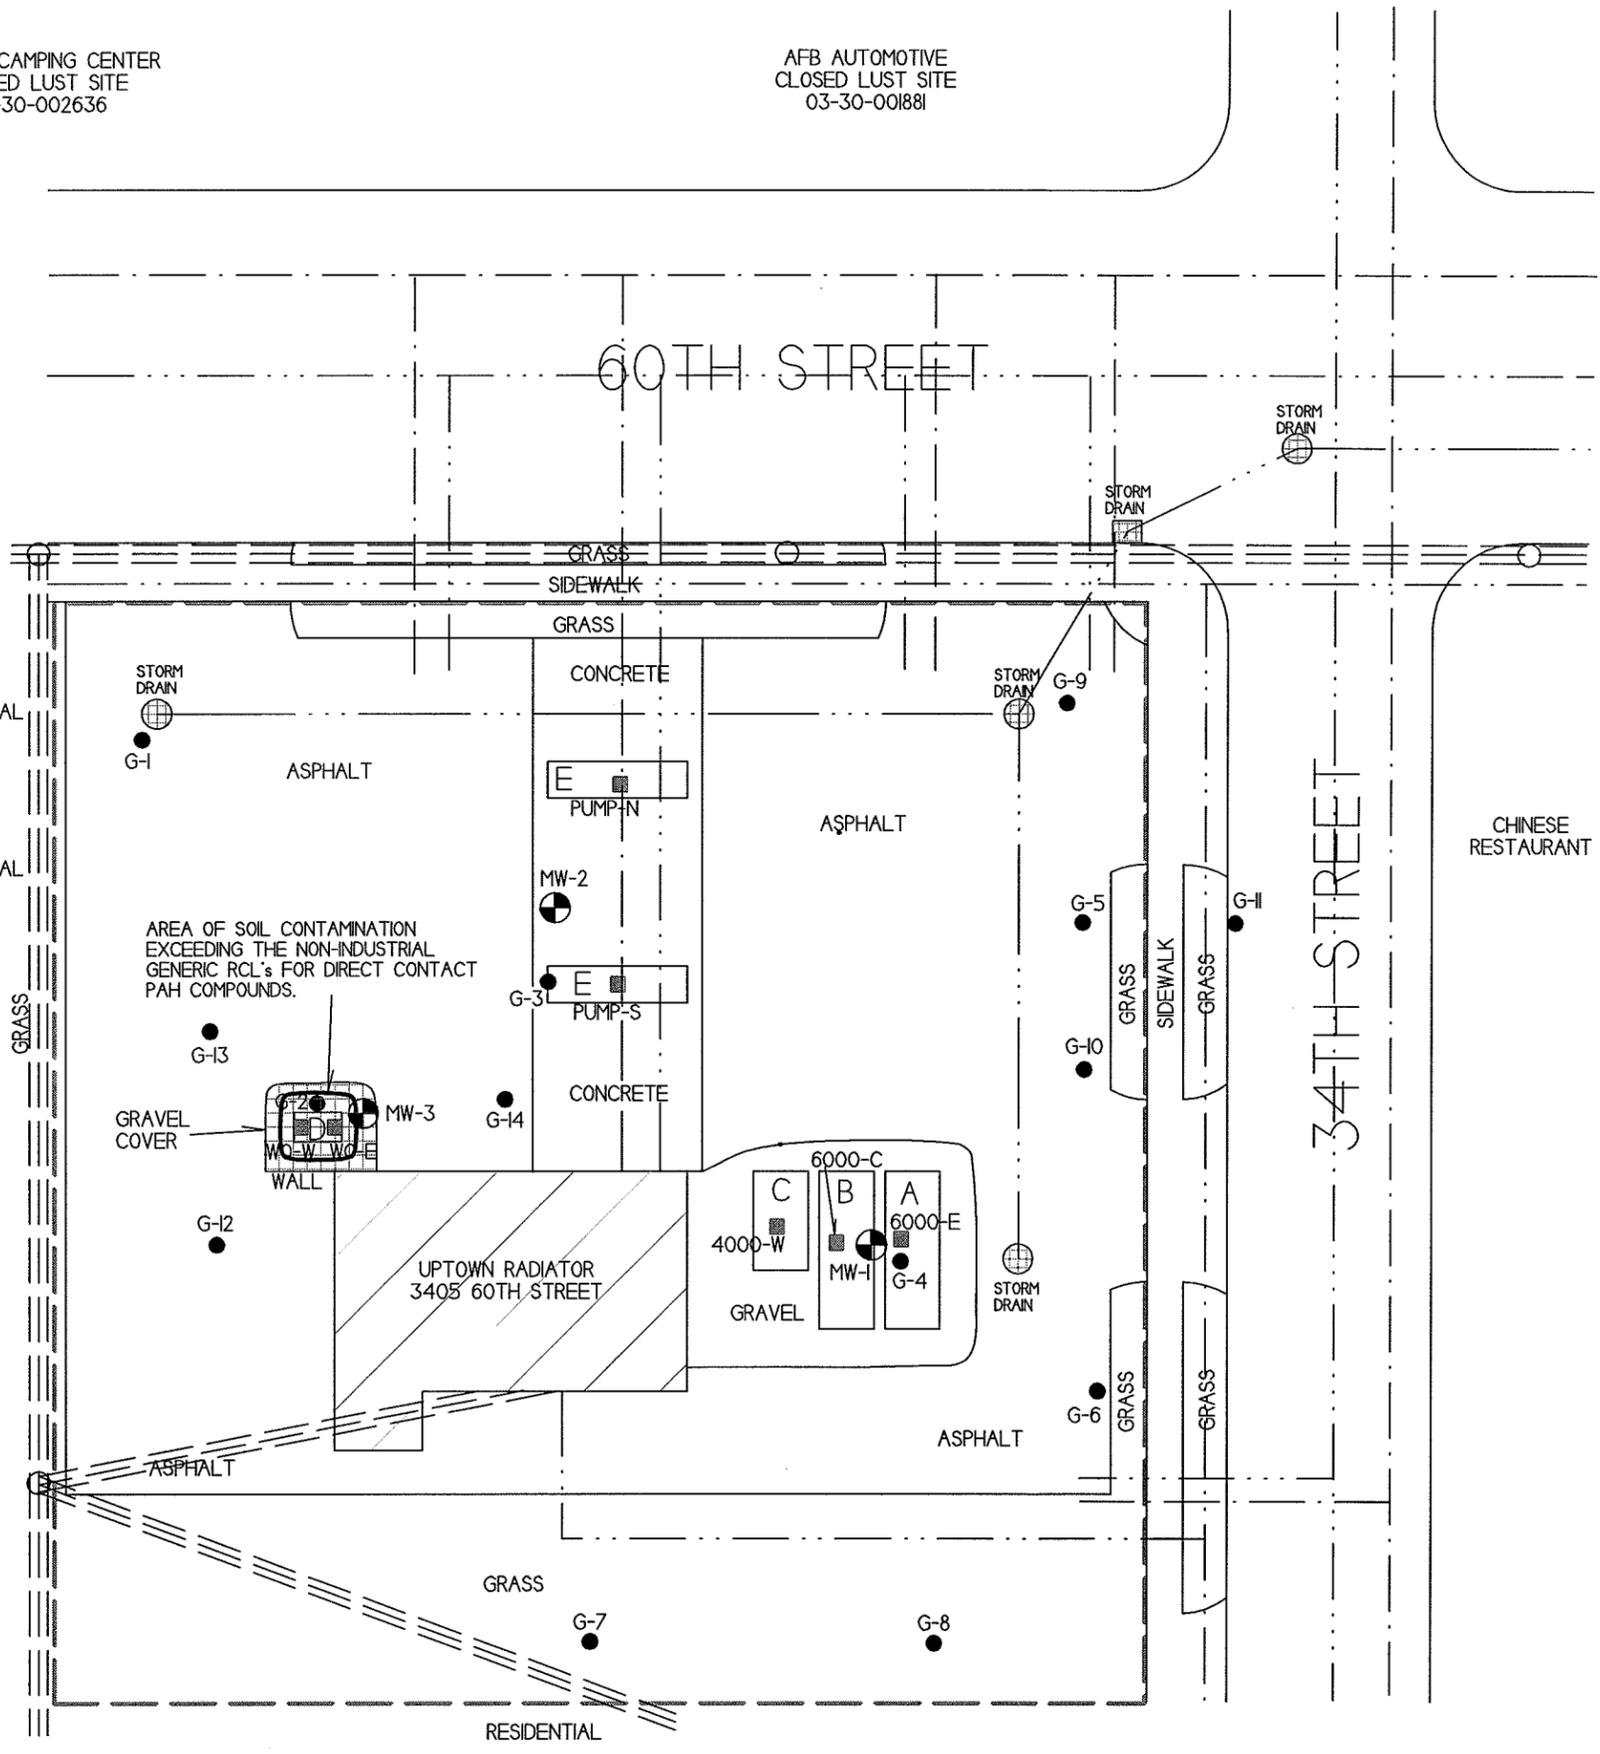
AREA OF SOIL CONTAMINATION
EXCEEDING THE NON-INDUSTRIAL
GENERIC RCL's FOR DIRECT CONTACT
PAH COMPOUNDS.

UPTOWN RADIATOR
3405 60TH STREET

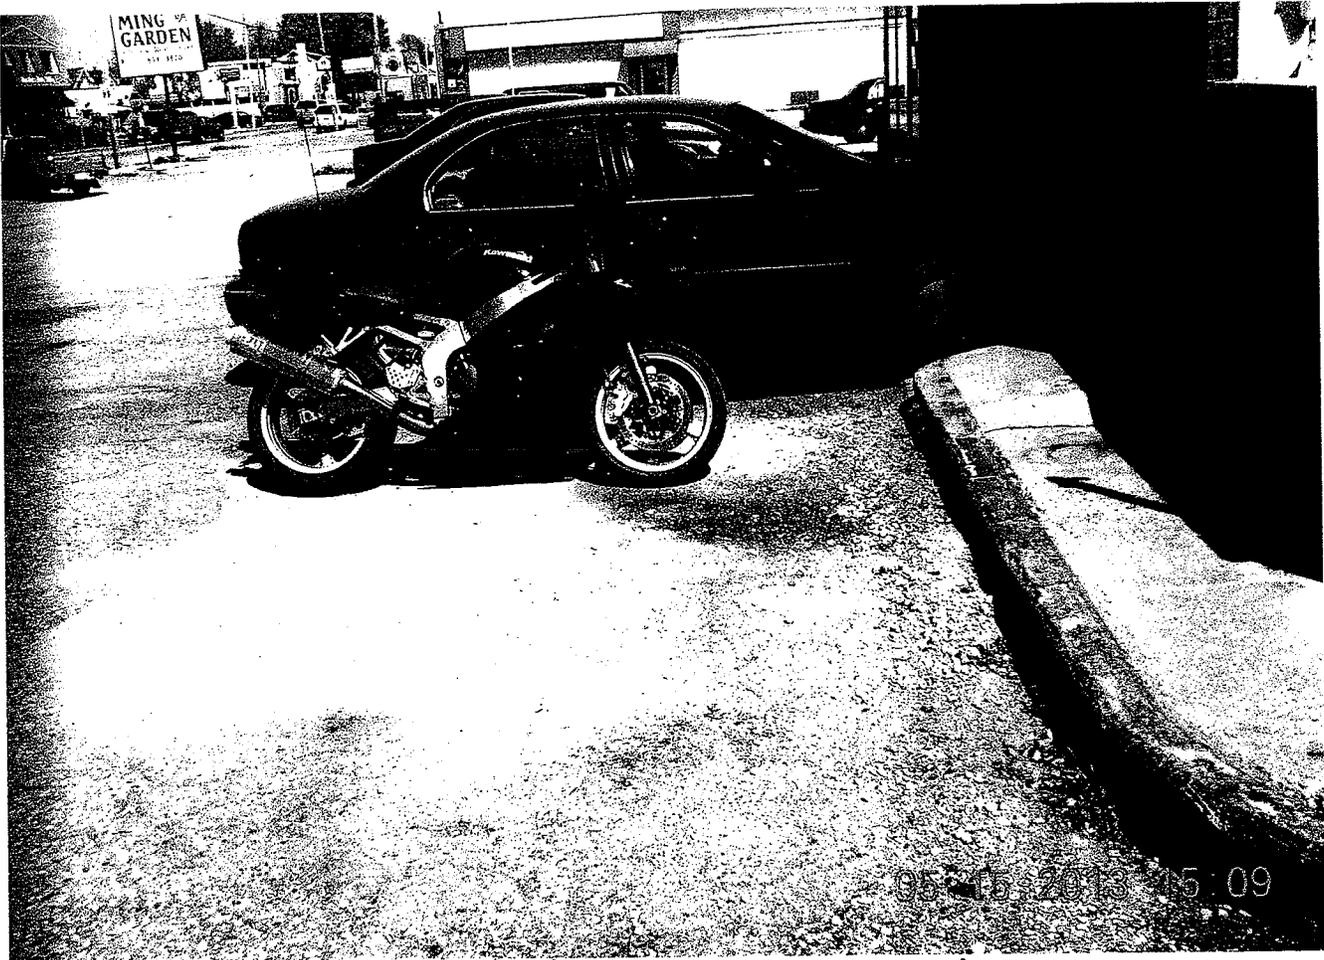
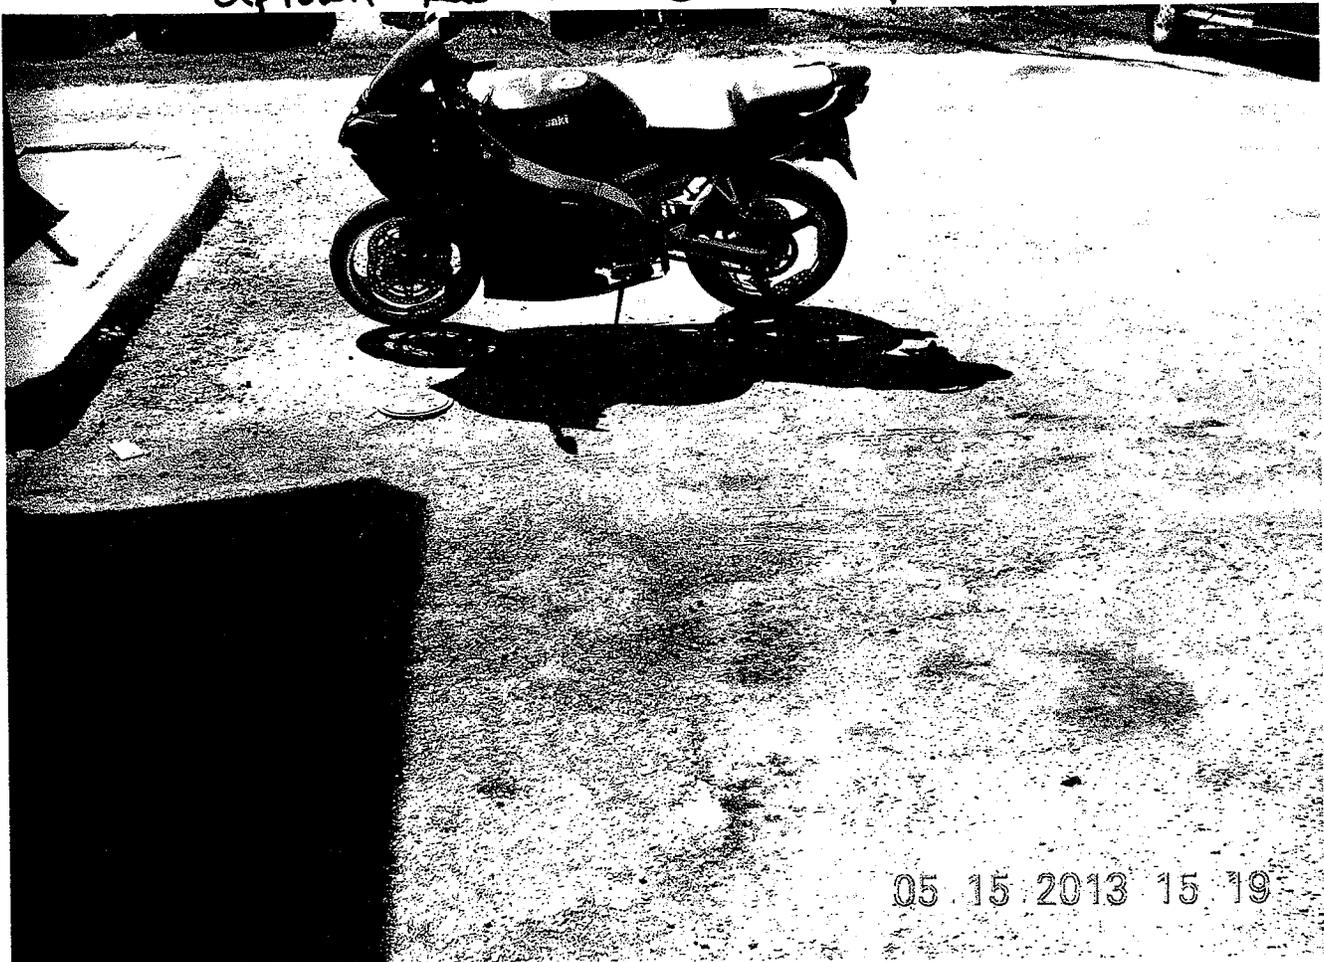
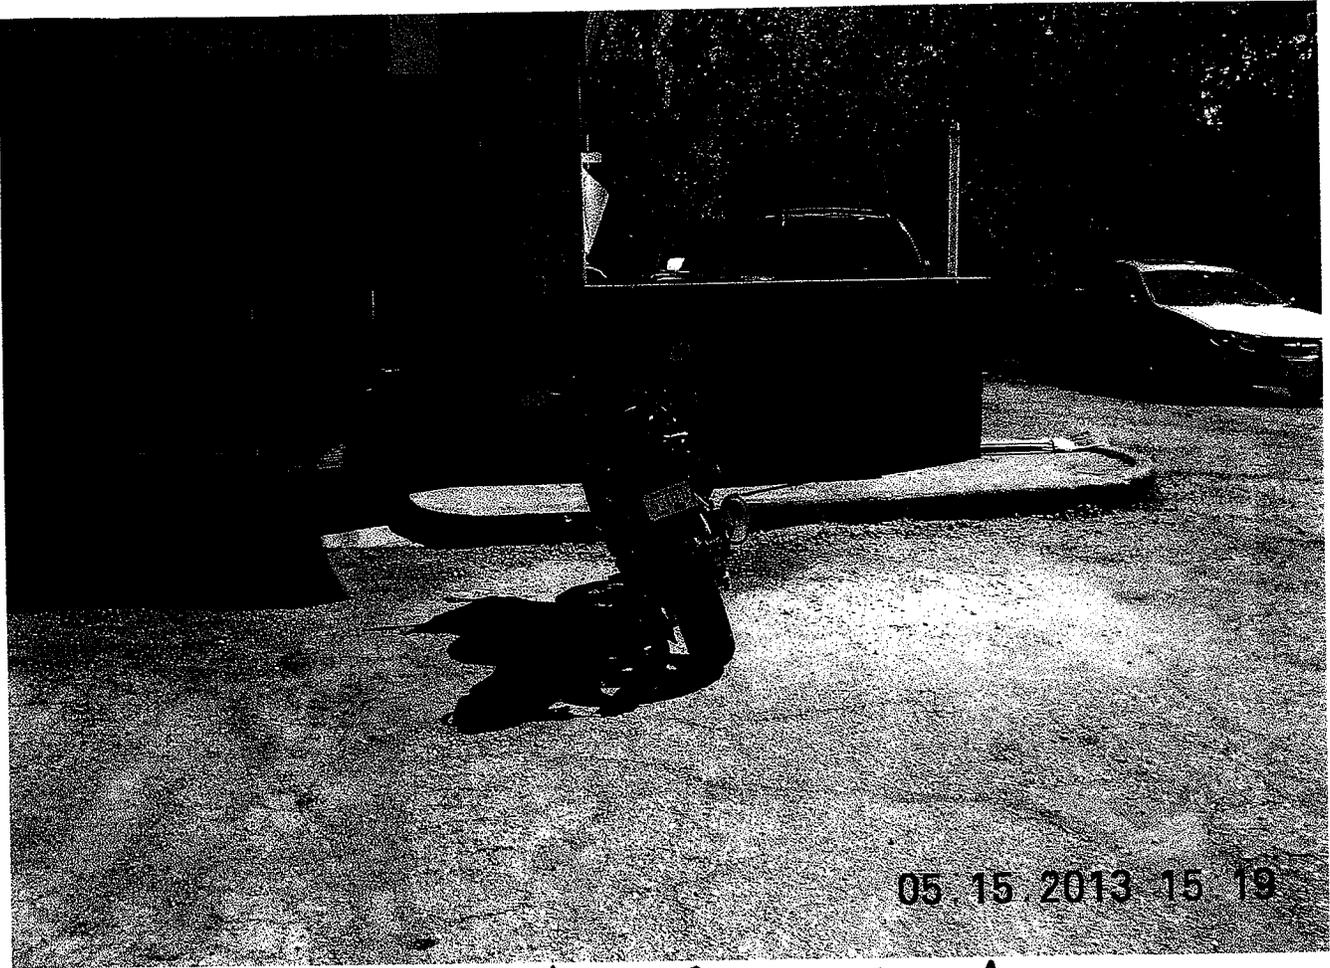
Uptown Radiator - Gravel Cap Area

The gravel cover overlying the contaminated soil as depicted in Exhibit B will be inspected once a year, normally in the spring after all snow and ice is gone, for erosion and other potential problems that can cause exposure to the underlying contaminated soils. The inspections will be performed to evaluate erosion due to settling, run-off, and other factors. Any area where the underlying contaminated soils have become or are likely to become exposed will be documented. A log of the inspections and any repairs will be maintained by the property owner and is included as Exhibit C, Cap Inspection Log. The log will include recommendations for necessary repair of any areas where underlying soils are exposed. Once repairs are completed, they will be documented in the inspection log.
