SITE NAME: Brewery Works Dev - Parcel 3A
 BRRTS #: 02-41-001124 FID # (if appropriate): 241807500
 COMMERCE # (if appropriate): NA
 CLOSURE DATE: 1-22-08
 STREET ADDRESS: N Commerce at W. Cherry Str.
 CITY: Milwaukee 53212
 SOURCE PROPERTY GPS COORDINATES (meters in WTM91 projection):
 X= 690005 Y= 288412

Subject: Case Closure with Land Use Limitations or Conditions for the RiverBend Place Development – Former Brewery Works Parcels 3A and 3B, Southeast corner of Commerce and Cherry St., Milwaukee

**Cap Maintenance Plan
Manpower Building Site
Parcels 3A and 3B
W. Cherry and N. Commerce Streets**

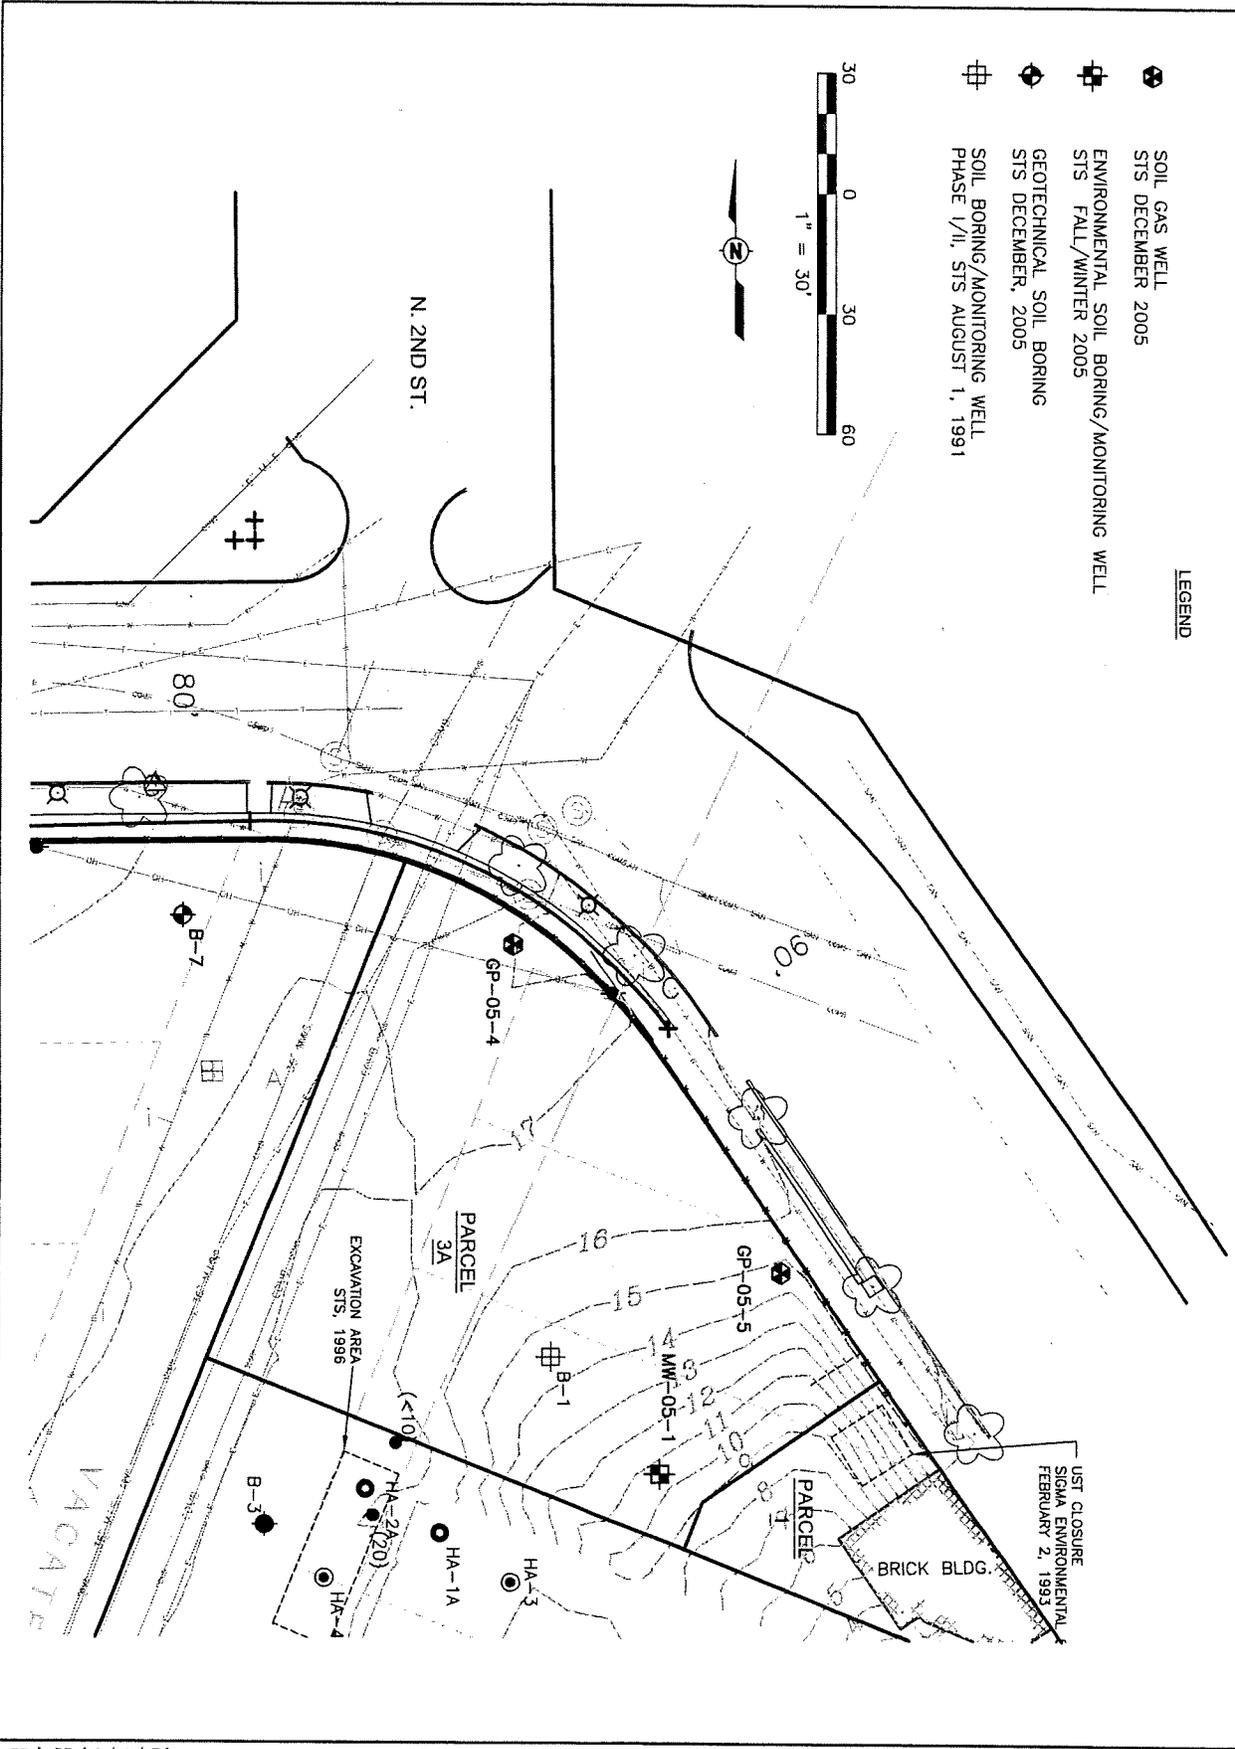
Drawn:	PDD 11/14/2007
Checked:	LLA 11/14/2007
Approved:	KLB 11/14/2007
PROJECT NUMBER:	200705531
FIGURE NUMBER:	2

- LEGEND**
- ⊕ SOIL GAS WELL
STS DECEMBER 2005
 - ⊕ ENVIRONMENTAL SOIL BORING/MONITORING WELL
STS FALL/WINTER 2005
 - ⊕ GEOTECHNICAL SOIL BORING
STS DECEMBER, 2005
 - ⊕ SOIL BORING/MONITORING WELL
PHASE I/II, STS AUGUST 1, 1991

**BORING AND MONITORING WELL LOCATIONS
BREWERY WORKS DEVELOPMENT -PARCEL 3A
W. CHERRY AND NORTH COMMERCE ST.
MILWAUKEE, WI**

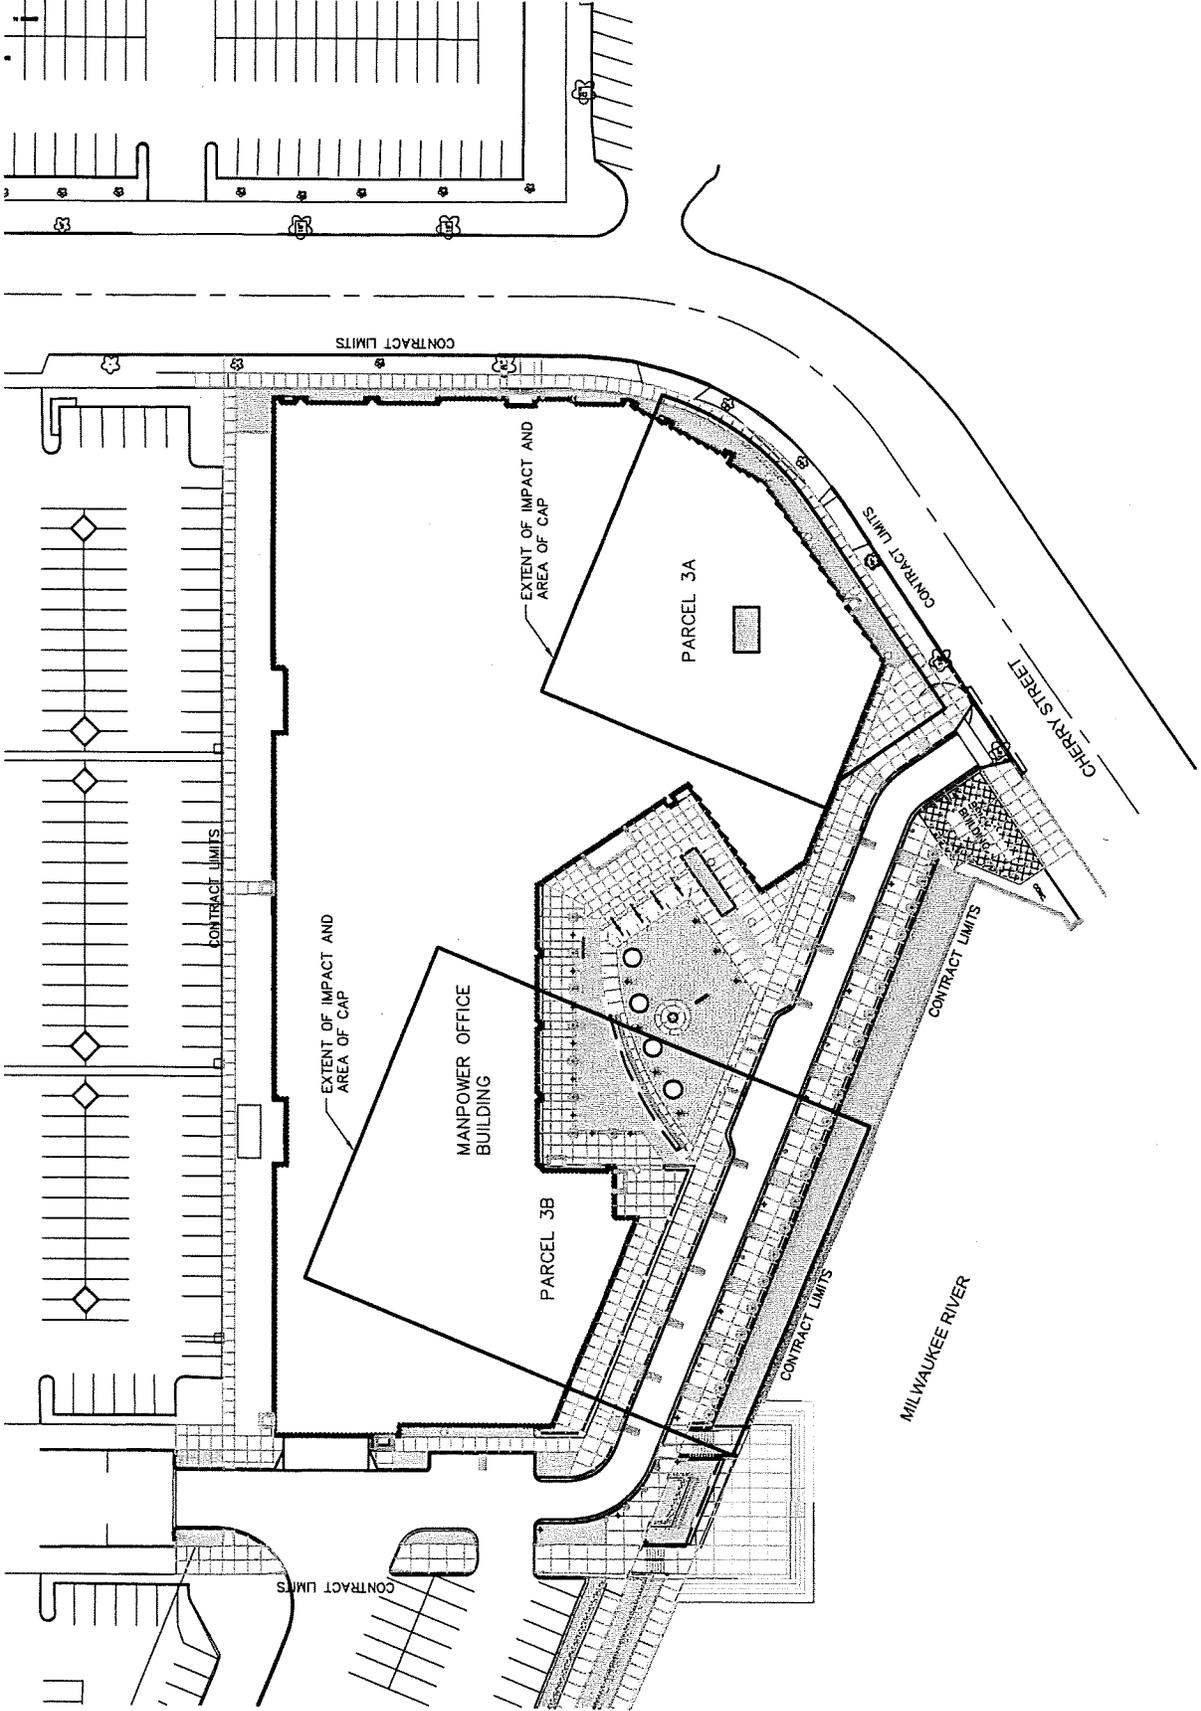
Drawn:	POD	11/14/2007
Checked:	LLA	11/14/2007
Approved:	KLB	11/14/2007
PROJECT NUMBER	200705531	
FIGURE NUMBER	3

SITE LAYOUT, EXTENT OF IMPACT AND AREA OF CAP
BREWERY WORKS DEVELOPMENT - PARCEL 3A
MILWAUKEE, WI

Pursuant to s. 292.12(2)(a), Wis. Stats., the pavement, building foundation and soil cover that currently exists in the location shown on the attached map shall be maintained in compliance with the attached maintenance plan in order to prevent direct contact with residual soil contamination that might otherwise pose a threat to human health. If soil in the specific locations described above is excavated in the future, the property owner at the time of excavation must sample and analyze the excavated soil to determine if residual contamination remains. If sampling confirms that contamination is present the property owner at the time of excavation will need to determine whether the material would be considered solid or

The following activities are prohibited on any portion of the property where pavement, a building foundation, and soil cover is required as shown on the attached map, unless prior written approval has been obtained from the Wisconsin Department of Natural Resources: 1) removal of the existing barrier; 2) replacement with another barrier; 3) excavating or grading of the land surface; 4) filling on capped or paved areas; 5) plowing for agricultural cultivation; or 6) construction or placement of a building or other structure.
