GIS REGISTRY
Cover Sheet

ACTIVITY NAME: Regency Auto Mart

PROPERTY ADDRESS: 4800 North 76th Street

CAP MAINTENANCE PLAN
4800 N. 76th Street,
Milwaukee, Wisconsin
DNR BRRTS Nos. 03-41-546829 and 02-41-552223
November 20, 2008

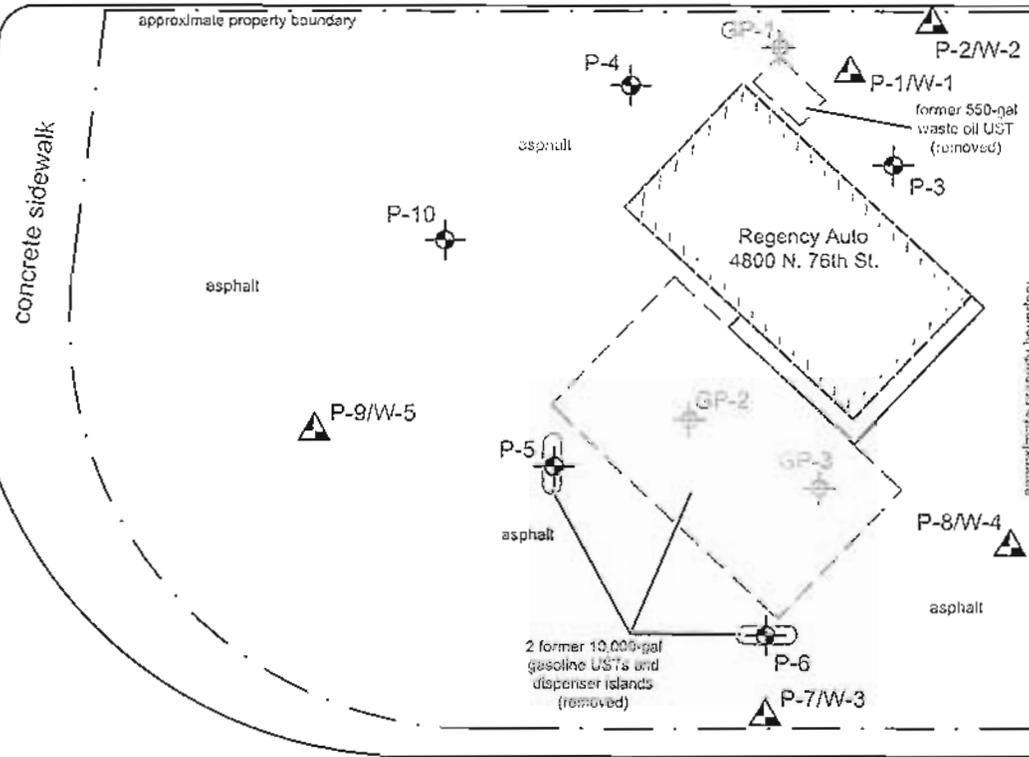
Site Features and Probehole/Well Locations Diagram
 Regency Auto Mart
 4800 N. 76th Street
 Milwaukee, Wisconsin

- ⊕ = Phase II probehole
- ⊗ = SI probehole
- △ = SI monitoring well

3. Property Information. 4800 N 76th Street, Milwaukee, Wisconsin. The Property location and features are illustrated on the attached Exhibits A and B.

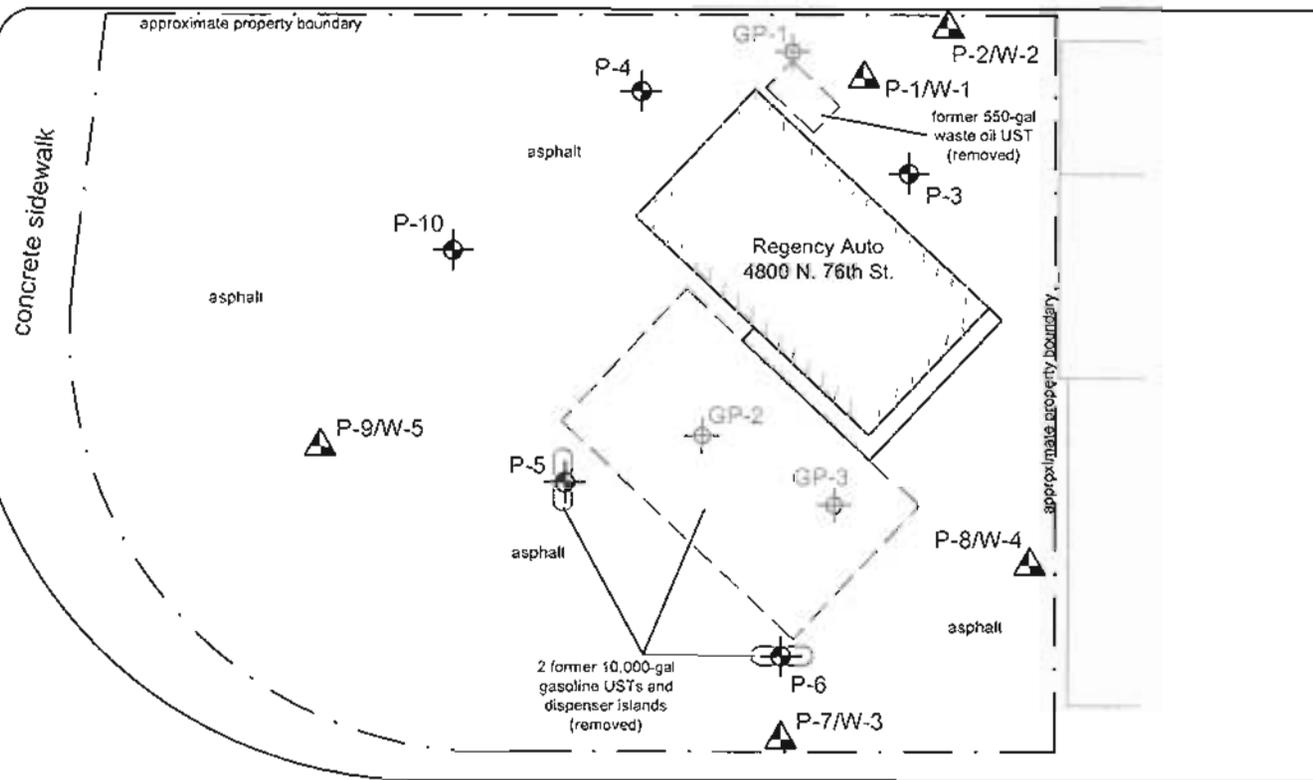
- ⊕ = Phase II probehole
- ⊗ = SI probehole
- ▲ = SI monitoring well

- Detailed Site Map:** A map that shows all relevant features (buildings, roads, individual property boundaries, contaminant sources, utility lines, monitoring wells and potable wells) within the contaminated area. This map is to show the location of all contaminated public streets, and highway and railroad rights-of-way in relation to the source property and in relation to the boundaries of groundwater contamination exceeding a ch. NR 140 Enforcement Standard (ES), and/or in relation to the boundaries of soil contamination exceeding a Residual Contaminant Level (RCL) or a Site Specific Residual Contaminant Levels (SSRCL) as determined under s. NR 720.09, 720.11 and 720.19.
Figure #: FIG 2 **Title:** SITE FEATURES AND BOREHOLE/WELL LOCATIONS DIAGRAM

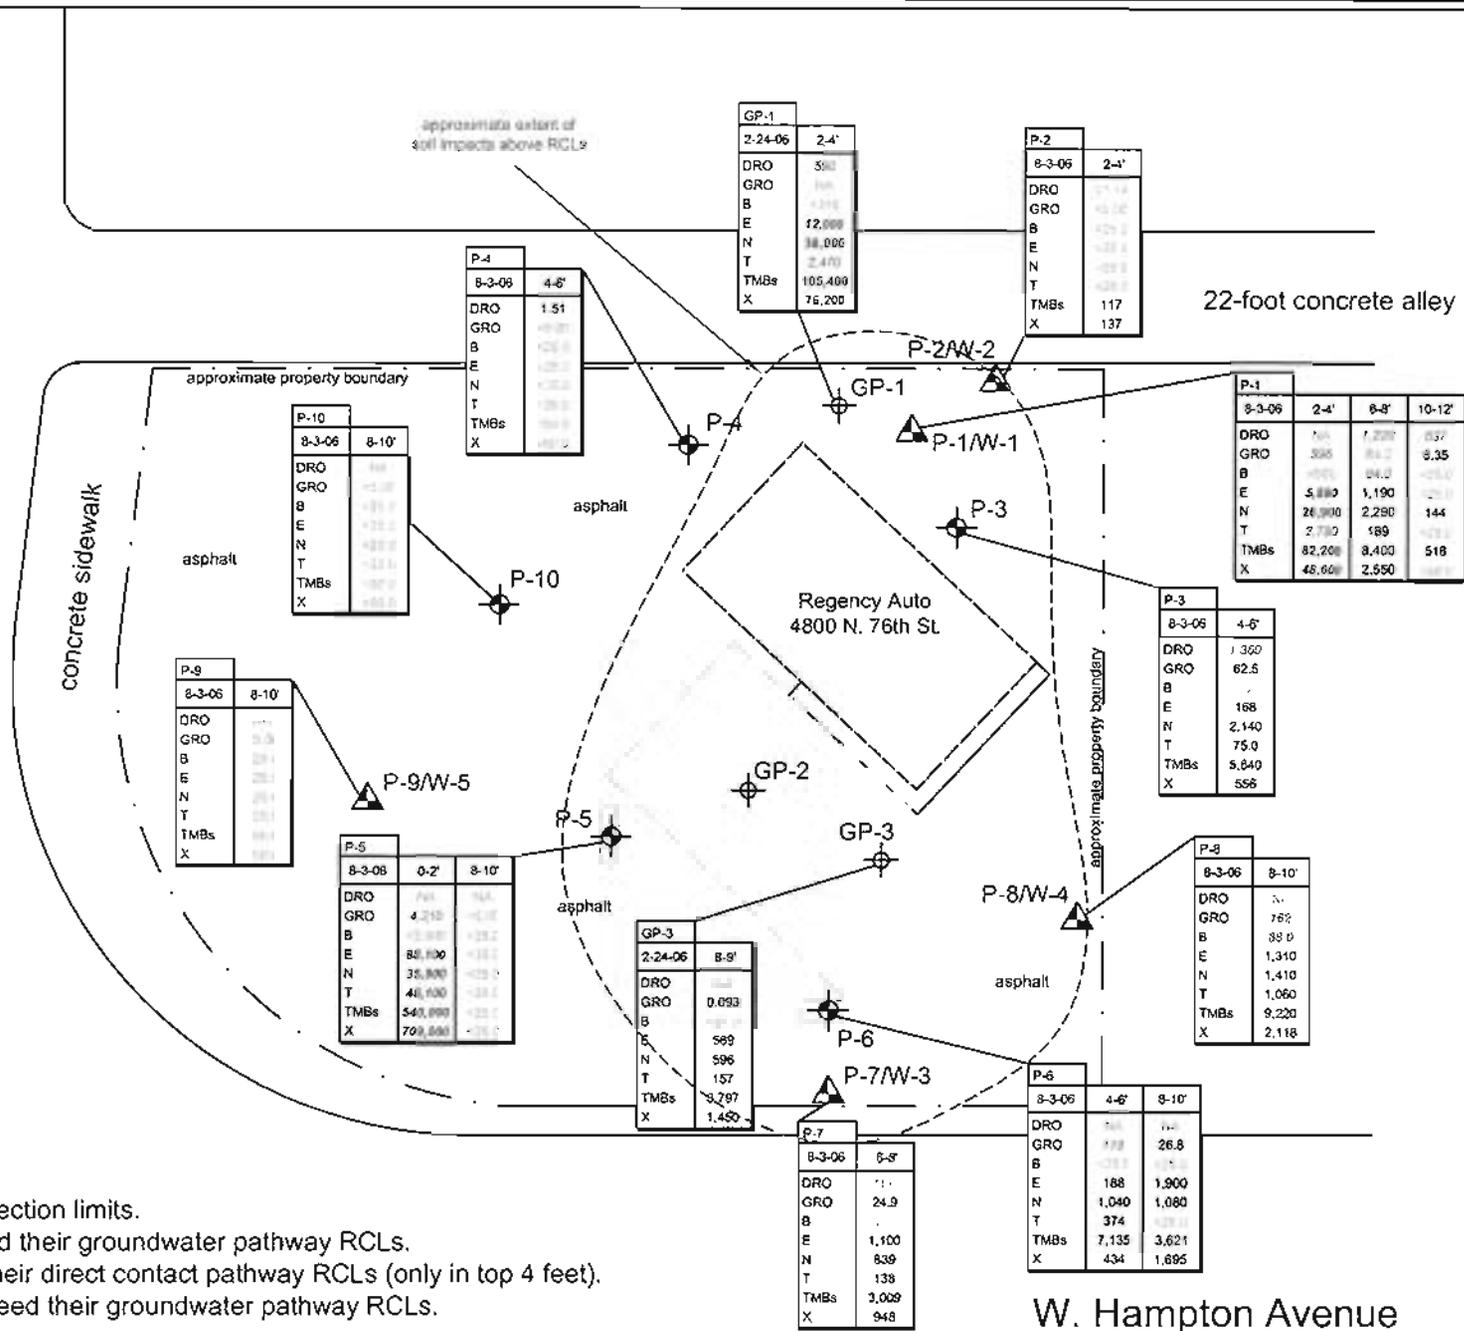
- = Phase II probehole
- = SI probehole
- = SI monitoring well
- DRO = diesel range organics
- GRO = gasoline range organics
- B = benzene
- E = ethylbenzene
- N = naphthalene
- T = toluene
- TMBs = comb. trimethylbenzenes
- X = total xylenes

- Soil Contamination Contour Map:** For sites closing with residual soil contamination, this map is to show the location of all contaminated soil and a single contour showing the horizontal extent of each area of contiguous residual soil contamination that exceeds a Residual Contaminant Level (RCL) or a Site Specific Residual Contaminant Level (SSRCL) as determined under s. NR 720.09, 720.11 and 720.19.
Figure #: FIG 3 **Title:** SOIL ANALYTICAL RESULTS ABOVE RCLs DIAGRAM
FIG 4 EXCAVATION LIMITS, SAMPLE LOCATIONS, AND SOIL ANALYTICAL RESULTS ABOVE RCLs DIAGRAM

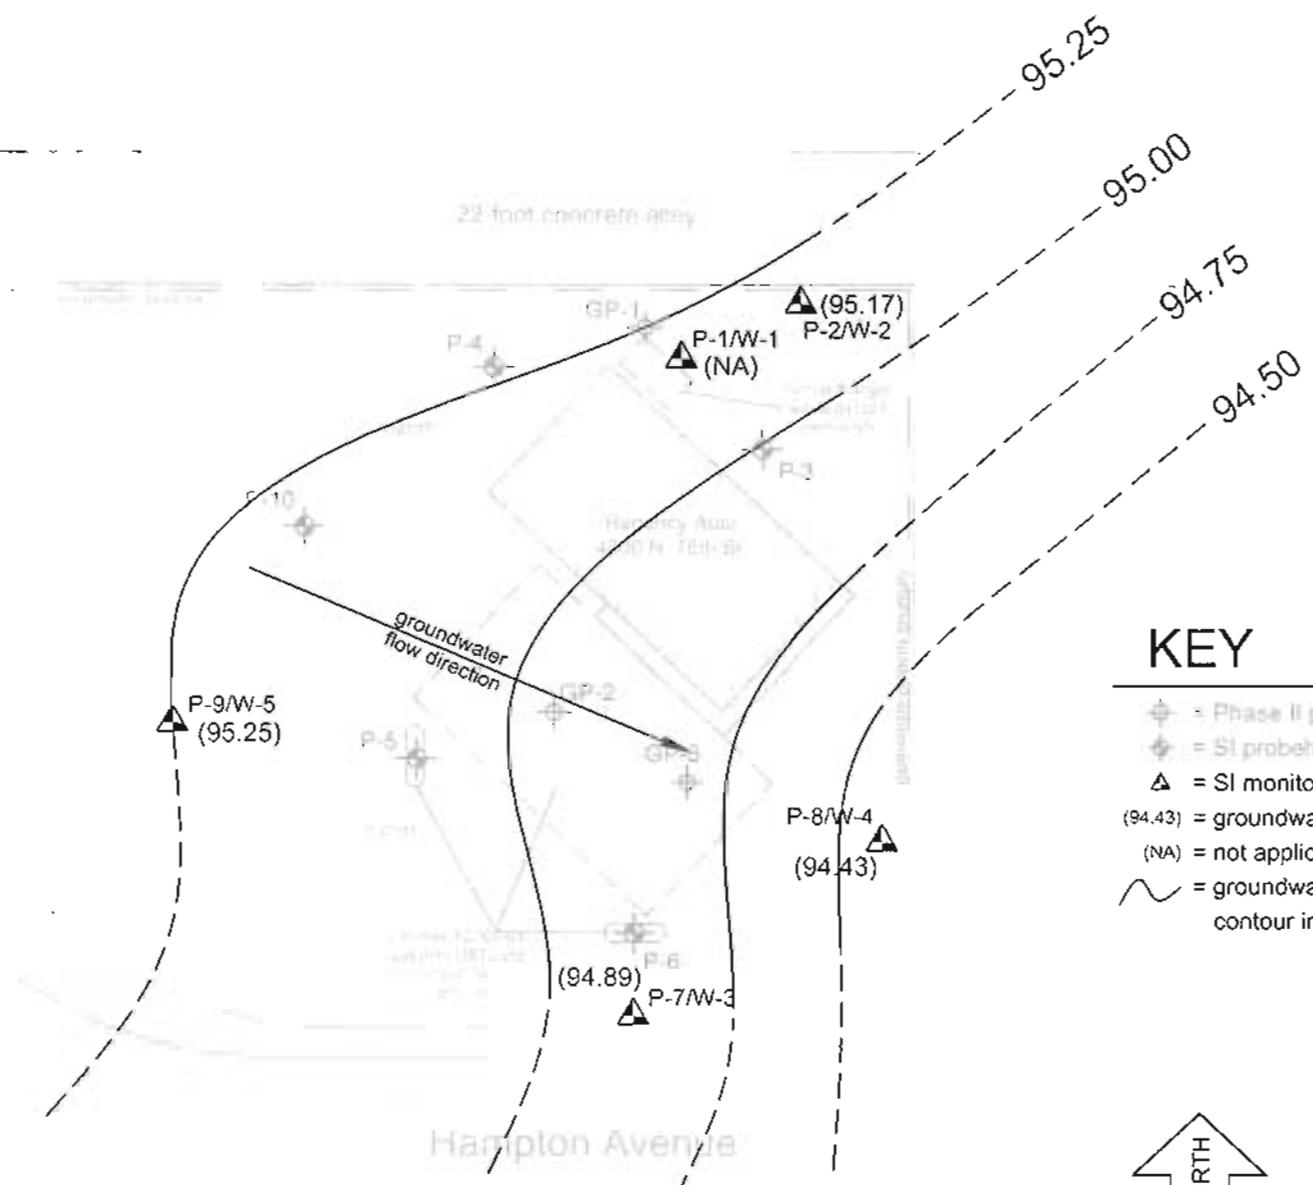
- = Phase II probehole
- = SI probehole
- = SI monitoring well
- (94.43) = groundwater elevation (10-8-07)
- (NA) = not applicable for contours
- = groundwater elevation contour
contour interval = 0.25 foot

Figure #: F166 Title: GROUNDWATER ELEVATION CROSS SECTION DIAGRAM (10-8-07)
