GIS REGISTRY
Cover Sheet

BRRTS #: 02-41-555541
ACTIVITY NAME: Hi-Hat/Garage Property
PROPERTY ADDRESS: 1701-1713 N. Arlington Place
MUNICIPALITY: Milwaukee
PARCEL ID #: 3551481100 and 3550839000

SUBJECT: Final Case Closure with Continuing Obligations
Hi-Hat/Garage Property, 1701-1713 North Arlington Place, Milwaukee, WI

BARRIER MAINTENANCE PLAN
1701 and 1713 NORTH ARLINGTON PLACE
MILWAUKEE, WISCONSIN
FID# To Be Determined
BRRTS# To Be Determined
JULY 2010

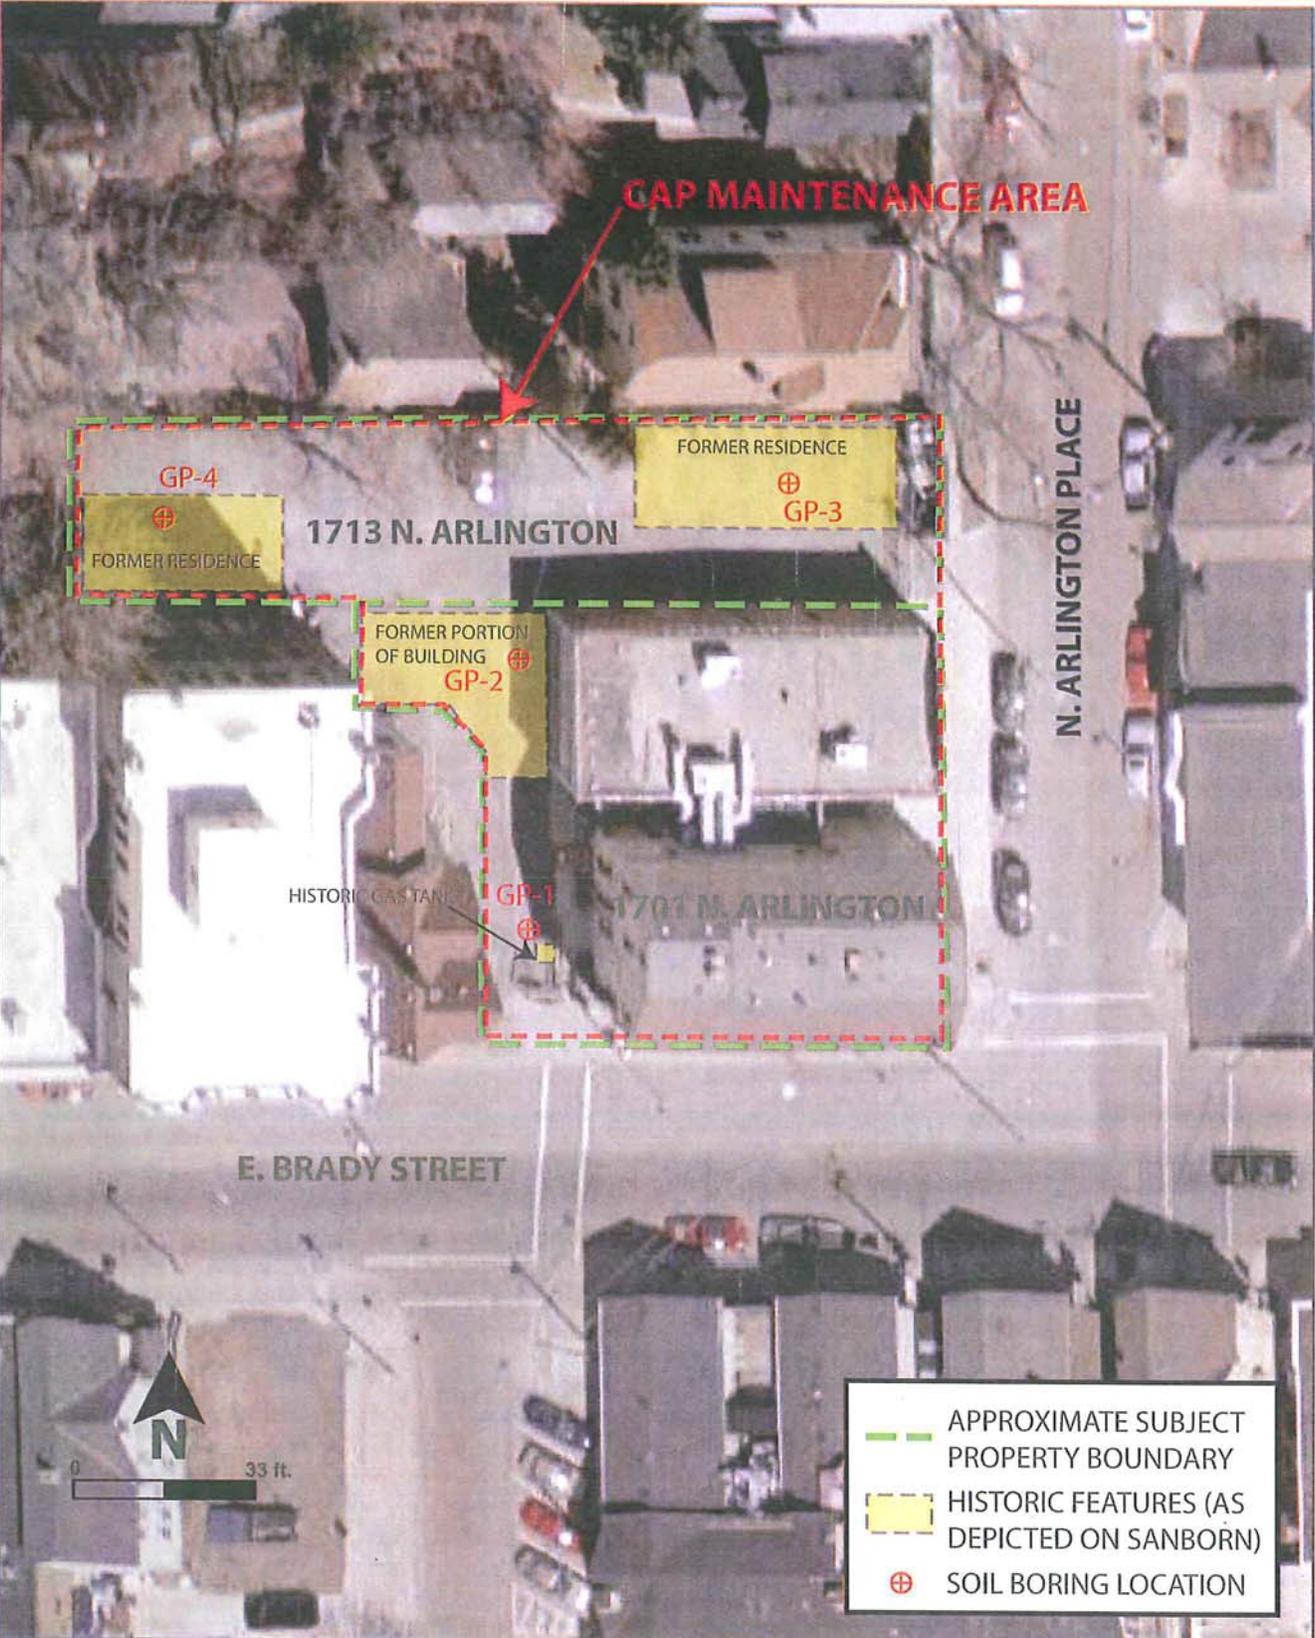
FIGURE

CAP MAINTENANCE AREA MAP

1701 AND 1713 NORTH ARLINGTON PLACE
MILWAUKEE, WISCONSIN

Description of Contamination: PAH and lead concentrations in excess of the Interim Guidance (Publication RR-519-97) Direct Contact non-industrial residual contaminant level (RCL) and Chapter NR 720 non-industrial RCLs were identified within the shallow fill material consisting of sandy silt, silt, and/or clay, located on the 1713 North Arlington Property. Elevated PAH and lead concentrations in excess of the Interim guidance industrial direct contact and/or groundwater pathway RCLs and non-industrial Chapter NR 720 RCLs were identified within the fill material, consisting of sandy silt with trace amounts of slag(non-native material) located immediately west of the northern most building. Impacted fill material is generally present at the site at depths ranging from ground surface to approximately eight feet below ground surface (bgs). The approximate cap maintenance area and subsequently approximate extent PAH and lead soil impacts identified to date is shown on the attached Figure.

Description of the Barrier to be Maintained: The Barrier consists of asphalt pavement. The Barrier is located as shown on the attached Figure.

Annual Inspection: The engineered barriers, as depicted in the attached Figure, will be inspected once a year, normally in the spring after all snow and ice is gone, for deterioration, cracks and other potential problems that can cause additional infiltration to or exposure to underlying soils and/or eroded soil areas. The inspections will be performed by the property owner or their designated representative. The inspections will be performed to evaluate damage due to settling, exposure to the weather, wear from traffic, increasing age and other factors. Any area where soils have become or are likely to become exposed and where infiltration from the surface will not be effectively minimized will be documented. A log of the inspections and any repairs will be maintained by the property owner and is included as Exhibit B, Cap Inspection Log. The log will include recommendations for necessary repair of any areas where underlying soils are exposed and where infiltration from the surface will not be effectively minimized. Once repairs are completed, they will be documented in the inspection log. A copy of the inspection log will be kept at the address of the property owner and available for submittal or inspection by Wisconsin Department of Natural Resources ("WDNR") representatives upon their request.

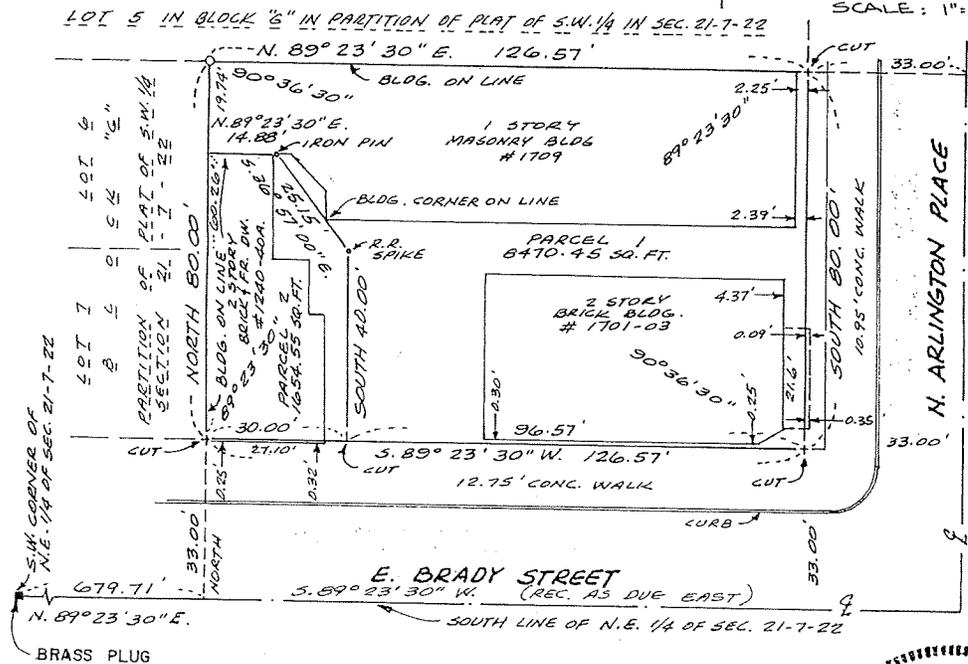
CERTIFIED SURVEY MAP No. 4205
Being a redivision of Lots 6 and 7, except the West 88.0 feet thereof,
in Block "G", in Partition of Southwest 1/4 of Northeast 1/4 of Section
21, Township 7 North, Range 22 East, in the City of Milwaukee, Milwaukee
County, Wisconsin.

0 INDICATES 1" X 24" IRON PIPE 1.13 LBS. PER LIN. FOOT
ALL DIMENSIONS ARE MEASURED TO THE NEAREST 0.01 OF A FOOT.
BEARINGS ARE REFERENCED TO THE SOUTH LINE OF THE
S.W. 1/4 SEC. 21-7-22 WHICH IS ASSUMED TO BEAR
S. 89° 23' 30" W.

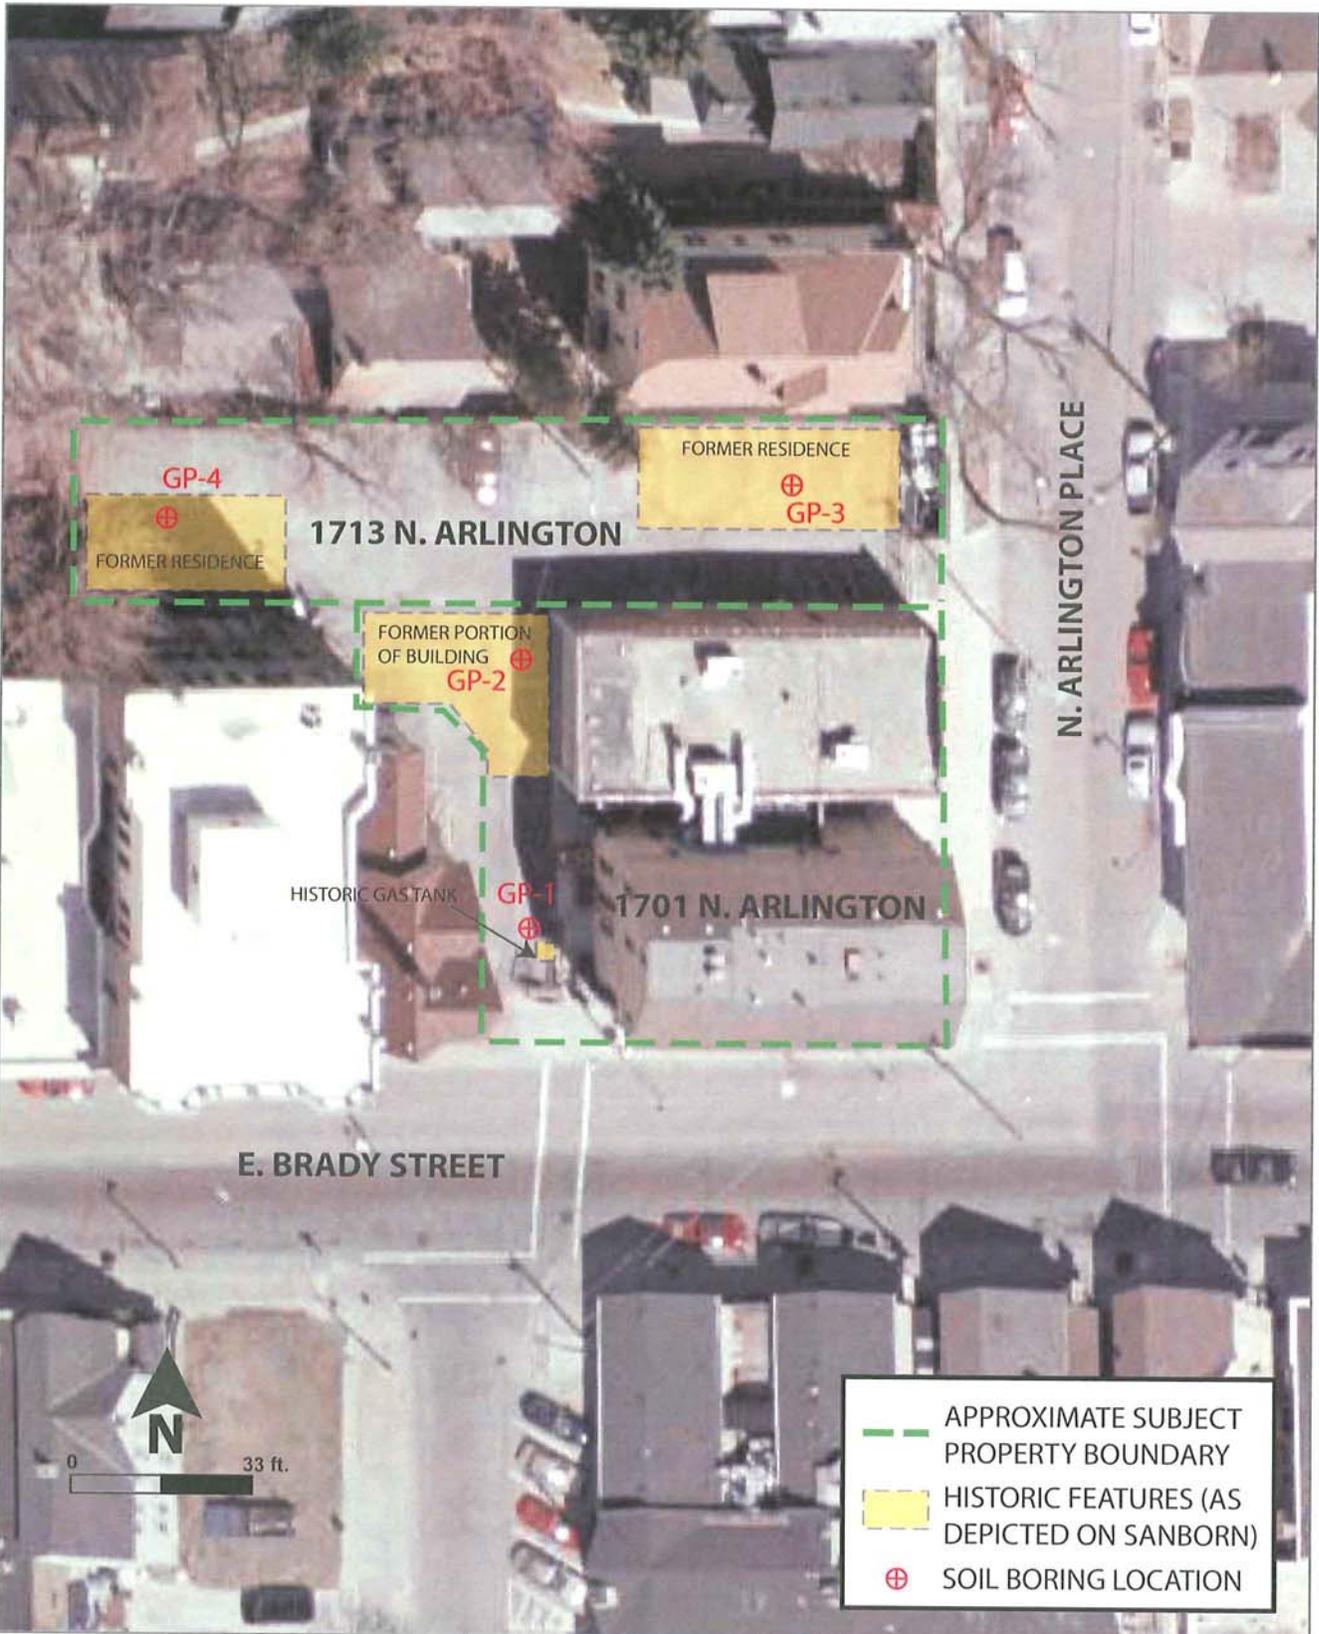
FIGURE

SITE PLAN MAP

1701 AND 1713 NORTH ARLINGTON PLACE
MILWAUKEE, WISCONSIN
