# GIS REGISTRY

ACTIVITY NAME: S K Williams Co

PROPERTY ADDRESS: 4600 N 124th St

Subject: Final Case Closure for the Former S. K. Williams Property 4600 North 124th Street  
Milwaukee, WI

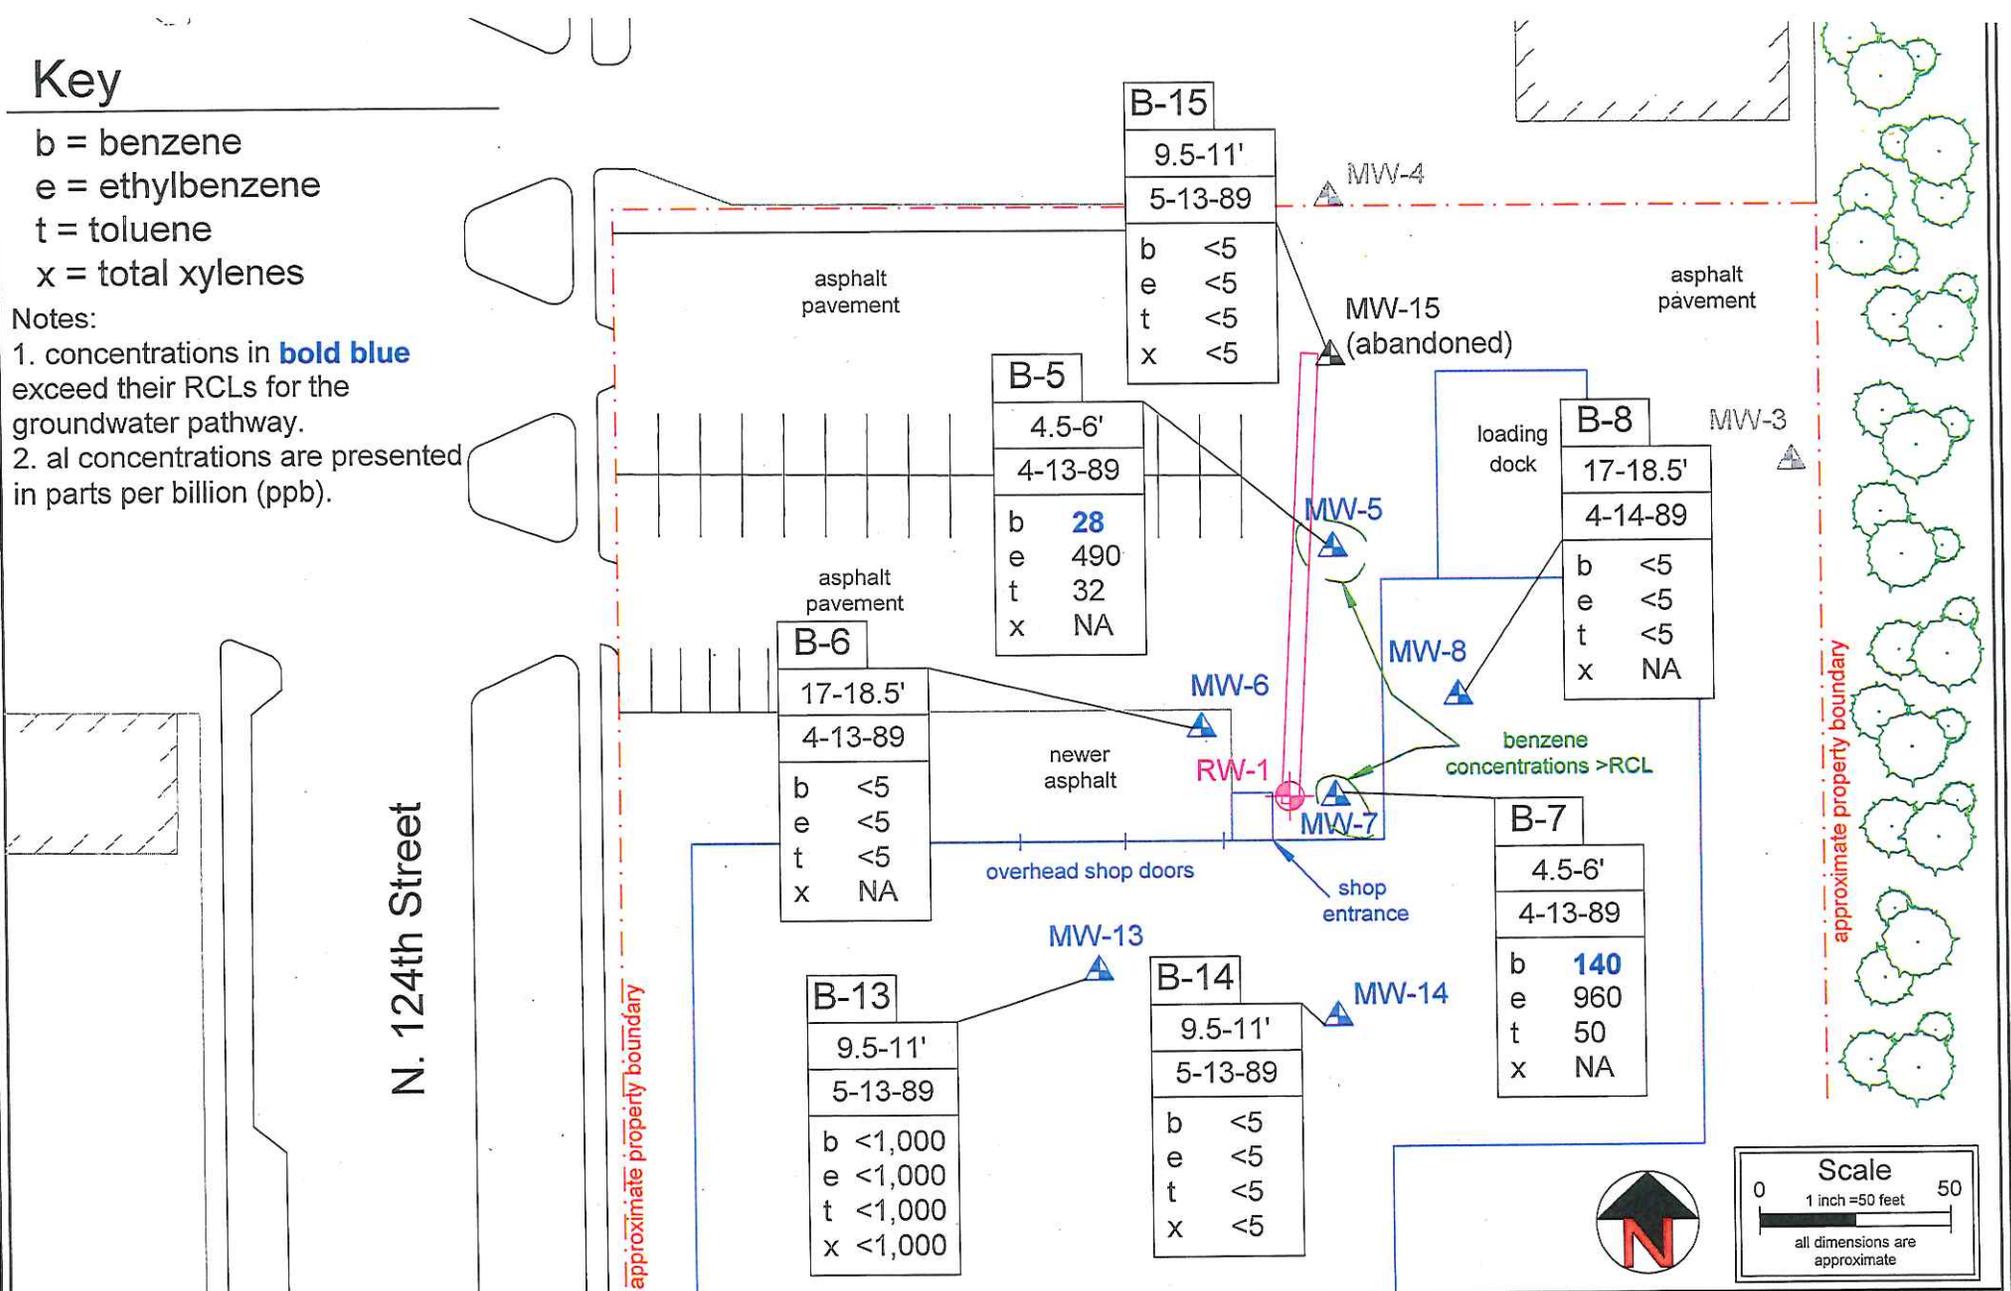
**Figure**

1. concentrations in **bold blue** exceed their RCLs for the groundwater pathway.
2. all concentrations are presented in parts per billion (ppb).

**Soil Impact Isoconcentration Diagram**  
 Former S.K. Williams Property  
 4600 N. 124th Street  
 Wauwatosa, Wisconsin

Residual soil contamination remains at or below 4-foot bgs for soil boring locations B-5, and B-7, as shown on the **attached map Figure 5**, and in the information submitted to the Department of Natural Resources. If soil in the specific locations described above is excavated in the future, then pursuant to ch. NR 718 or, if applicable, ch. 289, Stats., and chs. 500 to 536, the property owner at the time of excavation must sample and analyze the excavated soil to determine if residual contamination remains. If sampling confirms that contamination is present the property owner at the time of excavation will need to determine whether the material is considered solid or hazardous waste and ensure that any storage, treatment or disposal is in compliance with applicable standards and rules. In addition, all current and future owners and occupants of the property need to be aware that excavation of the contaminated soil may pose an inhalation or other direct contact hazard and as a result special precautions may need to be taken to prevent a direct contact health threat to humans.

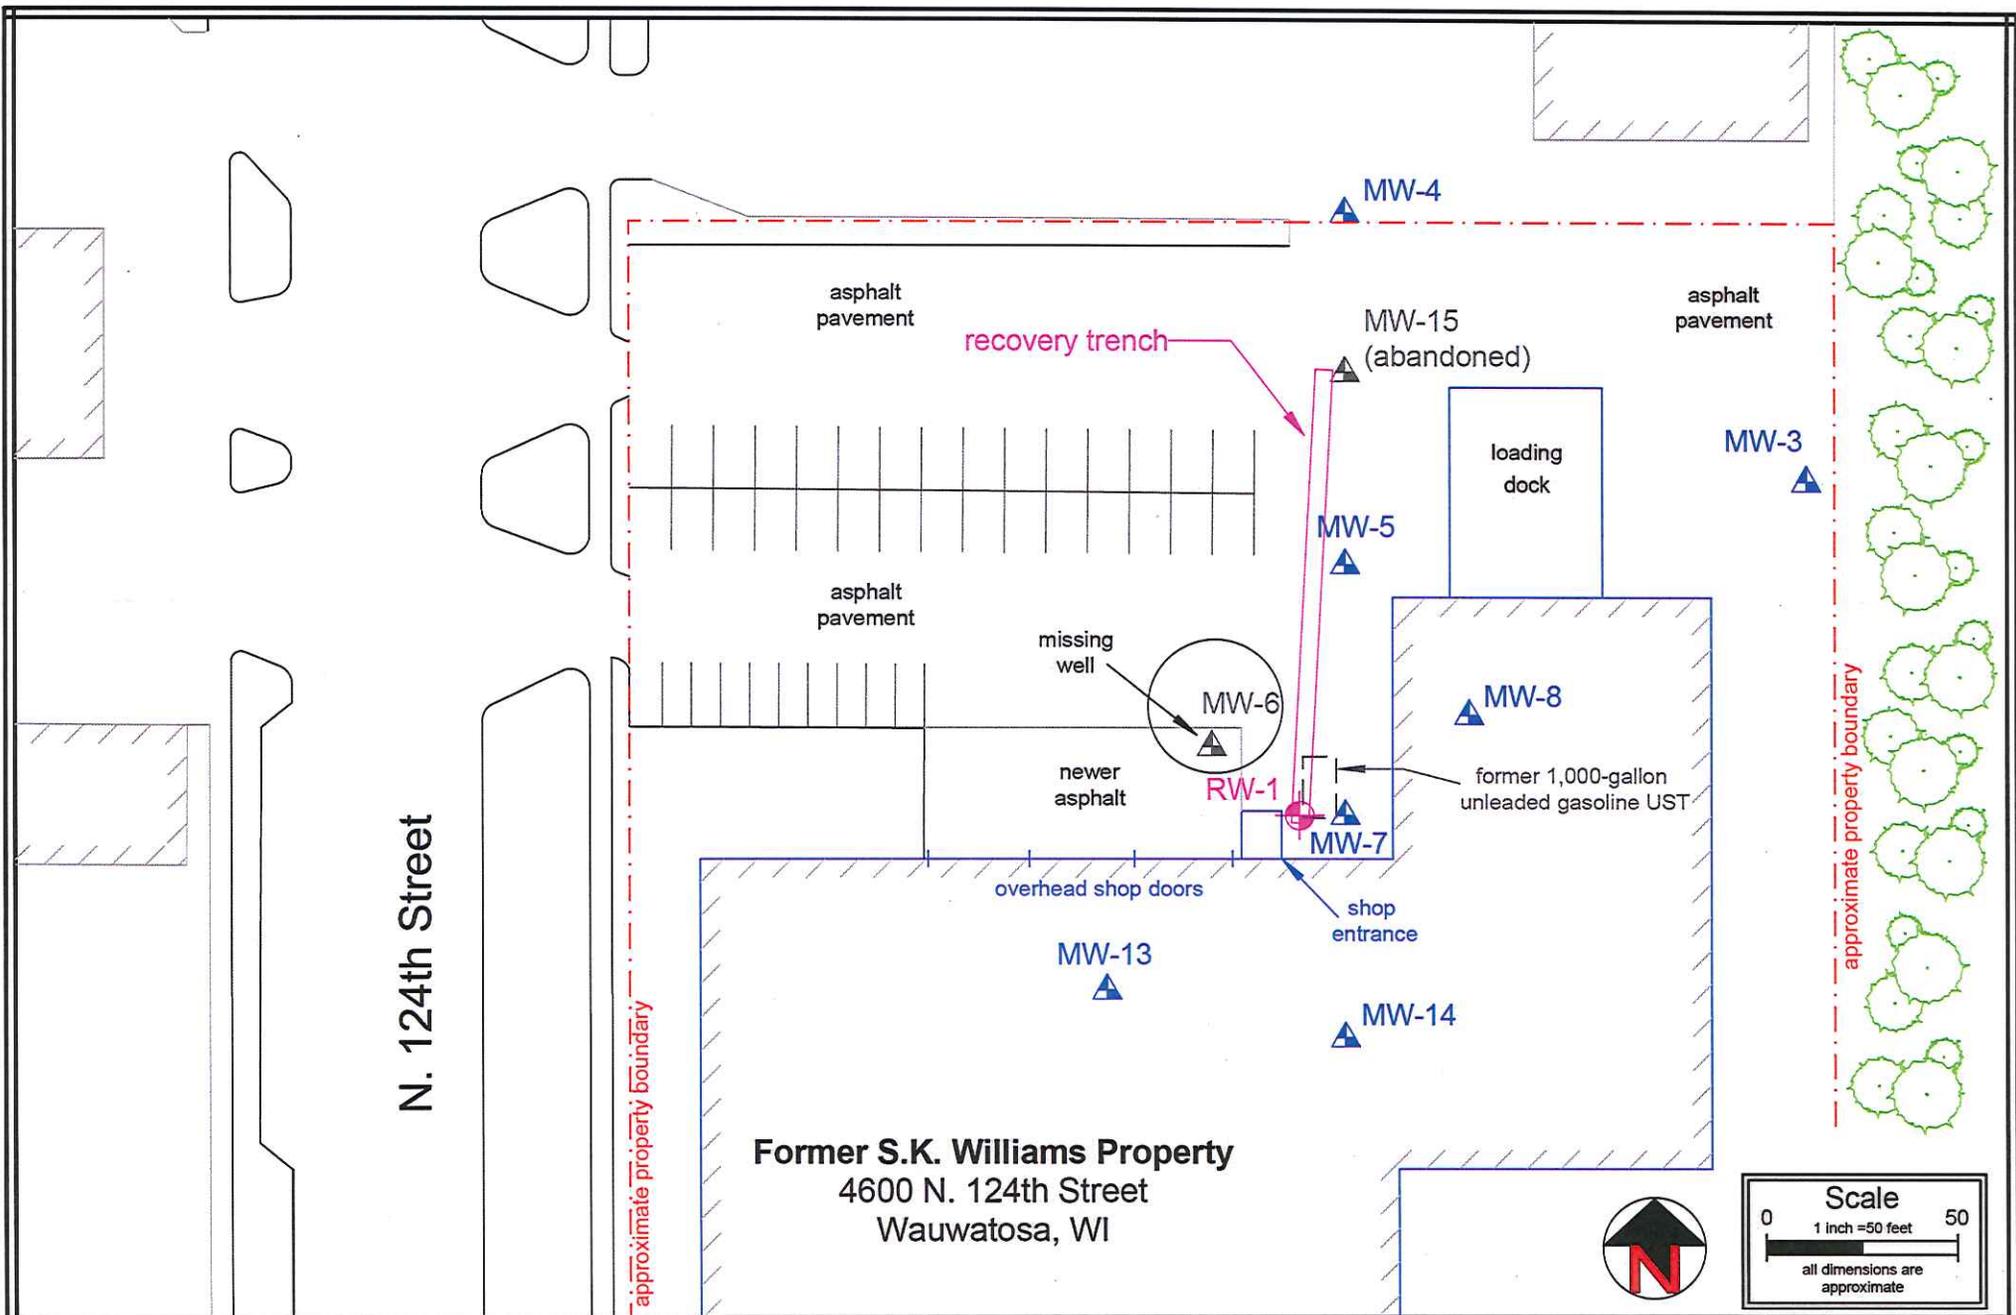
**Figure**  
 2

**Site Features Detail Diagram**  
 Former S.K. Williams Property  
 4600 N. 124th Street  
 Wauwatosa, Wisconsin

On May 27, 2011 your consultant Ready Earth, notified the Department that groundwater monitoring well MW-6 located on the property and shown on the **attached map Figure 2**, could not be properly abandoned because they were missing due to being paved over, covered or removed during site development activities. Your consultant has made a reasonable effort to locate the well depicted on the attached map and to determine whether it was properly abandoned but has been unsuccessful in those efforts. You need to understand that in the future you may be held liable for any problems associated with this monitoring well (MW-6) if it creates a conduit for contaminants to enter groundwater. If in the future, this groundwater monitoring well is found, the then current owner of the property on which the well is located will be required to notify the Department, to properly abandon the wells in compliance with the requirements in ch. NR 141, Wis. Adm. Code, and to submit the required documentation of that abandonment to the Department.

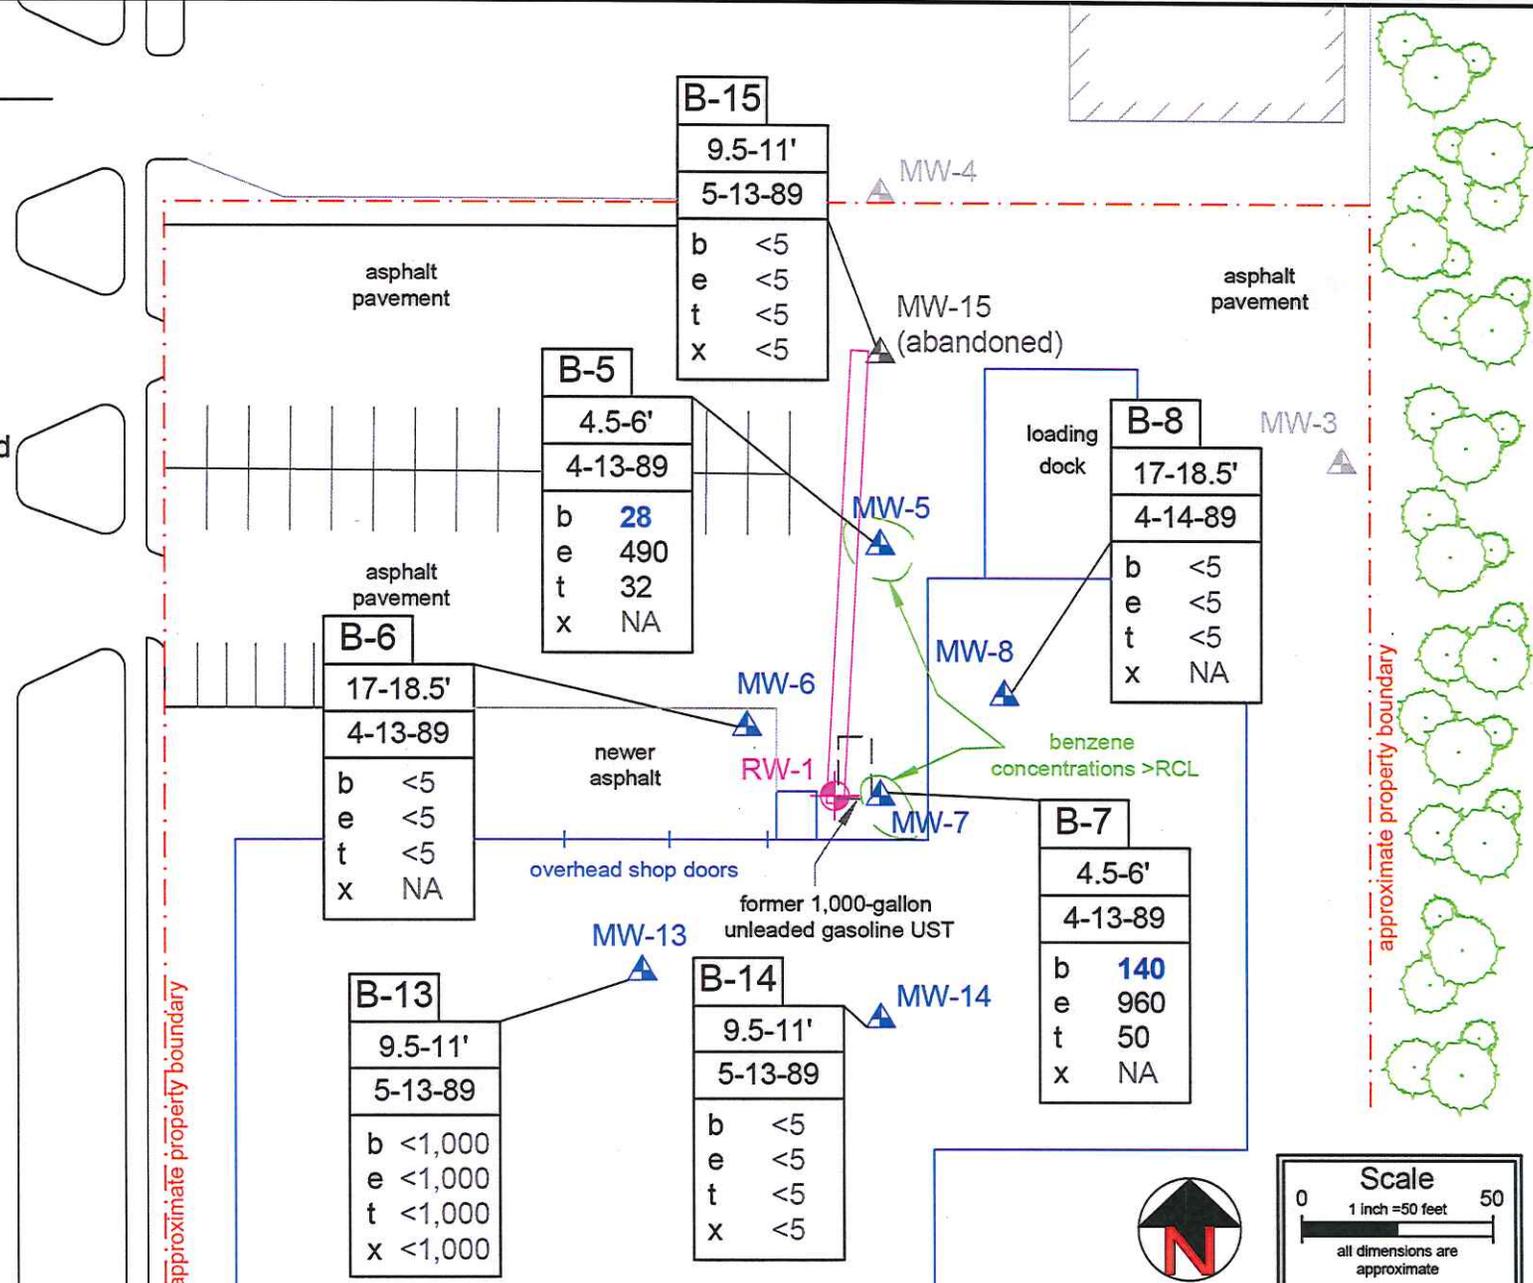
**Soil Impact Isoconcentration Diagram**  
 Former S.K. Williams Property  
 4600 N. 124th Street  
 Wauwatosa, Wisconsin
