Subject: Final Case Closure with Continuing Obligations for the Former Jose Luis Vargas
Property Located at 410 East Center Street, Milwaukee, WI

NO.	ISSUE/DESCRIPTION	BY	DATE
POST-REMEDIATION PETROLEUM CONTAMINATION IN SOIL			
JOSE LUIS VARGAS 410 EAST CENTER STREET MILWAUKEE, WISCONSIN			
PREPARED BY:	GZA GeoEnvironmental, Inc. Engineers and Scientists 20900 SWENSON DRIVE, SUITE 150 WALKESSHA, WISCONSIN 53186 (262) 754-2560	PREPARED FOR:	REDEVELOPMENT AUTHORITY OF THE CITY OF MILWAUKEE
PROJ MGR:	JFK	REVIEWED BY:	DGB
DESIGNED BY:	SEK	DRAWN BY:	CLK
DATE:	12/31/12	PROJECT NO.:	20.0152763
		REVISION NO.:	
			FIGURE B.2.b SHEET NO.

Subject: Conditional Closure Decision with Requirements to Achieve Final Closure for the Jose Luis Vargas (Former Filling Station) Property Located at 410 East Center Street Milwaukee, WI

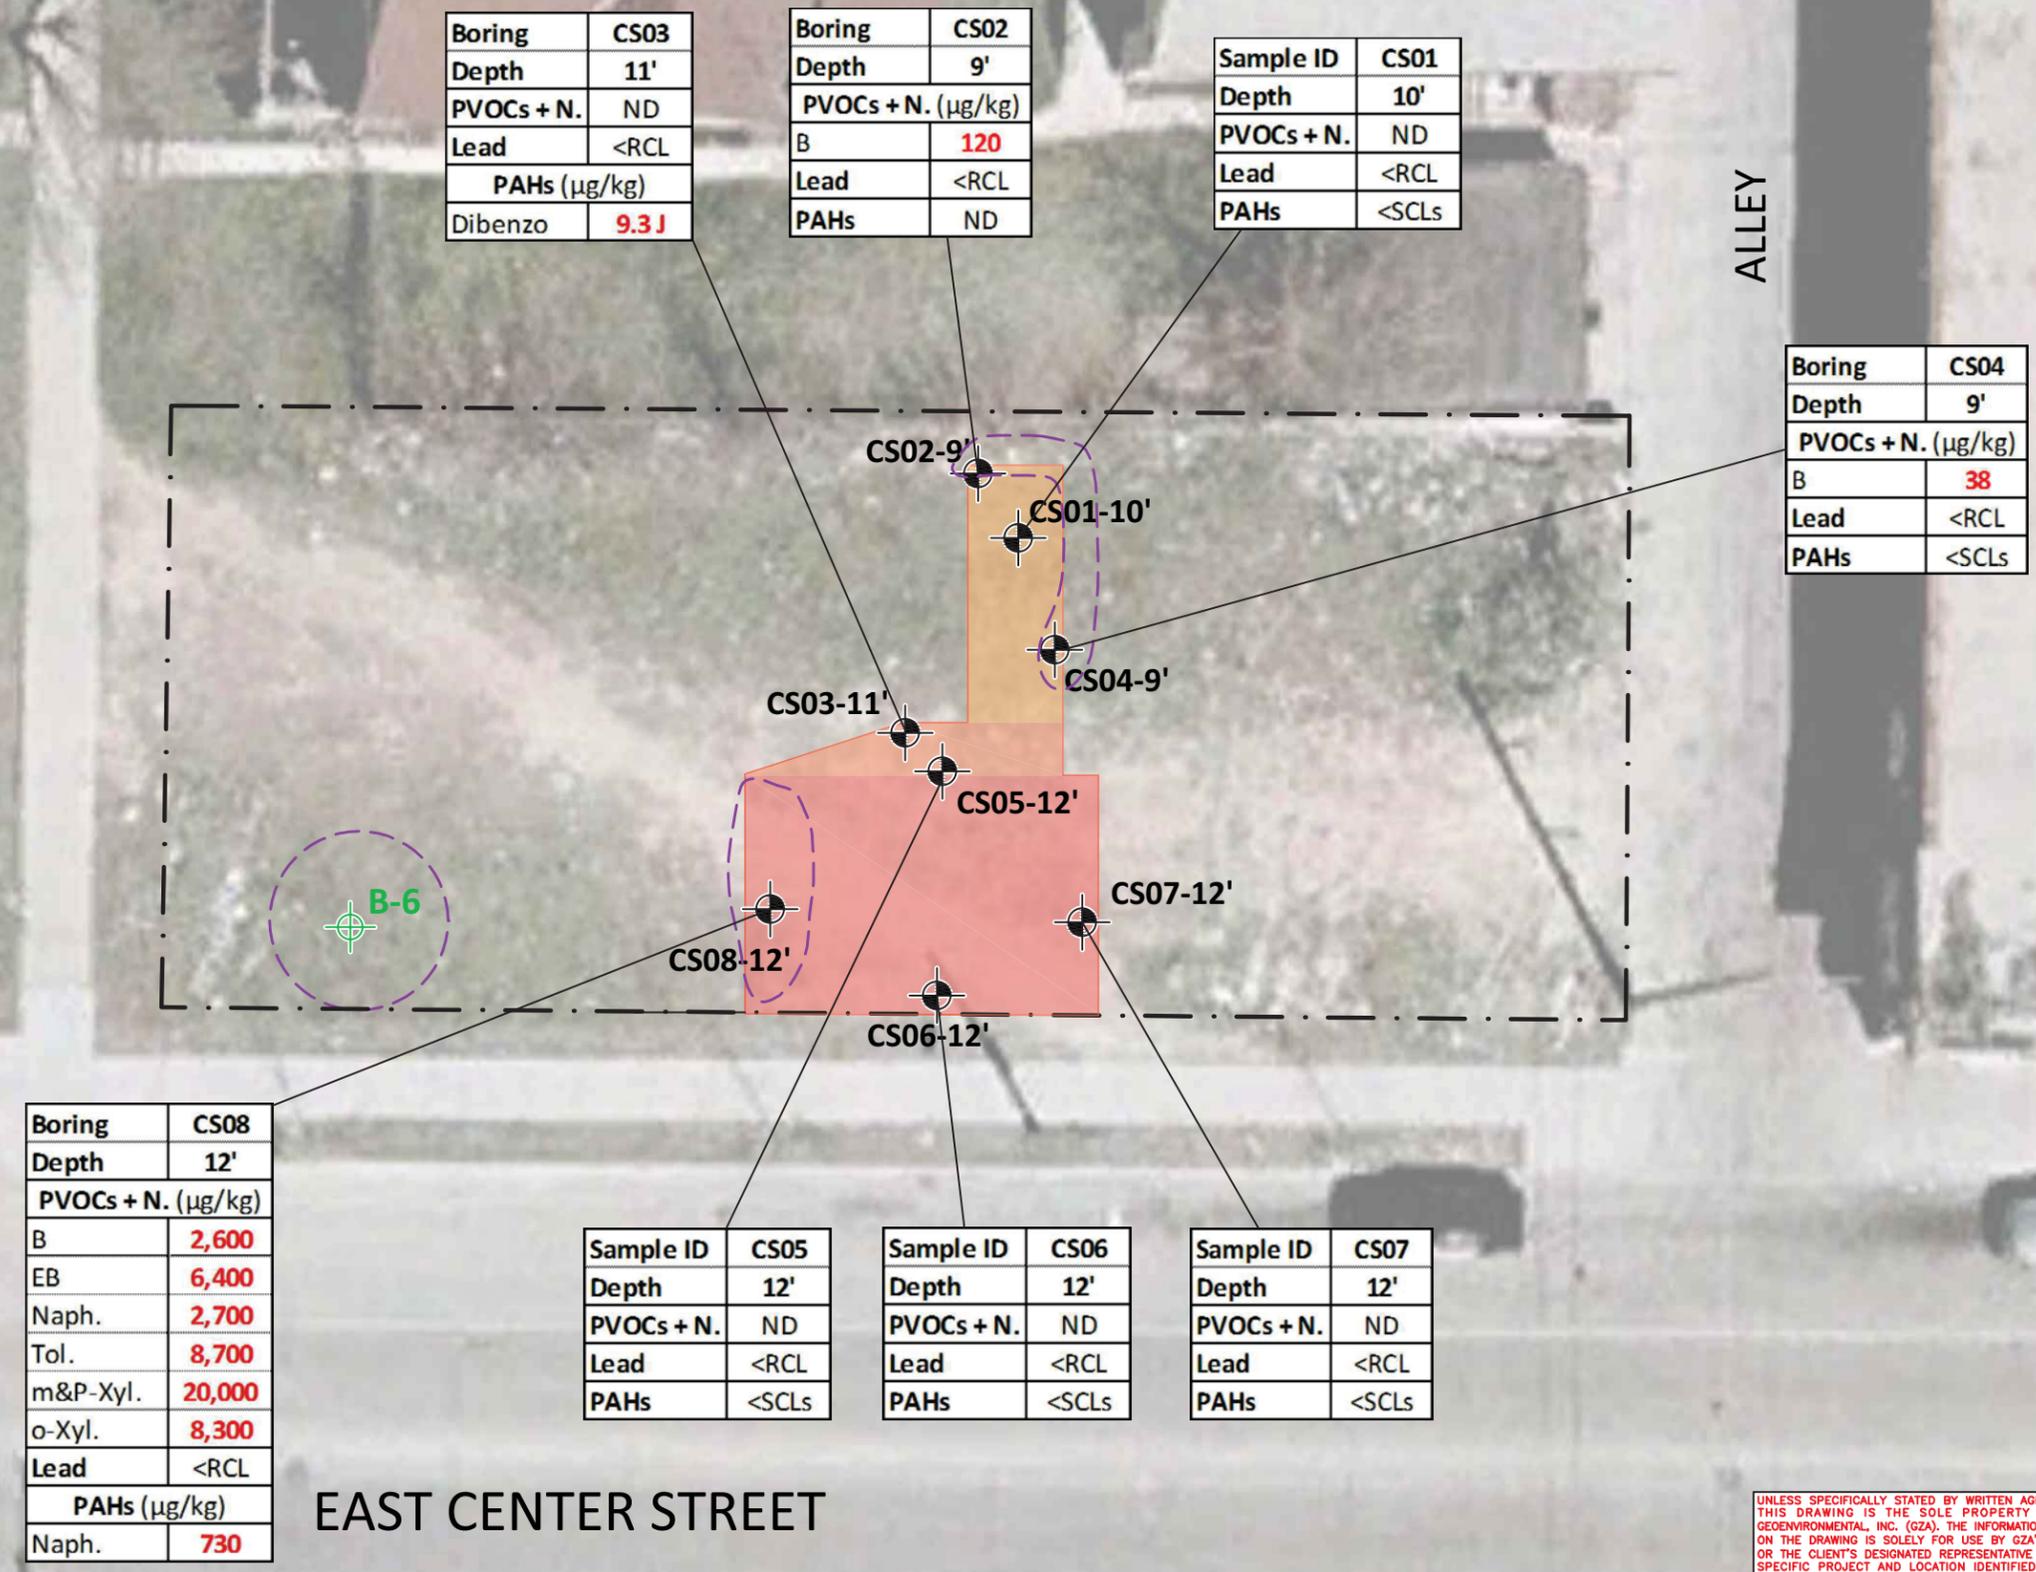
Boring	CS03
Depth	11'
PVOCs + N.	ND
Lead	<RCL
PAHs (µg/kg)	
Dibenzo	9.3 J

Boring	CS02
Depth	9'
PVOCs + N. (µg/kg)	
B	120
Lead	<RCL
PAHs	ND

Sample ID	CS01
Depth	10'
PVOCs + N.	ND
Lead	<RCL
PAHs	<SCLs

Boring	CS04
Depth	9'
PVOCs + N. (µg/kg)	
B	38
Lead	<RCL
PAHs	<SCLs

Boring	CS08
Depth	12'
PVOCs + N. (µg/kg)	
B	2,600
EB	6,400
Naph.	2,700
Tol.	8,700
m&P-Xyl.	20,000
o-Xyl.	8,300
Lead	<RCL
PAHs (µg/kg)	
Naph.	730

Sample ID	CS05
Depth	12'
PVOCs + N.	ND
Lead	<RCL
PAHs	<SCLs

Sample ID	CS06
Depth	12'
PVOCs + N.	ND
Lead	<RCL
PAHs	<SCLs

Sample ID	CS07
Depth	12'
PVOCs + N.	ND
Lead	<RCL
PAHs	<SCLs

- The area of petroleum-impacted soil excavation and locations of excavation closure samples are based on field measurements made by GZA during excavation and sampling activities performed at the Site in December 2010.

- The excavation was extended to depths ranging from 10 to 12 feet bgs, as shown.
- Analytical concentrations depicted in **Bold Red** font indicate an exceedance of the NR 720 Groundwater Pathway RCL and/or the NR746 Table 1 Screening Level for that compound.

- The estimated areas of Post-Remedial NR 720 Groundwater Pathway RCL and/or the NR 746 Table 1 Screening Level exceedances ("RCL Exceedances") for petroleum compounds (VOCs/PVOCs plus naphthalene) remaining in soil upon completion of excavation activities are shown.

- SCL exceedances for PAHs are also presented in chemboxes but the exceedance areas for these non-petroleum compounds are not delineated with RCL exceedance contours.

Soil contamination remains at the soil boring locations indicated on the **attached map Figure B.2.b**. If soil in the specific locations described above is excavated in the future, the property owner at the time of excavation must sample and analyze the excavated soil to determine if contamination remains. If sampling confirms that contamination is present, the property owner at the time of excavation will need to determine whether the material is considered solid or hazardous waste and ensure that any storage, treatment or disposal is in compliance with applicable standards and rules. In addition, all current and future owners and occupants of the property need to be aware that excavation of the contaminated soil may pose an inhalation or other direct contact hazard and as a result special precautions may need to be taken to prevent a direct contact health threat to humans.

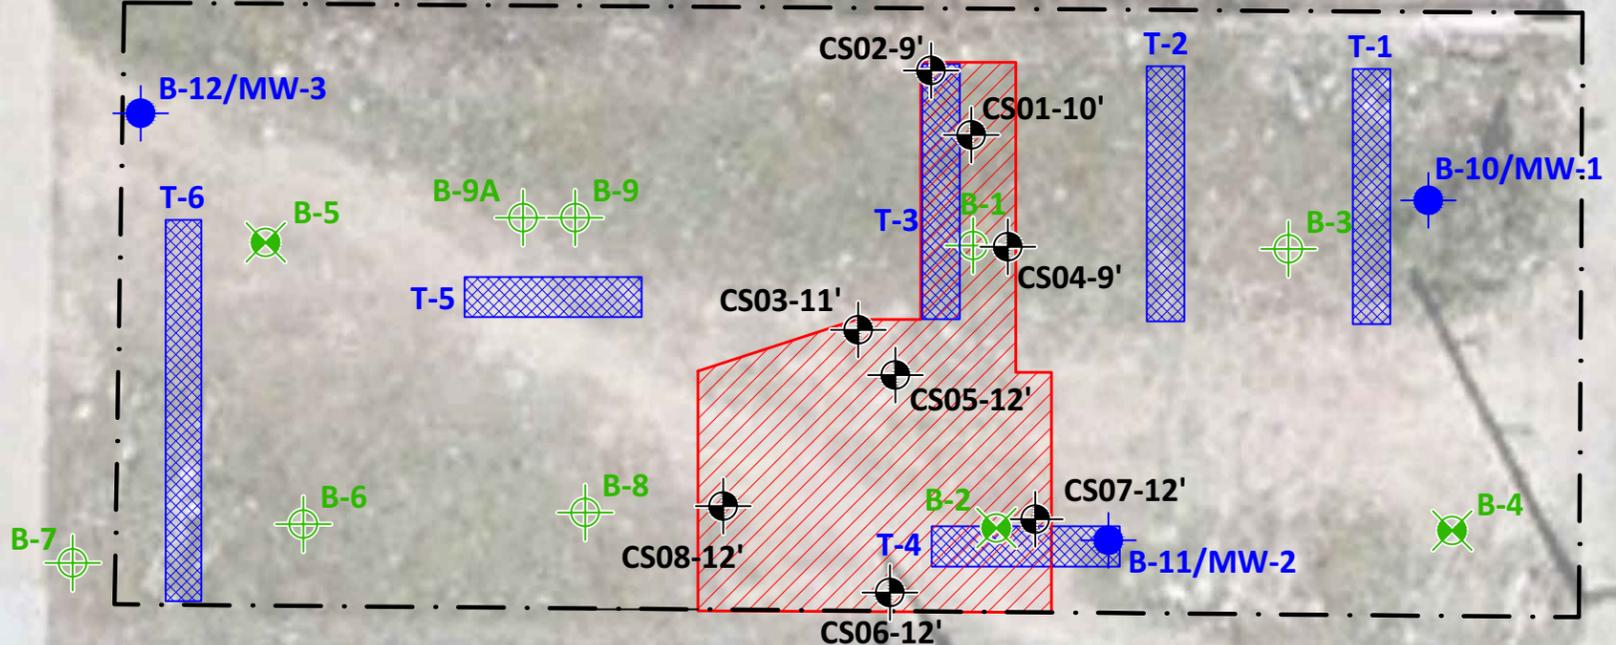
- APPROXIMATE SITE BOUNDARY
- B-6 PSI SOIL BORING
- B-4 PSI SOIL BORING AND TEMPORARY MONITORING WELL
- B-12/MW-3 PSI SOIL BORING/ PERMANENT MONITORING WELL
- CS02-9' EXCAVATION CLOSURE SAMPLE AND DEPTH
- T-4 PSI TEST PIT LOCATION
- AREA OF PETROLEUM-IMPACTED SOIL EXCAVATION

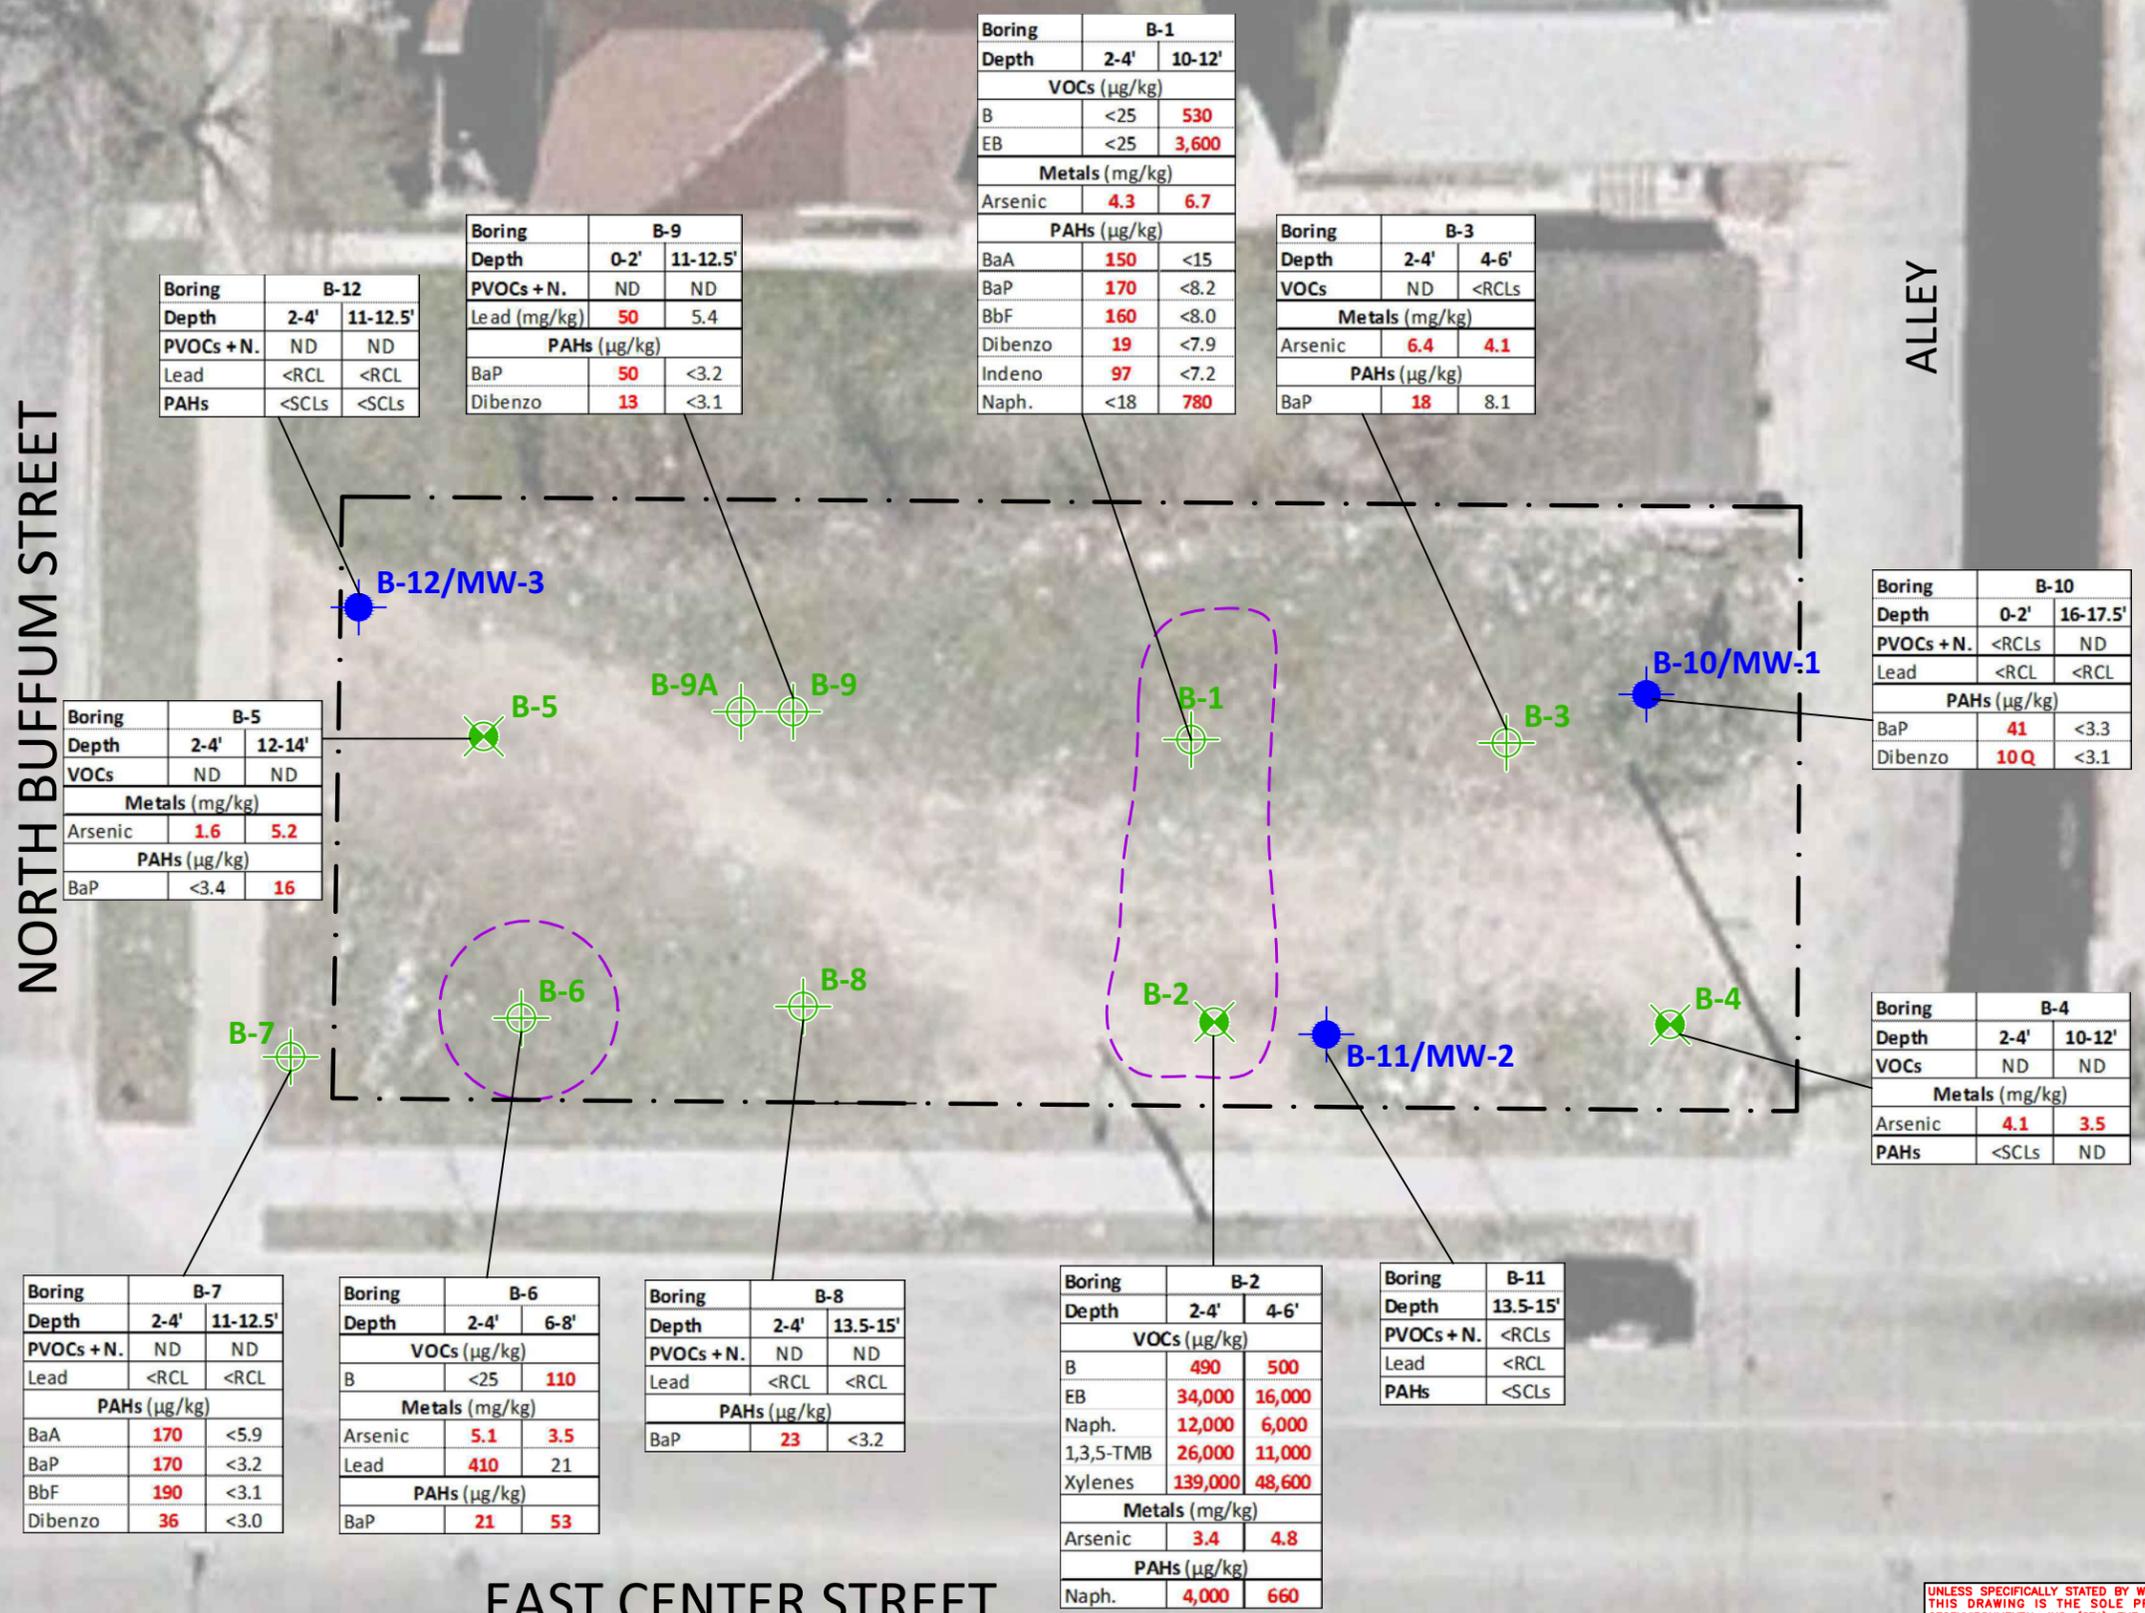
©2012 - GZA GeoEnvironmental, Inc. GZA-C:\Christina CAD\Project Files\A_GZA\Sue\Center Street\Site PLAN 12-31-12.dwg [B.2.a] January 03, 2013 - 11:32am Christinok

- APPROXIMATE SITE BOUNDARY
 - B-6 ⊕ PSI SOIL BORING
 - B-4 ⊗ PSI SOIL BORING AND TEMPORARY MONITORING WELL
 - B-12/MW-3 ⊕ PSI SOIL BORING/ PERMANENT MONITORING WELL
 - ESTIMATED EXTENT OF PRE-REMEDIATION NR 720 AND/OR NR 746 RCL EXCEEDANCES FOR PETROLEUM COMPOUNDS IN SOIL
- VOCs Volatile Organic Compounds
PVOCs Petroleum VOCs
PVOCs + N. PVOCs plus Naphthalene
PAHs Polycyclic Aromatic Hydrocarbons
µg/kg Micrograms per Kilogram
mg/kg Milligrams per Kilogram
ND Not detected
RCL Residual Contaminant Level
SCL Soil Screening Level
B Benzene
BaA Benzo(a)anthracene
BaP Benzo(a)pyrene
BbF Benzo(b)fluoranthene
Dibenzo Dibenzo(a,h)anthracene
EB Ethylbenzene
Indeno Indeno(1,2-cd)pyrene
Naph. Naphthalene
1,3,5-TMB 1,3,5-Trimethylbenzene

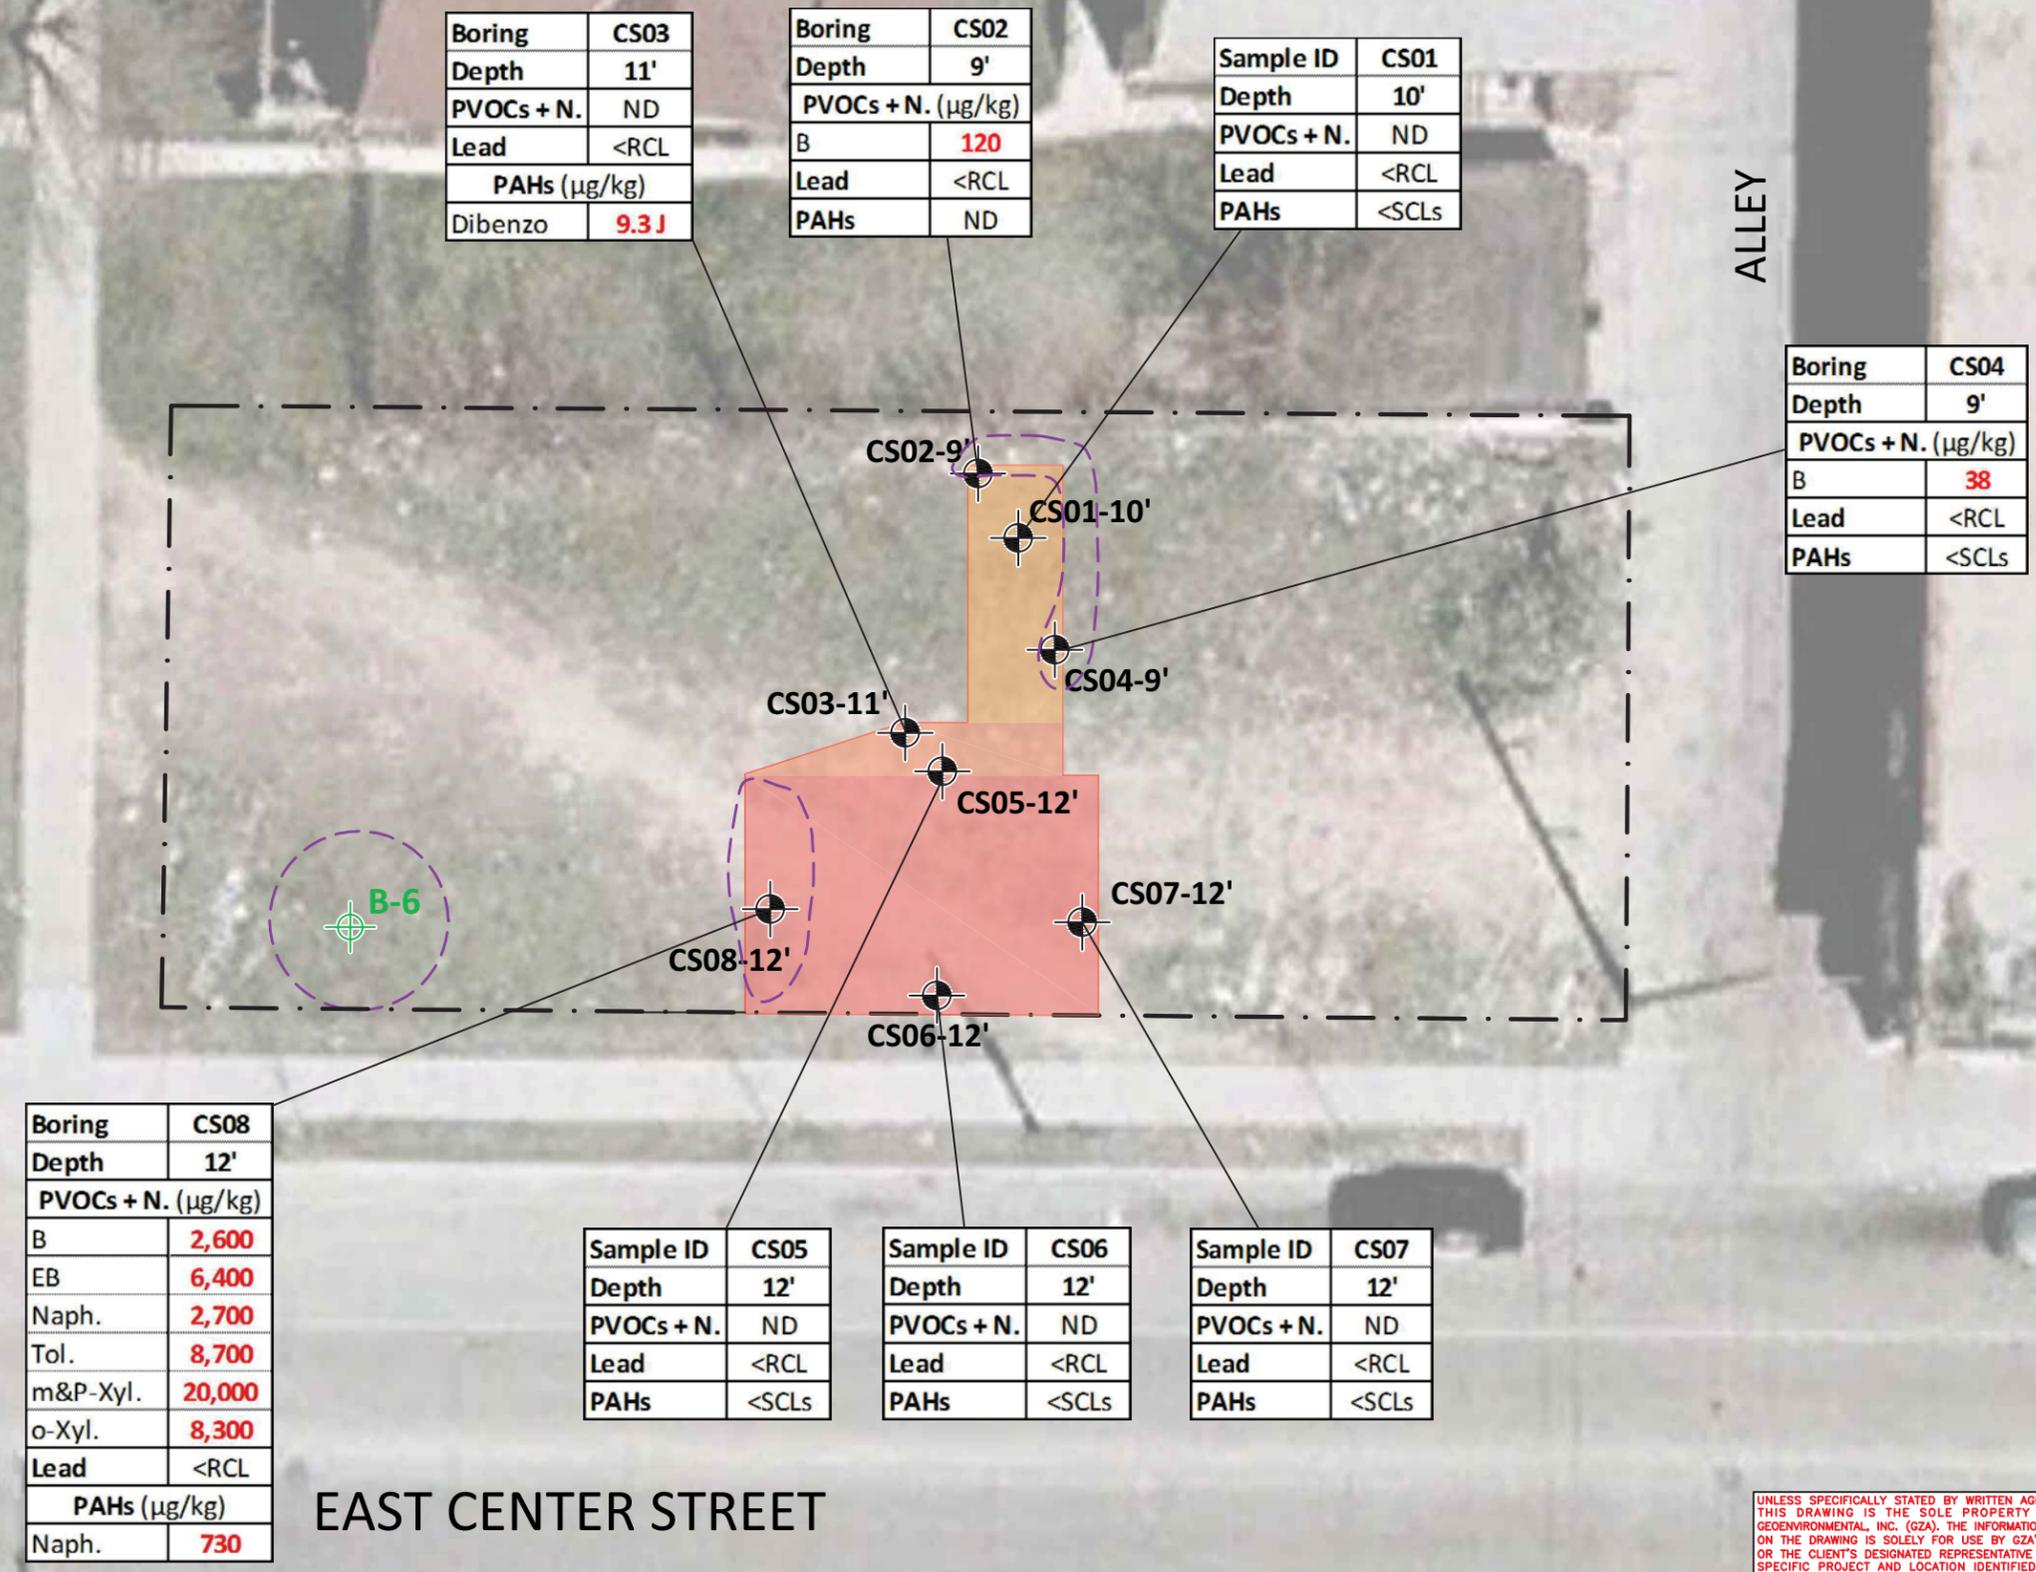
- . - - APPROXIMATE SITE BOUNDARY
- B-6 PSI SOIL BORING
- CS02-9' EXCAVATION CLOSURE SAMPLE AND DEPTH
- EXTENT OF PETROLEUM-IMPACTED SOIL EXCAVATION
 - AREA EXCAVATED TO DEPTH OF 10' BGS
 - AREA EXCAVATED TO DEPTH OF 11' BGS
 - AREA EXCAVATED TO DEPTH OF 12' BGS
- ESTIMATED EXTENT OF POST-REMEDIATION NR 720 AND/OR NR 746 RCL EXCEEDANCES FOR PETROLEUM COMPOUNDS IN SOIL

Boring	CS02
Depth	9'
PVOCs + N. (µg/kg)	
B	120
Lead	<RCL
PAHs	ND

Boring	CS04
Depth	9'
PVOCs + N. (µg/kg)	
B	38
Lead	<RCL
PAHs	<SCLs

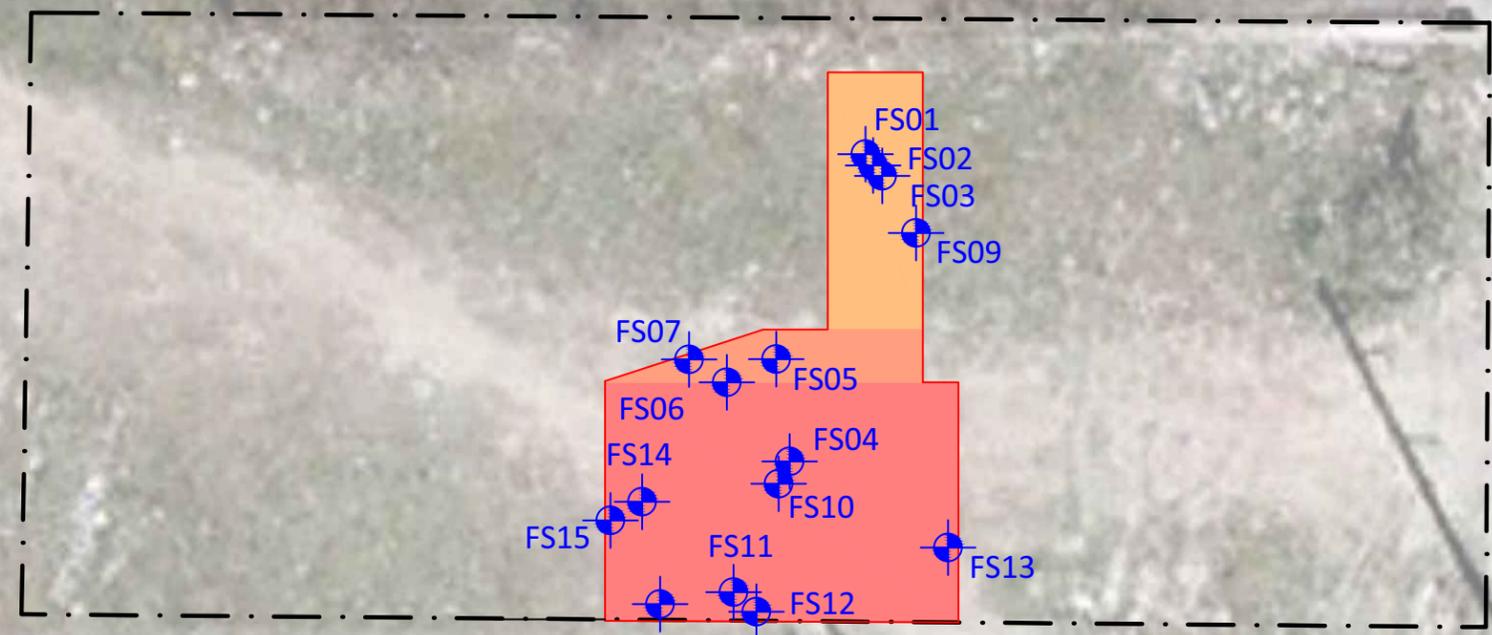
- APPROXIMATE SITE BOUNDARY
- FS01 FIELD SCREEN SAMPLE LOCATION
- EXTENT OF PETROLEUM-IMPACTED SOIL EXCAVATION
- AREA EXCAVATED TO DEPTH OF 10' BGS
- AREA EXCAVATED TO DEPTH OF 11' BGS
- AREA EXCAVATED TO DEPTH OF 12' BGS
