**SUBJECT:** Final Case Closure with Continuing Obligations  
Beckers Auto Body, 2915 N. Brookfield Rd., Brookfield  
DNR BRRTS # 03-68-191395 PECFA # 53045-3310-15-A

**B.3.b - Groundwater Isoconcentration**  
 Becker's Auto Body Property  
 2915 N. Brookfield Road  
 Brookfield, Wisconsin

Becker's Auto Body  
2915 N. Brookfield Road  
Brookfield, Wisconsin

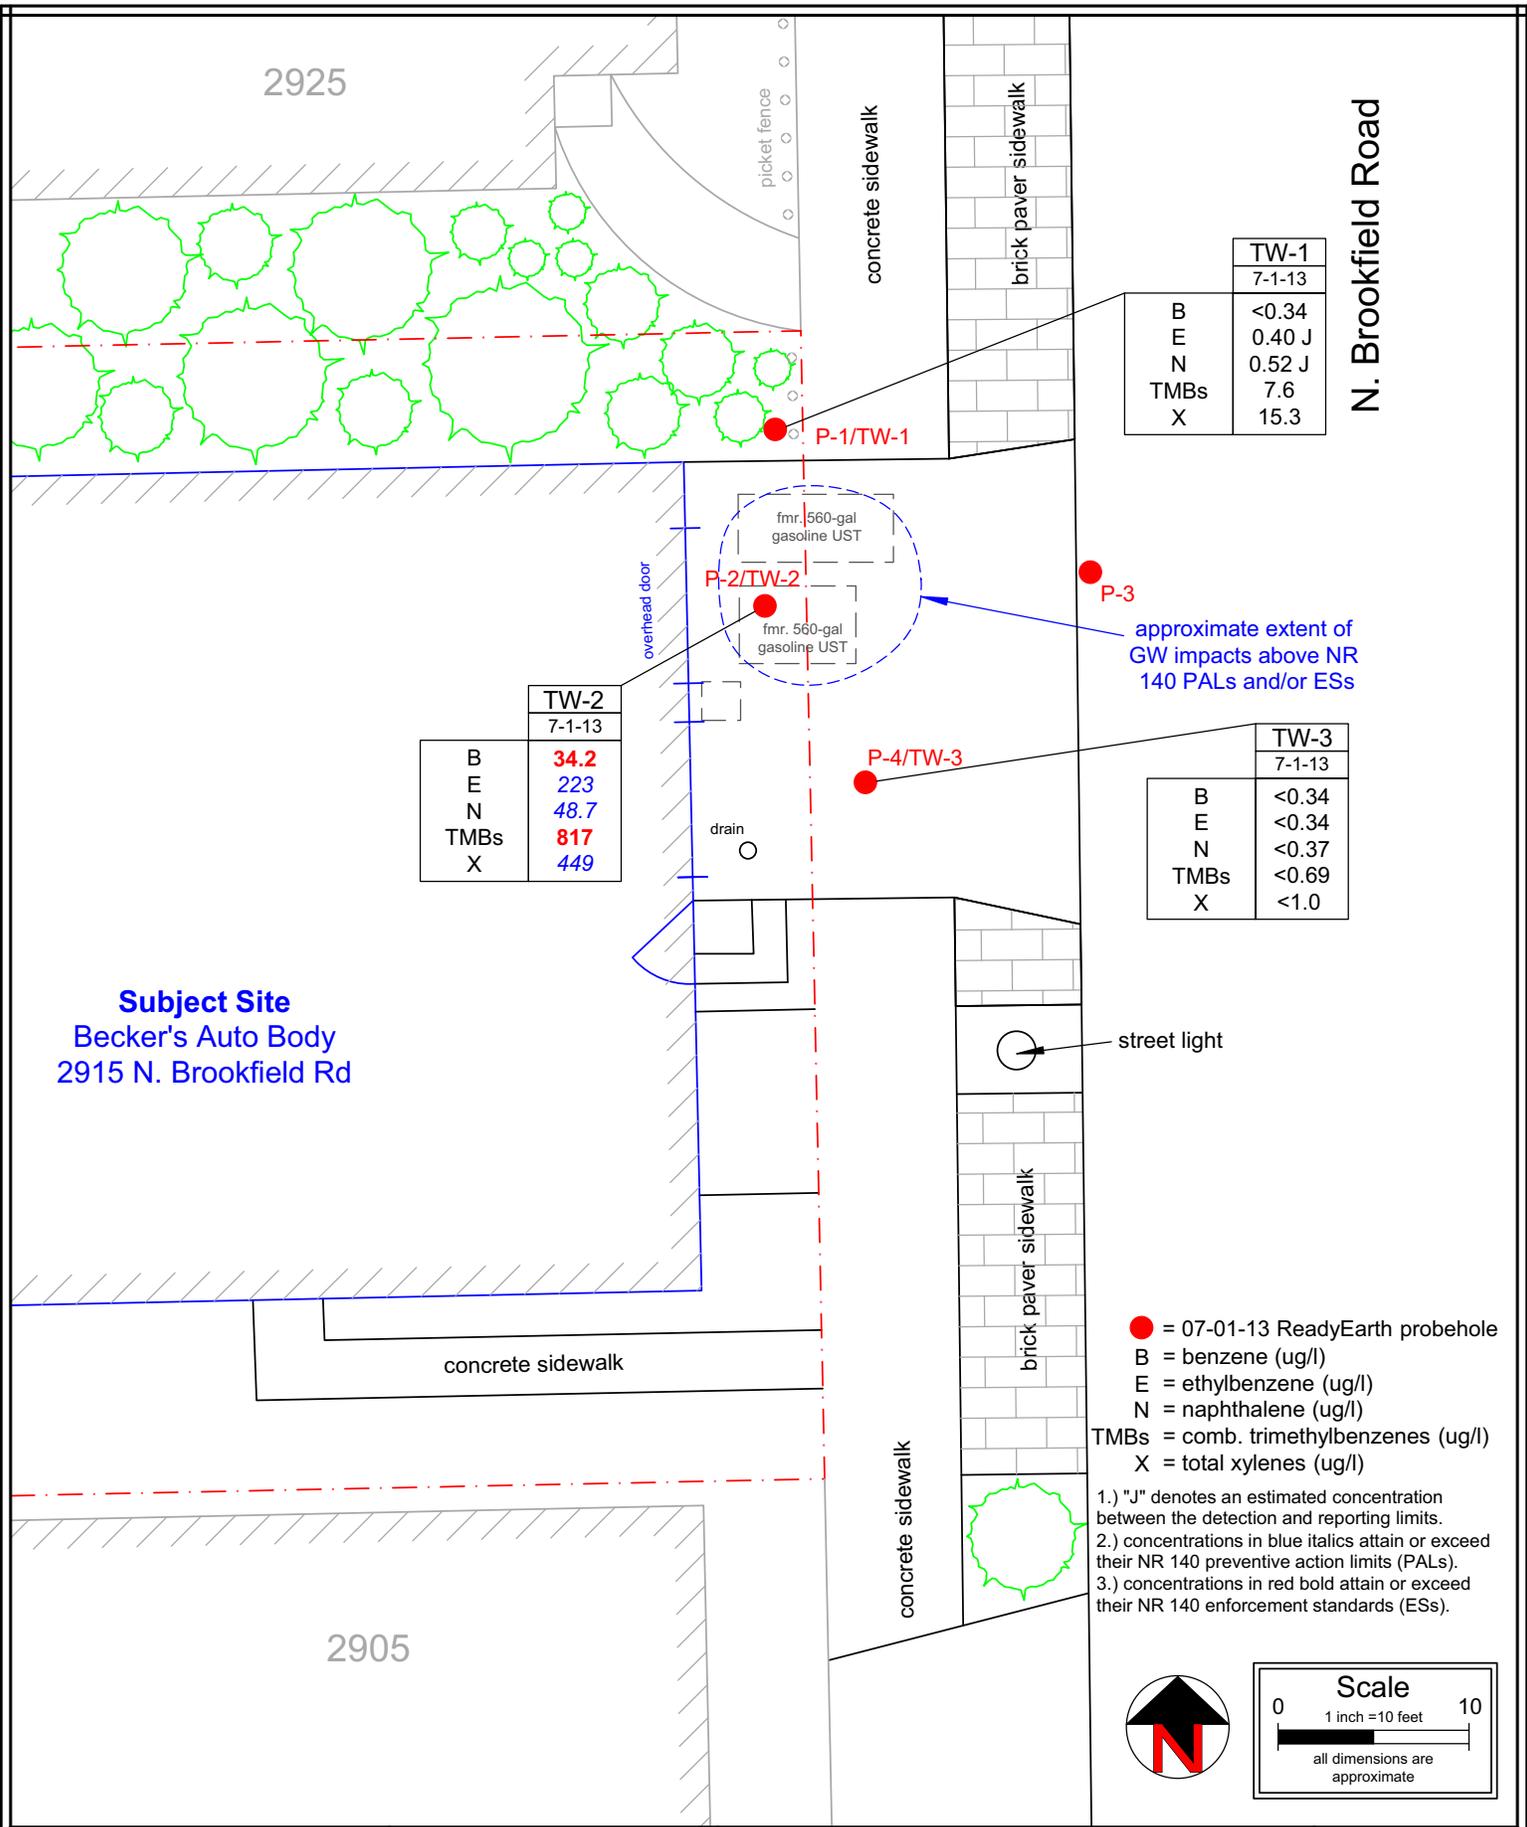
P-1	
8-10'	
B	<25
E	<25
M	<25
N	<25
T	<25
1,2,4	53.9 J
1,3,5	<25
X	<75

P-2	
	8-10'	12-14'
B	<25	<25
E	225	<25
M	<25	<25
N	153	<25
T	<25	<25
1,2,4	<i>1,140</i>	<25
1,3,5	<i>305</i>	<25
X	466	<75

- B.3.b Groundwater Isoconcentration, dated 10-11-13
- B.2.c Pre/Post Remaining Soil Contamination, dated 10-11-13

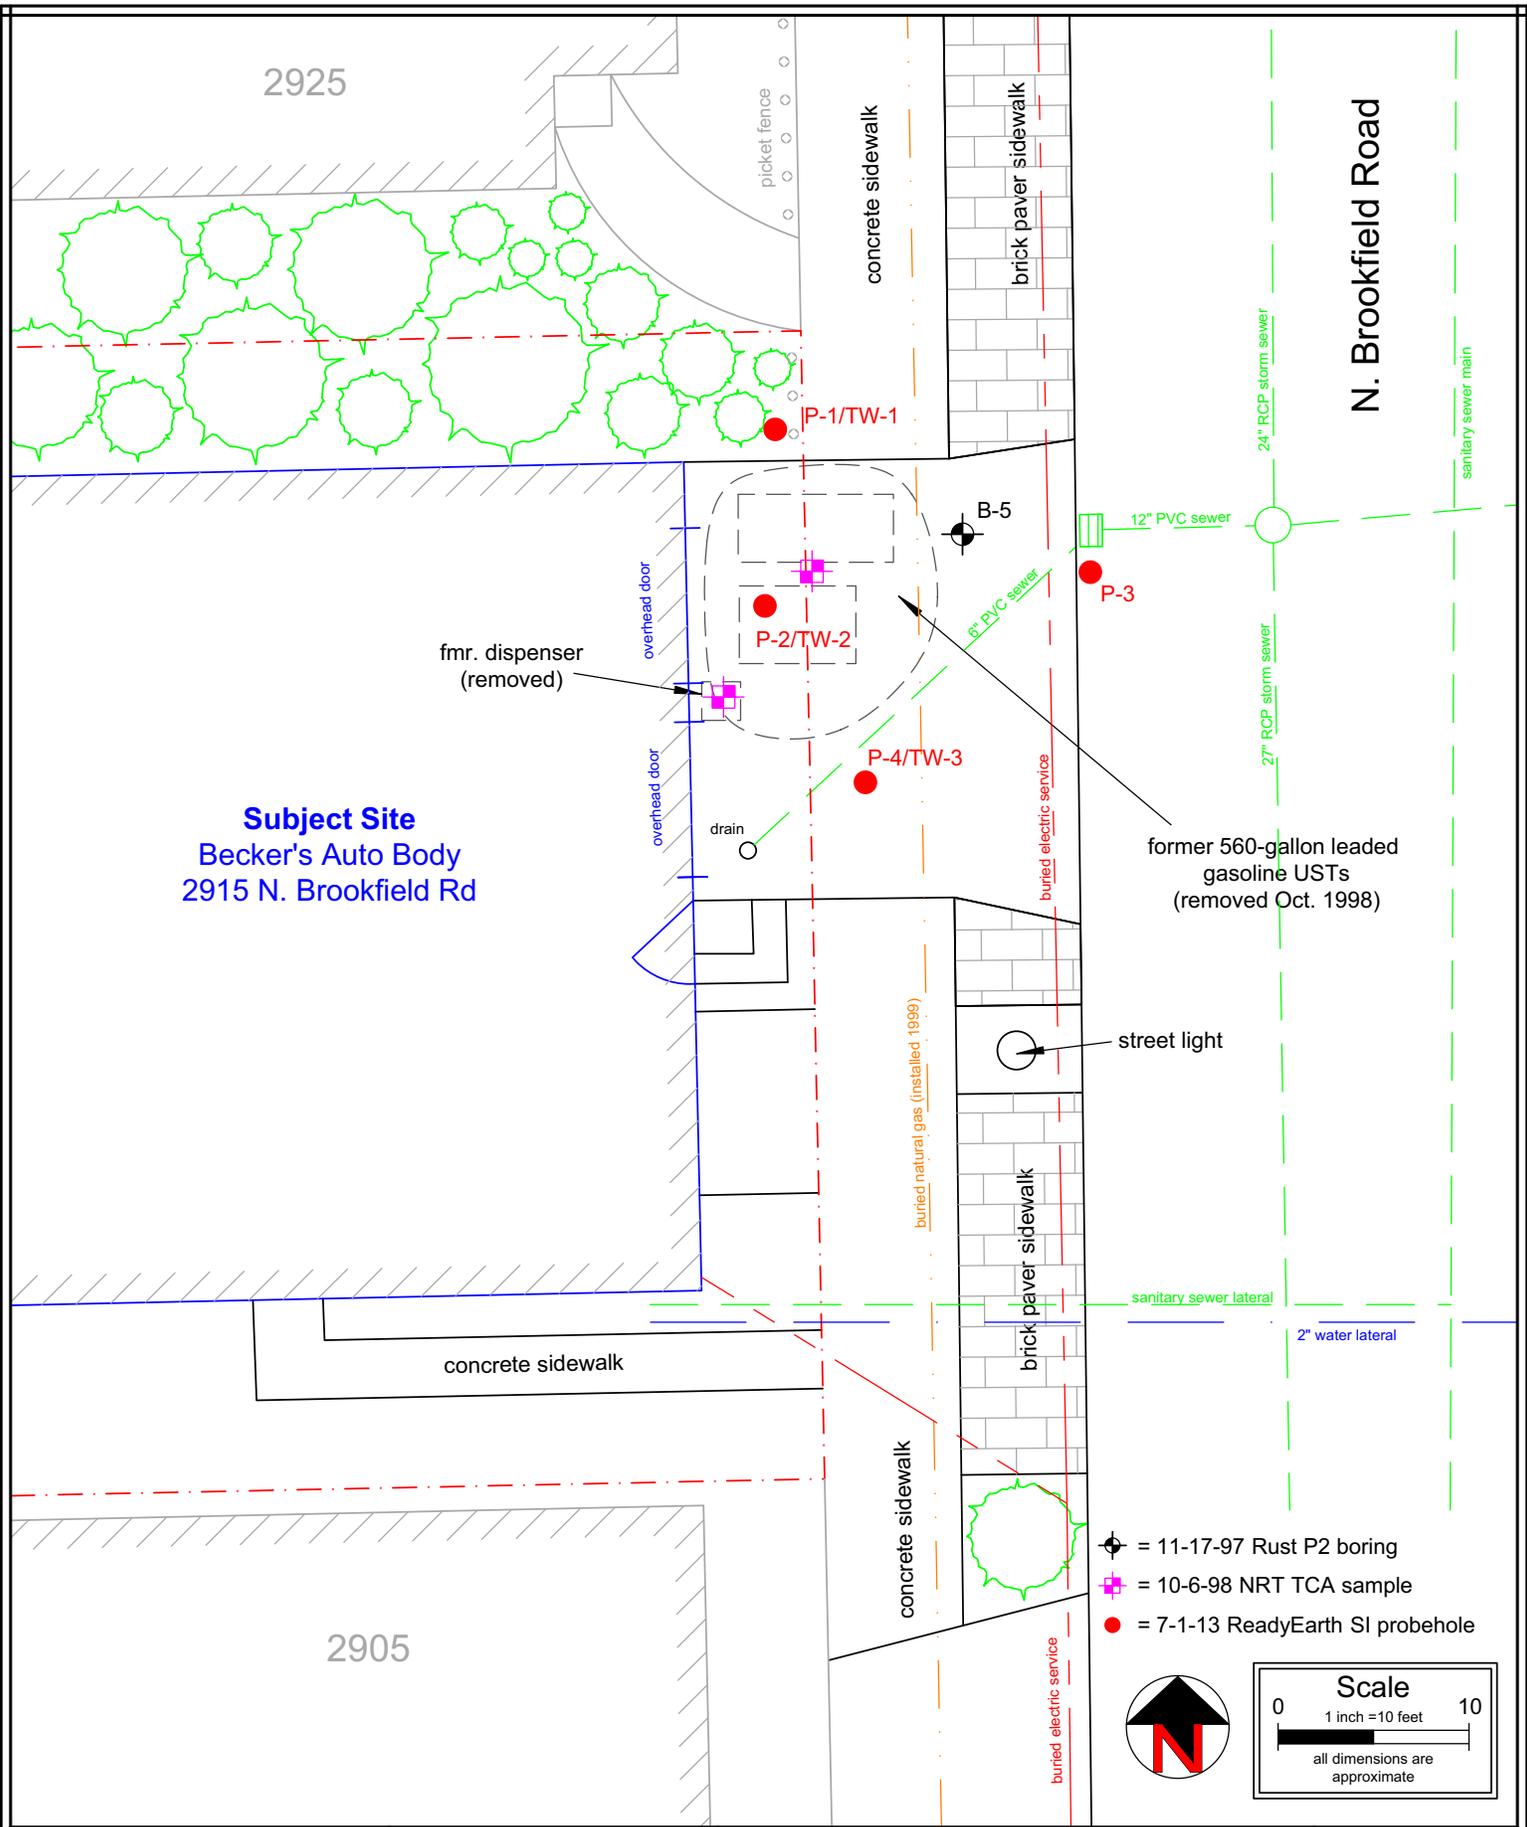
**B.1.b.1 - Detailed Site Map**  
Becker's Auto Body Property  
2915 N. Brookfield Road  
Brookfield, Wisconsin

**Subject Site**  
 Becker's Auto Body  
 2915 N. Brookfield Rd

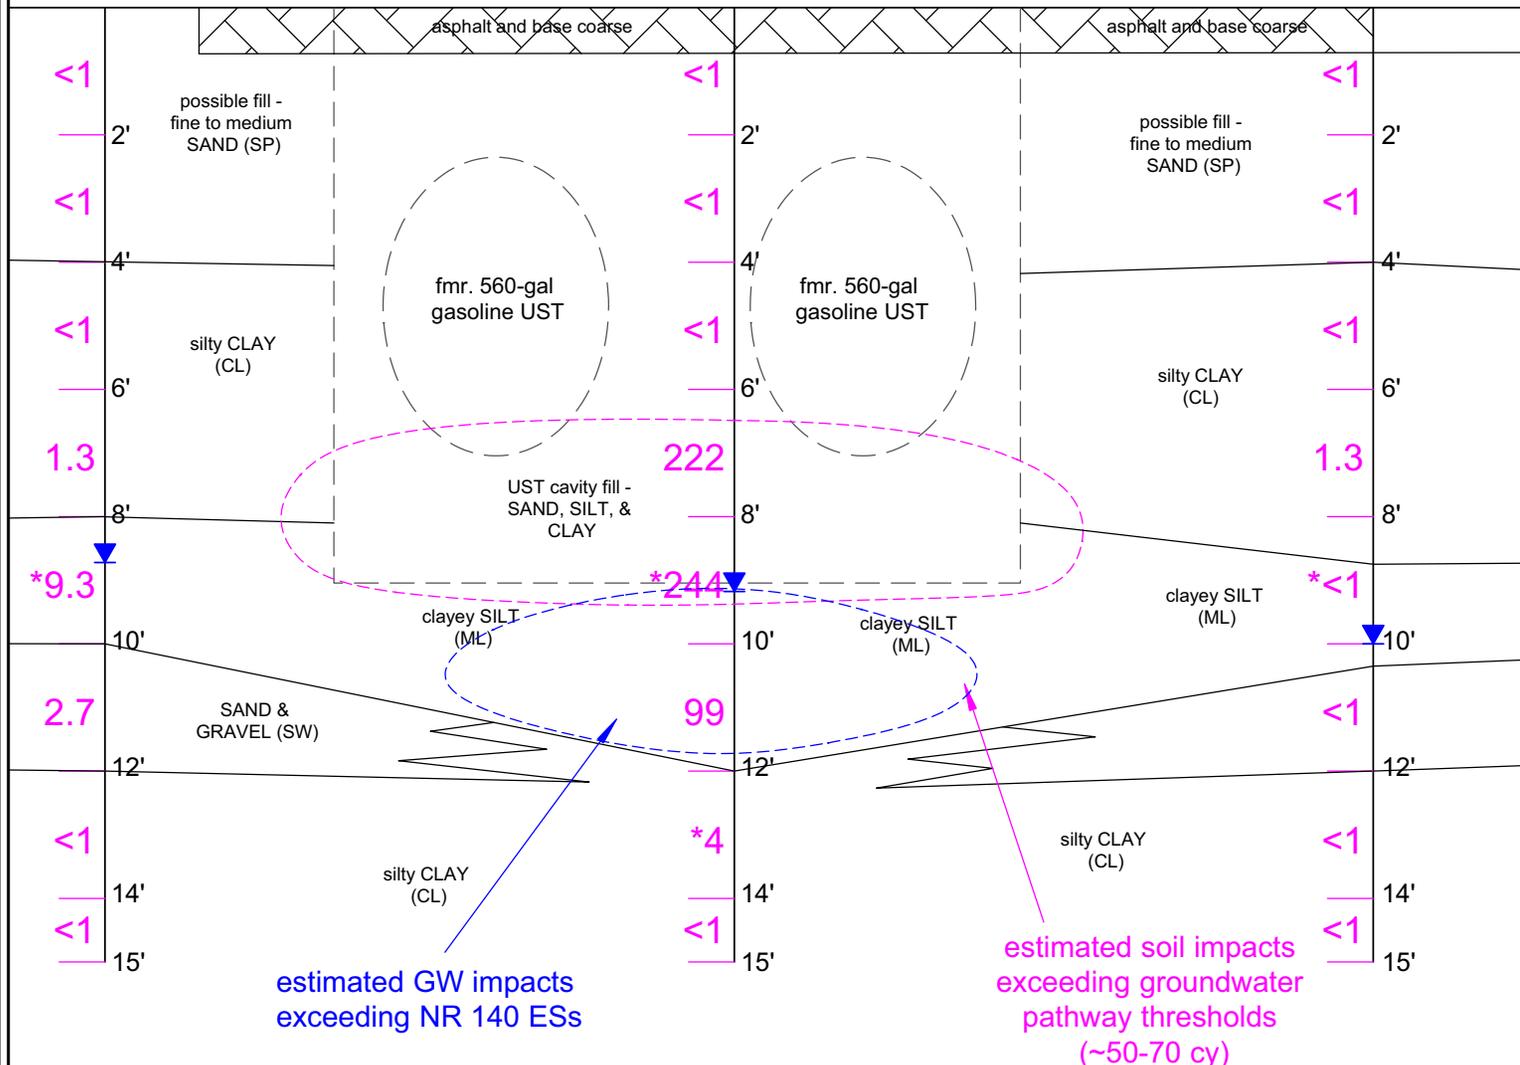
**B.3.a Geologic Cross-Section Figure**  
 Becker's Auto Body  
 2915 N. Brookfield Road  
 Brookfield, Wisconsin

horizontal scale: 1 in. = 3 ft.  
vertical scale: 1 in. = 3 ft

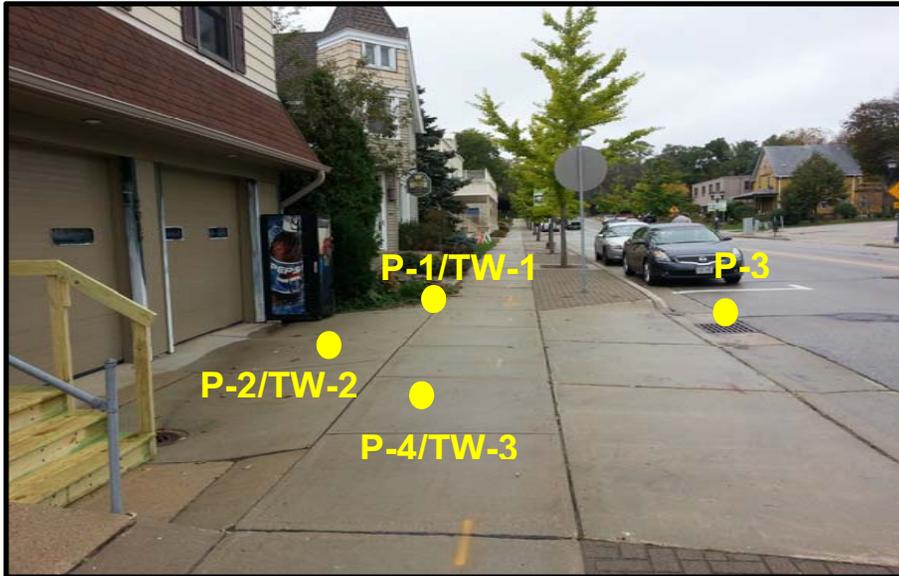
Photo 1 – Looking north at the site investigation area. P-2 is installed within the former UST cavity. The perimeter probes define the soil and groundwater impacts to the extent practicable.

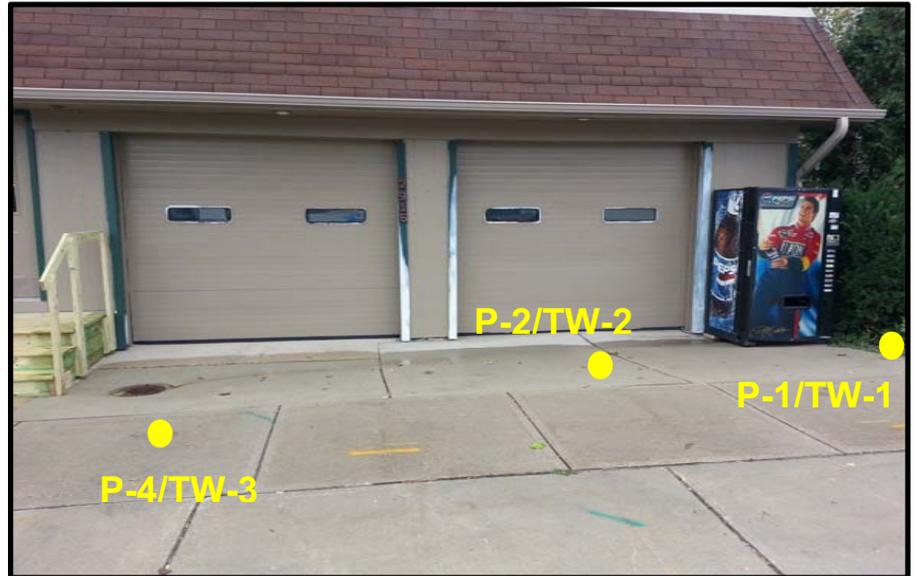
Photo 2 – Looking west at the area of the former UST cavity and site investigation area. The area is very confined. Additional work such as drilling monitoring wells is not warranted based on the temporary well data and may not be feasible due to spatial constraints.

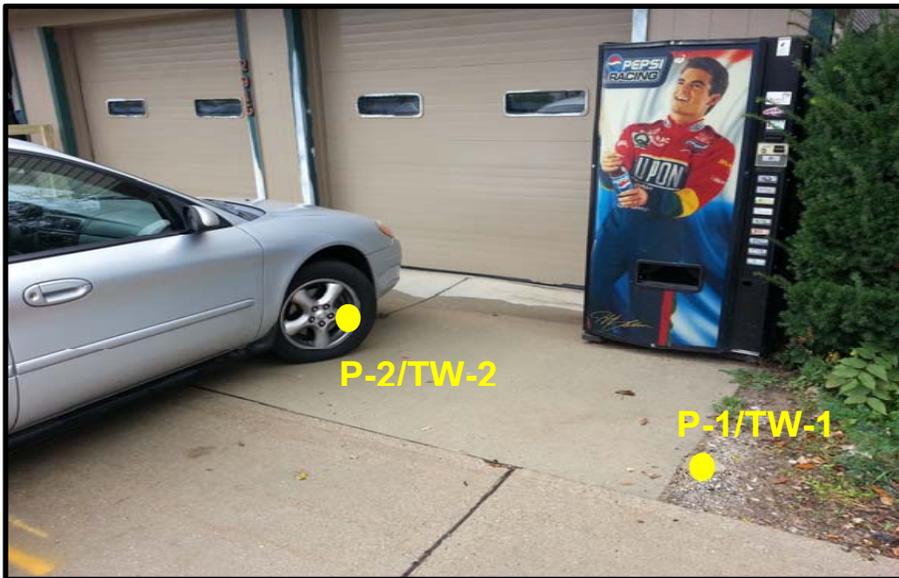
Photo 3 – Looking southwest at the former UST cavity area. The groundwater concentrations are defined with the existing temporary wells. Additional drilled wells will be either too close or too far to provide relevant information.

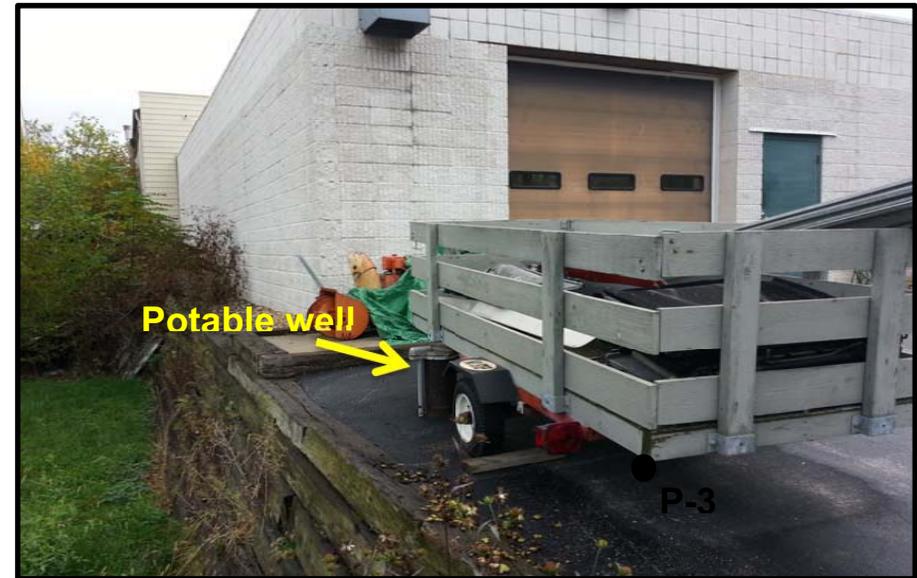
Photo 4 – Looking east at the potable well in the rear of the property. The well is over 100 feet vertically and laterally from the soil and groundwater impacts. The property is connected to the municipal water supply and the well is no longer in use.
