GIS REGISTRY INFORMATION

SITE NAME: Farmers Flying Service - Bancroft
BRRTS #: 02-50-547299 **FID # (if appropriate):** 750064040
DATCP # (if appropriate): 88405071101
CLOSURE DATE: 29-Oct-07
STREET ADDRESS: 5485 Jessie Judd Rd
CITY: Town of Pine Grove

Subject: **No Further Action Notice**
Former Farmer's Flying Service Property – Bancroft
DATCP case # 88405071101 DNR BRRTS# 02-50-547299

***RE: Poplar Plantation and Engineered Barrier Maintenance Plan
Former Farmer's Flying Service - Bancroft, Wisconsin
DATCP Case No. 88405071101***

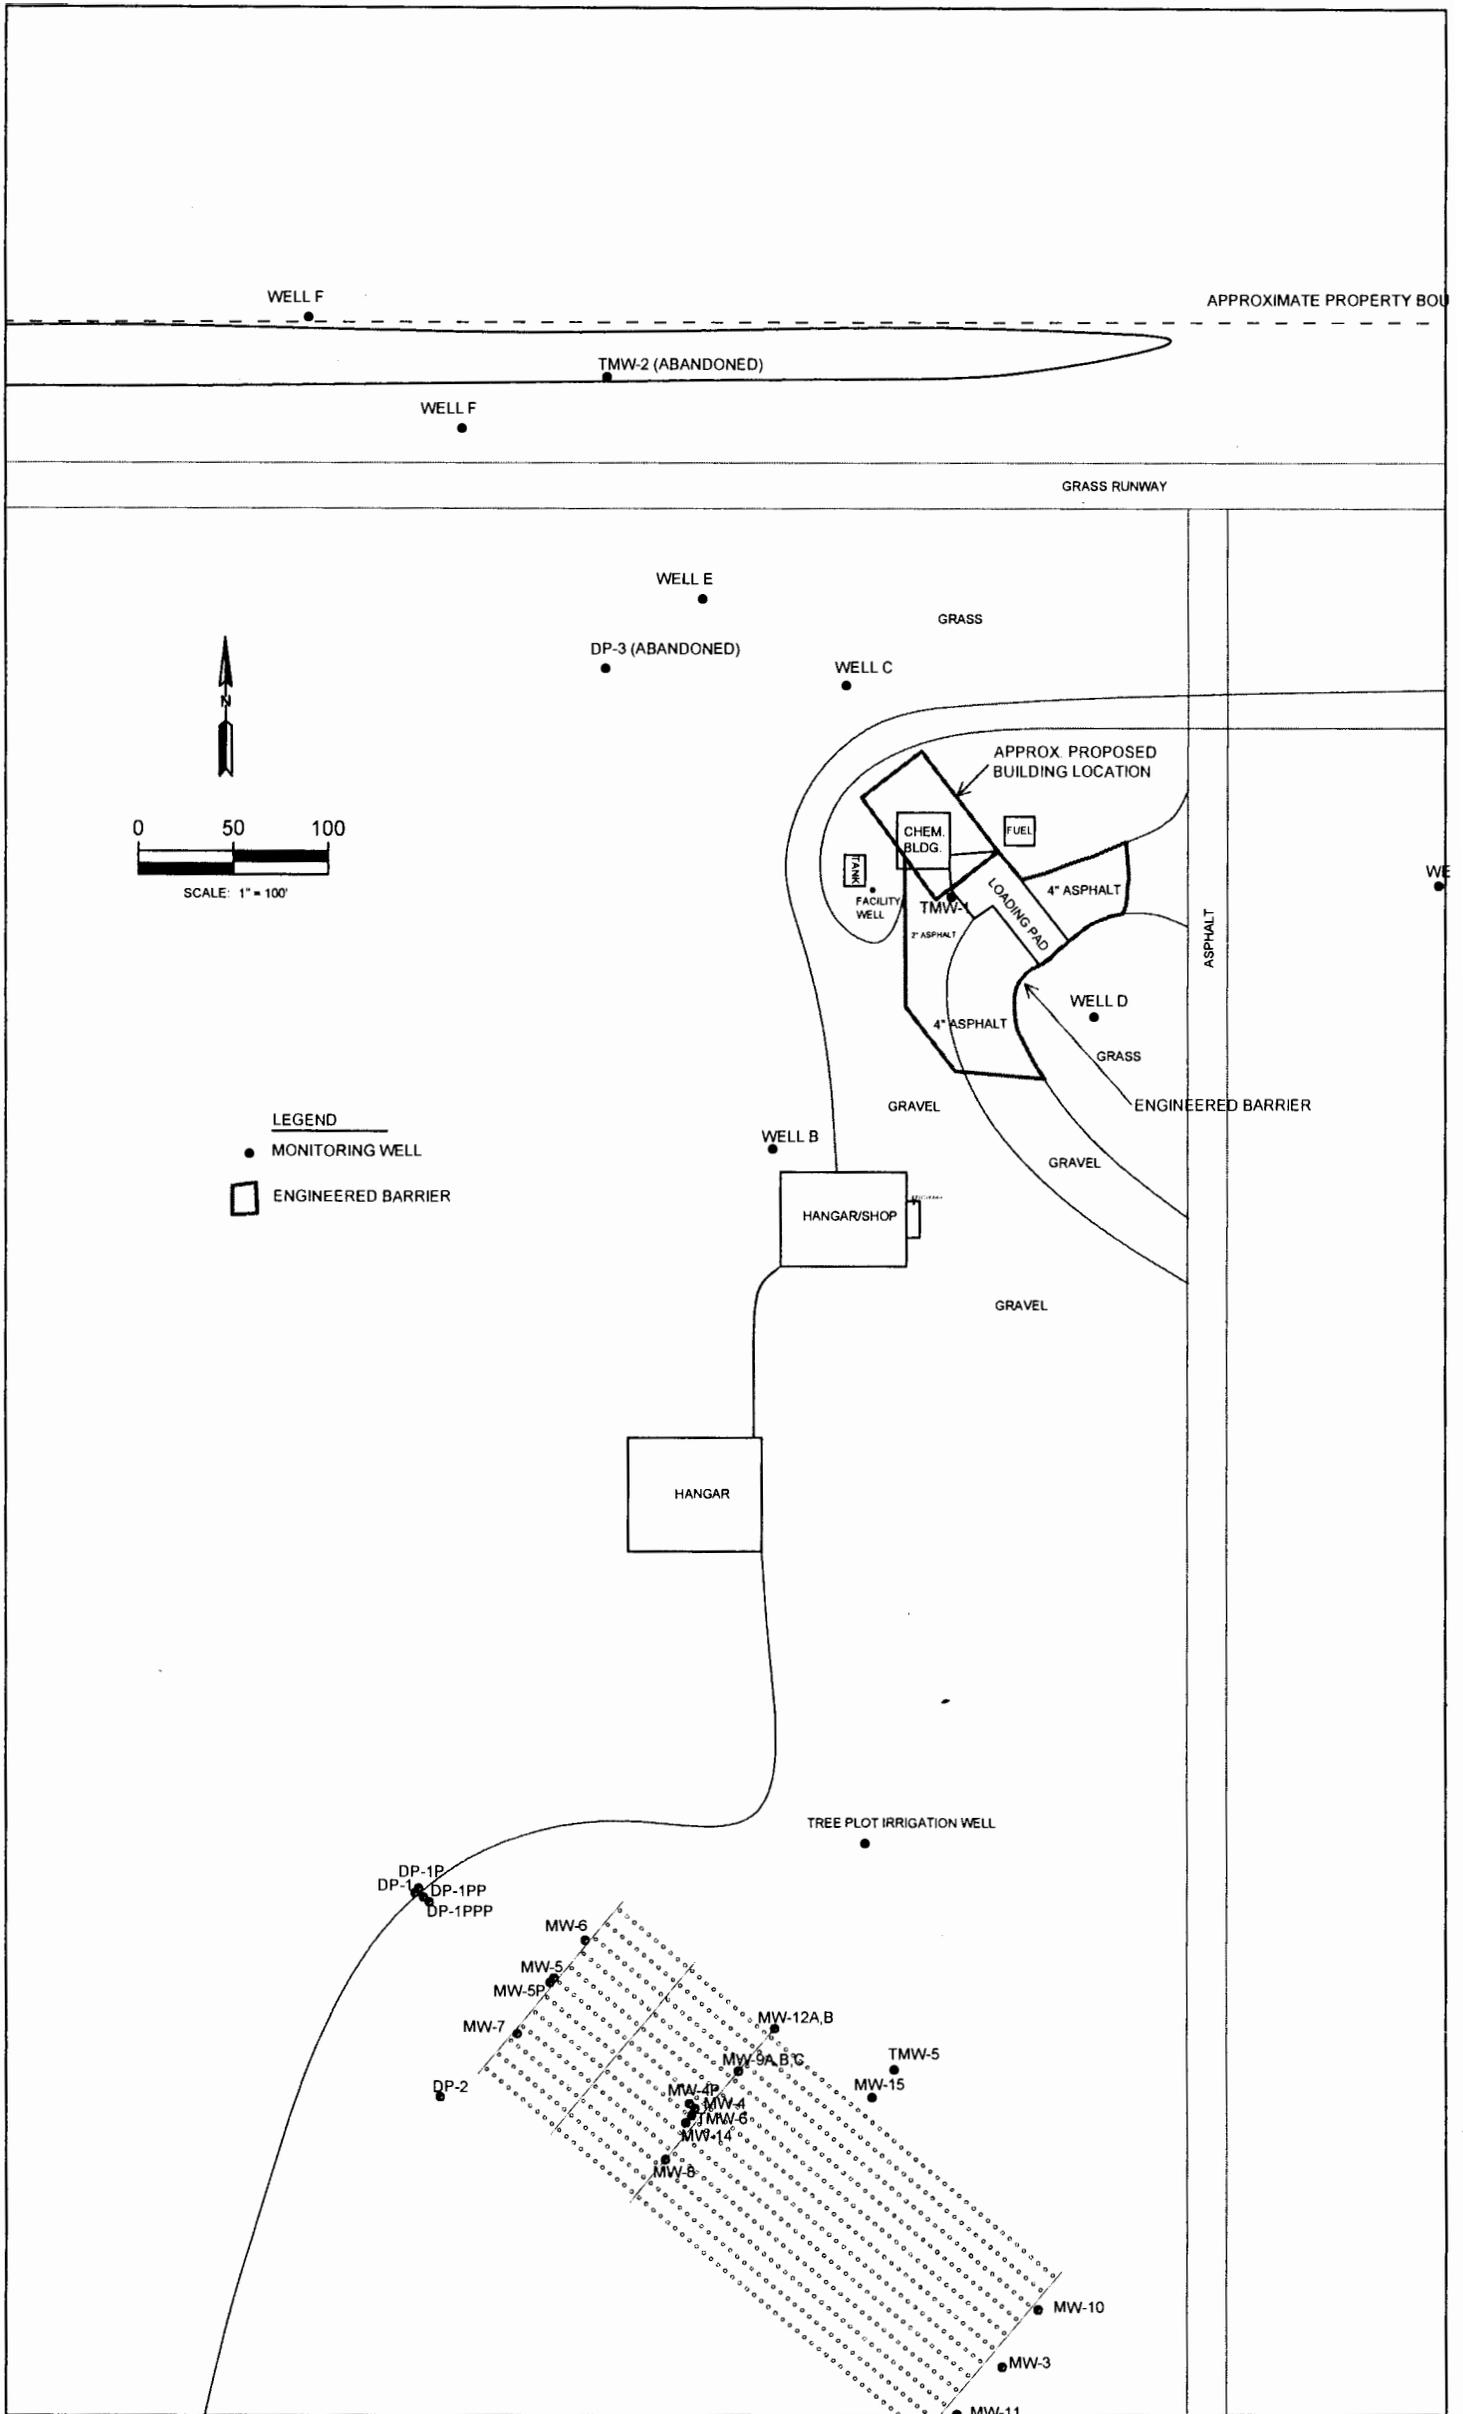
FIGURE 1
 DATE: AUG. 30, 2006
 DRAWN BY: MD

SITE PLAN
FORMER FARMERS FLYING SERVICE
BANCROFT, WI

Residual pesticide-impacted soil at concentrations greater than 1 mg/kg total pesticides is present below asphalt and concrete (pavement) at the Former Farmer's Flying Service facility located at 5485 Jessie Judd Road, in Bancroft, Wisconsin. As required under NR 720.19(2), the use of pavement as an engineering control to protect groundwater requires the on-going maintenance of the barrier until the barrier is removed and impacted soils are excavated or are determined to not be a threat to groundwater. The locations of the barrier and the residual pesticide-impacted soil are included on the attached Figure 1.

Pesticide-impacted soil is present in the following areas (see Figure 1):

1. South Sprayer Test Area.
2. Mix/Load pad.

South Sprayer Test Area: The south sprayer test area, covered by what is now a seven year old hybrid poplar plantation (approximately 37,440 sf), has a surface area with pesticide concentrations greater than 0.1 mg/kg of 13,500 square feet (sf) and greater than 1.0 mg/kg of 6,900 square feet (*Alpha Terra Science, Inc. 1998*). The volume of soil with total pesticide concentrations greater than 0.1 mg/kg is estimated to be 2,900 cubic yards (cy) and greater than 1.0 mg/kg is 1,400 cy. Chlorothalonil was detected over most of the area with the highest concentration of 89 mg/kg. Dinoseb was detected over the entire area. The estimated surface area impacted with dinoseb at concentration greater than 0.1 mg/kg is 13,000 sf. The total estimated volume of soil impacted with dinoseb at concentrations greater than 0.1 mg/kg is 2,500 cy. The highest dinoseb concentration detected was 9.0 mg/kg.

Mix/Load Pad: This area is covered by asphalt pavement and the chemical storage building (engineered barrier) with an area of approximately 11,000 square feet. According to site investigation results reported by Alpha Terra Science in 1998, the volume of soil with total pesticide concentrations greater than 0.1 mg/kg is estimated to be 3,700 cubic yards (cy) and greater than 1.0 mg/kg is 2,800 cy. Of the impacted soil an estimated 3,600 cy of soil is impacted with dinoseb at concentrations greater than 0.1 mg/kg.

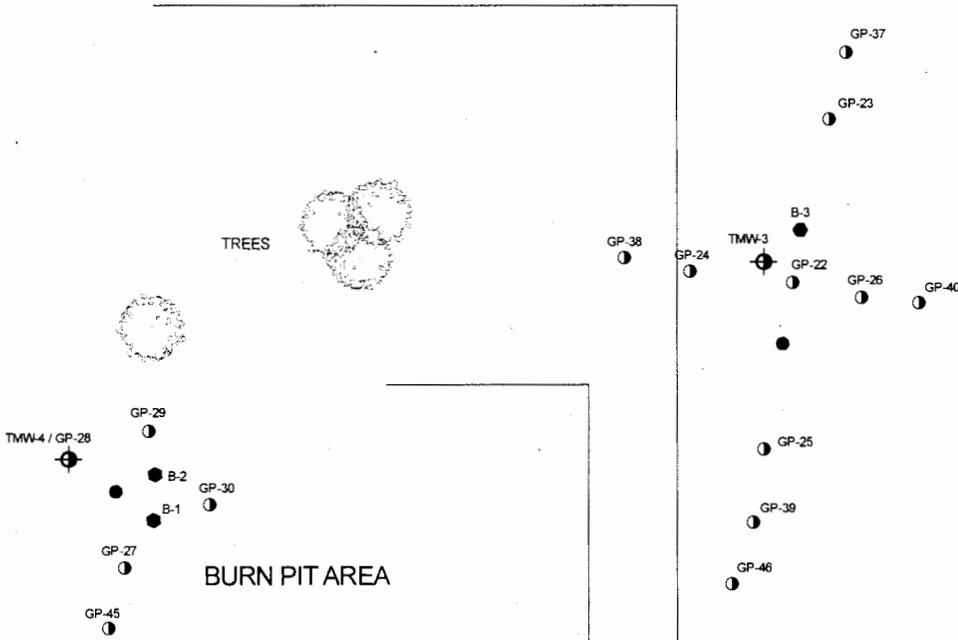
FARMER'S FLYING SERVICE, INC.				
SOIL SAMPLING LOCATIONS CONT'D				
REV	DATE	DESCRIPTION	APPVD	DATE 12/28/98 FILE #s98011_0g3b
				APPROVED <i>MD</i> FIGURE 3

NORTH SPRAYER TEST AREA

SOUTH SPRAYER TEST AREA

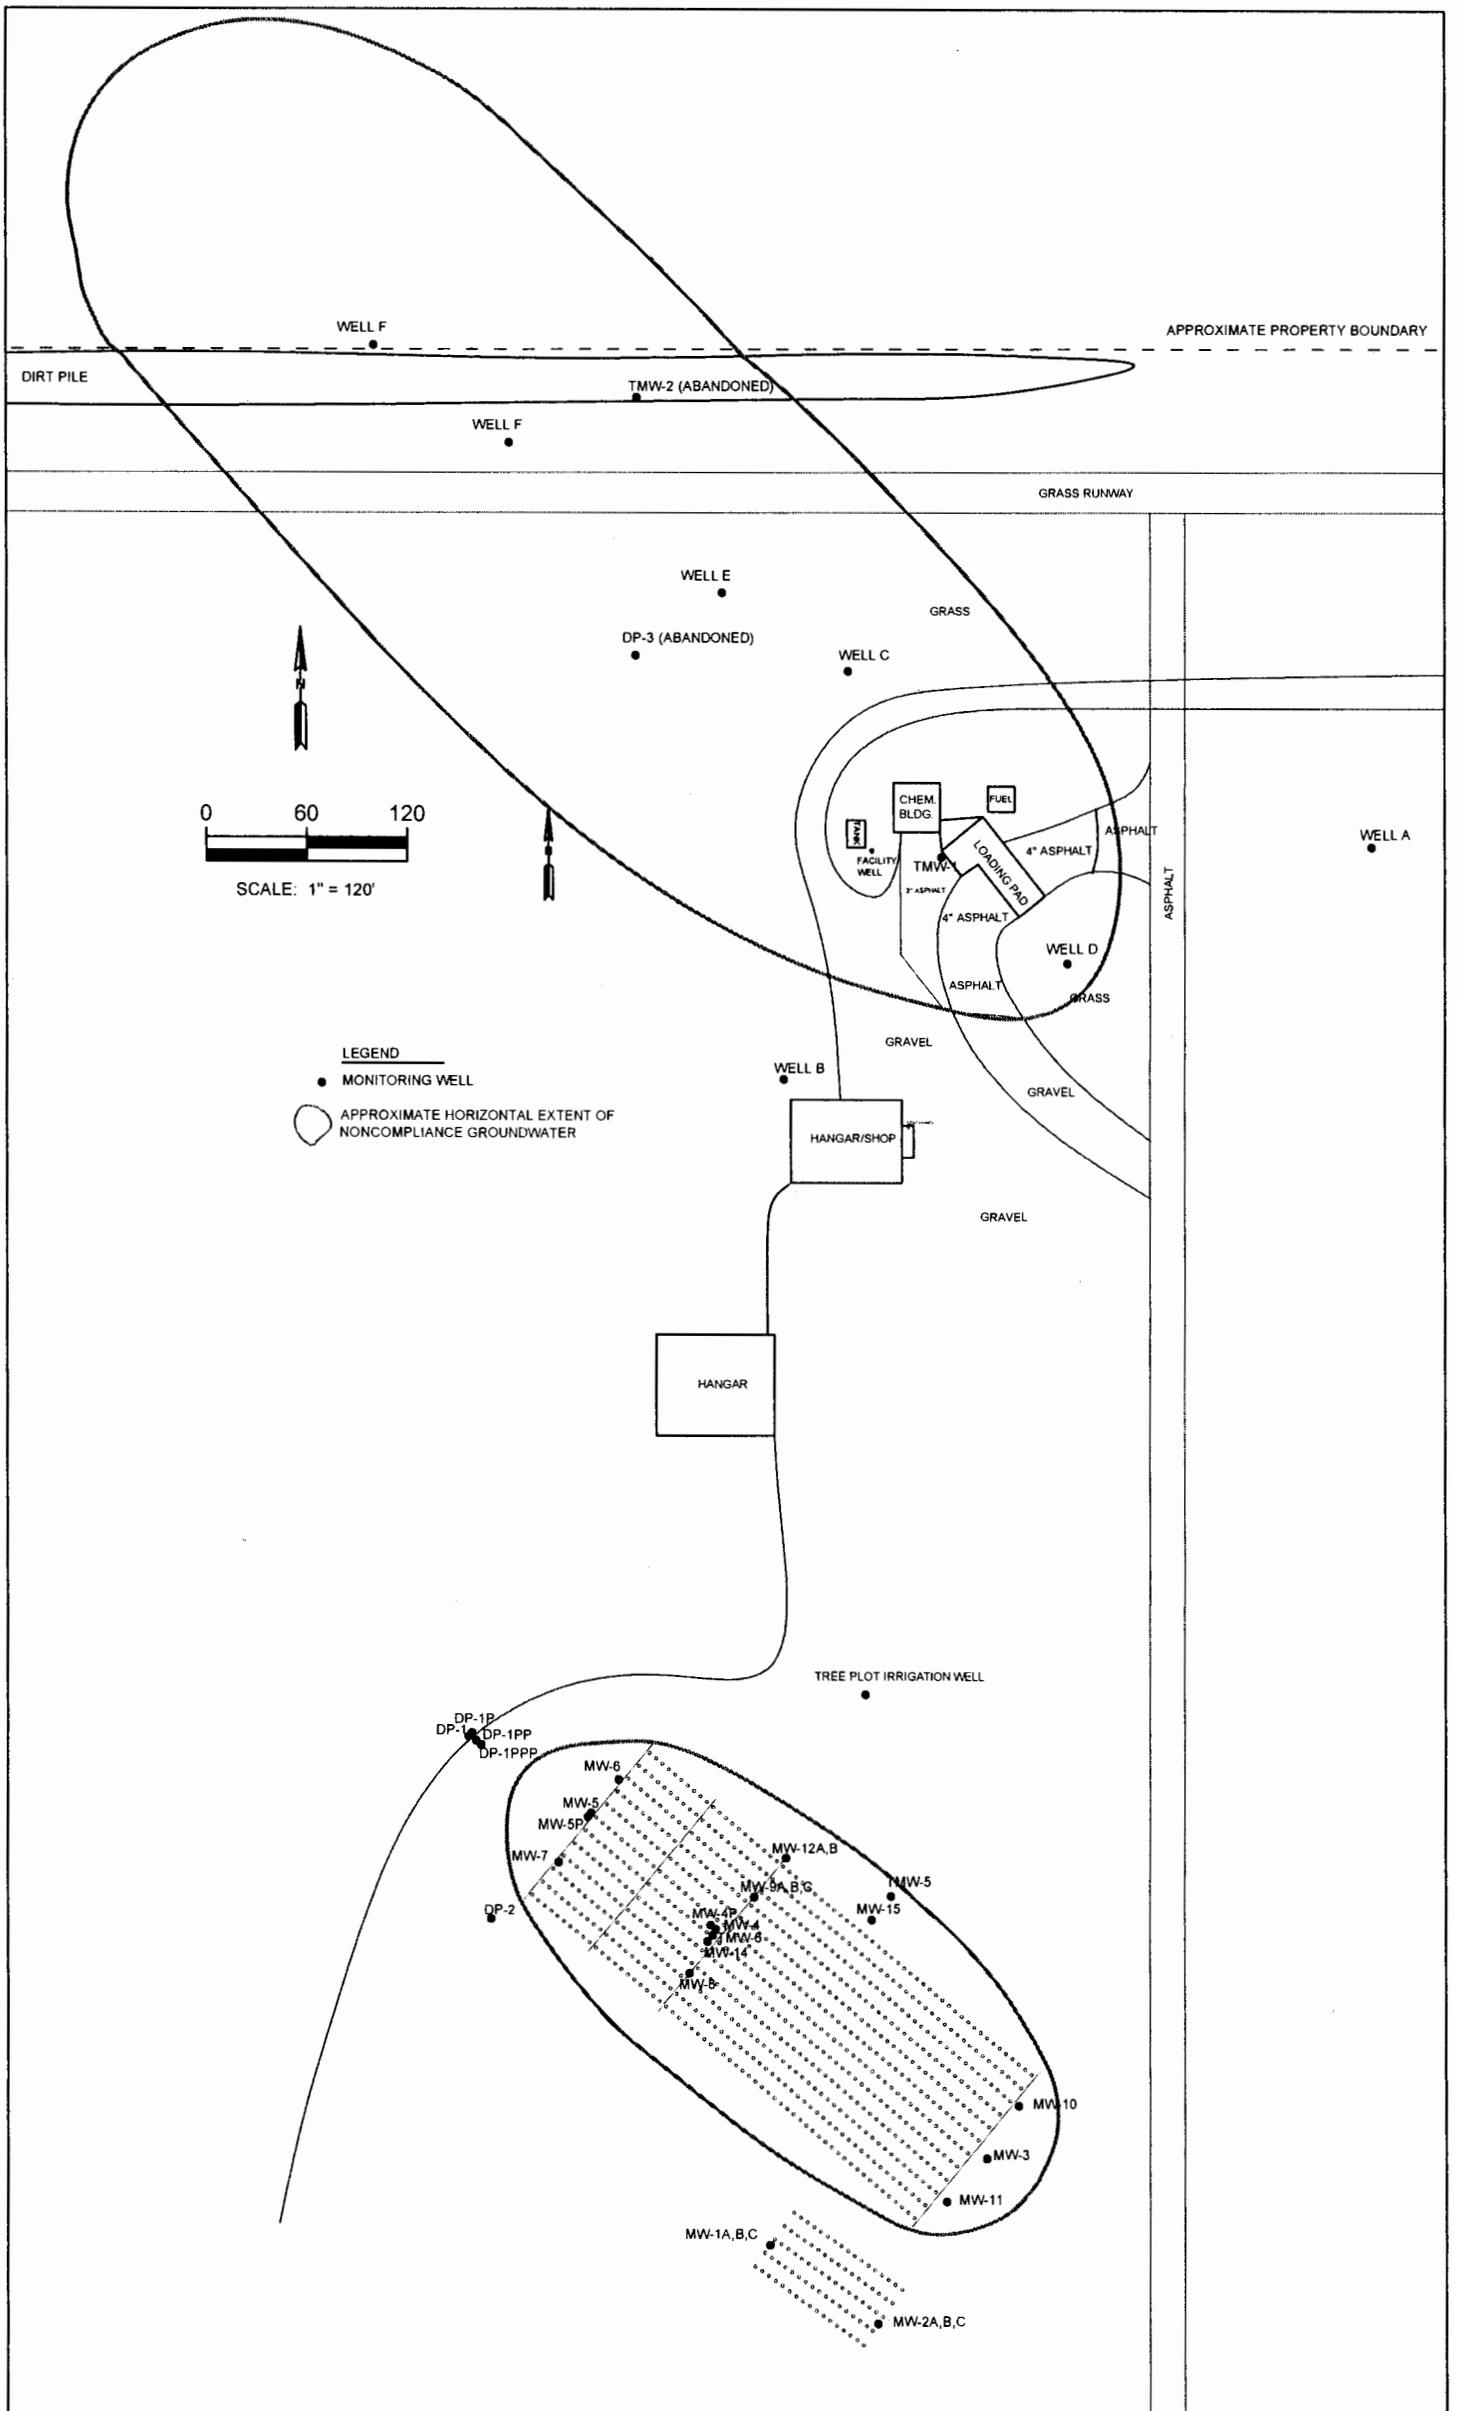
FIGURE 6
 DATE: JULY 24, 2007
 DRAWN BY: RSH

**APPROXIMATE HORIZONTAL EXTENT OF
 NONCOMPLIANCE GROUNDWATER
 FORMER FARMERS FLYING SERVICE
 BANCROFT, WI**

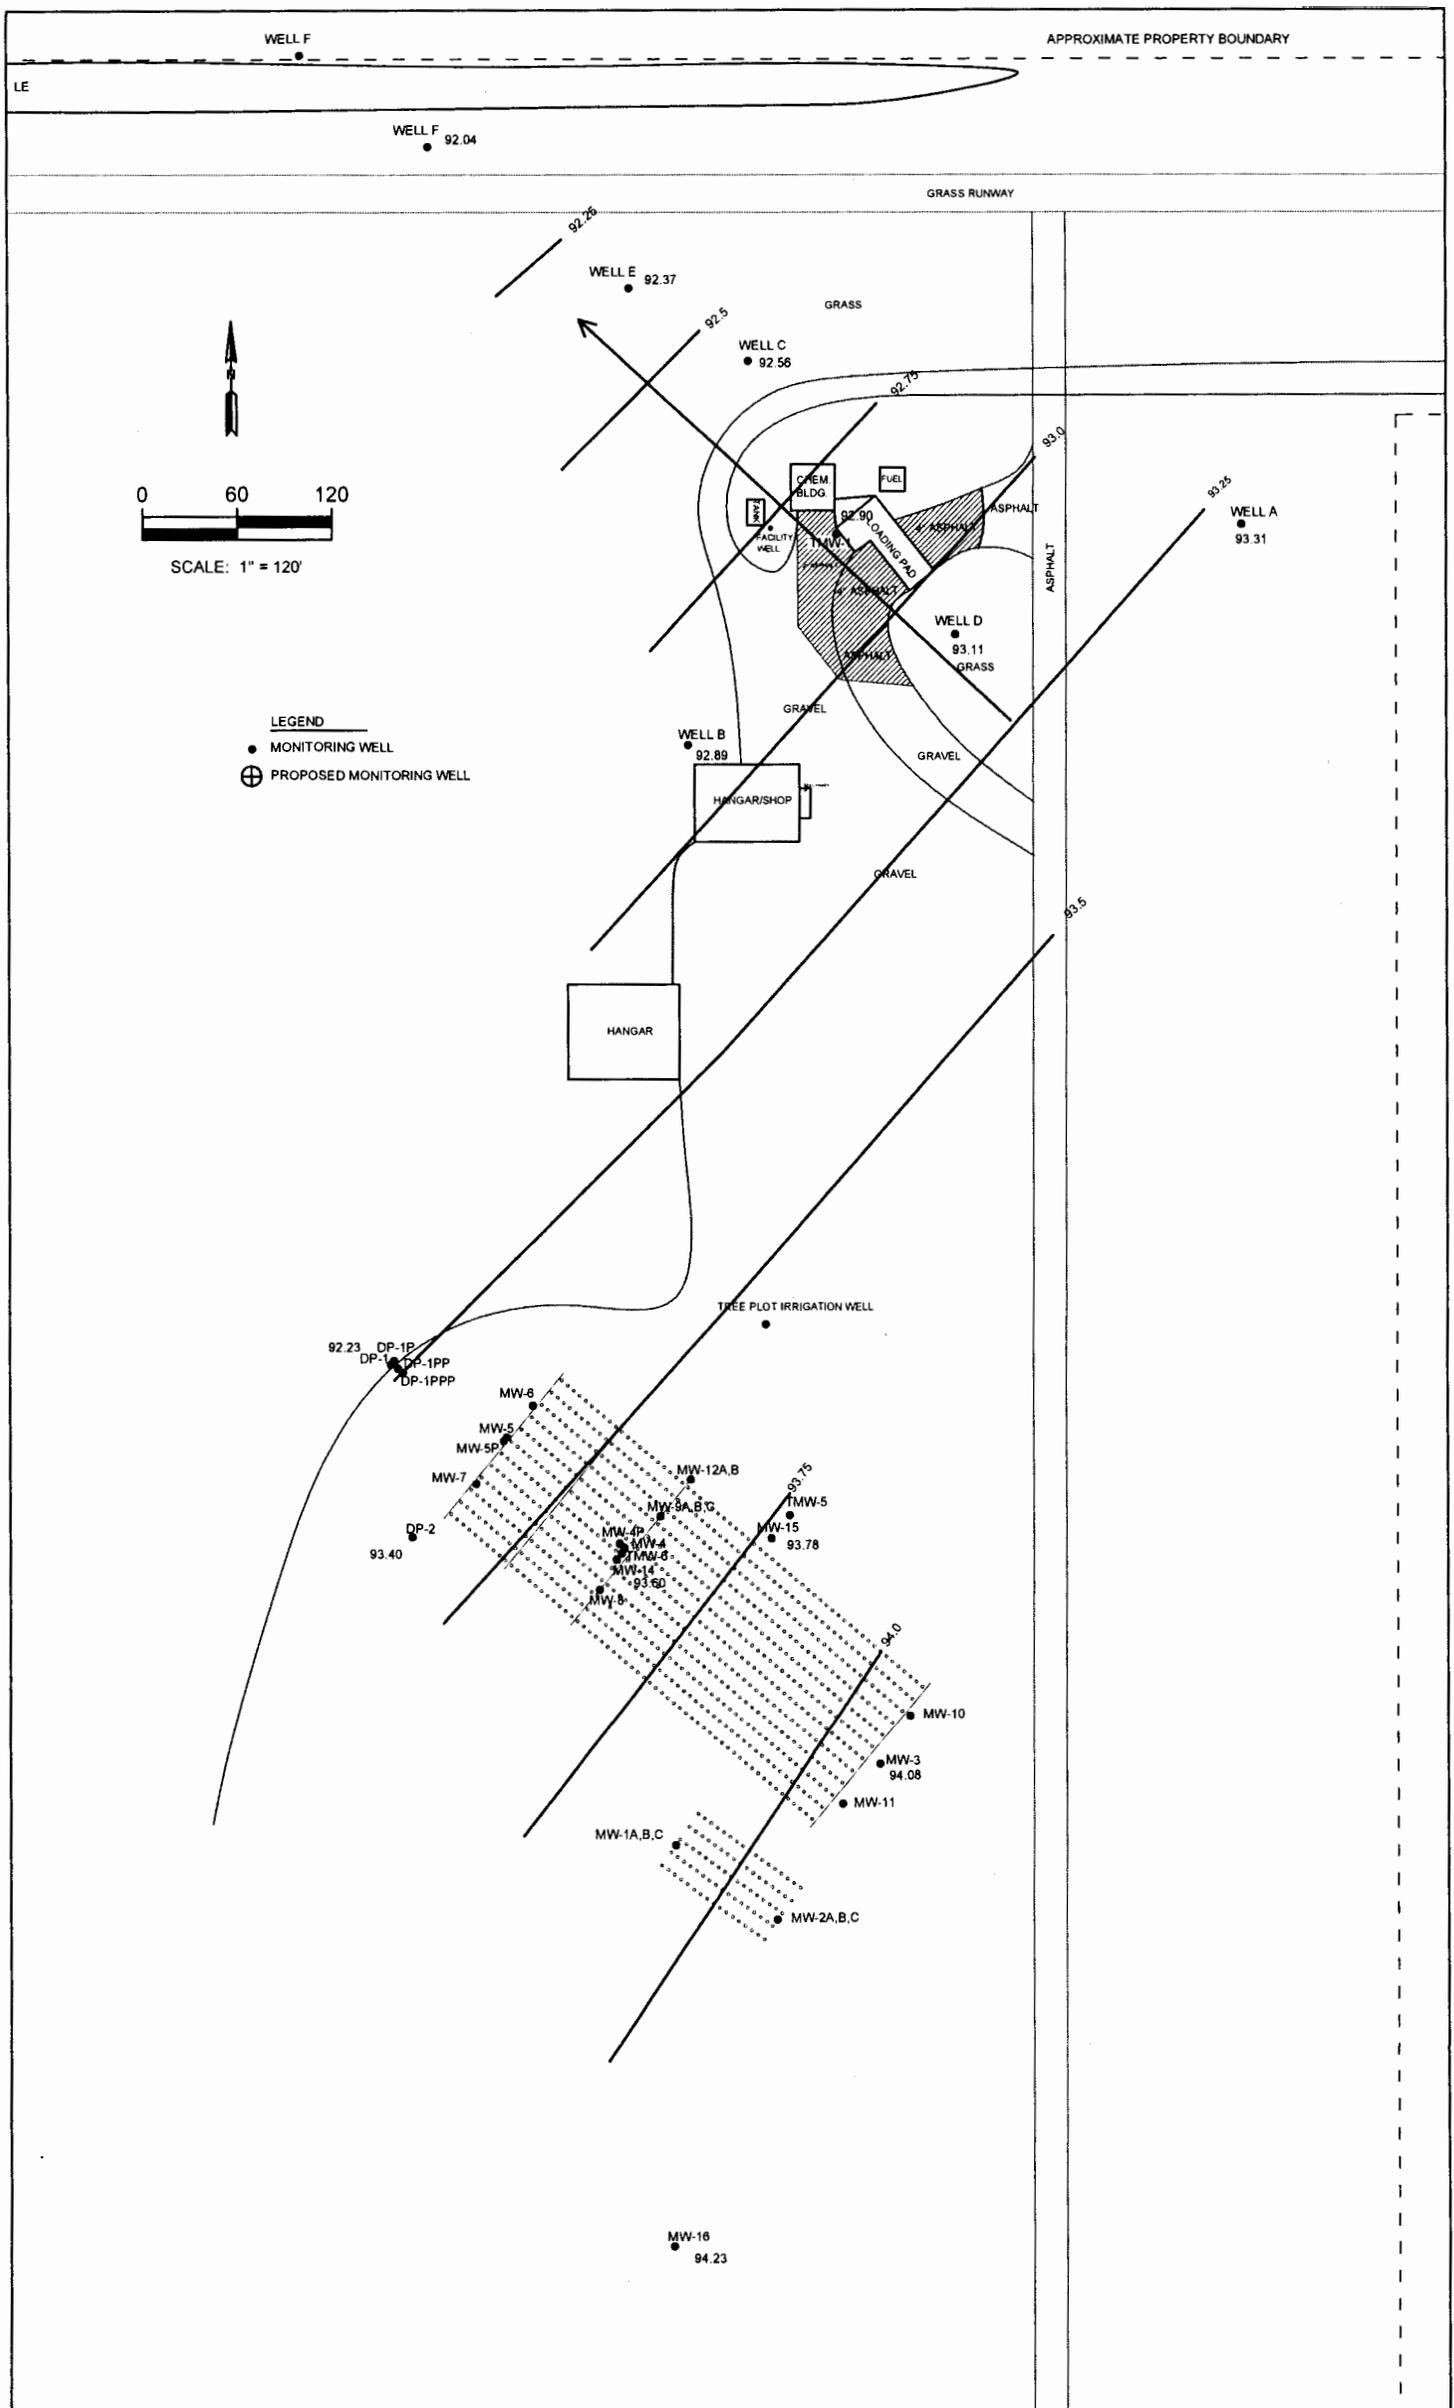
FIGURE 7

**GROUNDWATER FLOW DIRECTION MAP
 FOR APRIL 13, 2005**
**FORMER FARMERS FLYING SERVICE.
 BANCROFT, WI**

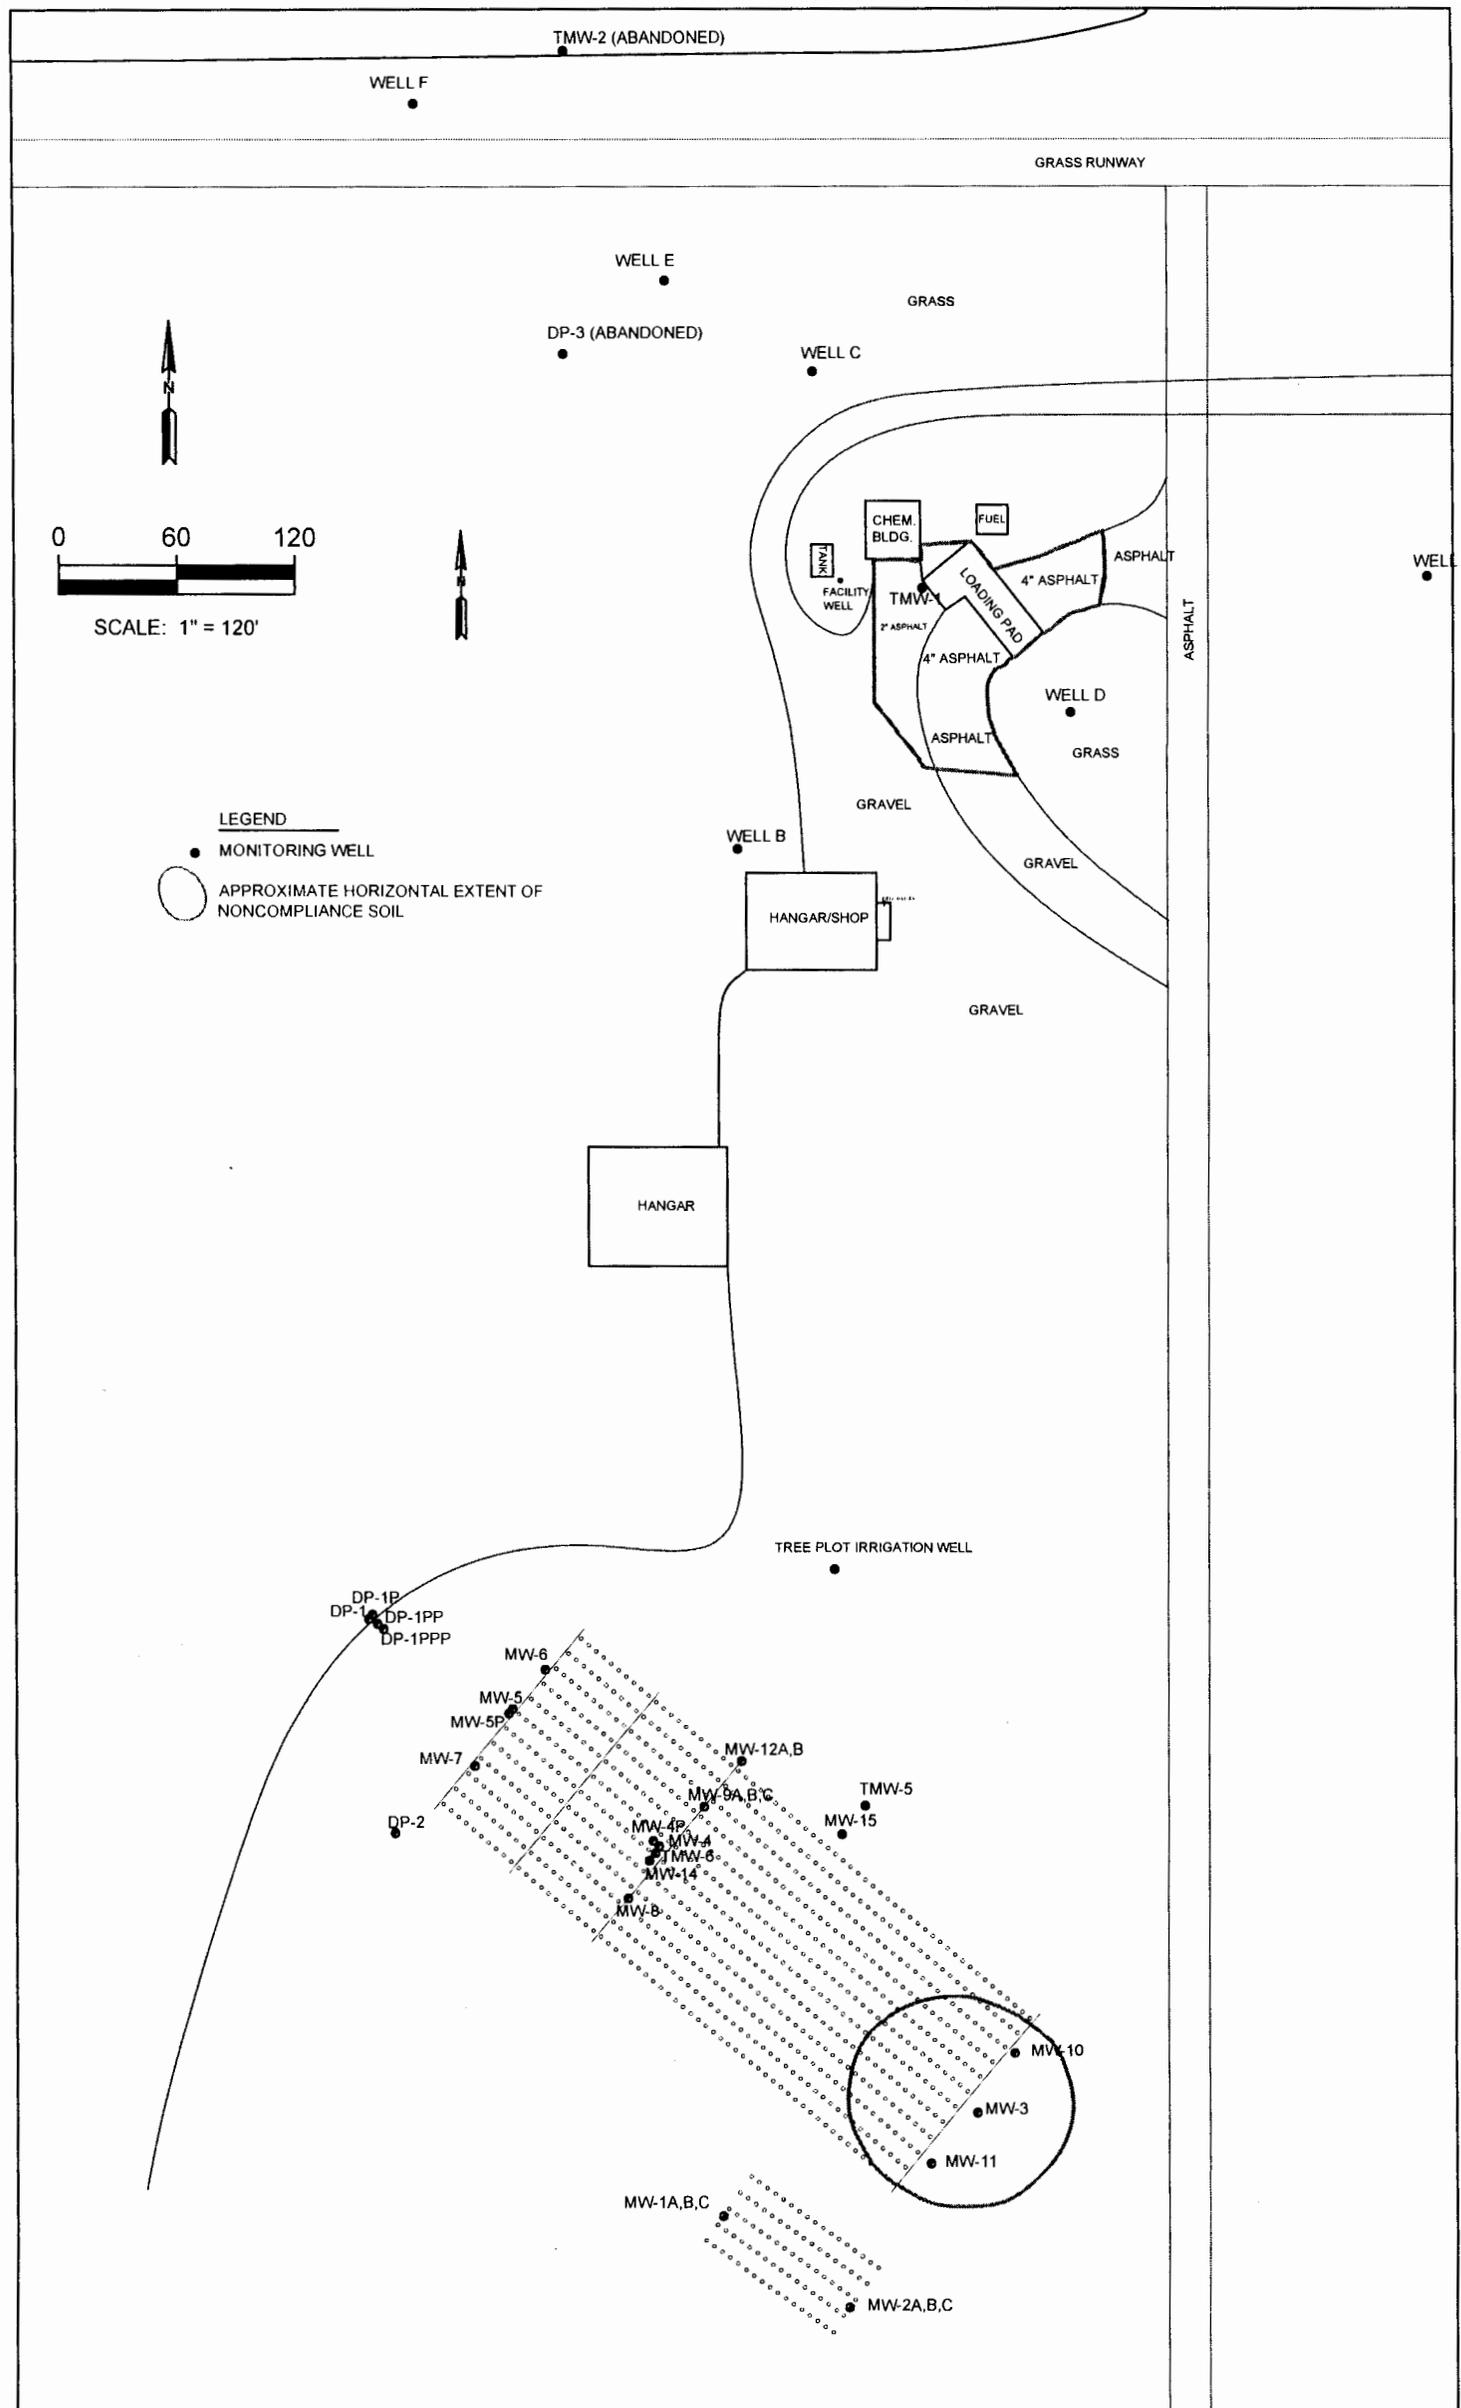
FIGURE 8
 DATE: JULY 24, 2007
 DRAWN BY: RSH

- MONITORING WELL
- APPROXIMATE HORIZONTAL EXTENT OF NONCOMPLIANCE SOIL

APPROXIMATE HORIZONTAL EXTENT OF NONCOMPLIANCE SOIL
FORMER FARMERS FLYING SERVICE
BANCROFT, WI
