ACTIVITY NAME: Leis Oil Viroqua Bulk Plt E

PROPERTY ADDRESS: 523 N Center Street

SUBJECT: Post-closure Cap Modification and Revision of Database Listing

## **OPERATION AND MAINTENANCE PLAN**

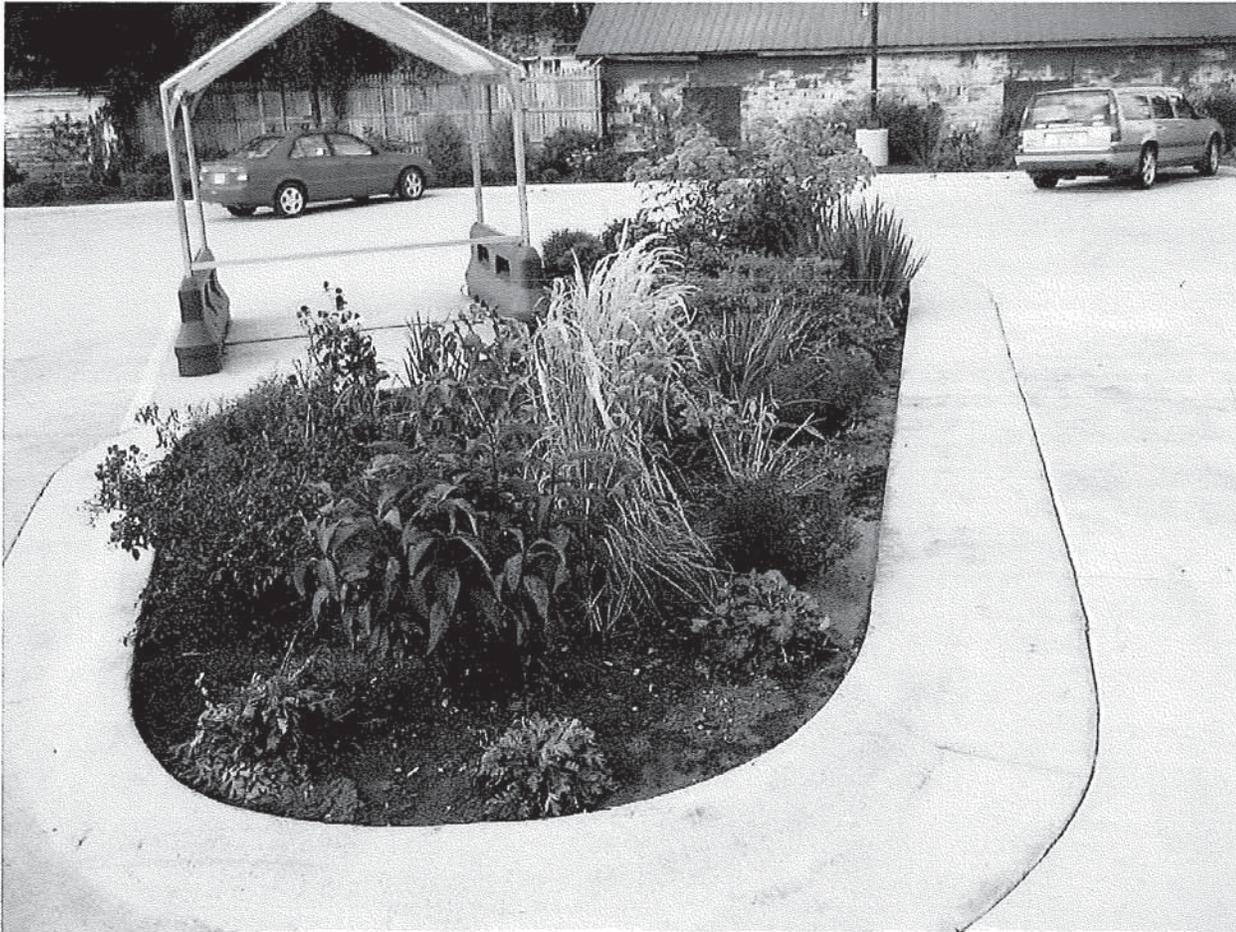
Parking Lot Biofilter shortly after construction (08/13/2012)

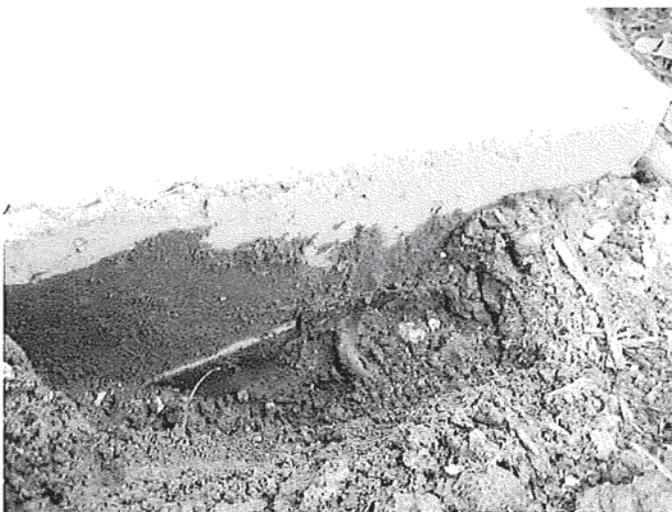
EPDM liner visible next to curb

Digging within the biofilter should be avoided due to the use of an impermeable EPDM liner below the filter soil media. Shallow digging for maintenance and plant replacement should be done carefully,

especially near the edges of the device. Where excavation exposes the liner, a close inspection of the liner should be done to insure that there was no damage done to the liner. Damage and repairs should be described in the inspection log. Provide a detailed description of the location of any repair.

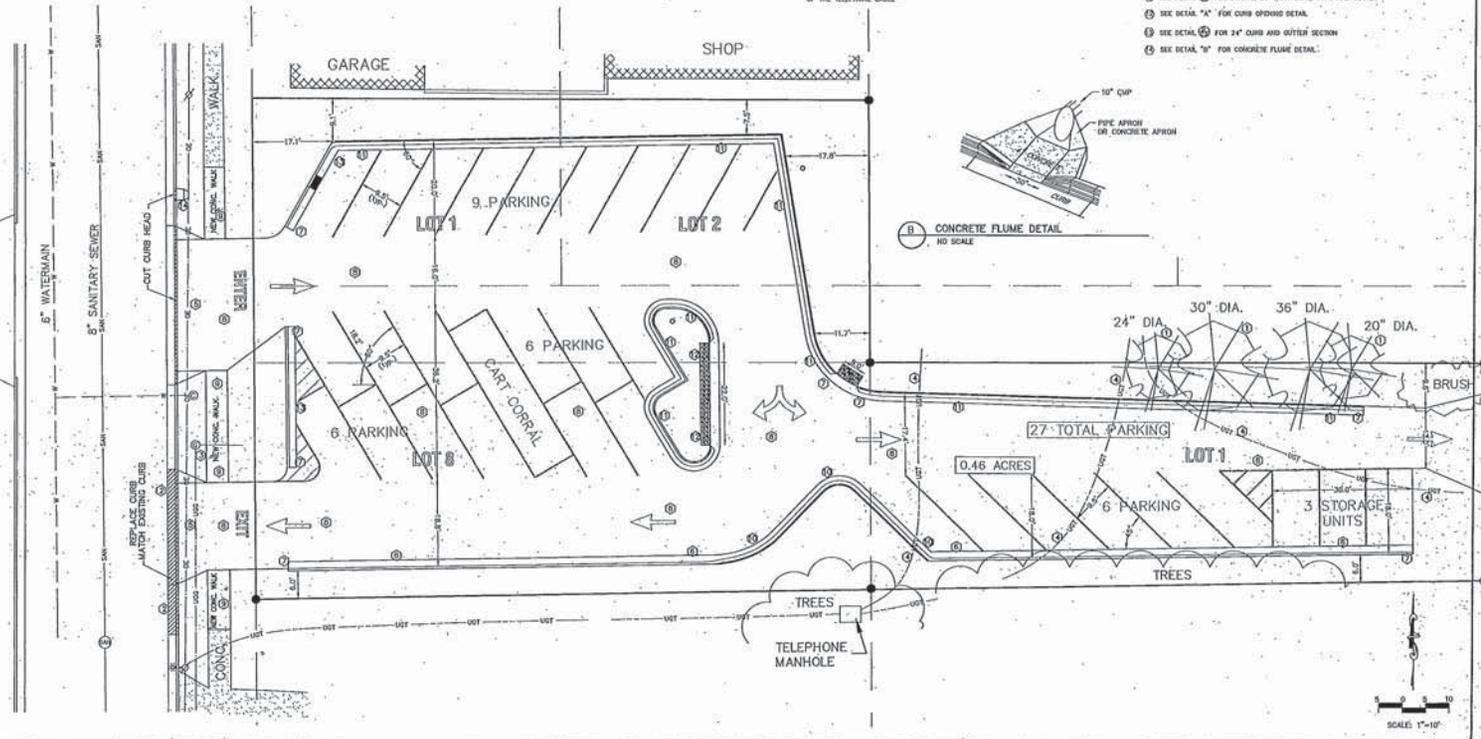
SCALE	1"=10'
PROJECT NO.	
DATE	October 12, 2016
SCALE	1"=10'
CAD FILE	
15-MINUTE PLOT AREA	
SHEET	
<b>C1</b>

**PARAGON ASSOCIATES**  
 1000 W. WISCONSIN ST. SUITE 200  
 VIROQUA, WISCONSIN 54601  
 TEL: 608.731.1210 FAX: 608.731.1377  
**VIROQUA FOOD CO-OP PARKING ADDITION**  
**VIROQUA FOOD CO-OP**  
**CITY OF VIROQUA, VERNON COUNTY, WISCONSIN**  
**SITE PLAN**
