GIS REGISTRY INFORMATION

SITE NAME: Vernon Co-op Cardtrol Station Site 1
BRRTS #: 03-63-107724 **FID # (if appropriate):** 663049640
COMMERCE # (if appropriate): 54665-1603-20
CLOSURE DATE: 08-Mar-2006
STREET ADDRESS: 120 East Decker Street
CITY: Viroqua

SUBJECT: Final Case Closure By Closure Committee With Conditions Met
Vernon Co-op Cardtrol Station Site 1, 120 East Decker Street Viroqua, WI
WDNR BRRTS Activity #: 03-63-107724

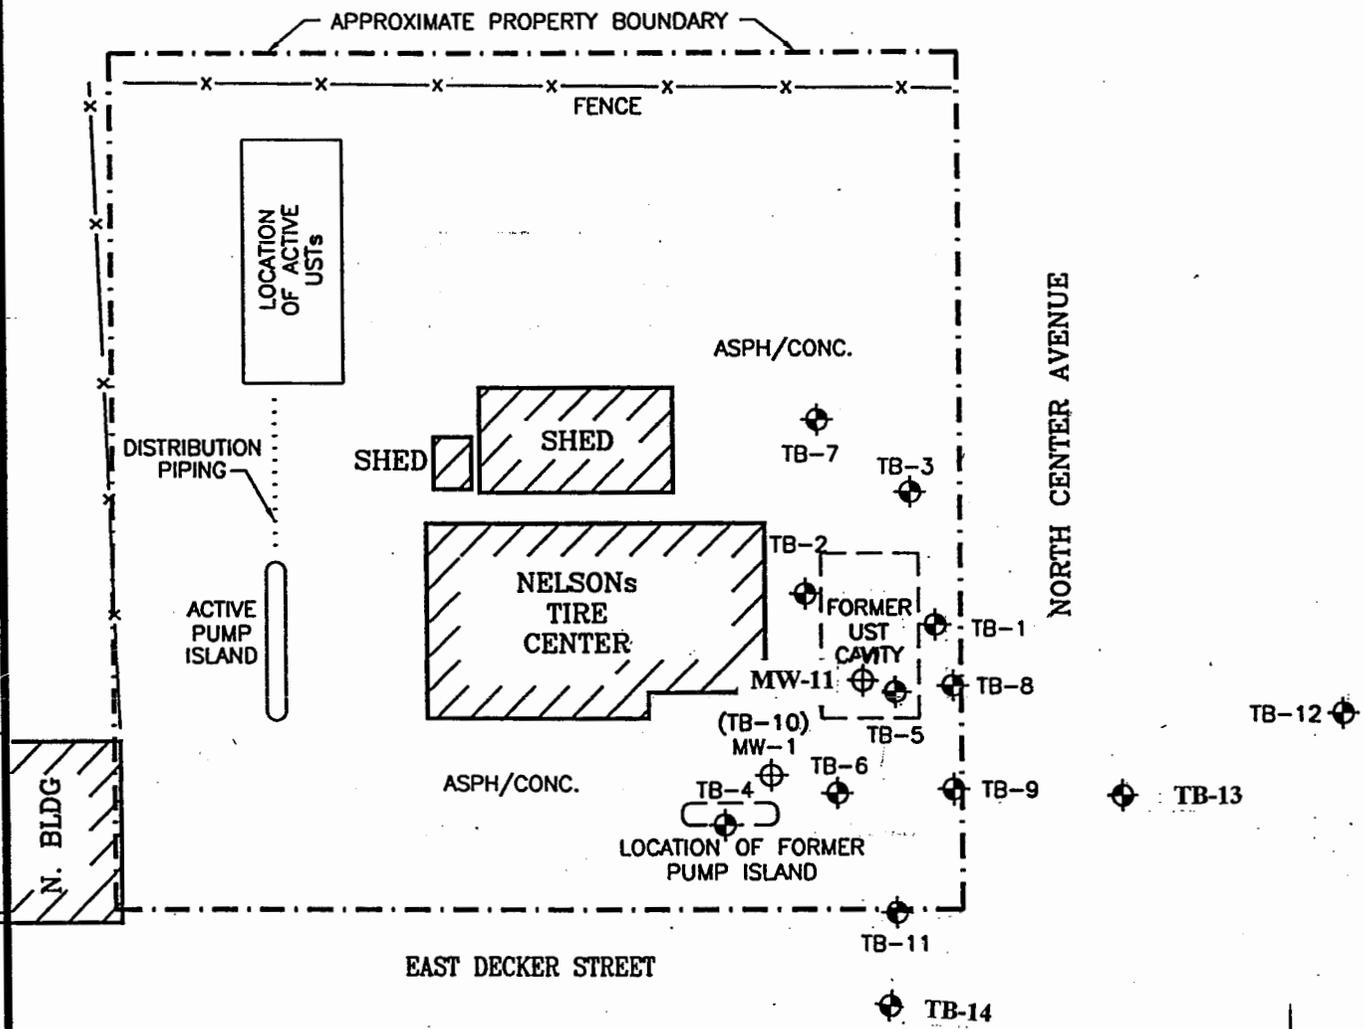
FIGURE NO.
1

TB-1 THROUGH TB-6 (12/9-6/97)
 TB-7 THROUGH TB-12 (4/17-18/97)

**Test Boring Locations
 Vernon Cooperative
 Cardrol Site
 Viroqua, Wisconsin**

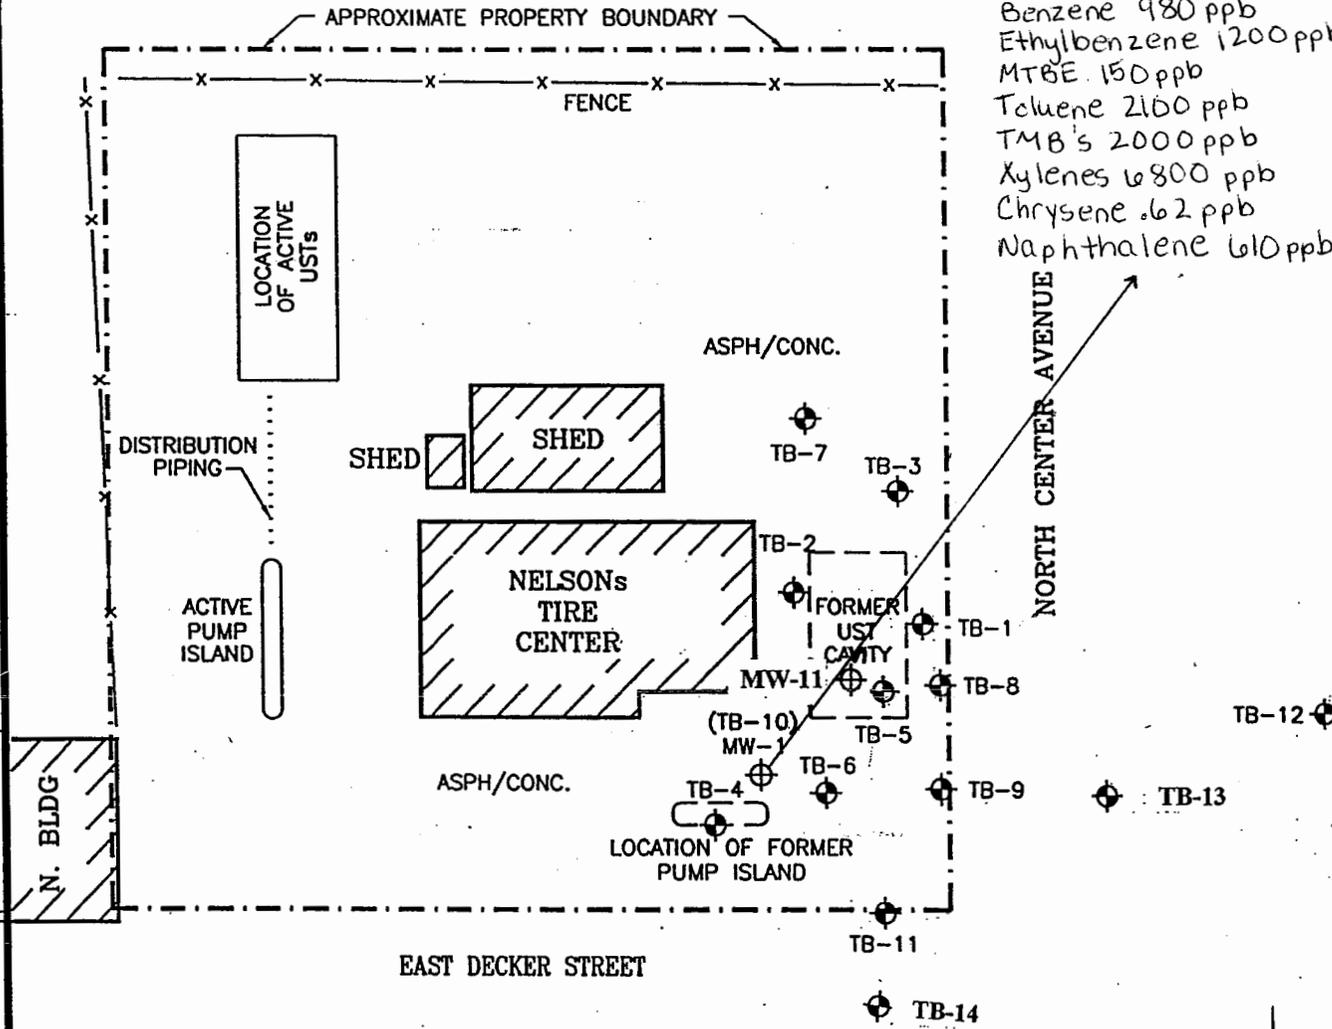
Groundwater Analytical Results Map

MW-1 ES Exceedances
(7-15-99)

Benzene 980 ppb
Ethylbenzene 1200 ppb
MTBE 150 ppb
Toluene 2100 ppb
TMB's 2000 ppb
Xylenes 6800 ppb
Chrysene .62 ppb
Naphthalene 610 ppb

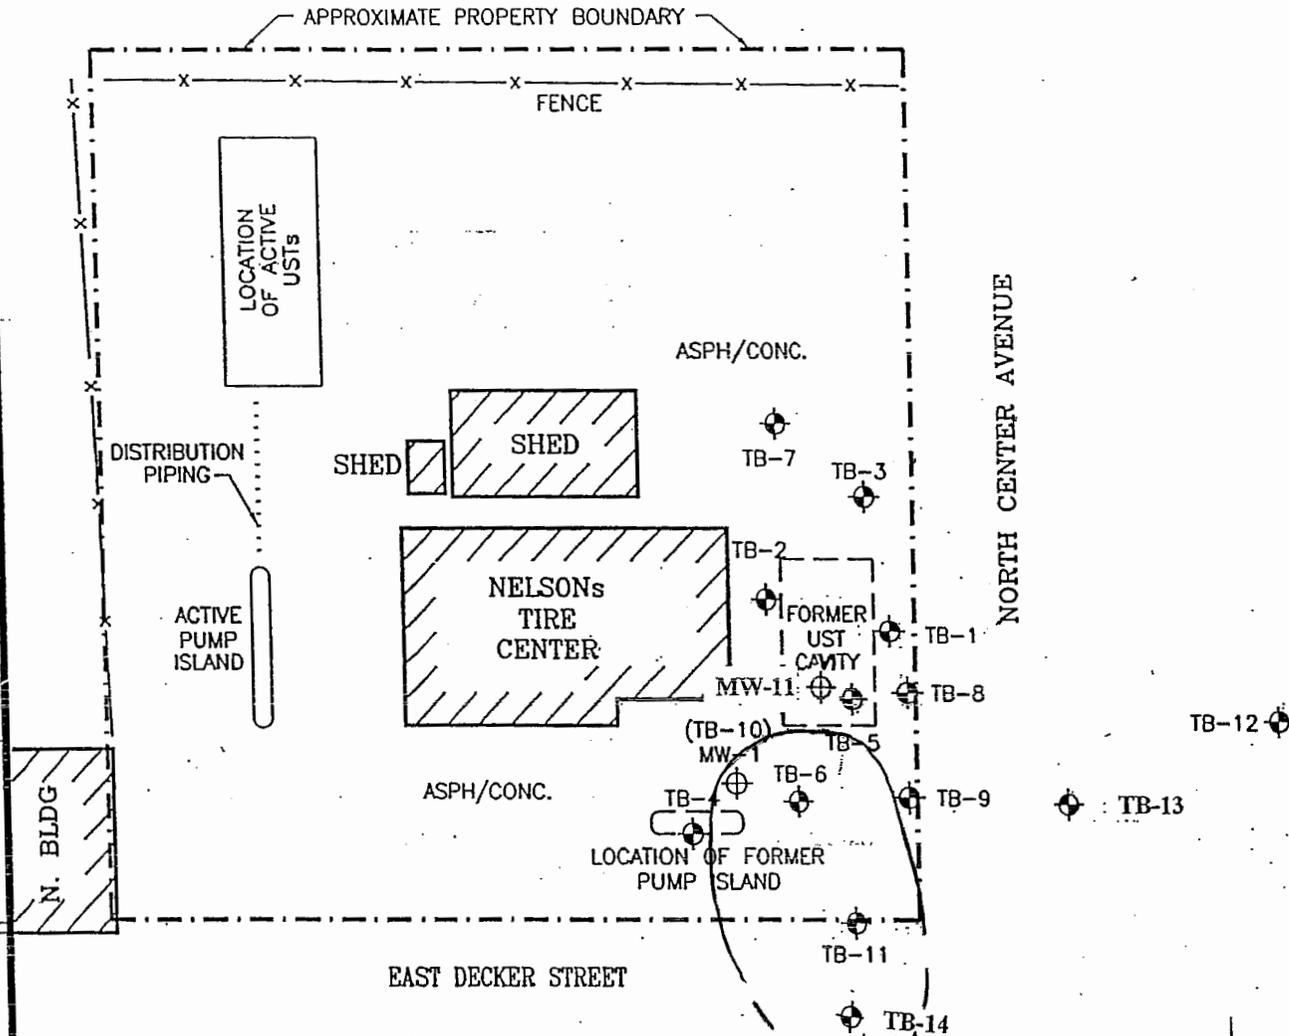
FIGURE NO.
1

Extent of Residual Soil Contamination
 Exceeding NR 720 and/or NR 746 Guidelines

Residual soil contamination remains in the southeast corner of the property, in the areas of a former underground petroleum storage tank and pump island, as indicated in the information submitted to the Department of Natural Resources. If soil in these specific locations is excavated in the future, the property owner at the time of excavation will be required to sample and analyze the excavated soil to determine whether the contamination still remains. If contamination remains, all current and future owners and occupants of the property need to be aware that excavation of the contaminated soil may pose an inhalation or other direct contact hazard at the time of excavation. **Special precautions may need to be taken during excavation activities to prevent a direct contact health threat to humans.** Based upon the results of sample analysis, the current owner will also have to properly store, treat, or dispose of any excavated materials, in accordance with state and federal laws.

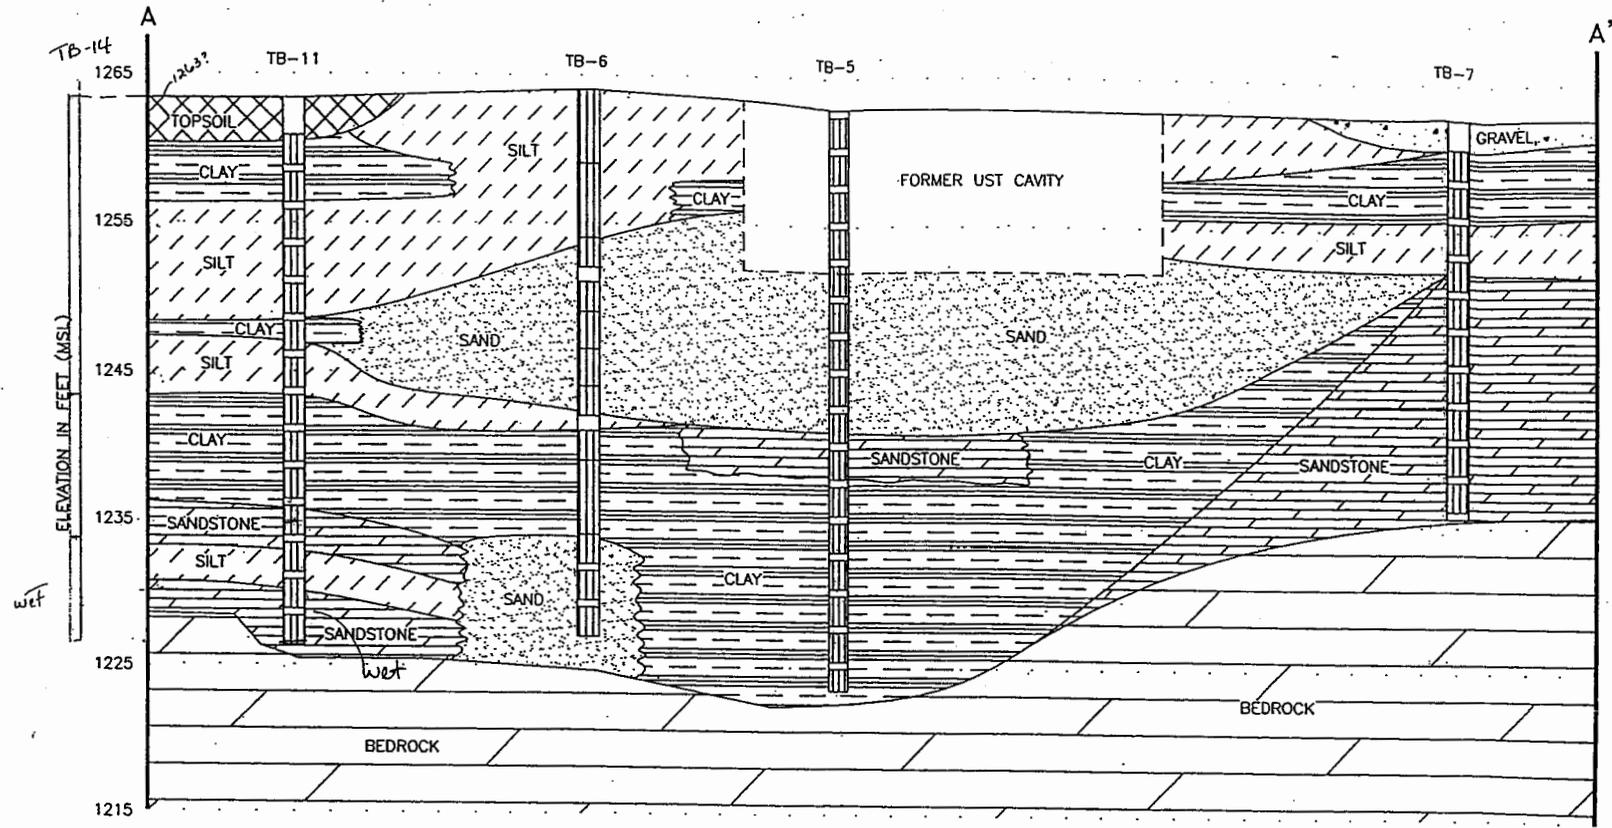
FIGURE NO.
 8

LEGEND
 ▨ SAMPLE INTERVAL

SCALE
 HORIZONTAL: 1" = 10'
 VERTICAL: 1" = 10'

Geologic Cross-Section A-A'
 Vernon Cooperative
 Cardrol Site
 Viroqua, Wisconsin

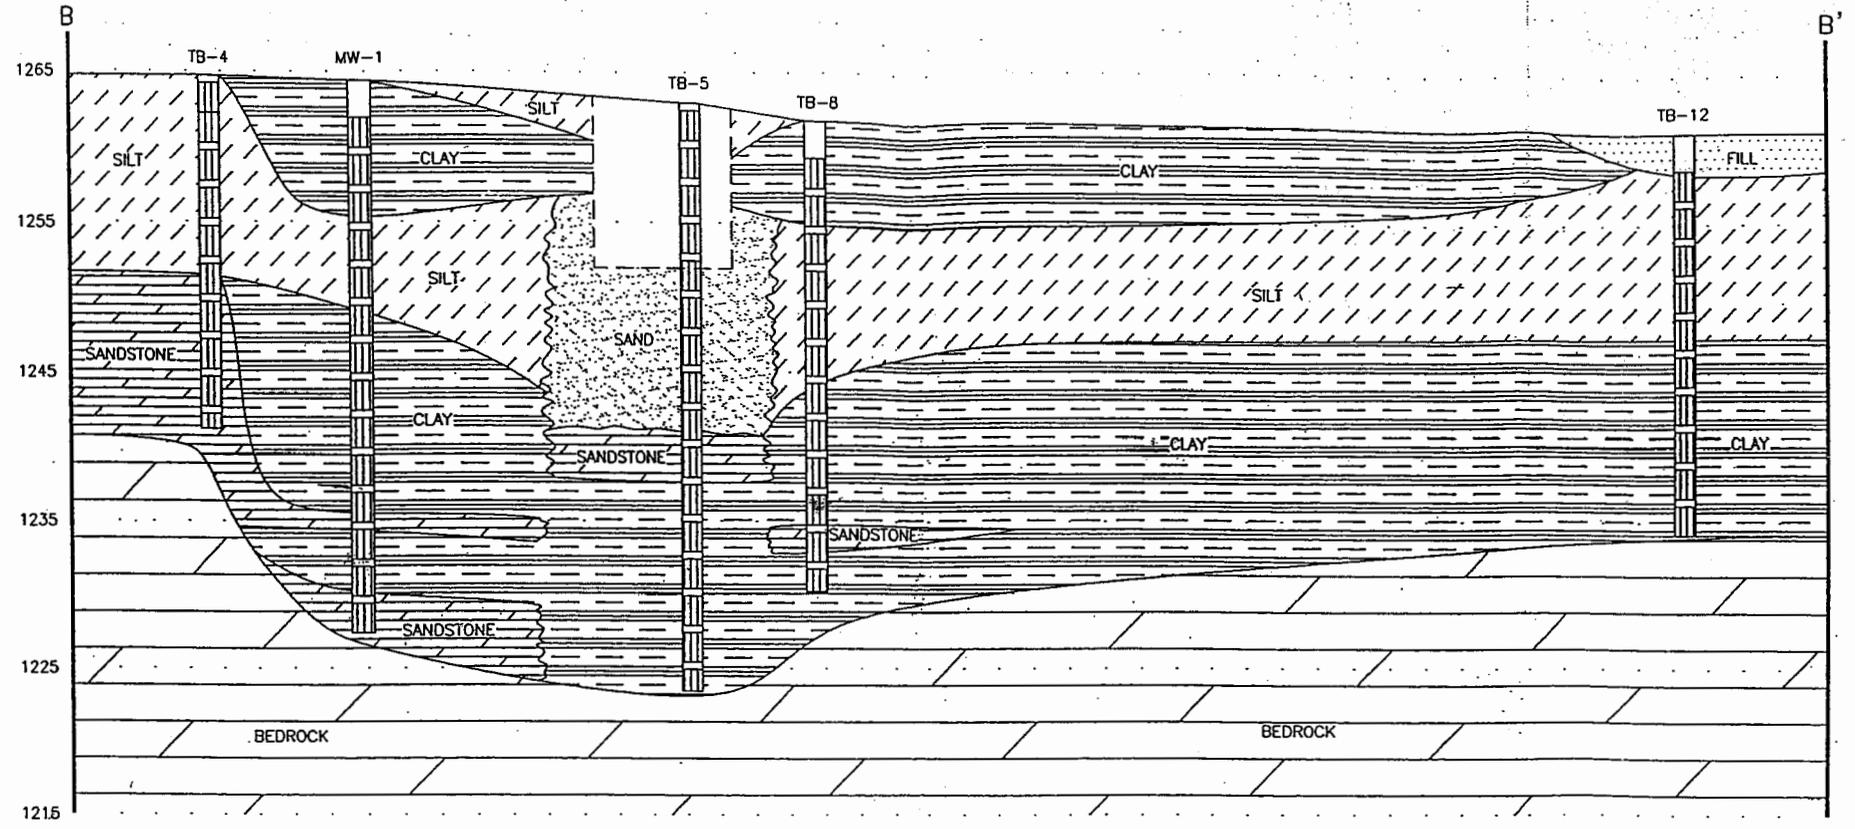
FIGURE NO.
 9

LEGEND
 ||| SAMPLE INTERVAL

SCALE
 HORIZONTAL: 1" = 10'
 VERTICAL: 1" = 10'

Geologic Cross-Section B-B'
 Vernon Cooperative
 Cardtrol Site
 Viroqua, Wisconsin

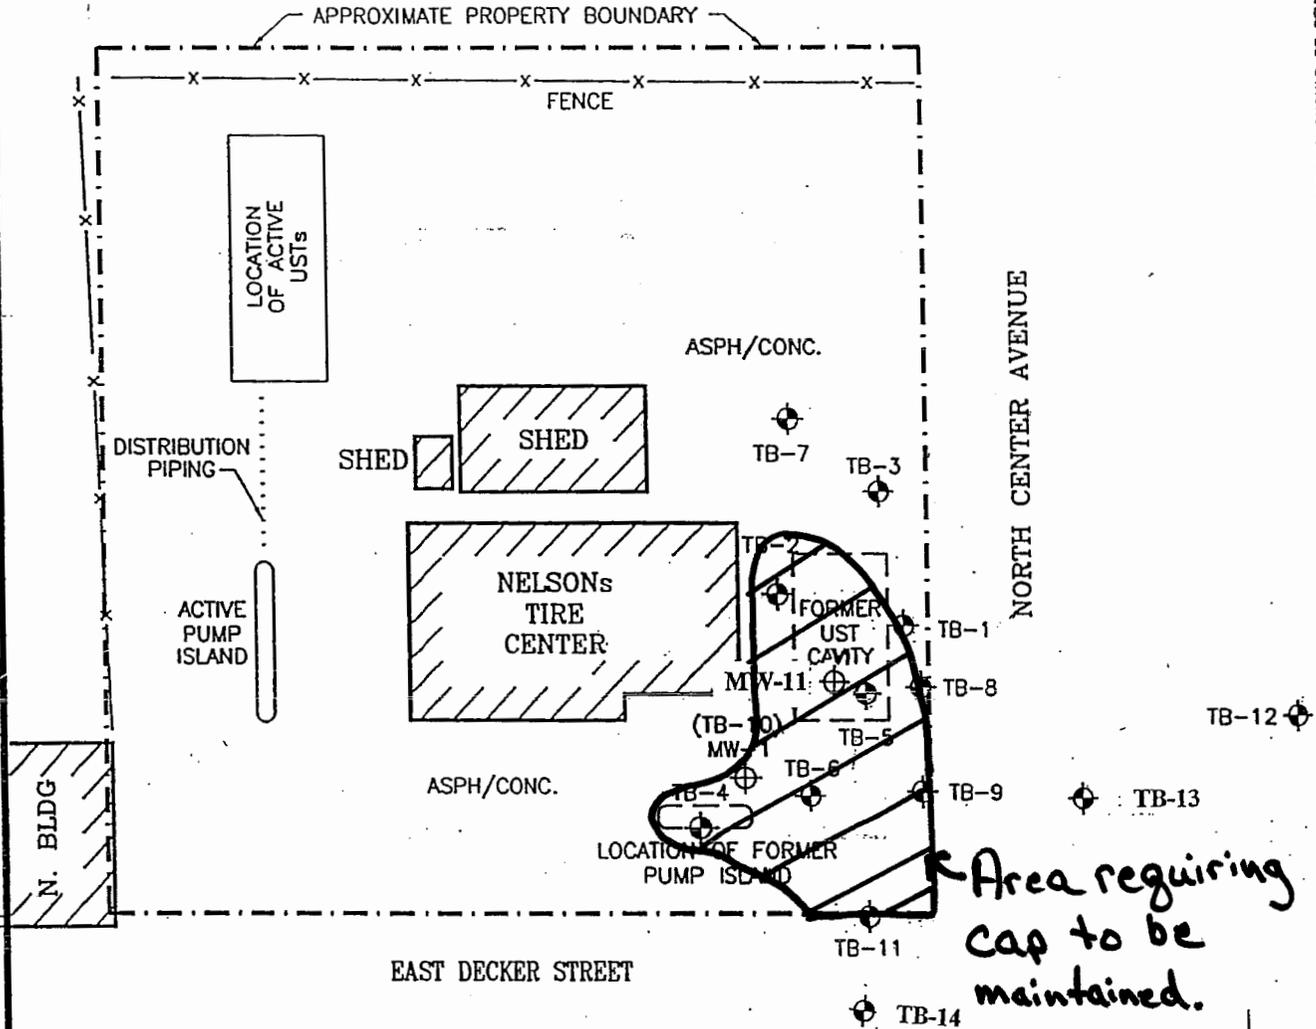
The asphalt pavement that existed on the above-described property in the location shown on the attached map, labeled "Exhibit A" on the date that this restriction was signed shall be maintained in compliance with the "Pavement Cover Maintenance Plan" dated January 12, 2006, that was submitted to the Wisconsin Department of Natural Resources by Jason T. Powell of METCO, as required by section NR 724.13 (2), Wis. Adm. Code (October 1999). A copy of the maintenance plan can be found at the Vernon Cooperative Oil Association office located at 107 Railroad Avenue, Viroqua, WI 54665-0026. This pavement must be maintained in order to minimize the infiltration of water and prevent additional groundwater contamination that would violate the groundwater quality standards in ch. NR 140, Wis. Adm. Code. If soil that remains on the property in the location or locations described above where there is residual contamination is excavated in the future, the soil must be sampled and analyzed, may be

In addition, the following activities are prohibited on any portion of the above-described property where pavement is required, as shown on "Exhibit A", unless prior written approval has been obtained from the Wisconsin Department of Natural Resources or its successor or assign: (1) Replacement with another barrier; (2) Excavating or grading of the land surface; (3) Filling on capped or paved areas; (4) Plowing for agricultural cultivation; and (5) Construction or placement of a building or other structure in an area where pavement is required.

**Test Boring Locations
 Vernon Cooperative
 Cardrol Site
 Viroqua, Wisconsin**

WHEREAS, one or more petroleum discharges have occurred on this property, and as of December 9-10, 1996, April 17-18, 1997, November 2, 1998, and July 19, 2005, when soil samples were collected on this property, petroleum-contaminated soil remained on this property at the following location: In and south of the former UST area and east/southeast of the former dispenser area as noted on the attached site layout map (Exhibit A).

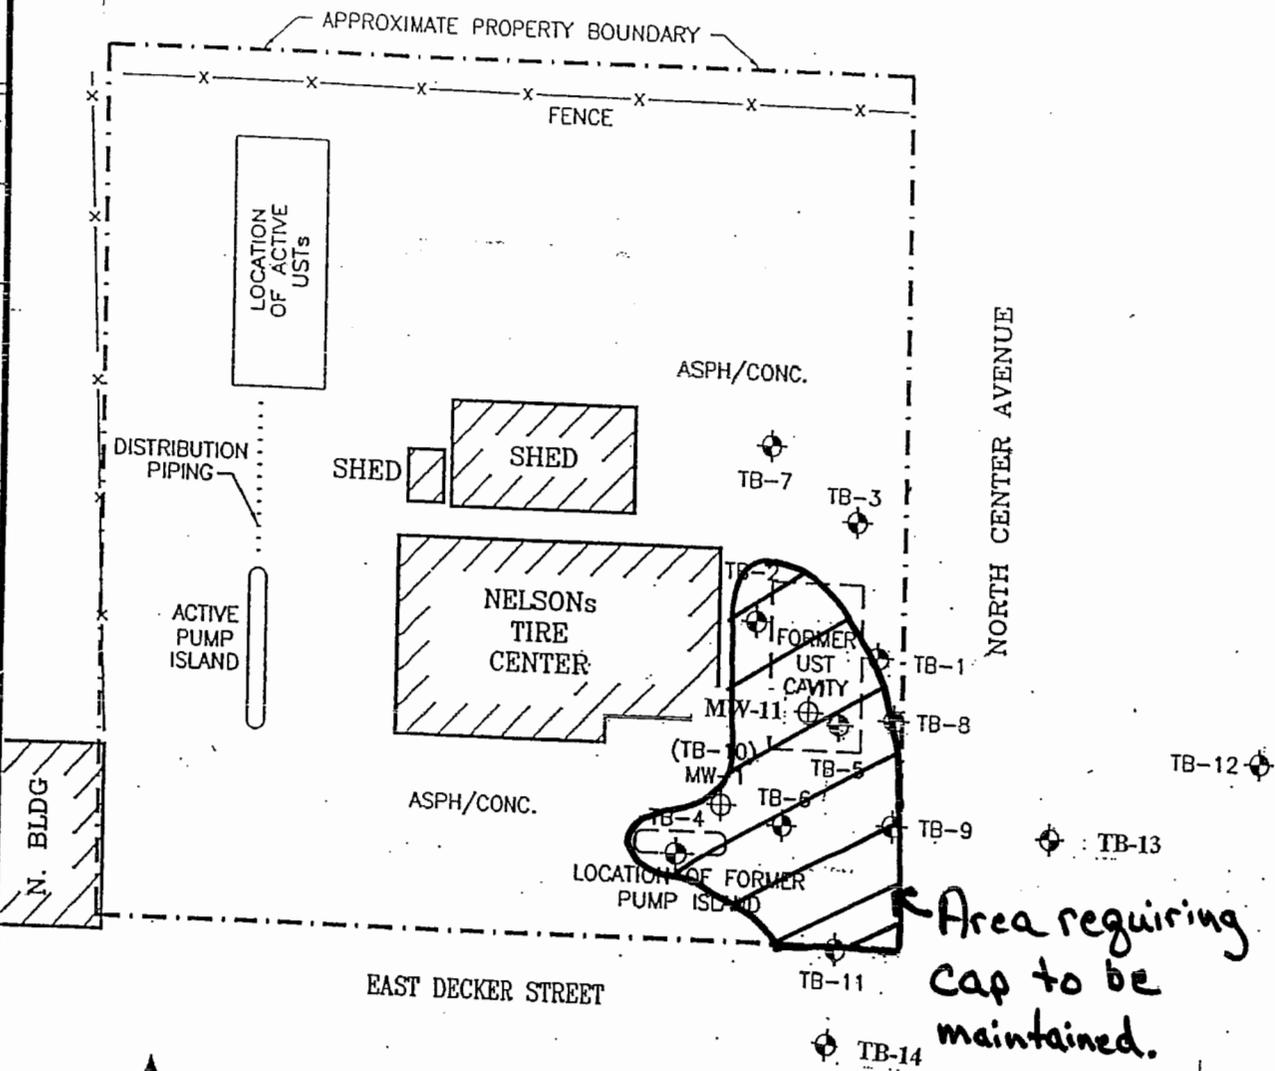
"Exhibit A"

This document is the Maintenance Plan for a pavement cover at the above-referenced property in accordance with the requirements of s. NR 724.13(2), Wisconsin Administrative Code. The maintenance activities relate to the existing paved surface occupying the area over the contaminated soil on the property. The contaminated soil is impacted by Gasoline Range Organics, 1,2,4 & 1,3,5-Trimethylbenzene, Benzene, Ethylbenzene, Xylene, Naphthalene, and Toluene. The location of the paved surface to be maintained in accordance with this Maintenance Plan, as well as the impacted soil are identified in the attached map (Exhibit A).

The paved surface overlying the contaminated soil as depicted in Exhibit A will be inspected once a year, normally in the spring after all snow and ice is gone, for deterioration, cracks and other potential problems that can cause additional infiltration into underlying soils. The inspections will be performed to evaluate damage due to settling, exposure to the weather, wear from traffic, increasing age and other factors. Any area where soils have become or are likely to become exposed will be documented. A log of the inspections and any repairs will be maintained by the property owner and is included as Exhibit B, Cap Inspection Log. The log will include recommendations for necessary repair of any areas where underlying soils are exposed. Once repairs are completed, they will be documented in the inspection log.

*Test Boring Locations
 Vernon Cooperative
 Cardrol Site
 Viroqua, Wisconsin*
