**BRRTS #:** 02-72-195035  
**ACTIVITY NAME:** Nekoosa Papers Sulfuric Acid Spill  
**PROPERTY ADDRESS:** 301 Point Basse AVE  
**MUNICIPALITY:** Nekoosa  
**PARCEL ID #:** 3000150

Approximately 280 gallons of sulfuric acid was released to the environment occurred due to a failure of an aboveground sulfuric acid pipeline between the Chemical Pump House (a.k.a. Old ClO<sub>2</sub> Plant Building) and Methanol Tank at the Domtar Nekoosa facility (see Property Site Diagram, Figure B.1.a.1). The acid was neutralized and the accessible impacted soil was excavated to approximately four feet below grade. However, due to concerns about nearby building foundations and buried utilities not all of the impacted soil could be removed, nor could the extent of the impacted groundwater be determined. The conditions of closure and continuing obligations required were based on the property being used for industrial purposes.

Subject: Conditional Closure Decision With Requirements to Achieve Final Closure  
Nekoosa Papers Sulfuric Acid Spill  
Domtar Papers, Nekoosa, Wisconsin

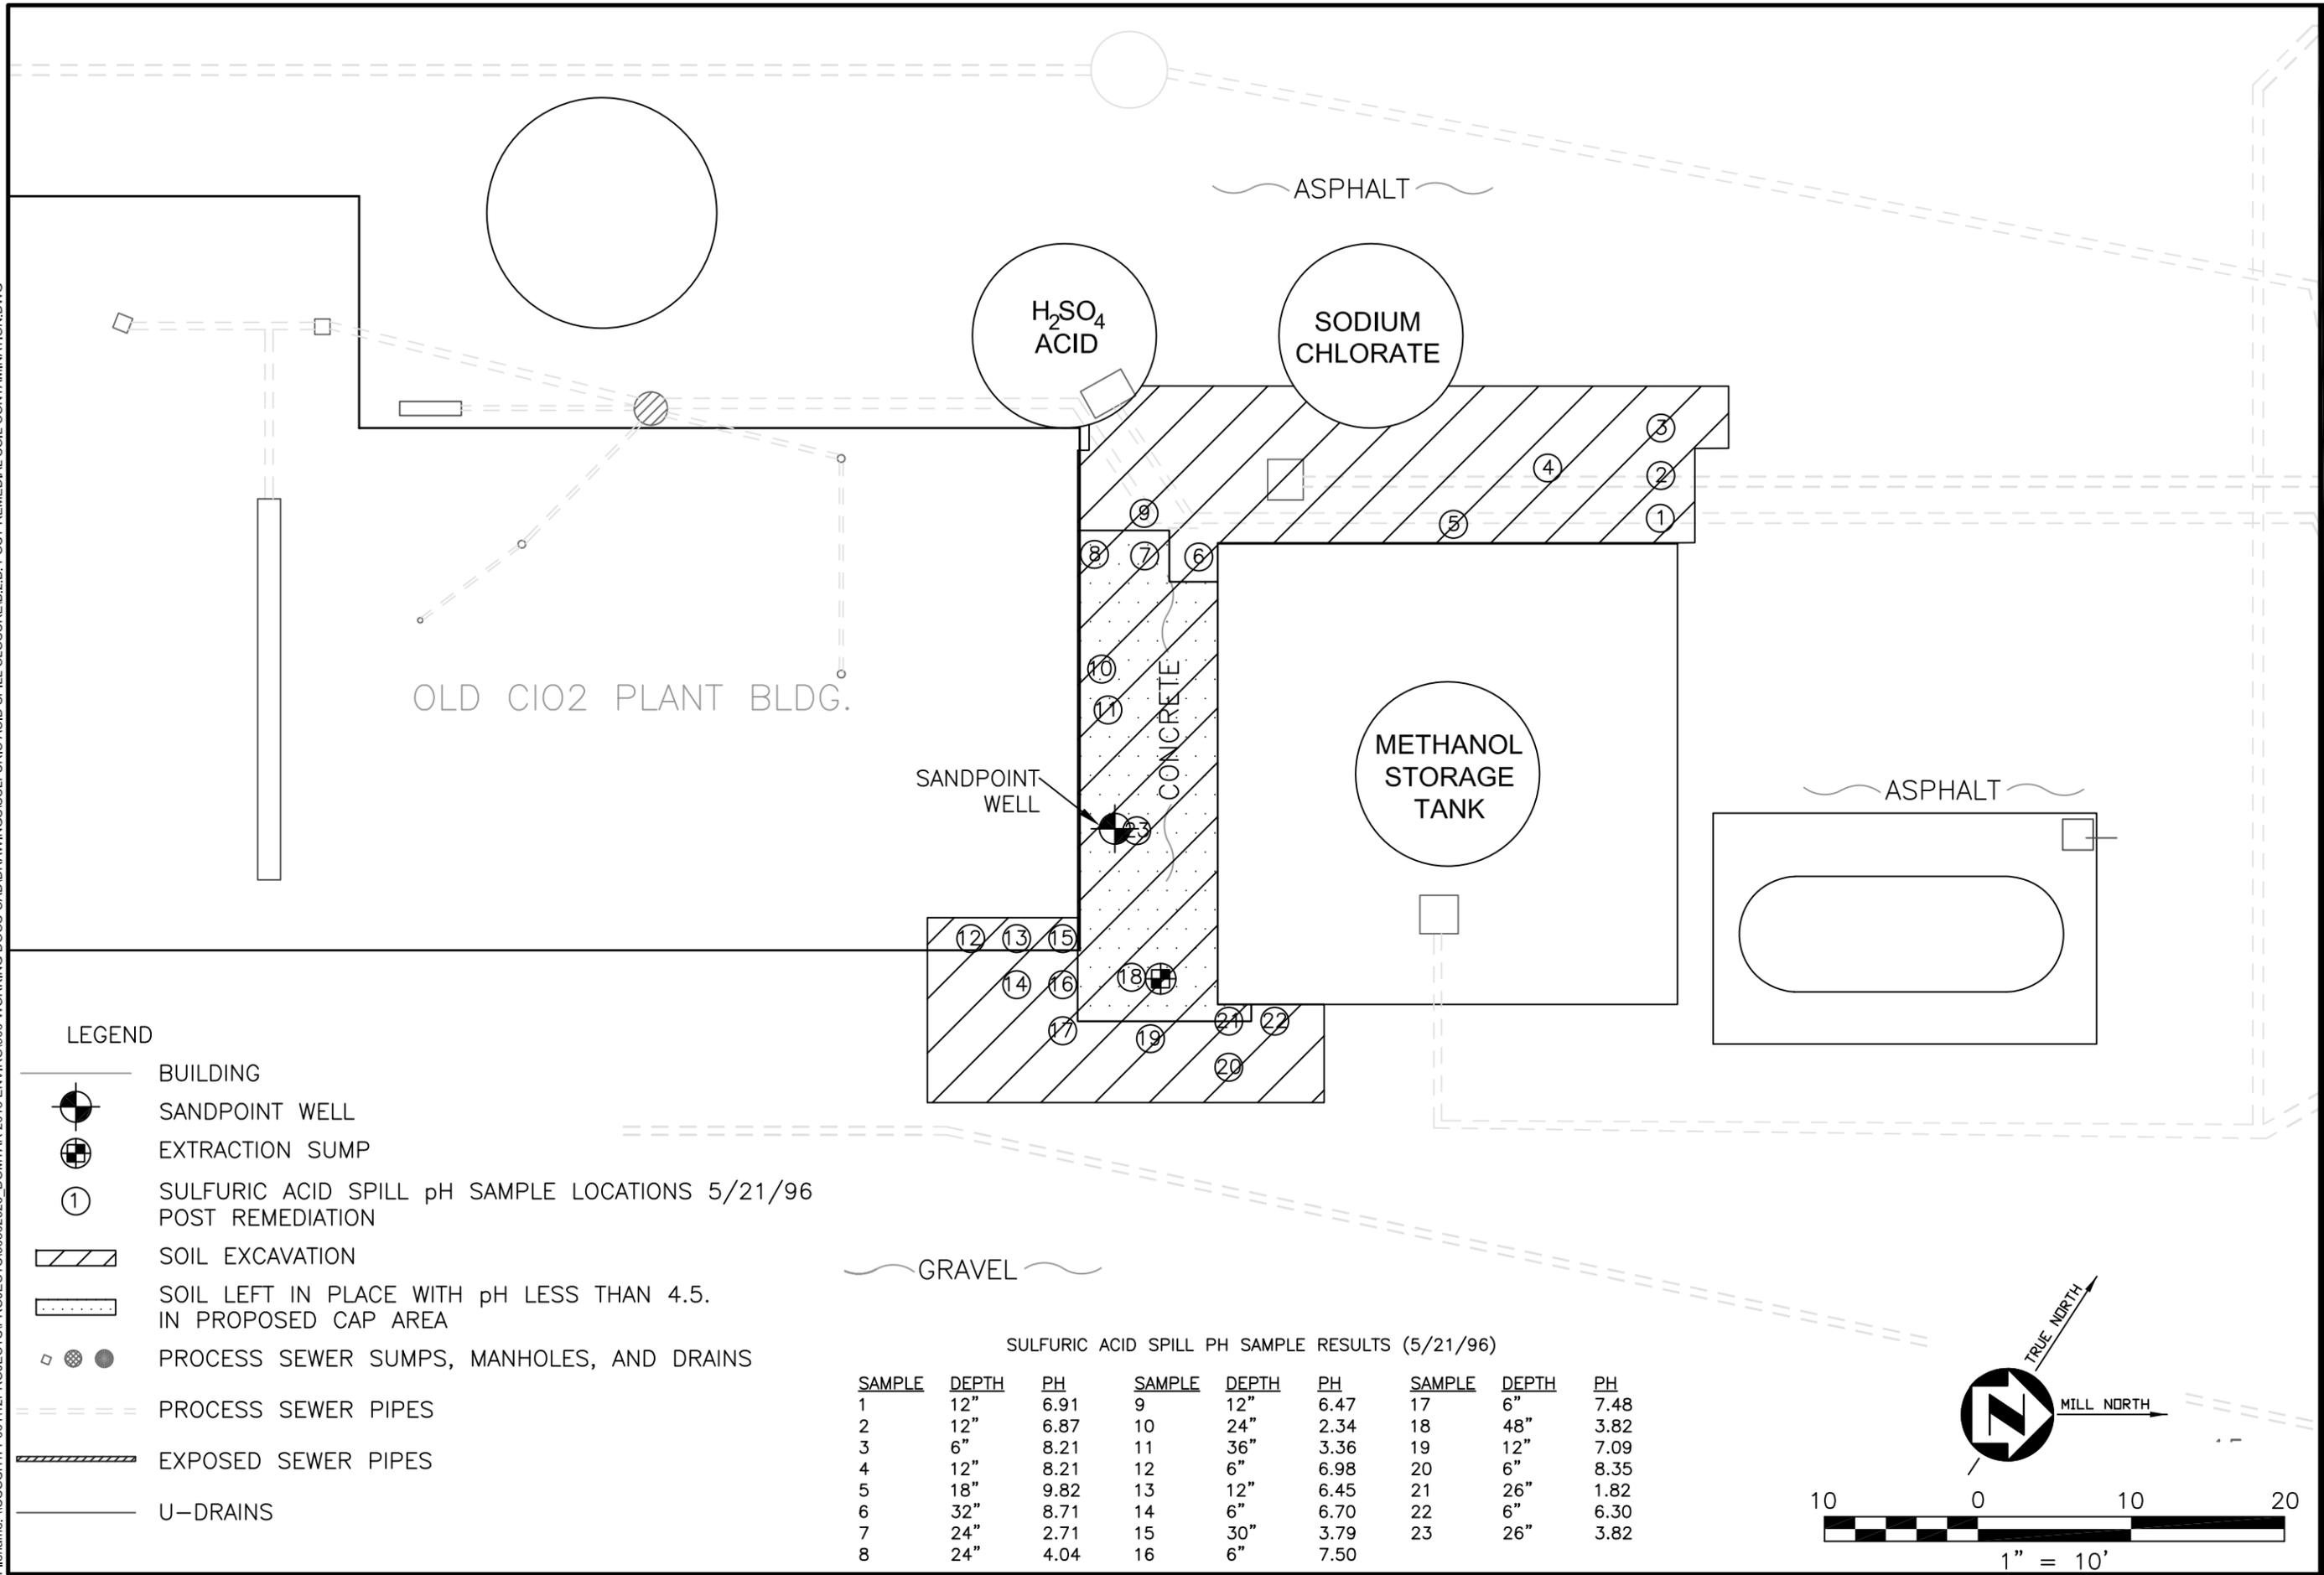
PRE-REMEDIAL SOIL ANALYTICAL DATA WAS NOT OBTAINED DUE TO THE QUICK TURN-AROUND OF REMEDIAL ACTIVITIES. ON MAY 21, 1996 AROUND 6:00 AM THE LEAK WAS OBSERVED. NEUTRALIZATION OF THE AREA TOOK PLACE AT APPROXIMATELY 9:30 AM, MAY 21, 1996. FOLLOWING NEUTRALIZATION, THE AREA WAS EXCAVATED THROUGH MAY 23, 1996. SOIL PH WAS ASSESSED DURING EXCAVATION (SEE FIGURE B.2.c). EXCAVATION WAS PERFORMED UNTIL SOIL WAS REMOVED TO A BACKGROUND PH OR UNTIL BUILDING INTEGRITY WOULD HAVE BEEN JEOPARDIZED. LIME WAS SPREAD ON THE BASE OF THE EXCAVATION TO FURTHER NEUTRALIZE ANY IMPACTED SOIL LEFT IN PLACE. THE EXCAVATED AREA WAS FILLED WITH CLEAN SOIL ON THE AFTERNOON OF MAY 24, 1996.

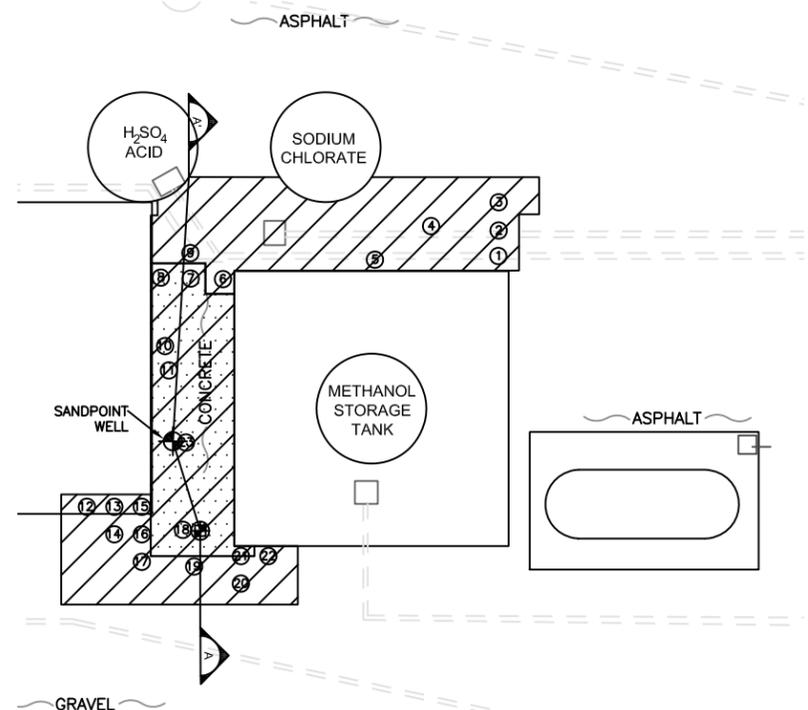
SINCE PRE-REMEDIAL SAMPLING WAS NOT PERFORMED (SEE EXPLANATION ON FIGURE B.2.a), SEE FIGURE B.2.b FOR POST-REMEDIAL SAMPLING, WHICH SHOWS ALL SAMPLING PERFORMED FOR THE SULFURIC ACID SPILL.

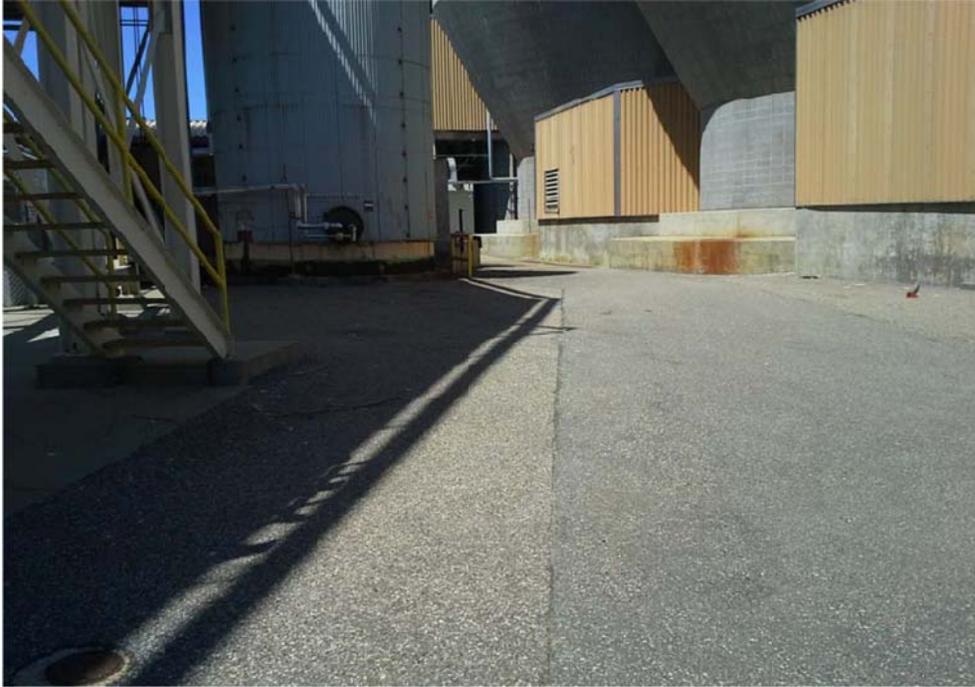
<b>Client Name:</b> Domtar		<b>Site Location:</b> Sulfuric Acid Spill		<b>Project No.:</b> 60302620	
<b>Photo No.</b> 1	<b>Date:</b> 6/13/2013

<b>Direction Photo Taken:</b>  Southwest					
<b>Description:</b>  Sulfuric Acid spill site located in the top left hand corner of the photo. Process sewer lines running north-south making additional investigation difficult. Area is completely paved with asphalt or concrete. Monitoring well B-9 is located in the bottom left hand corner of the photo.

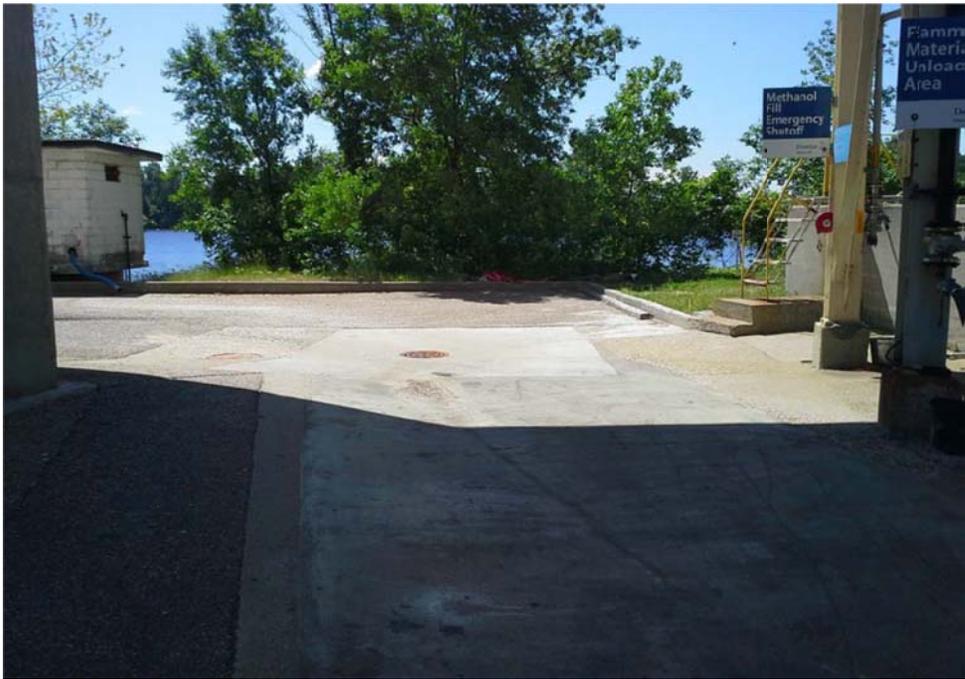
<b>Photo No.</b> 2	<b>Date:</b>

<b>Direction Photo Taken:</b>  East					
<b>Description:</b>  Sulfuric Acid, Methanol and hydrogen peroxide unloading area. Curb and concrete slab constructed in early 2000s.

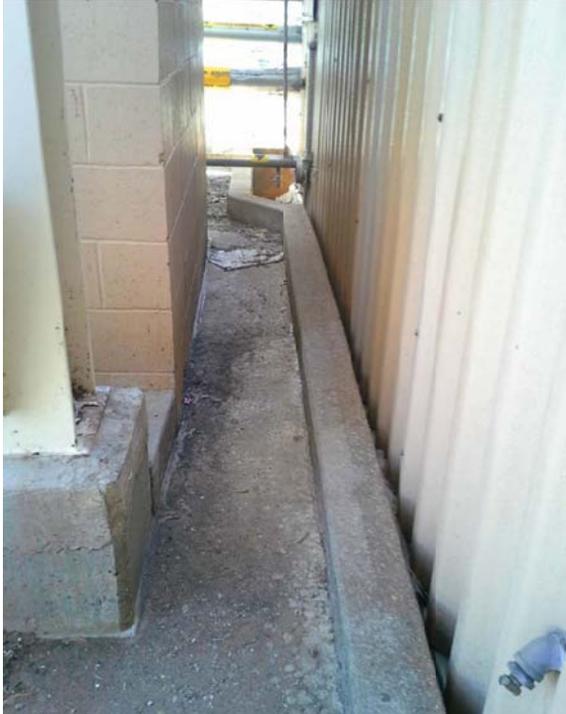
<b>PHOTOGRAPHIC LOG</b>			
<b>Client Name:</b> Domtar		<b>Site Location:</b> Sulfuric Acid Spill	<b>Project No.:</b> 60302620
<b>Photo No.</b> 3	<b>Date:</b> 6/13/2013

<b>Direction Photo Taken:</b> East			
<b>Description:</b> Area of sulfuric acid spill area with residual low pH impacted soil. The entire area is capped with concrete and curbed.

The cap overlying the contaminated groundwater plume and soil, as depicted in Figures B.3.b and B.2.b, will be inspected once a year, normally in the spring after all snow and ice is gone, for deterioration, cracks and other potential problems that can cause infiltration into, or exposure to underlying soils. The inspections will be performed by the property owner or their designated representative. The inspections will be performed to evaluate damage due to settling, exposure to the weather, wear from traffic, increasing age and other factors. Any area where soils have become or are likely to become exposed and where infiltration from the surface will not be effectively minimized will be documented. A log of the inspections and any repairs will be maintained by the property owner and is included as Exhibit B, Cap Inspection Log. The log will include recommendations for necessary repair of any areas where underlying soils are exposed and where infiltration from the surface will not be effectively minimized. Once repairs are completed, they will be documented in the inspection log. A copy of the inspection log will be kept at the address of the property owner and available for submittal or inspection by Wisconsin Department of Natural Resources ("WDNR") representatives upon their request.

If problems are noted during the annual inspections or at any other time during the year, repairs will be scheduled as soon as practical. Repairs can include patching and filling or larger resurfacing or construction operations. In the event that necessary maintenance activities expose the underlying soil, the owner must inform maintenance workers of the direct contact exposure hazard and provide them with appropriate personal protection equipment ("PPE"). The owner must also sample any soil that is excavated from the site prior to disposal to ascertain if contamination remains. The soil must be treated, stored and disposed of by the owner in accordance with applicable local, state and federal law.

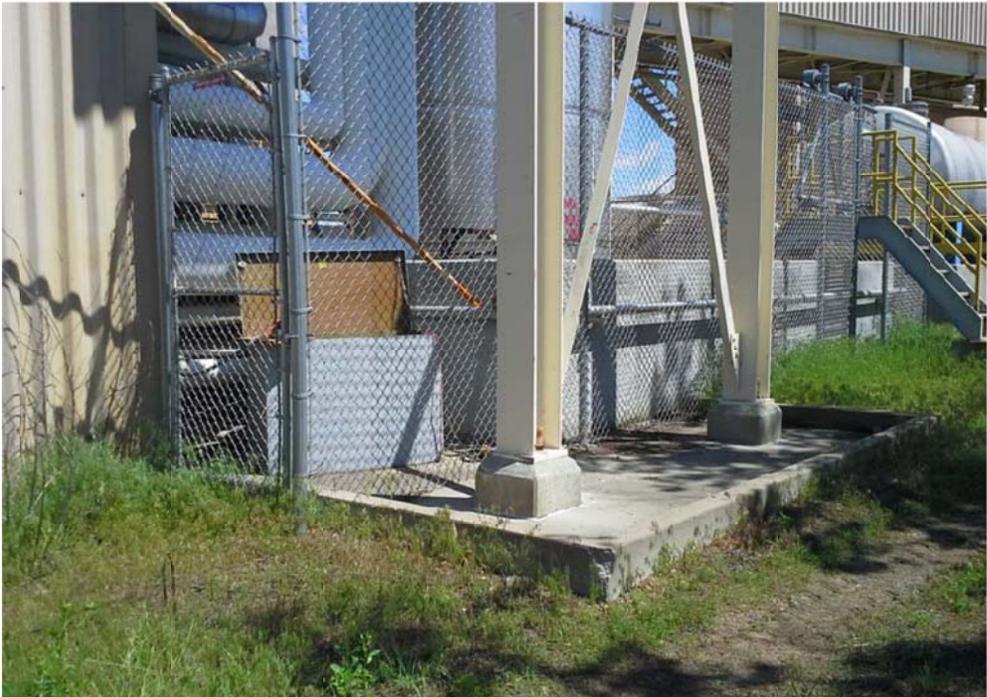
<b>Photo No.</b> 4	<b>Date:</b> 6/13/2013

<b>Direction Photo Taken:</b> Northwest			
<b>Description:</b> Sulfuric acid sump area with concrete pavement and containment curbs.

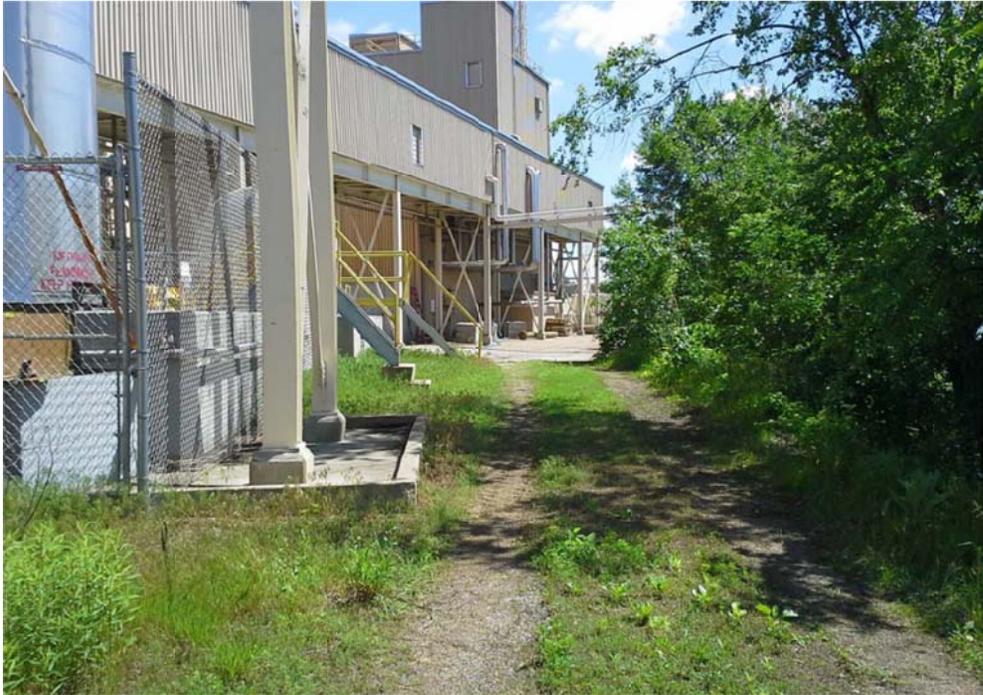
<b>PHOTOGRAPHIC LOG</b>			
<b>Client Name:</b> Domtar		<b>Site Location:</b> Sulfuric Acid Spill	<b>Project No.:</b> 60302620
<b>Photo No.</b> 5	<b>Date:</b> 6/13/2013

<b>Direction Photo Taken:</b>  Northeast			
<b>Description:</b>  Looking northeast with Wisconsin River on immediate right and sump area to the left. Process lines run directly under gravel access road.
