GIS REGISTRY INFORMATION

SITE NAME: Centerville Coop Creamery
BRRTS #: 02-62-548751 **FID # (if appropriate):** 662021360
DATCP # (if appropriate): 05416101301
CLOSURE DATE: 10-Jul-07
STREET ADDRESS: W25727 State Rd 35/54
CITY: Trempealeau

SUBJECT: Final Case Closure with Land Use Conditions, Agricultural chemical cleanup, Centerville Coop Creamery, W25727 State Rd 35/54, Trempealeau, WI 54661.

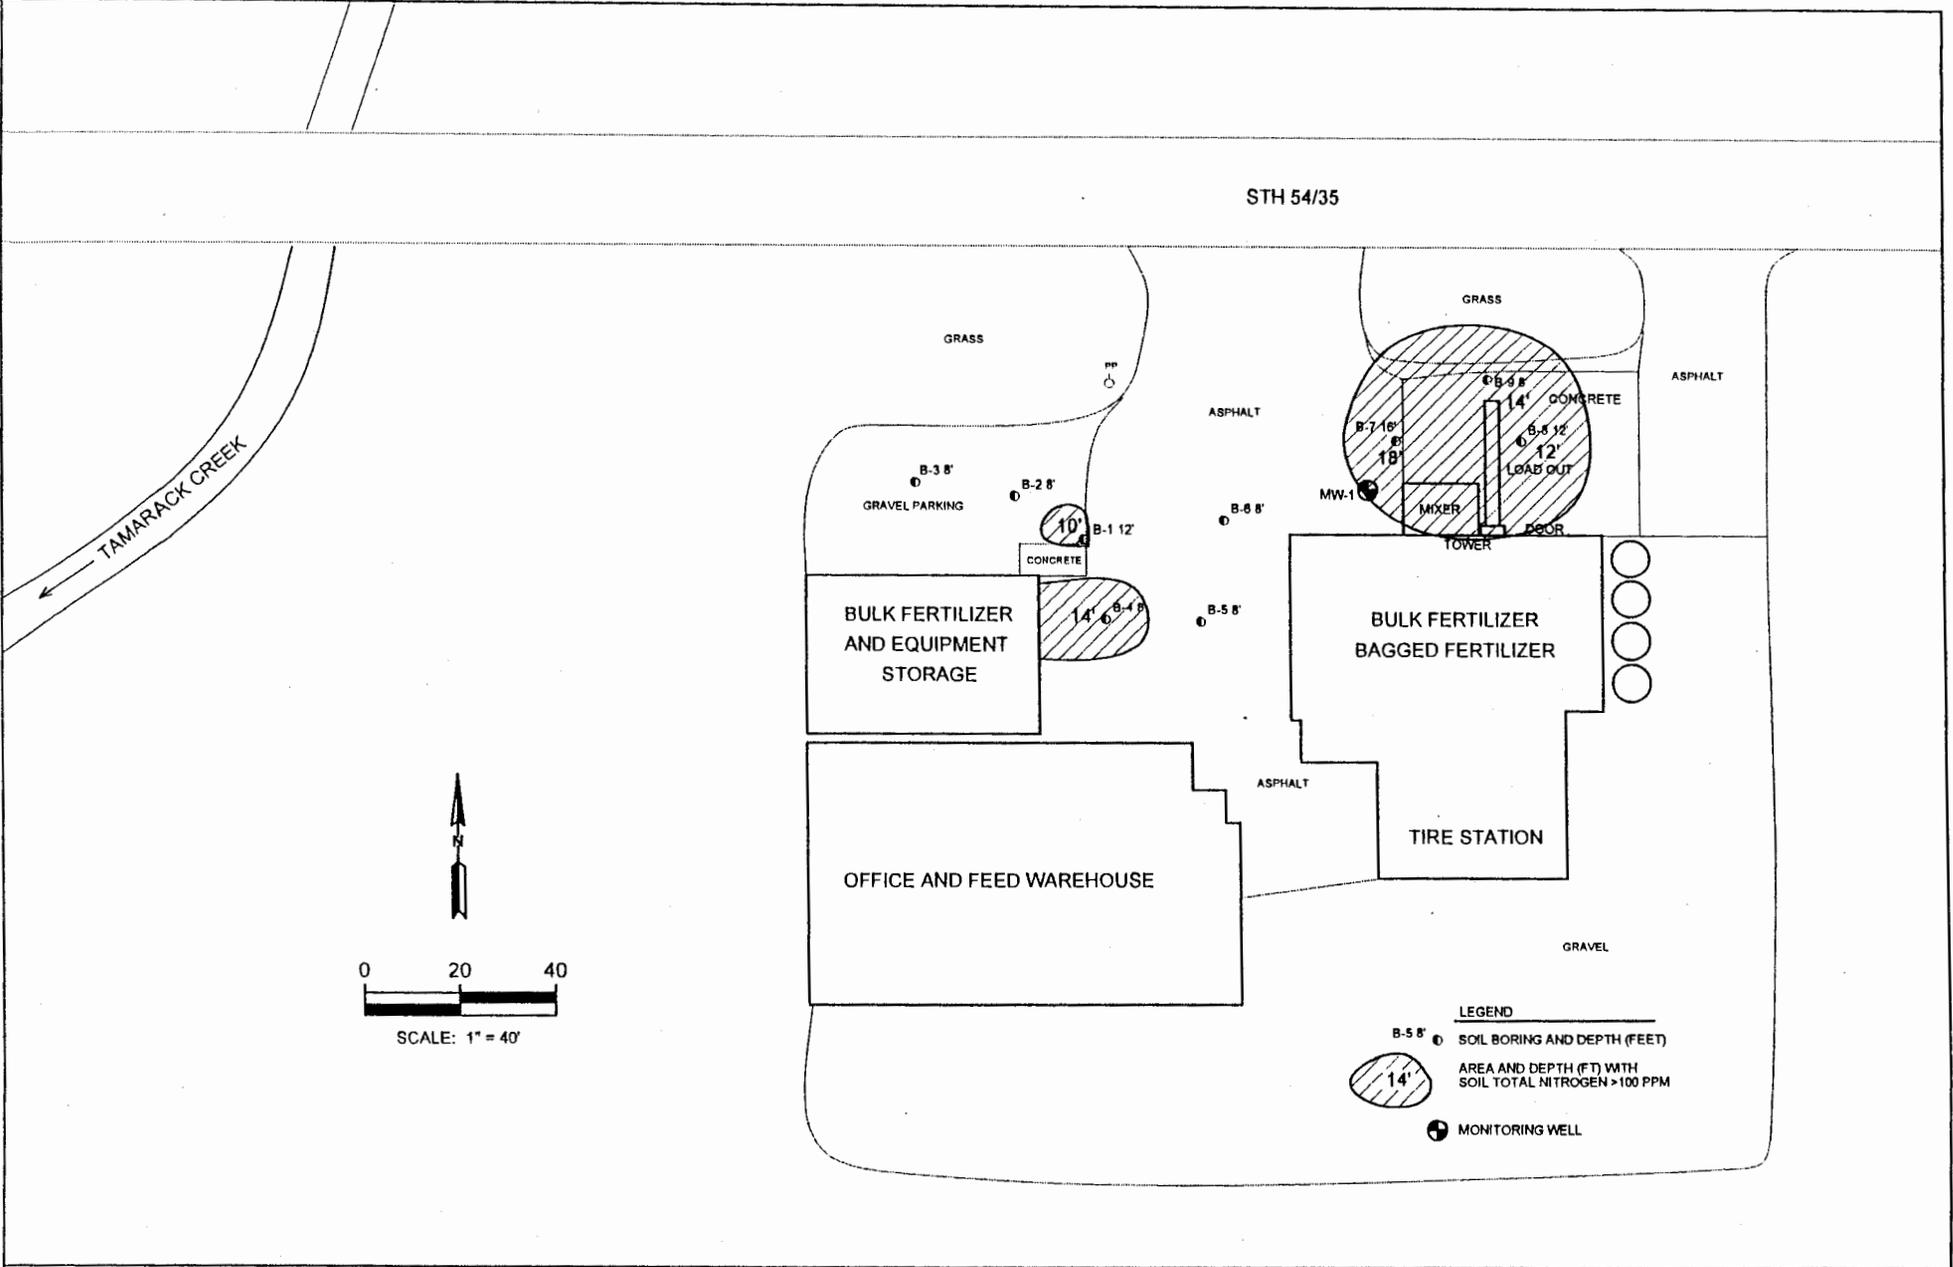
FIGURE 1

**SITE PLAN AND
 NITROGEN IMPACTED SOIL
 CENTERVILE CO-OP
 TREMPLEALEAU, WISCONSIN**

The following activities within the contaminated soil areas shown on the attached map are prohibited without prior written approval by the Department of Agriculture, Trade and Consumer Protection: 1) removal of existing asphalt and concrete pavement/barriers; 2) replacement with another barrier or 3) construction or placement of new buildings or other structures that adjoin or cover the contaminated soil.
