GIS REGISTRY INFORMATION

SITE NAME: Ellisville-Luxemburg Coop
BRRTS #: 03-31-182464 **FID # (if appropriate):** _____
COMMERCE # (if appropriate): _____
CLOSURE DATE: 10/02/2006
STREET ADDRESS: 413 Cedar Street
CITY: Luxemburg

SUBJECT: Final Case Closure By Closure Committee With Conditions Met
Ellisville-Luxemburg Coop, 413 Cedar Street, Luxemburg, WI
WDNR BRRTS # 03-31-182464

CAP MAINTENANCE PLAN

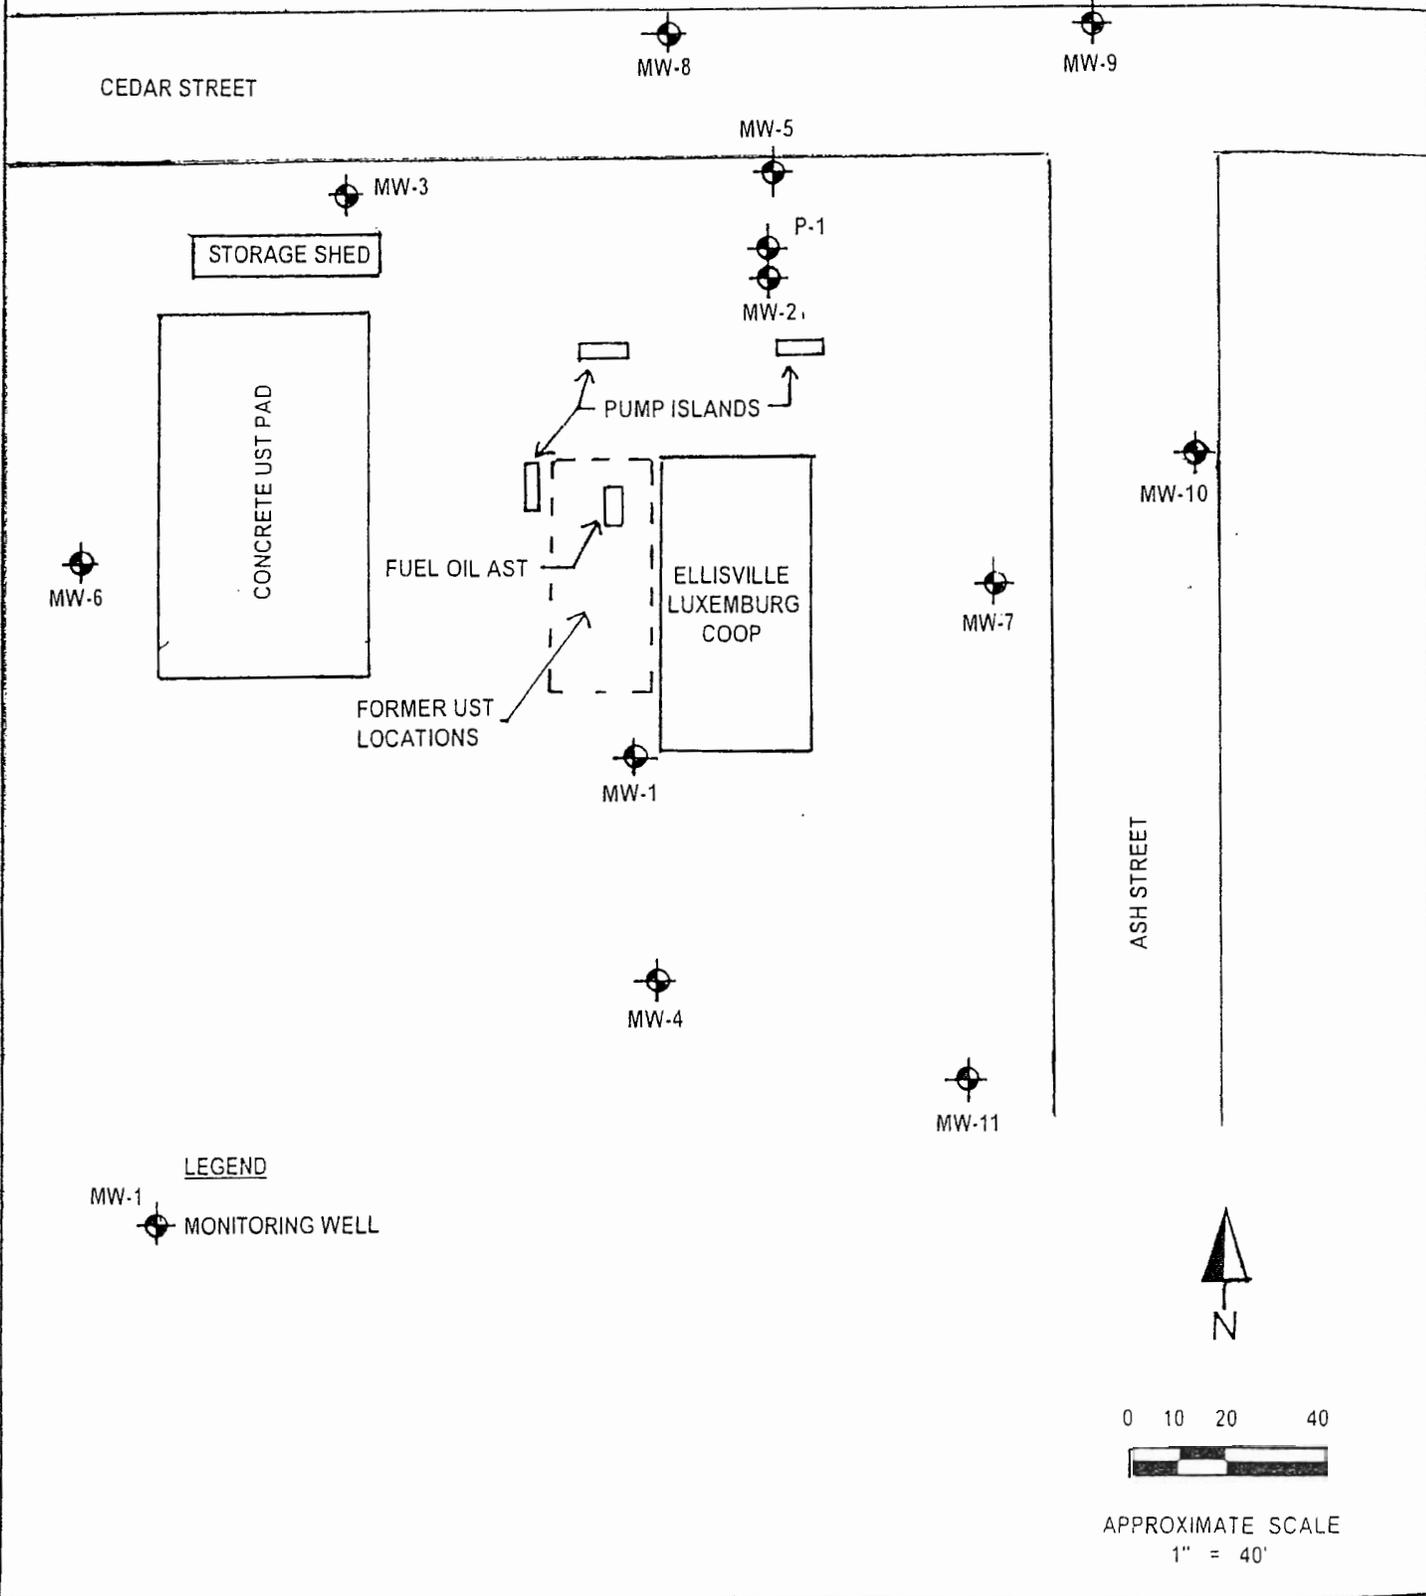
FIGURE: FIGURE 2 - SITE DETAIL MAP

exhibit A

WHEREAS, one or more Petroleum discharges have occurred on this property, and as of December 1997 when soil samples were collected on this property, Petroleum-contaminated soil remained on this property at the following location: soil sampling location LB1. Benzene contamination remains in the soil at a concentration less than 2000 micrograms per kilogram (µg/kg), which is above the Wisconsin Administrative Code Chapter NR 720 value of 5.5 µg/kg. Ethyl Benzene remains in the soil at a concentration of 10,000 micrograms per kilogram (µg/kg), which is above the Wisconsin Administrative Code Chapter NR 720 value of 2,900 µg/kg. Toluene contamination remains in the soil at a concentration of 5,000 micrograms per kilogram (µg/kg), which is above the Wisconsin Administrative Code Chapter NR 720 value of 1,500 µg/kg. Total Xylenes remains in the soil at a concentration of 68,000 micrograms per kilogram (µg/kg), which is above the Wisconsin Administrative Code Chapter NR 720 value of 4,100 µg/kg. Location of the soil sample is provided on exhibit A (figure 2) and is attached and made part of this restriction.

The impervious cap that existed on the above-described property in the location shown on the attached map, labeled Exhibit A on the date that this restriction was signed shall be maintained in compliance with the Ellisville-Luxemburg Cap Maintenance Plan dated June 24, 2004 that was submitted to the Wisconsin Department of Natural Resources by

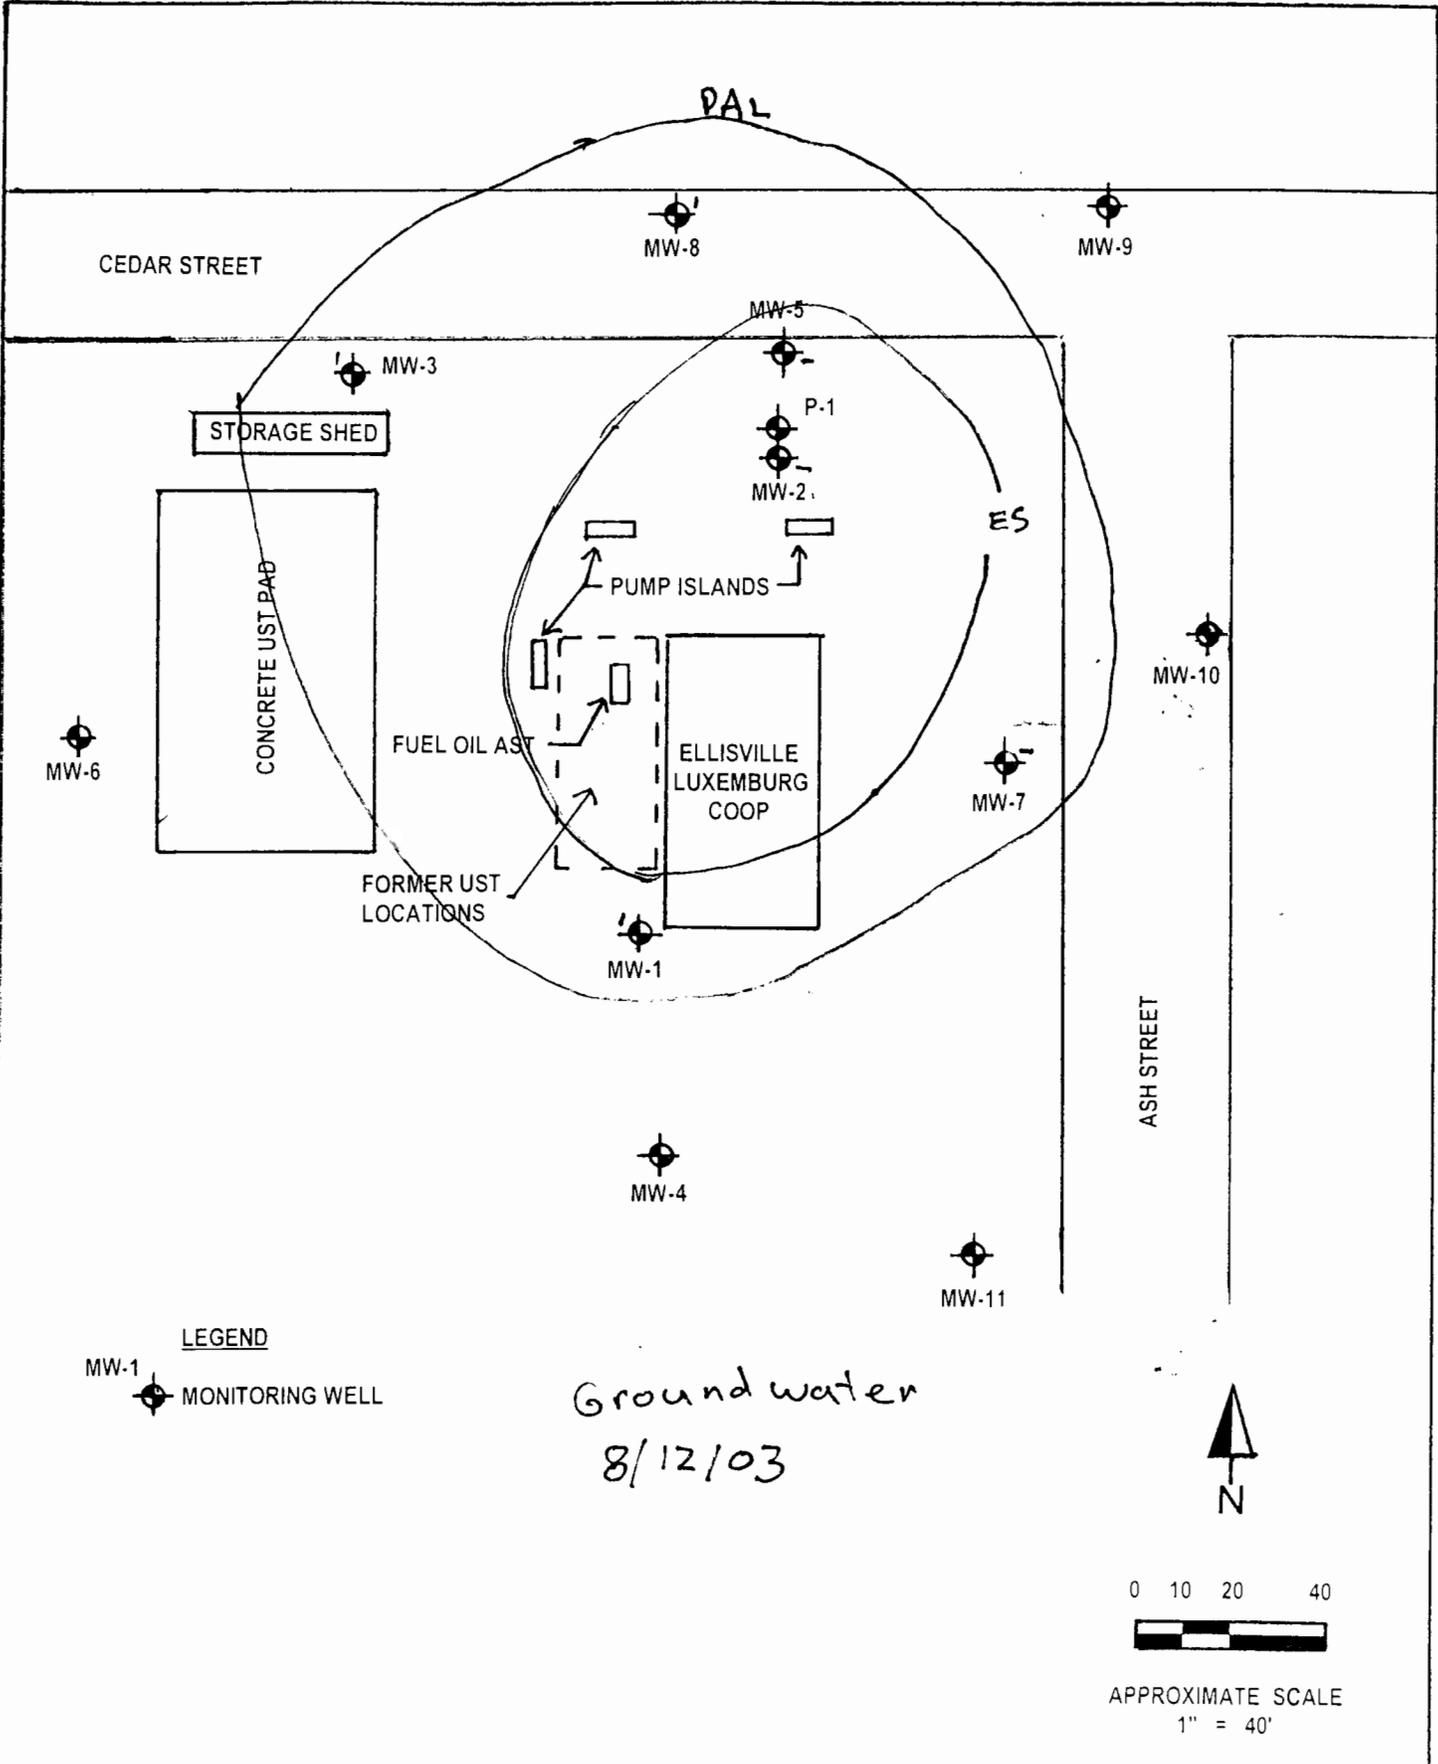
FIGURE: FIGURE 2 - SITE DETAIL MAP

boring LB2 - ND

boring LB3 - ND

12,000 gallon UST

boring LB1, 14,000 DRO

PROJECT: ENVIRONMENTAL ASSESSMENT, 12/18/97

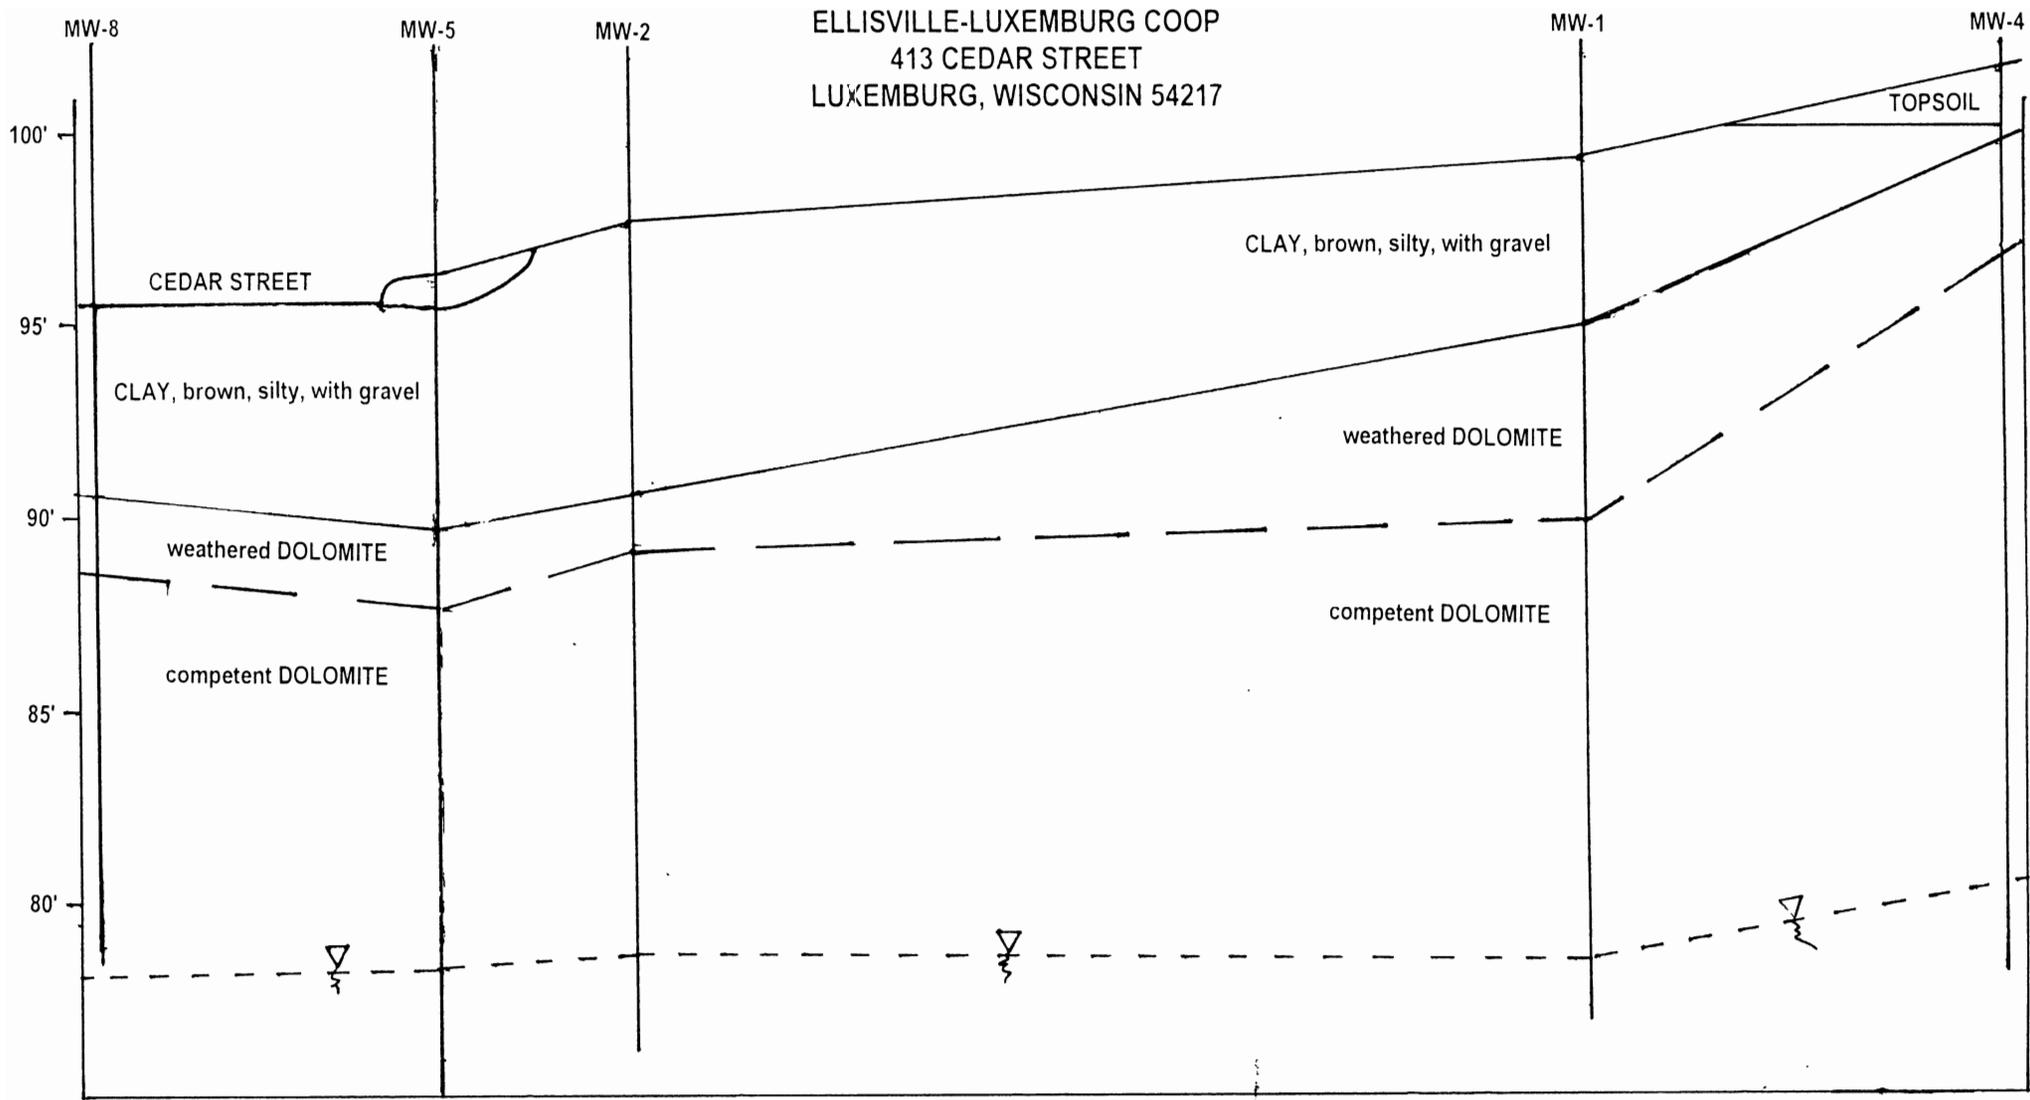
HORIZONTAL SCALE
1" = 20'
VERTICAL SCALE
1" = 5'

— ▽ — GROUNDWATER TABLE
