GIS REGISTRY

Subject: Final Case Closure with Continuing Obligations
Skana Aluminum (K&V) Sumps (chlorinated solvents)
Building 5C at 2009 Mirro Drive, Manitowoc Wisconsin
WDNR Environmental Repair Activity # 02-36-544601

BARRIER/CAP MAINTENANCE PLAN

VLPE #06-36-556282
WI DNR Environmental Repair Activity # 02-36-544601/02-36-550138
Facility ID# 436106110

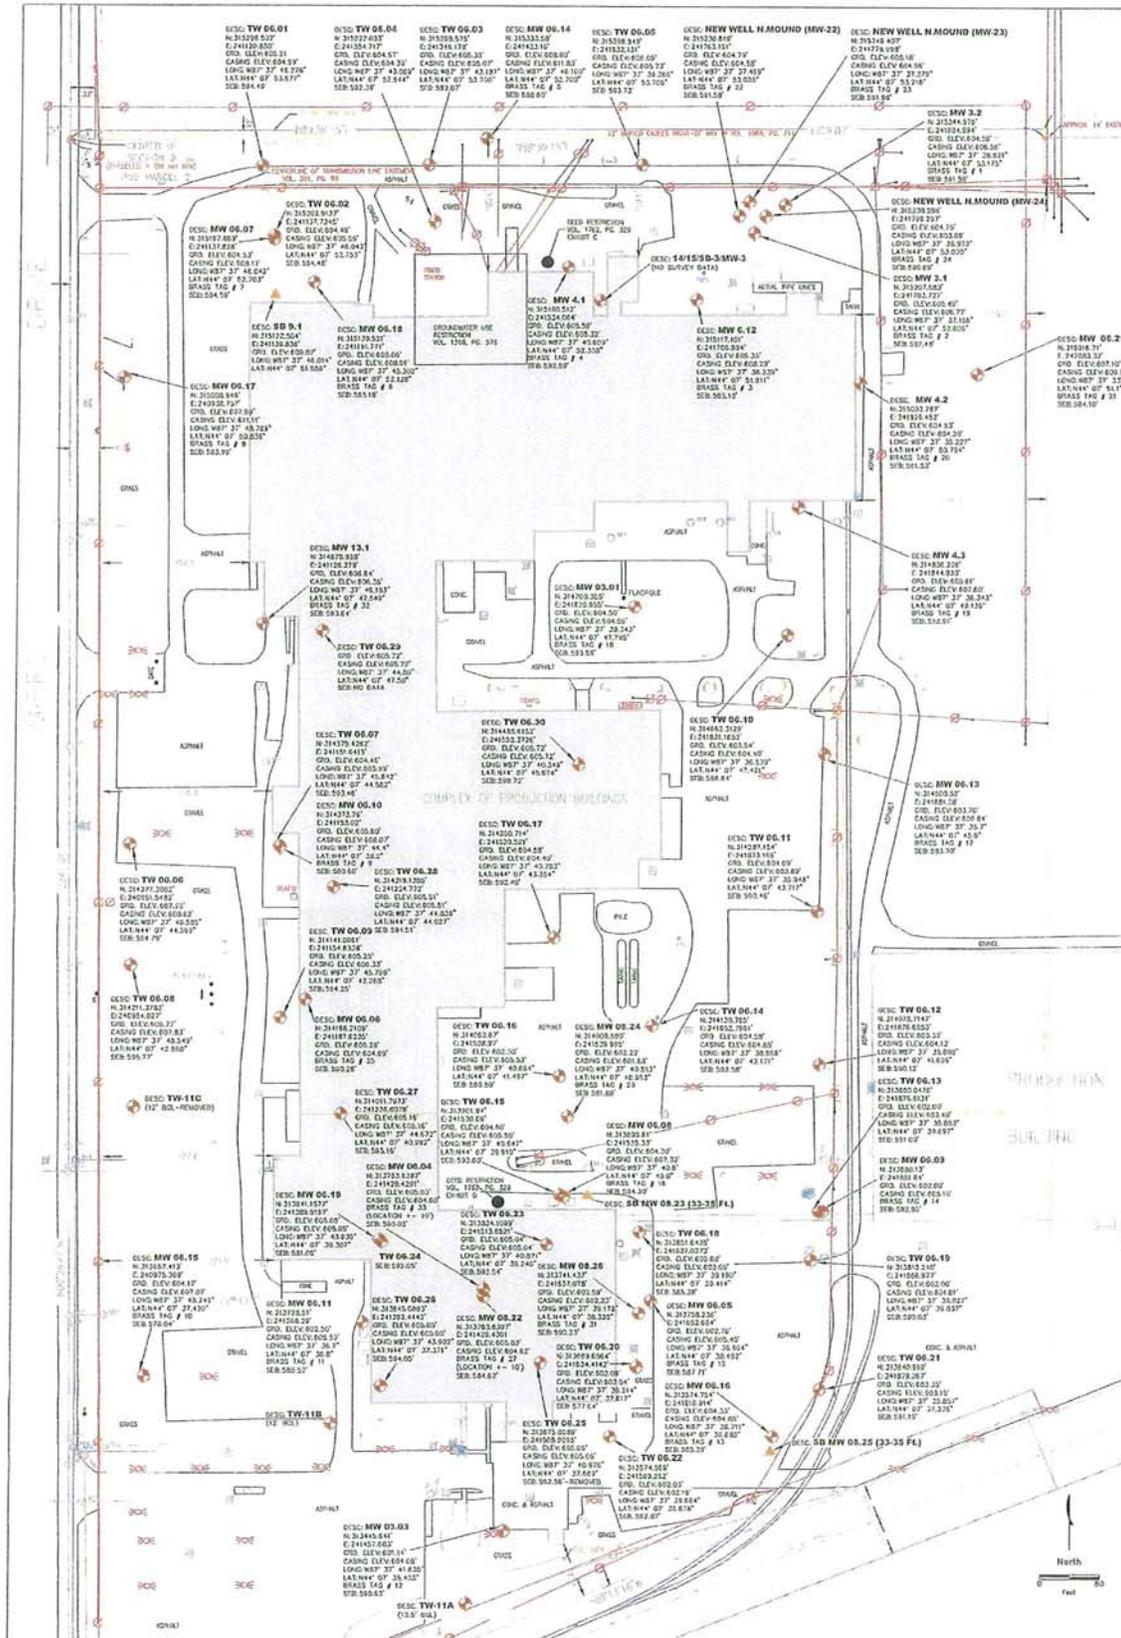
Well Locations, Screen Depths & Soil Sample Locations (SB MW 08.23 & SB MW 08.25)
 Skana Aluminum Company
 Menitowoc, Wisconsin
 (Nov 2011)

MONITORING WELL DATA ACQUIRED BY STERNBERGER & MENAUE, INC., DECEMBER 3, 2010.
 NOTE: THE LATITUDE AND LONGITUDE SHOWN IS BASED ON A COORDINATION FROM THE
 MANITOWOC COUNTY COORDINATE. THE ELEVATION DATUM IS USGS (NAVD83).
 SOL BORING LOCATION (SB MW 08.23, SB MW 08.25) (SAMPLE DEPTH IN FEET)
 SB - WELL SCREEN BOTTOM ELEVATION
 Prepared by: Environmental Consulting & Technology, Inc.
 Adapted from an ALTA/ACSM Land Title Survey by Andrew Czerwanka.

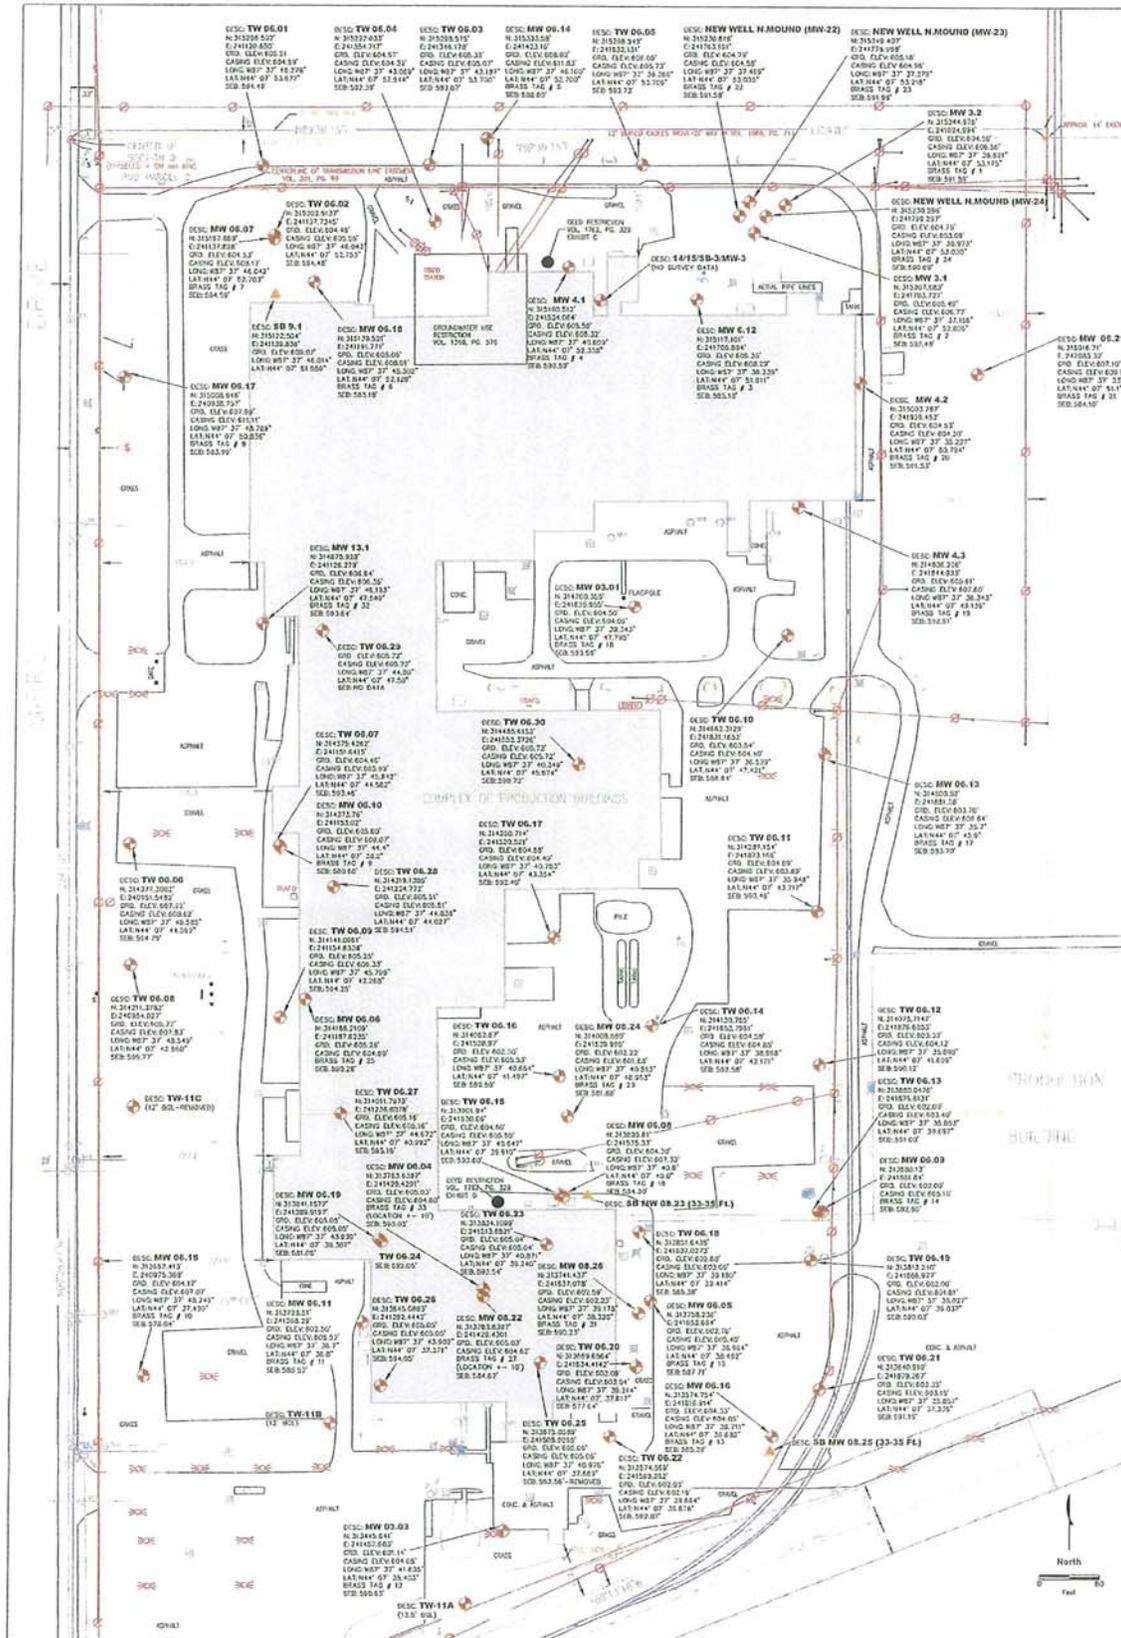
Well Locations, Screen Depths & Soil Sample Locations (SB MW 08.23 & SB MW 08.25)
 Skana Aluminum Company
 Manitowoc, Wisconsin
 (Nov 2011)

MONITORING WELL DATA ACQUIRED BY STERNBERGER & MENAUE, INC., DECEMBER 3, 2010.
 NOTE: THE LATITUDE AND LONGITUDE SHOWN IS BASED ON A COORDINATION FROM THE MANITOWOC COUNTY COORDINATE. THE ELEVATION DATUM IS USGS (NAVD83).
 SOL BORING LOCATION (SB MW 08.23, SB MW 08.25) (SAMPLE DEPTH IN FEET)
 SB - WELL SCREEN BOTTOM ELEVATION

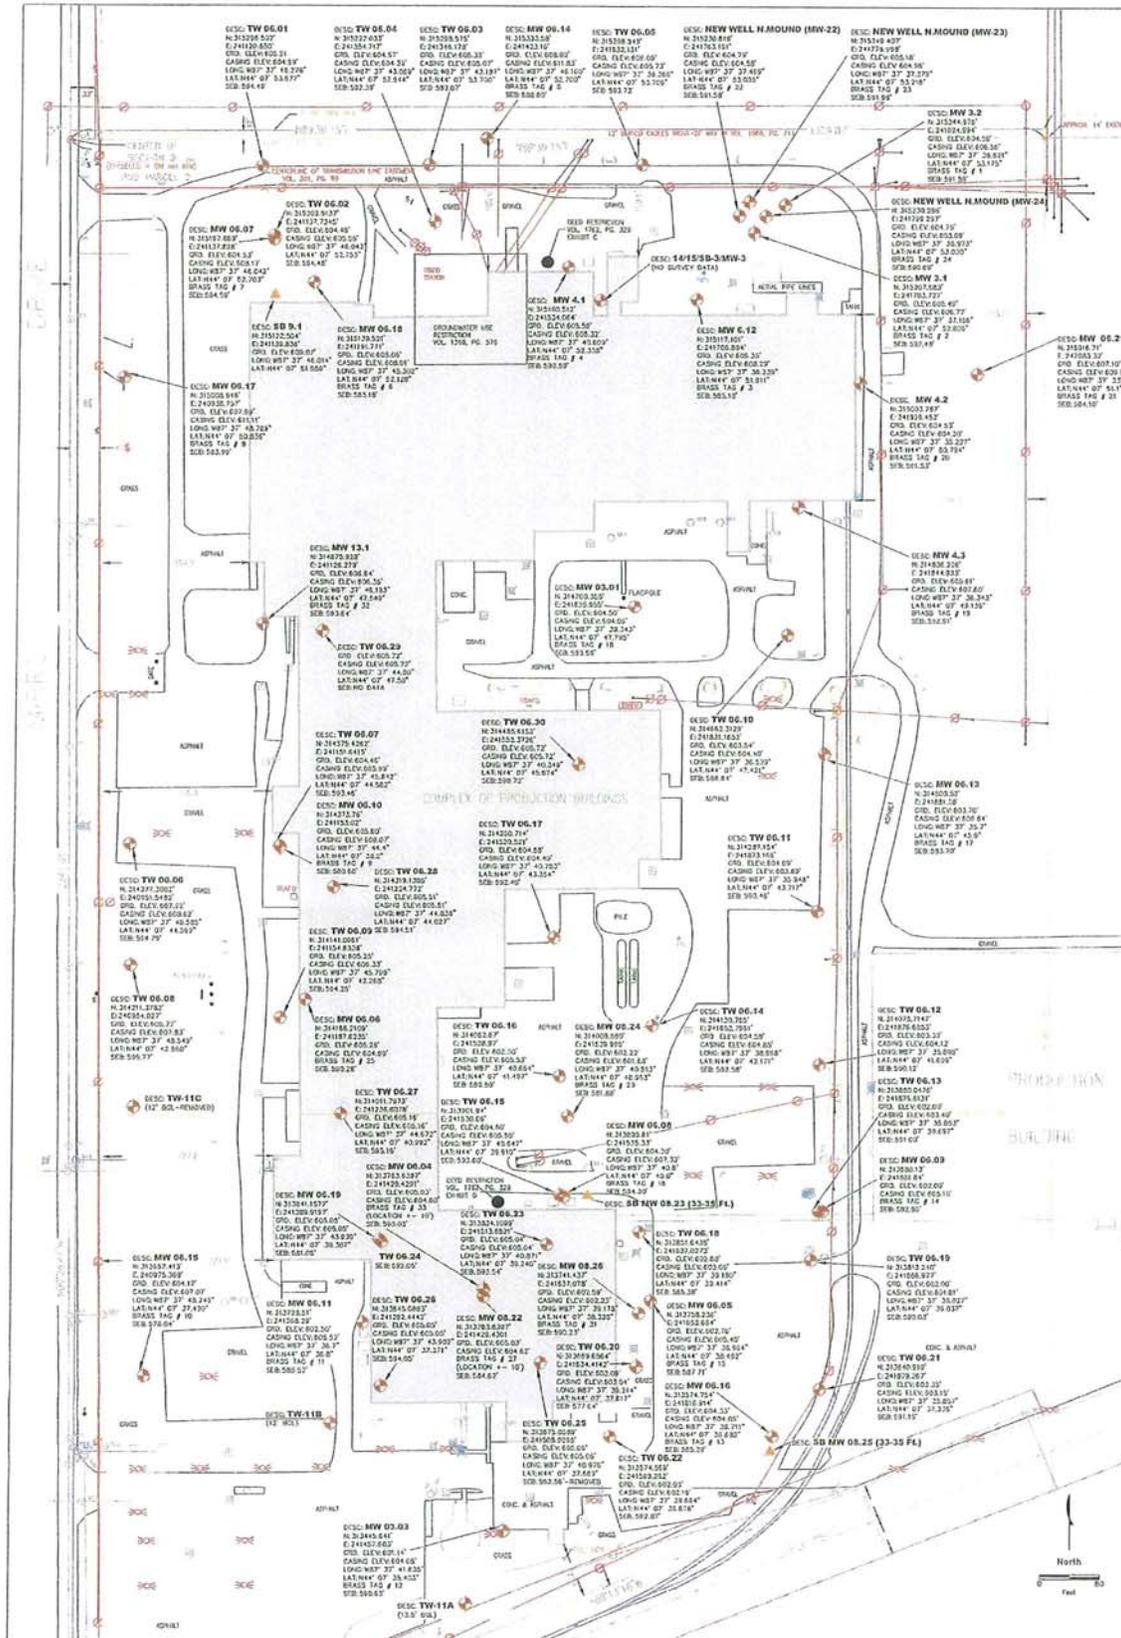
Well Locations, Screen Depths & Soil Sample Locations (SB MW 08.23 & SB MW 08.25)
 Skana Aluminum Company
 Menitowoc, Wisconsin
 (Nov 2011)

MONITORING WELL DATA ACQUIRED BY STERNBERGER & MENAUE, INC., DECEMBER 3, 2010.
 NOTE: THE LATITUDE AND LONGITUDE SHOWN IS BASED ON A CONVERSION FROM THE
 MANITOWOC COUNTY COORDINATE. THE ELEVATION DATUM IS USGS (NAVD83).
 SOL BORING LOCATION (SB MW 08.23, SB MW 08.25) (SAMPLE DEPTH IN FEET)
 SB - WELL SCREEN BOTTOM ELEVATION
 Prepared by: Environmental Consulting & Technology, Inc.
 Adapted from an ALTA/ACSM Land Title Survey by Andrew Czerwanka.

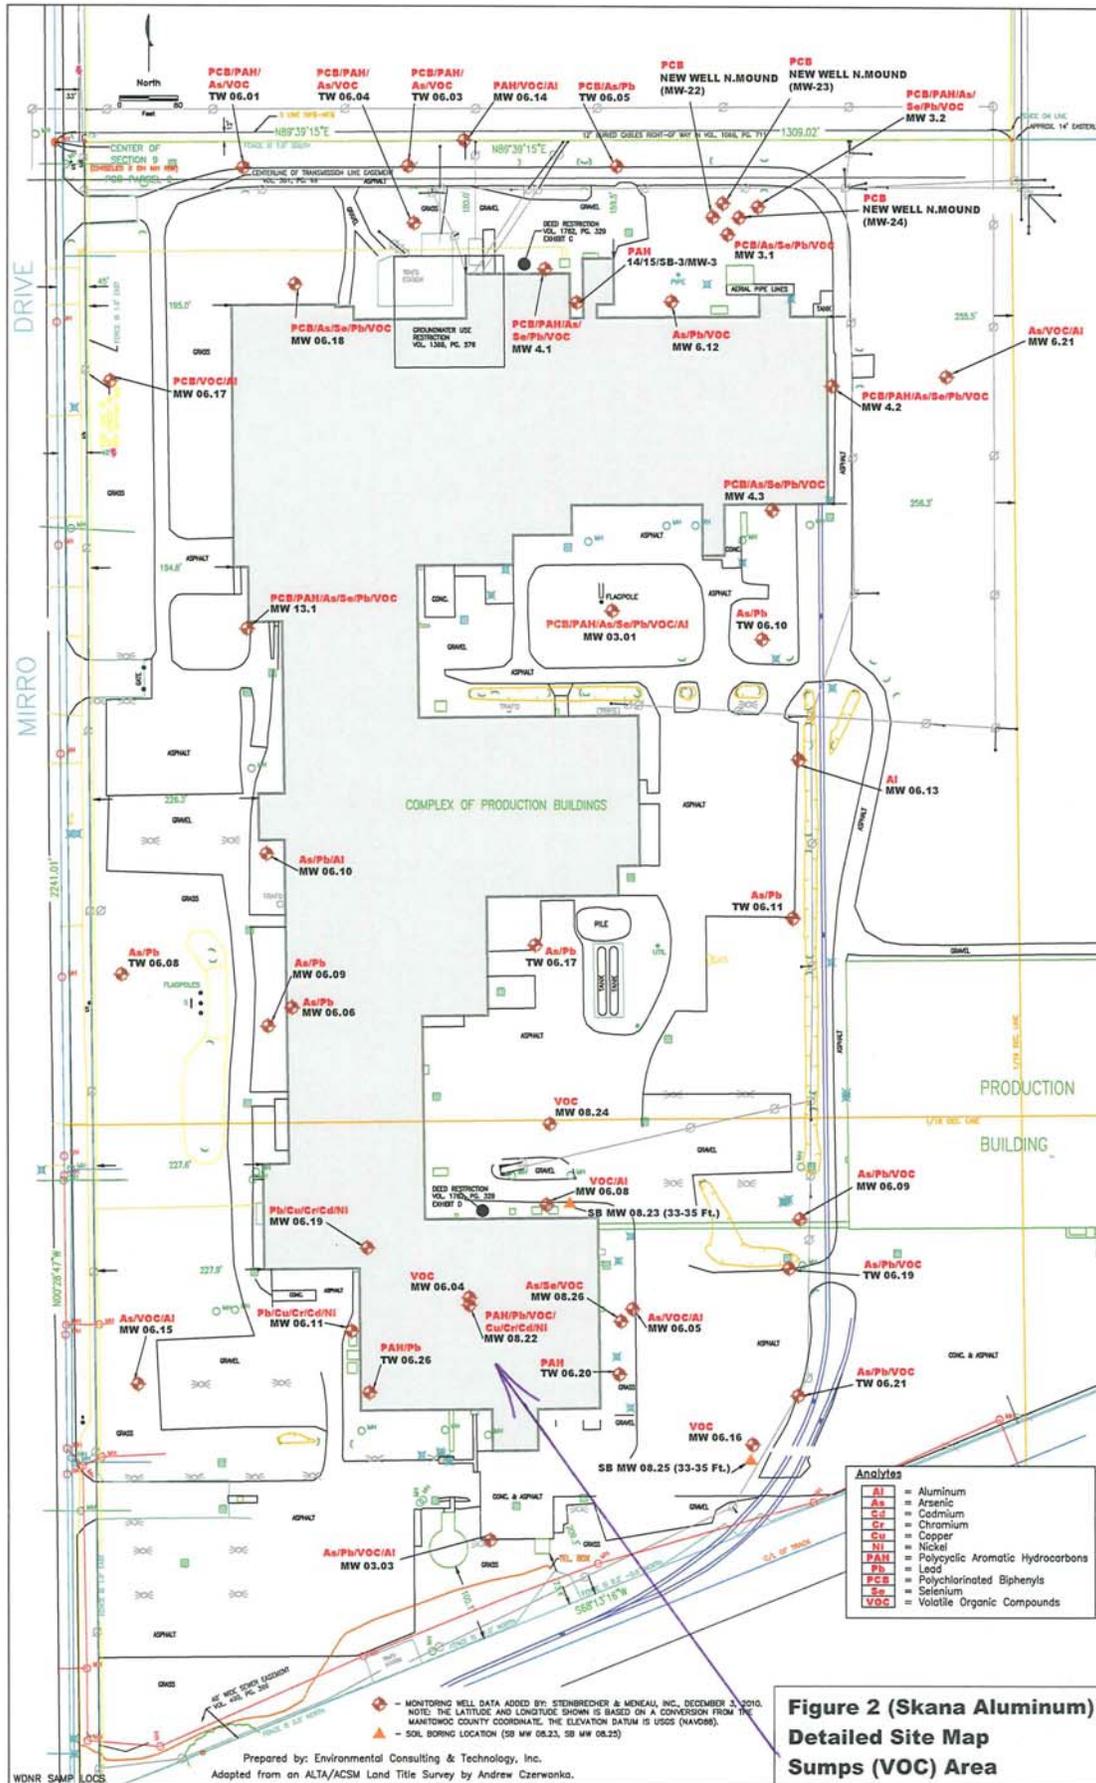
**Figure 2 (Skana Aluminum)
Detailed Site Map
Sumps (VOC) Area**

Analytes	
Al	= Aluminum
As	= Arsenic
Cd	= Cadmium
Cr	= Chromium
Cu	= Copper
Ni	= Nickel
PAH	= Polycyclic Aromatic Hydrocarbons
Pb	= Lead
PCB	= Polychlorinated Biphenyls
Se	= Selenium
VOC	= Volatile Organic Compounds

Certain activities are prohibited at closed sites because maintenance of a barrier is intended to prevent contact with any remaining contamination. When a barrier is required, the condition of closure requires notification of the DNR before making a change, in order to determine if further action is needed to maintain the protectiveness of the remedy employed. The following activities are prohibited on any portion of the property where pavement and the building foundation are required, as shown on the shaded area of attached Figure 2, unless prior written approval has been obtained from the DNR:

The pavement and building that exists in the shaded areas shown on the **attached Figure 2** shall be maintained in compliance with the **attached maintenance plan** in order to minimize the infiltration of water and prevent additional groundwater contamination that would violate the groundwater quality standards in ch. NR 140, Wis. Adm. Code, and to prevent direct contact with residual soil contamination that might otherwise pose a threat to human health.
