# GIS REGISTRY

The Department of Natural Resources (DNR) considers the "Malchow Property (former)" case closed, with continuing obligations. No further investigation or remediation is required at this time. However, you and future property owners must comply with the continuing obligations as explained in the conditions of closure in this letter. Please read over this letter closely to ensure that you comply with all conditions and other on-going requirements. Provide this letter and any attached maintenance plan to anyone who purchases this property from you.

A former dry cleaner operated at this site, leaving residual soil and groundwater contaminated with chlorinated volatile organic compounds (CVOCs). Source area soils were excavated in October 2005, followed by long-term monitoring for natural attenuation. At present, the site is paved and utilized as a used car sales lot with no structures present. The conditions of closure and continuing obligations required were based on the property being used for commercial purposes.

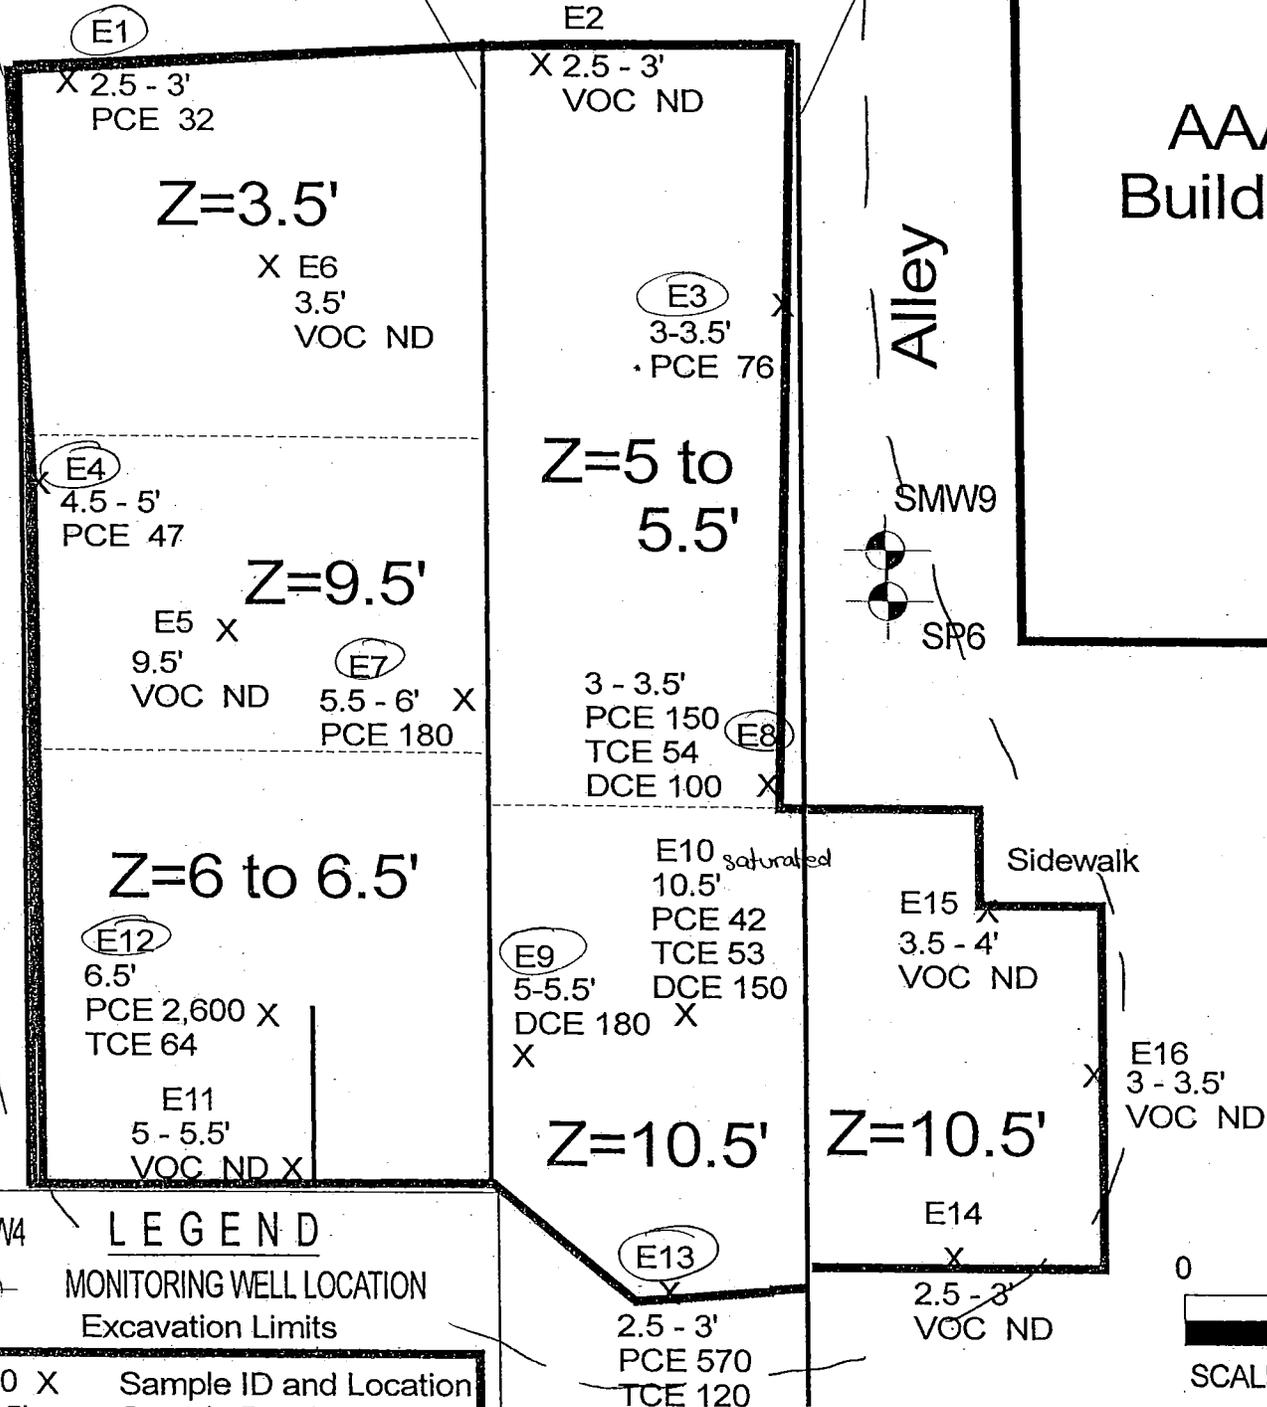
TITLE: REMEDIAL EXCAVATION SOIL CHEMISTRY OCTOBER 11, 2005		 <b>ALPHA TERRA</b> SCIENCE	
SITE: Malchow Property - Appleton, WI			
DATE: 10/25/05		DRAWN BY: JPM	FIGURE 4

- Monitoring Well Location
- Excavation Limits
- 10 X Sample ID and Location
- 0.5' Sample Depth
- PCE 42 Tetrachloroethene
- PCE 53 Trichloroethene
- PCE 150 cis-1,2-Dichloroethene
- Z=10.5' Excavation Depth
- All units in ug/kg
- Only Detected Compounds Are Shown

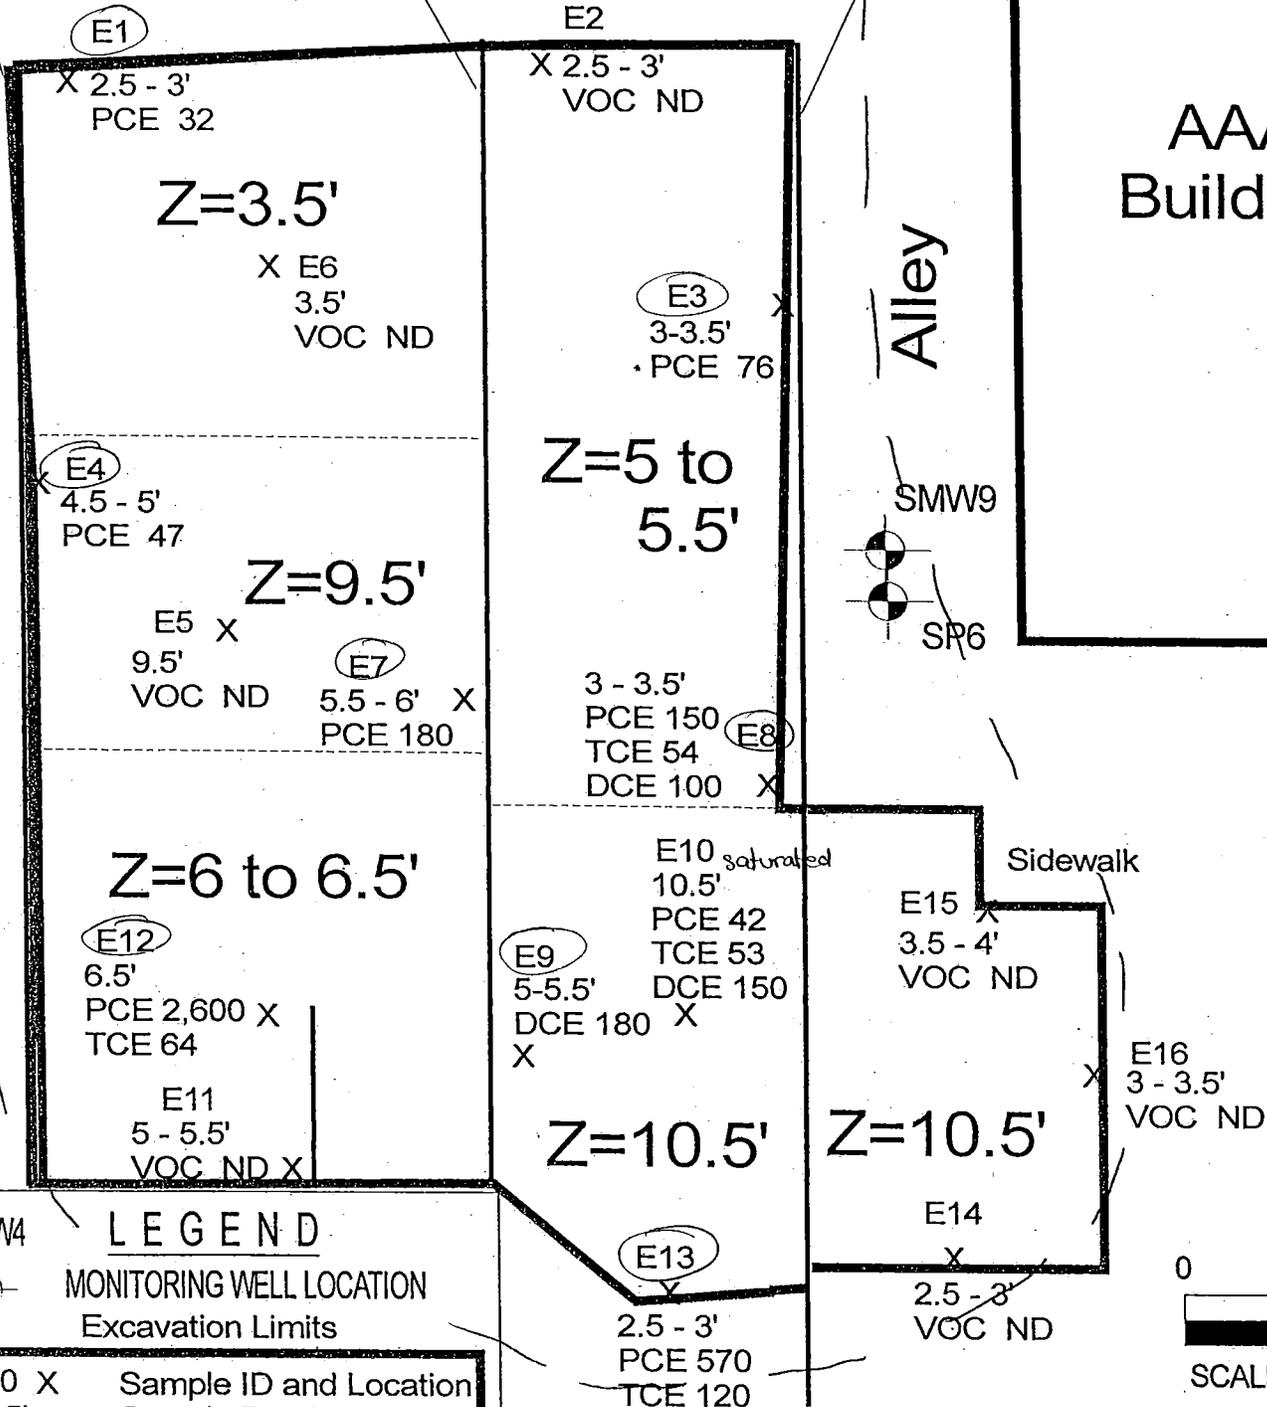
TITLE: REMEDIAL EXCAVATION SOIL CHEMISTRY OCTOBER 11, 2005		 <b>ALPHA TERRA</b> SCIENCE
SITE: Malchow Property - Appleton, WI		
DATE: 10/25/05	SCALE: 1"=10'	FILE: DRAWN BY: JPM <b>FIGURE 4</b>

- SMW4 MONITORING WELL LOCATION
- Excavation Limits
- 10 X Sample ID and Location
- 0.5' Sample Depth
- PCE 42 Tetrachloroethene
- PCE 53 Trichloroethene
- PCE 150 cis-1,2-Dichloroethene
- Z=10.5' Excavation Depth
- All units in ug/kg
- Only Detected Compounds Are Shown

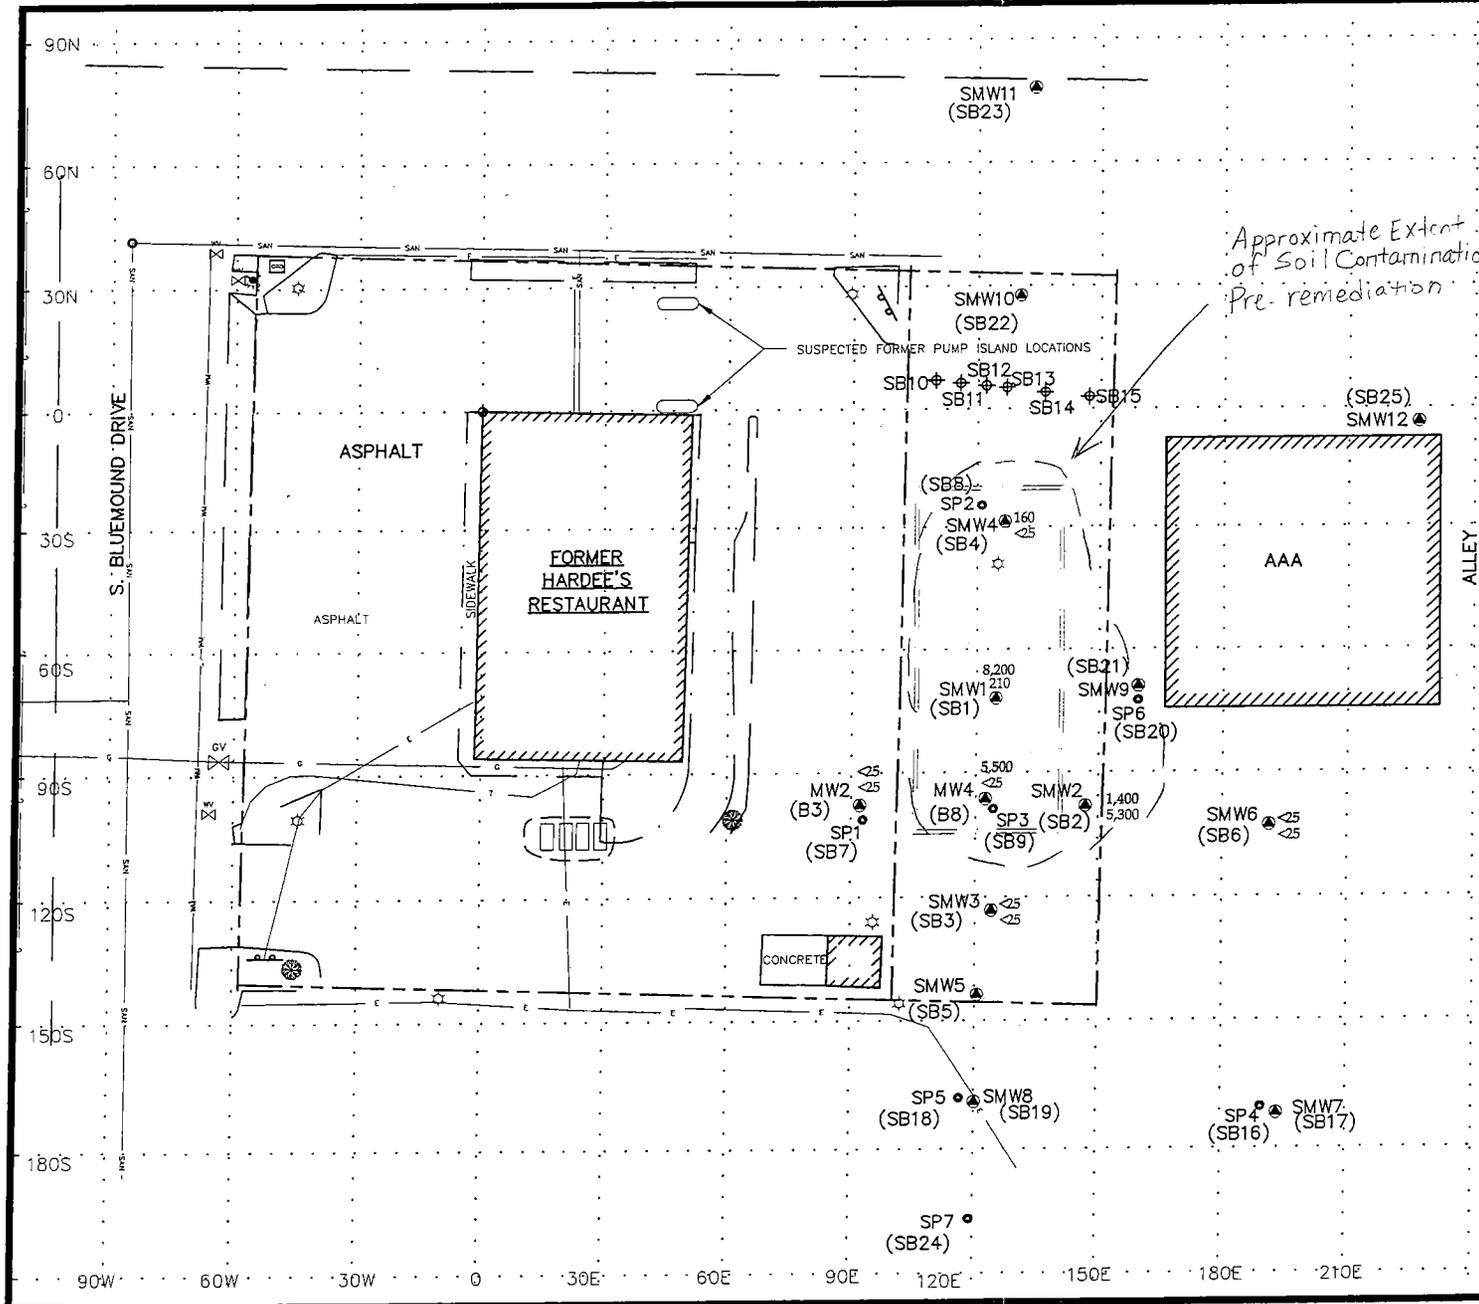
- 8200 Tetrachloroethene Concentration in Soil (ppb)
- 210 Trichloroethene Concentration in Soil (ppb)
- MW4 ● Well Location and I.D. No.
- SP4 ● Piezometer Location and I.D. No.
- SB1 ◆ Soil Boring Location and I.D. No.
- ▬▬▬ Former Building Foundation
- ▭ Suspected Former Tank Location
- ▬▬▬ 6,000 Gallon Gasoline USTs
- ▬▬▬ Property Line
- - - - - Approximate Limit of Excavation
- ▬▬▬ Edge of Asphalt
- ▬▬▬ Edge of Concrete Pavement
- ▨▨▨ Building Face
- ⊕ Hydrant
- ⊗ Water Valve
- ⊗ Gas Valve
- c — Gas Line
- w — Watermain
- t — Telephone Cable
- ☐ Telephone Booth
- ☆ Light Post
- SAN — Sanitary Line with Manhole
- E — Electrical Line
- ◆ Reference Point
- 30N - - - Grid Line (30' Interval)

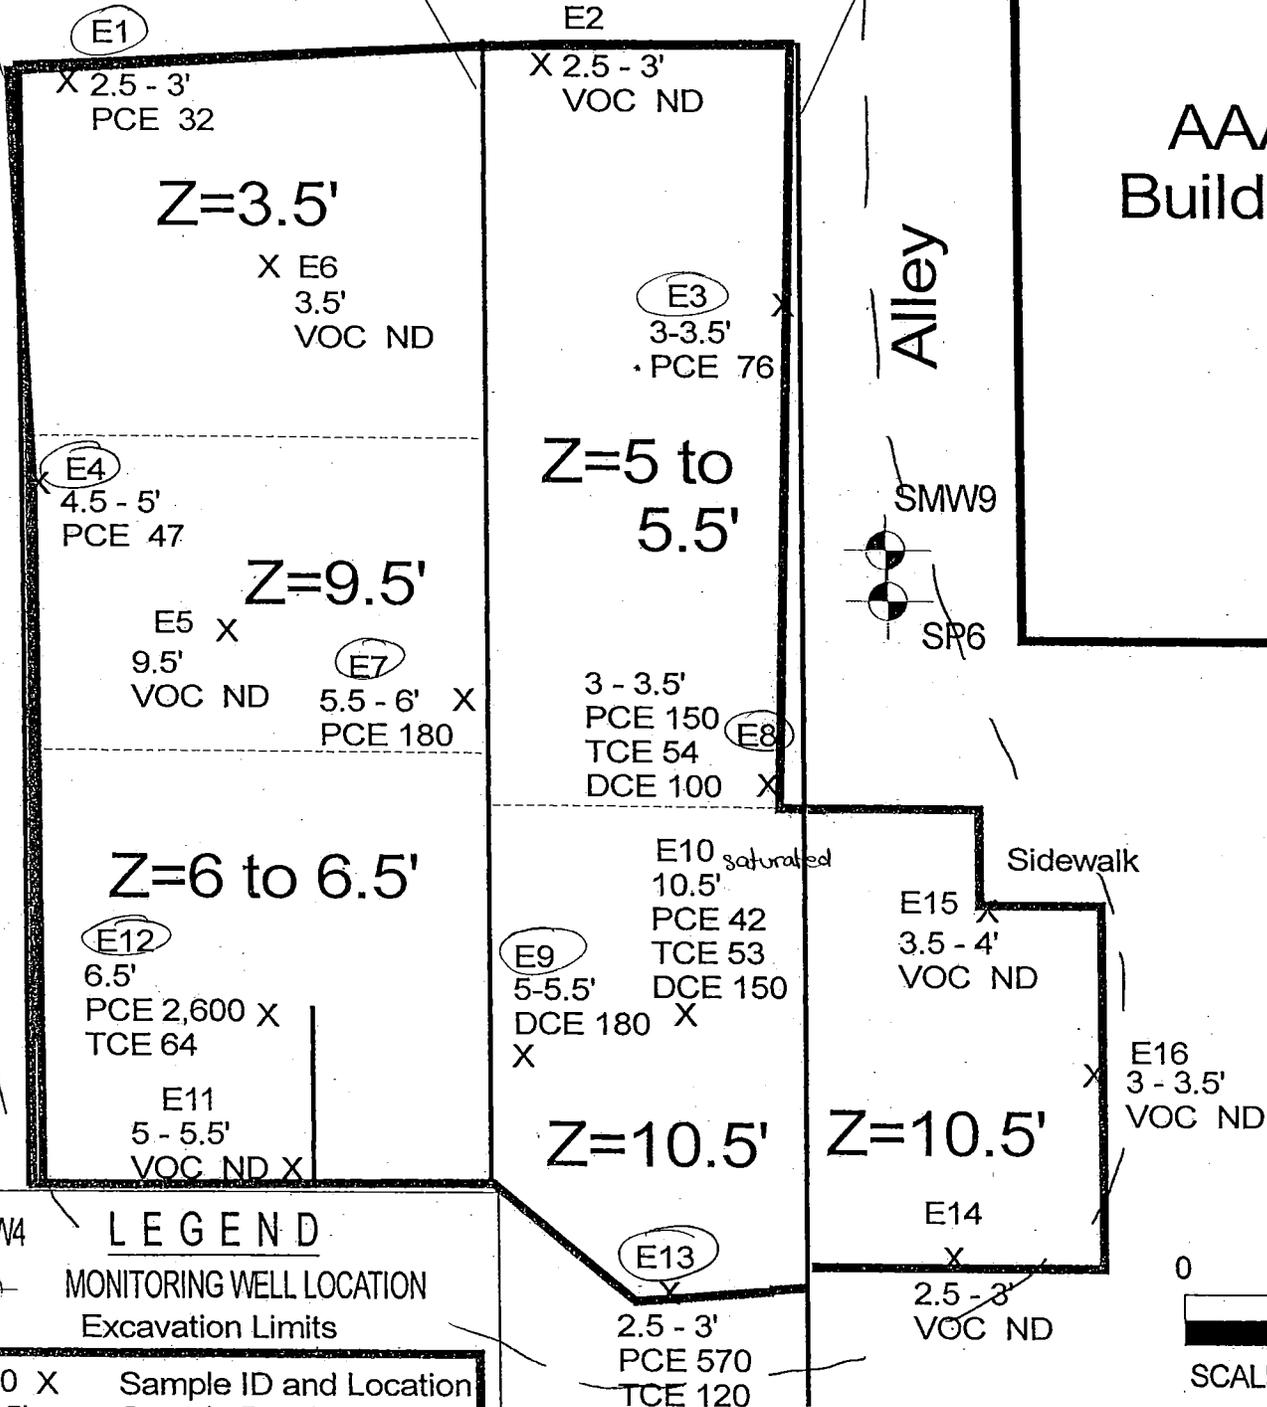
TITLE: REMEDIAL EXCAVATION SOIL CHEMISTRY OCTOBER 11, 2005		 <b>ALPHA TERRA</b> SCIENCE	
SITE: Malchow Property - Appleton, WI			
DATE: 10/25/05		DRAWN BY: JPM	<b>FIGURE 4</b>

- Monitoring Well Location
- Excavation Limits
- 10 X Sample ID and Location
- 0.5' Sample Depth
- PCE 42 Tetrachloroethene
- PCE 53 Trichloroethene
- PCE 150 cis-1,2-Dichloroethene
- Z=10.5' Excavation Depth
- All units in ug/kg
- Only Detected Compounds Are Shown

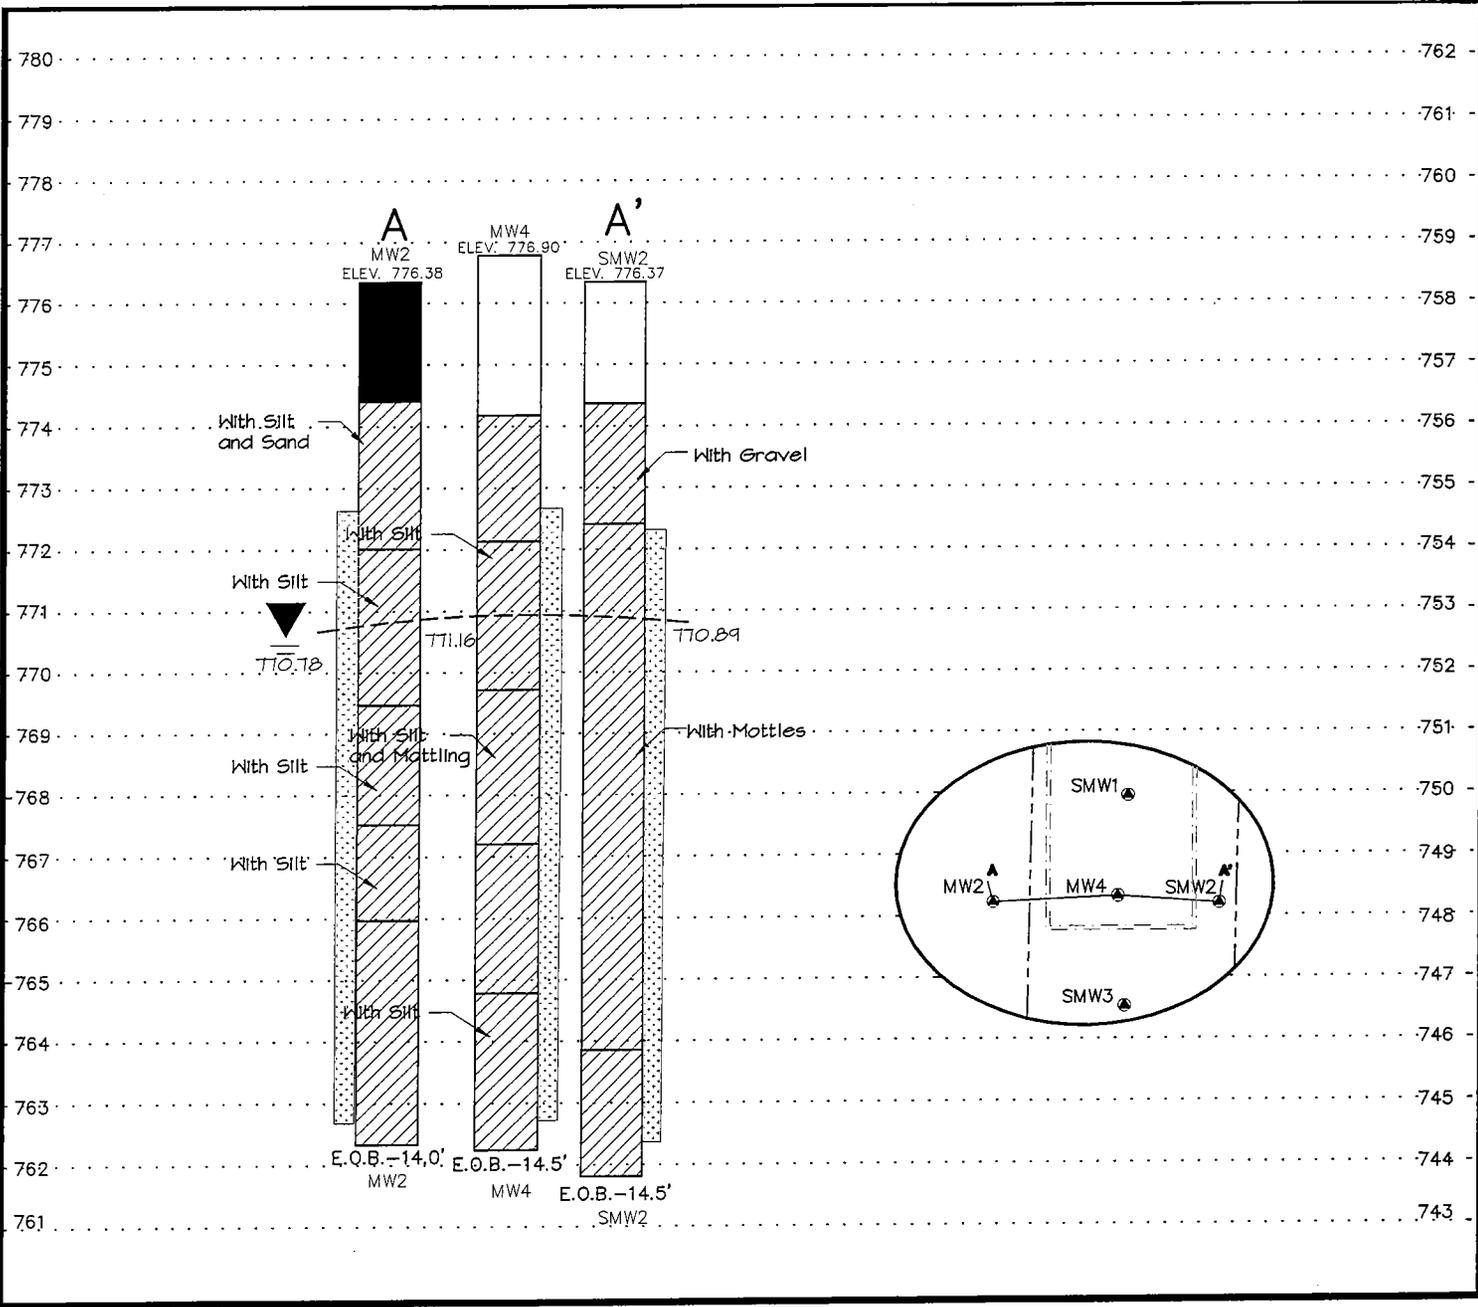
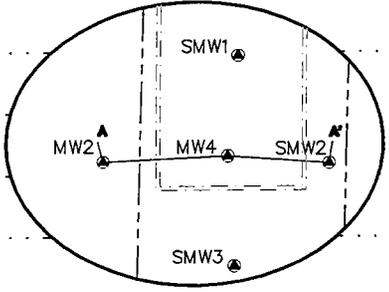
**FIGURE 5**  
 DIAGRAMMATIC CROSS-SECTION  
 OF STRATIGRAPHY FROM A TO A'

- LEGEND:**
- Asphalt
  - Clay
  - Screened interval
  - Water Table (9/13/00)
  - Groundwater Line
  - 770.89 Groundwater Elevation (1/31/03)

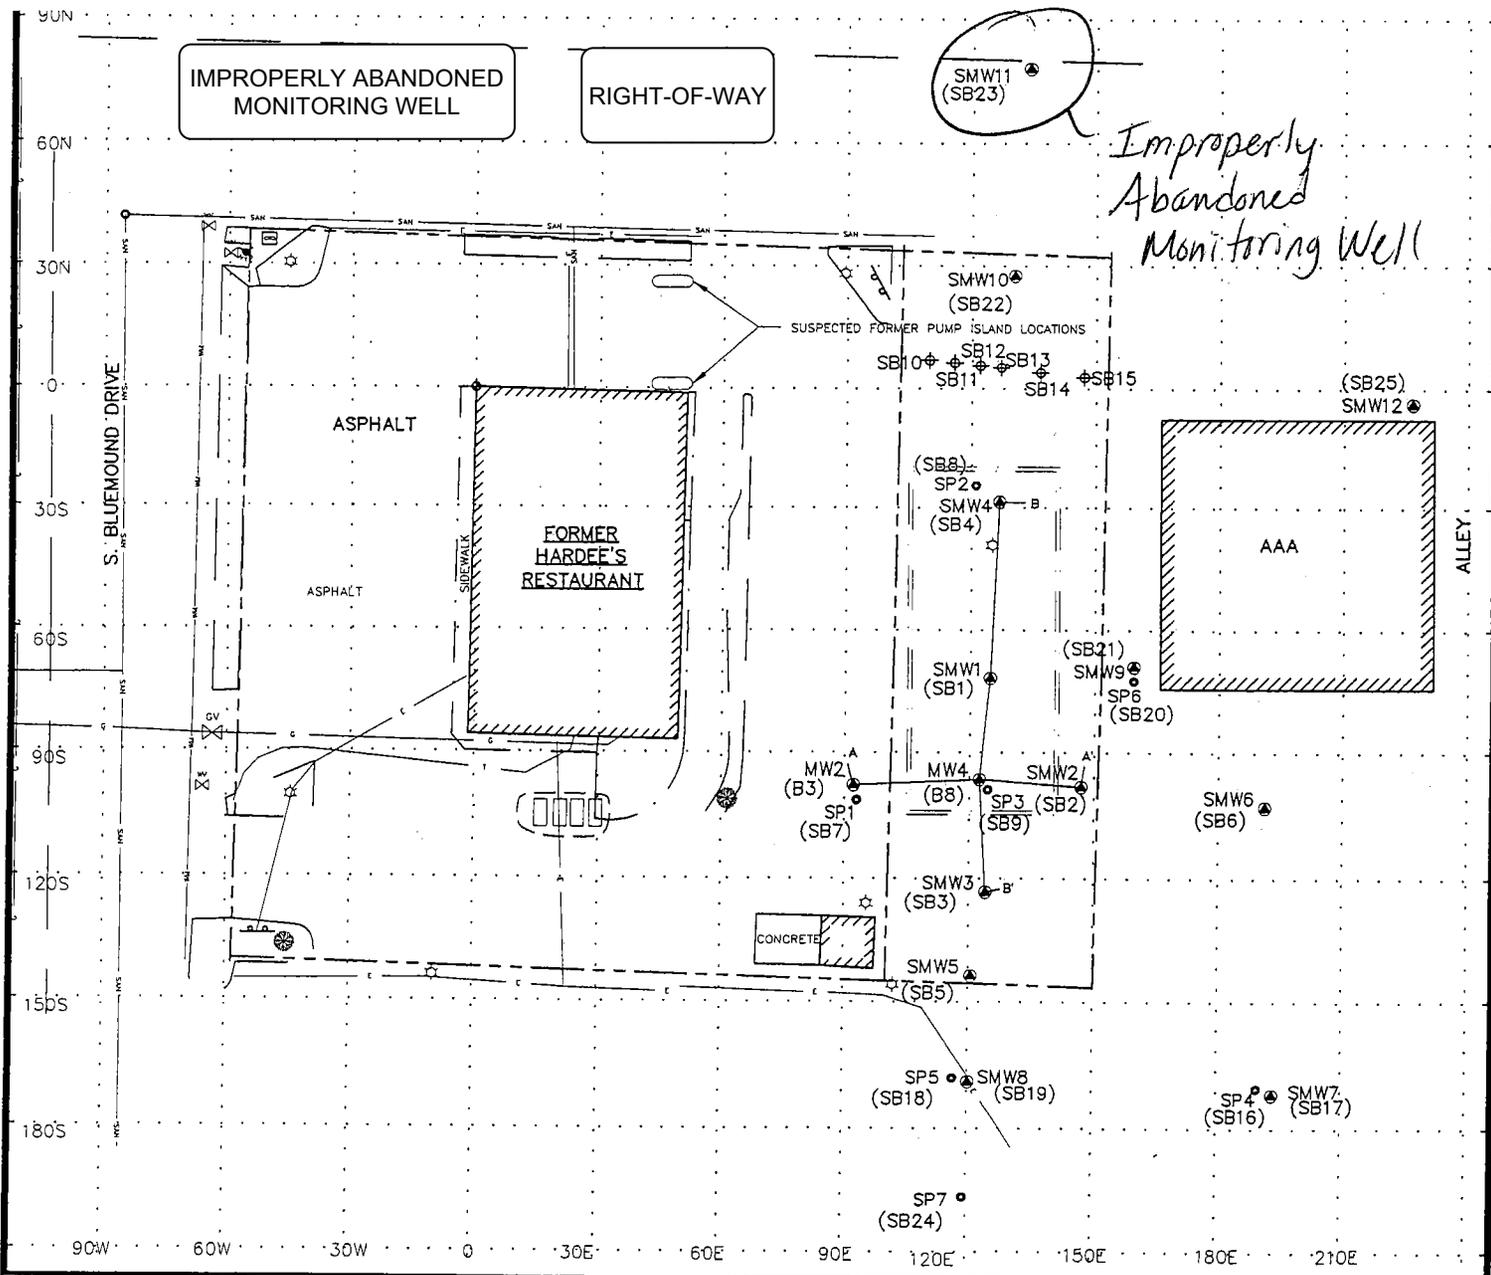
**FIGURE 2  
SITE DETAIL MAP**

- Cross Section
- MW4 Well Location and I.D. No.
- SP4 Piezometer Location and I.D. No.
- SB1 Soil Boring Location and I.D. No.
- Former Building Foundation
- Suspected Former Tank Location
- 6,000 Gallon Gasoline USTs
- Property Line
- Approximate Limit of Excavation
- Edge of Asphalt
- Edge of Concrete Pavement
- Building Face
- Hydrant
- Water Valve
- Gas Valve
- Gas Line
- Watermain
- Telephone Cable
- Telephone Booth
- Light Post
- Sanitary Line with Manhole
- Electrical Line
- Reference Point
- Grid Line (30' Interval)

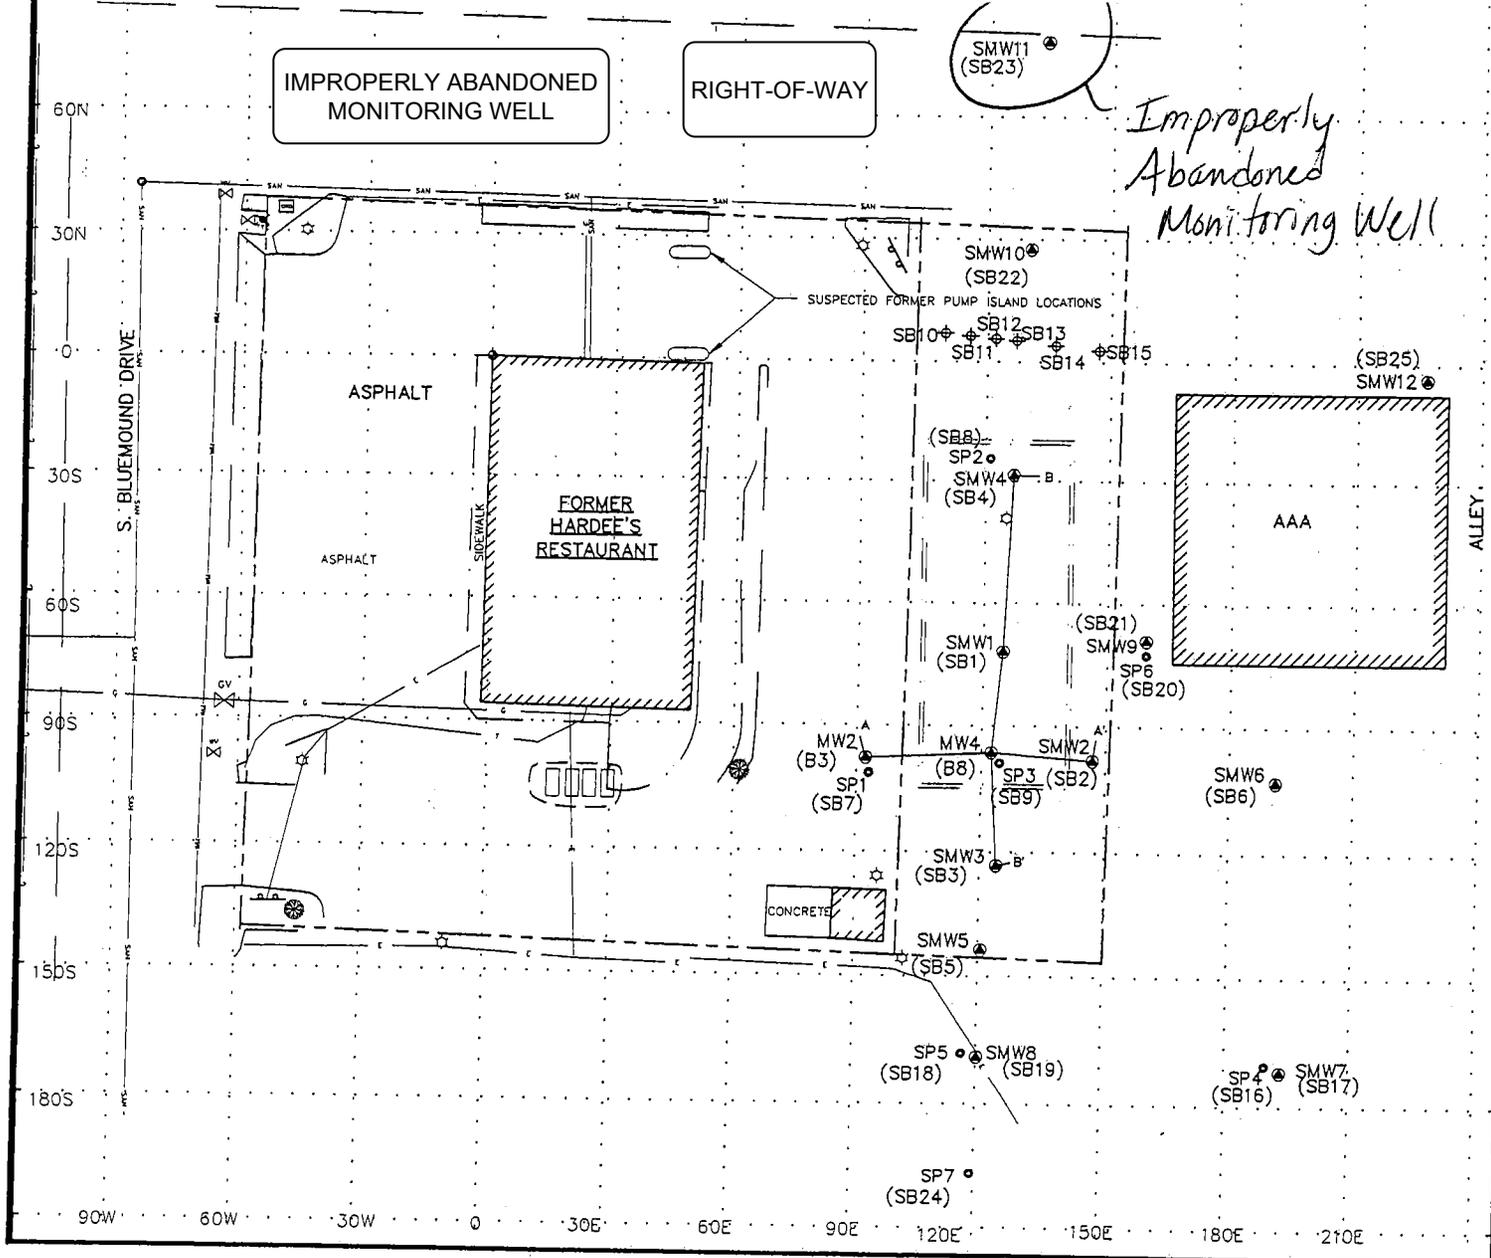
**FIGURE 2  
SITE DETAIL MAP**

- Cross Section**
- MW4 ● Well Location and I.D. No.
  - SP4 ● Piezometer Location and I.D. No.
  - SB1 ⊕ Soil Boring Location and I.D. No.
  - ▬▬▬ Former Building Foundation
  - ▭ Suspected Former Tank Location
  - ▬▬▬ 6,000 Gallon Gasoline USTs
  - ▬▬▬ Property Line
  - - - - - Approximate Limit of Excavation
  - ▬▬▬ Edge of Asphalt
  - ▬▬▬ Edge of Concrete Pavement
  - ▬▬▬ Building Face
  - ⊕ Hydrant
  - ⊕ Water Valve
  - ⊕ Gas Valve
  - ▬ Gas Line
  - ▬ Watermain
  - ▬ Telephone Cable
  - ⊕ Telephone Booth
  - ⊕ Light Post
  - ▬ Sanitary Line with Manhole
  - ▬ Electrical Line
  - ⊕ Reference Point
  - 30N - - - Grid Line (30' Interval)

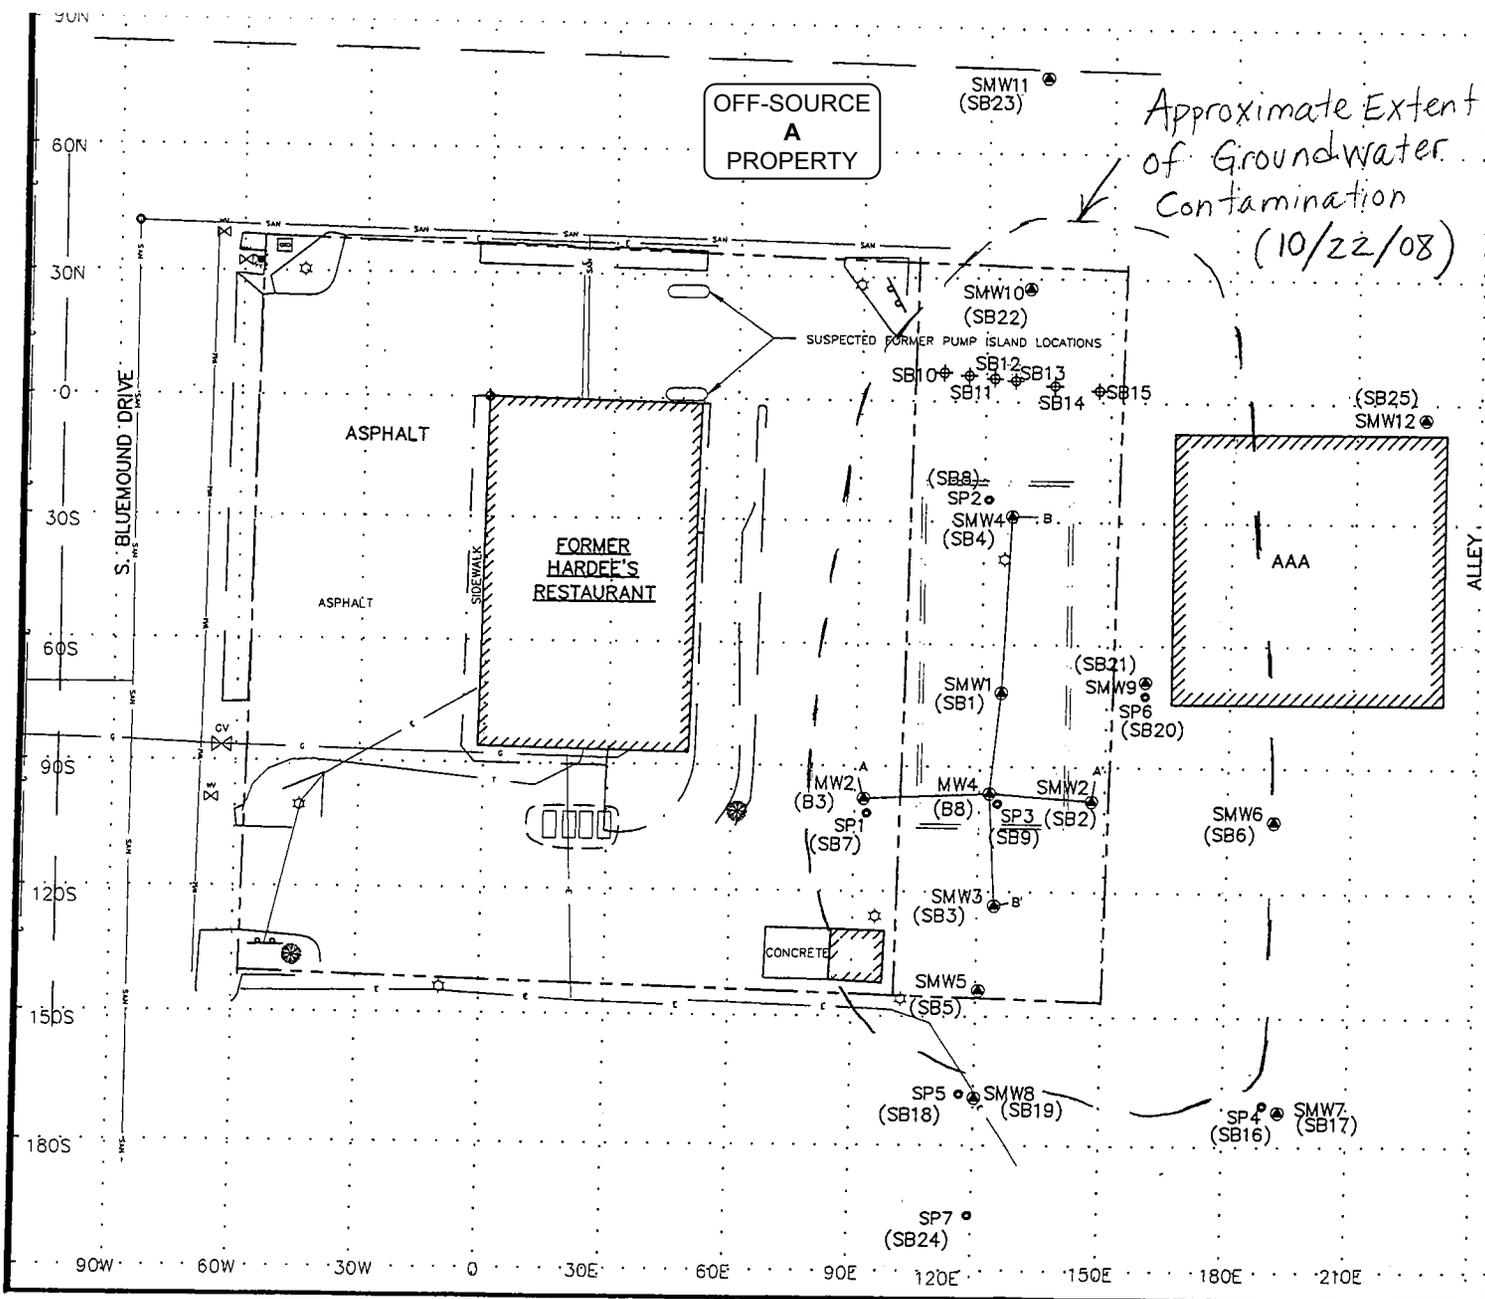
FIGURE 7  
Approximate Extent of Groundwater Contamination (10/22/08)

- SCALE: 1" = 30'
- LOCAL GRID NORTH
- Legend:
- Cross Section
  - MW4 ● Well Location and I.D. No.
  - SP4 ● Piezometer Location and I.D. No.
  - SB1 ⊕ Soil Boring Location and I.D. No.
  - ▭ Former Building Foundation
  - ▭ Suspected Former Tank Location
  - ▭ 6,000 Gallon Gasoline USTs
  - Property Line
  - - - Approximate Limit of Excavation
  - Edge of Asphalt
  - - - Edge of Concrete Pavement
  - ▨ Building Face
  - ⊕ Hydrant
  - ⊕ Water Valve
  - ⊕ Gas Valve
  - Gas Line
  - Watermain
  - Telephone Cable
  - ⊕ Telephone Booth
  - ☆ Light Post
  - Sanitary Line with Manhole
  - Electrical Line
  - ⊕ Reference Point
  - 30N - - - Grid Line (30' Interval)

The asphalt cover overlying the contaminated soil and groundwater on-site and as depicted in Figure 7 will be inspected once a year, normally in the spring after all snow and ice is gone, for deterioration, cracks and other potential problems that can cause additional infiltration into underlying soils. The inspections will be performed by the property owner or their designated representative. The inspections will be performed to evaluate damage due to settling, exposure to the weather, wear from traffic, increasing age and other factors. Any area where soils have become or are likely to become exposed and where infiltration from the surface will not be effectively minimized will be documented. A log of the inspections and any repairs will be

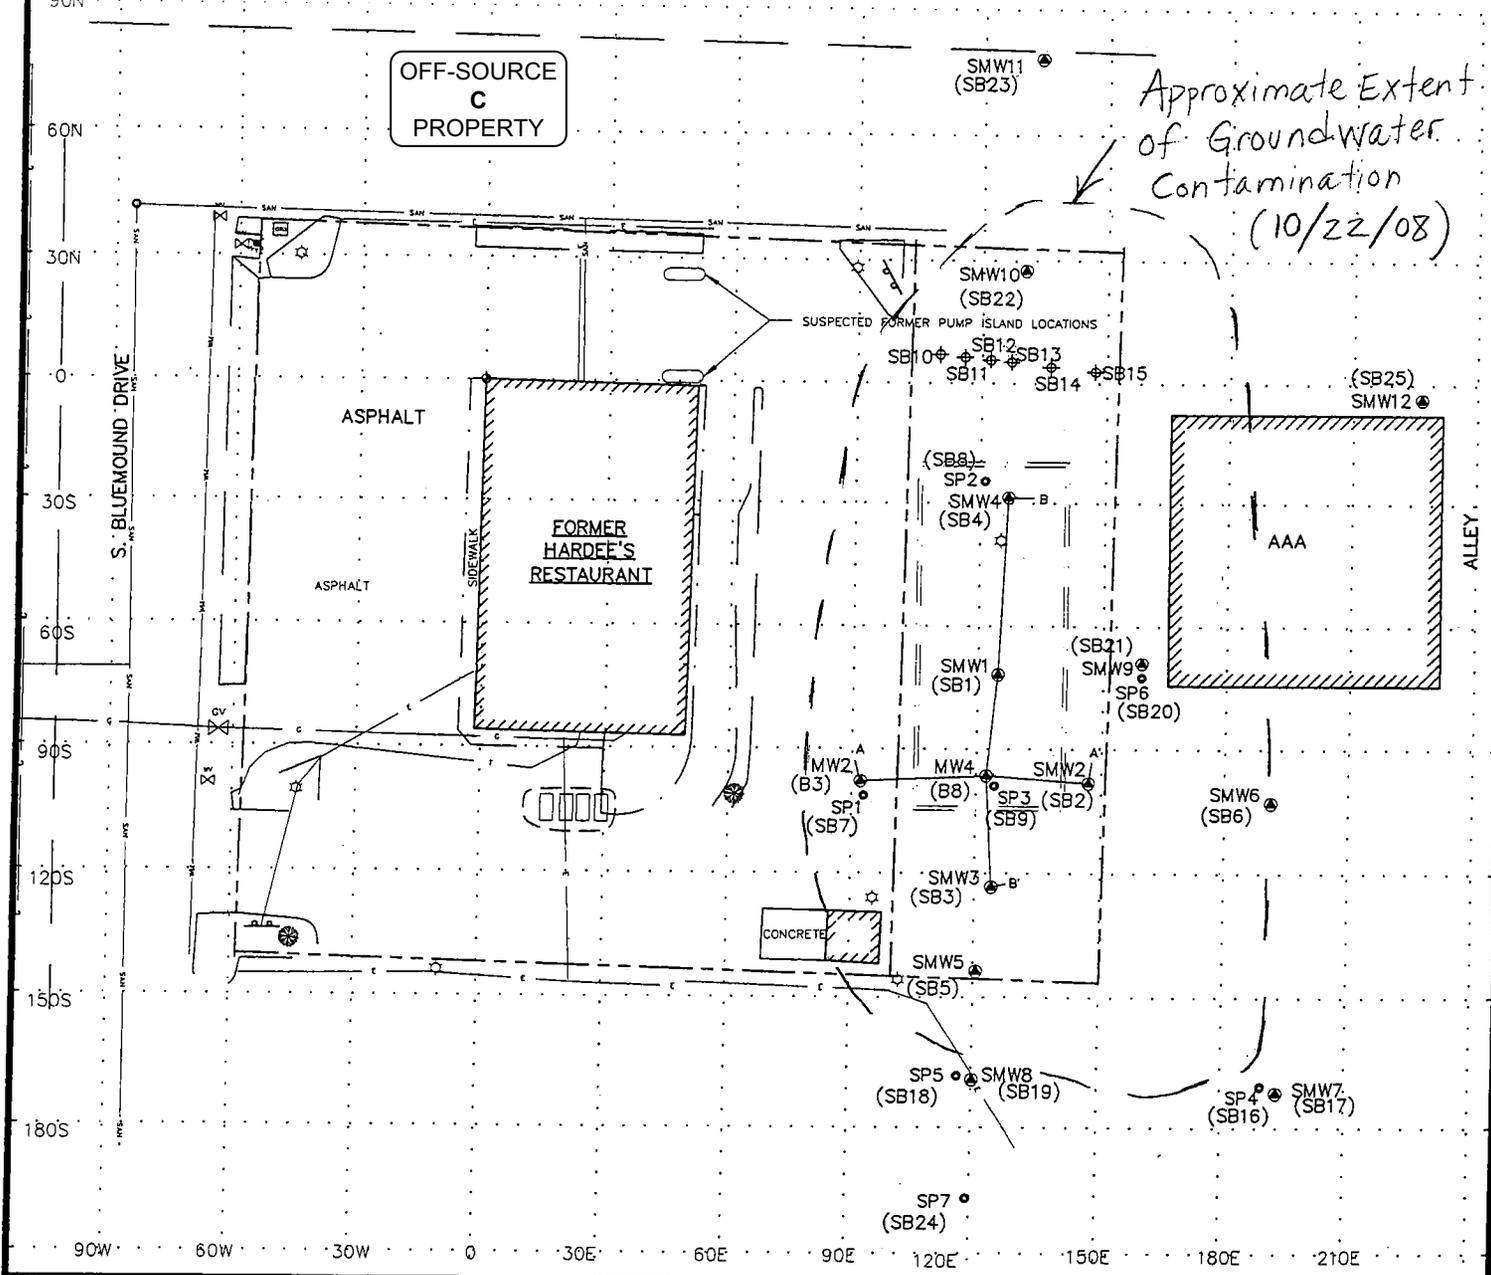
FIGURE 7  
Approximate Extent of Groundwater Contamination (10/22/08)

- SCALE: 1" = 30'
- LOCAL GRID NORTH
- Legend:
- B — B' — Cross Section
  - MW4 ⊙ Well Location and I.D. No.
  - SP4 ⊙ Piezometer Location and I.D. No.
  - SB1 ⊕ Soil Boring Location and I.D. No.
  - ▭ Former Building Foundation
  - ▭ Suspected Former Tank Location
  - ▭ 6,000 Gallon Gasoline USTs
  - — — Property Line
  - - - - - Approximate Limit of Excavation
  - — — Edge of Asphalt
  - — — Edge of Concrete Pavement
  - ▨ Building Face
  - ⊗ Hydrant
  - ⊗ Water Valve
  - ⊗ Gas Valve
  - — — Gas Line
  - — — Watermain
  - — — Telephone Cable
  - ⊞ Telephone Booth
  - ⊙ Light Post
  - — — Sanitary Line with Manhole
  - — — Electrical Line
  - ⊕ Reference Point
  - 30N - - - Grid Line (30' Interval)

The asphalt cover overlying the contaminated soil and groundwater on-site and as depicted in Figure 7 will be inspected once a year, normally in the spring after all snow and ice is gone, for deterioration, cracks and other potential problems that can cause additional infiltration into underlying soils. The inspections will be performed by the property owner or their designated representative. The inspections will be performed to evaluate damage due to settling, exposure to the weather, wear from traffic, increasing age and other factors. Any area where soils have become or are likely to become exposed and where infiltration from the surface will not be effectively minimized will be documented. A log of the inspections and any repairs will be

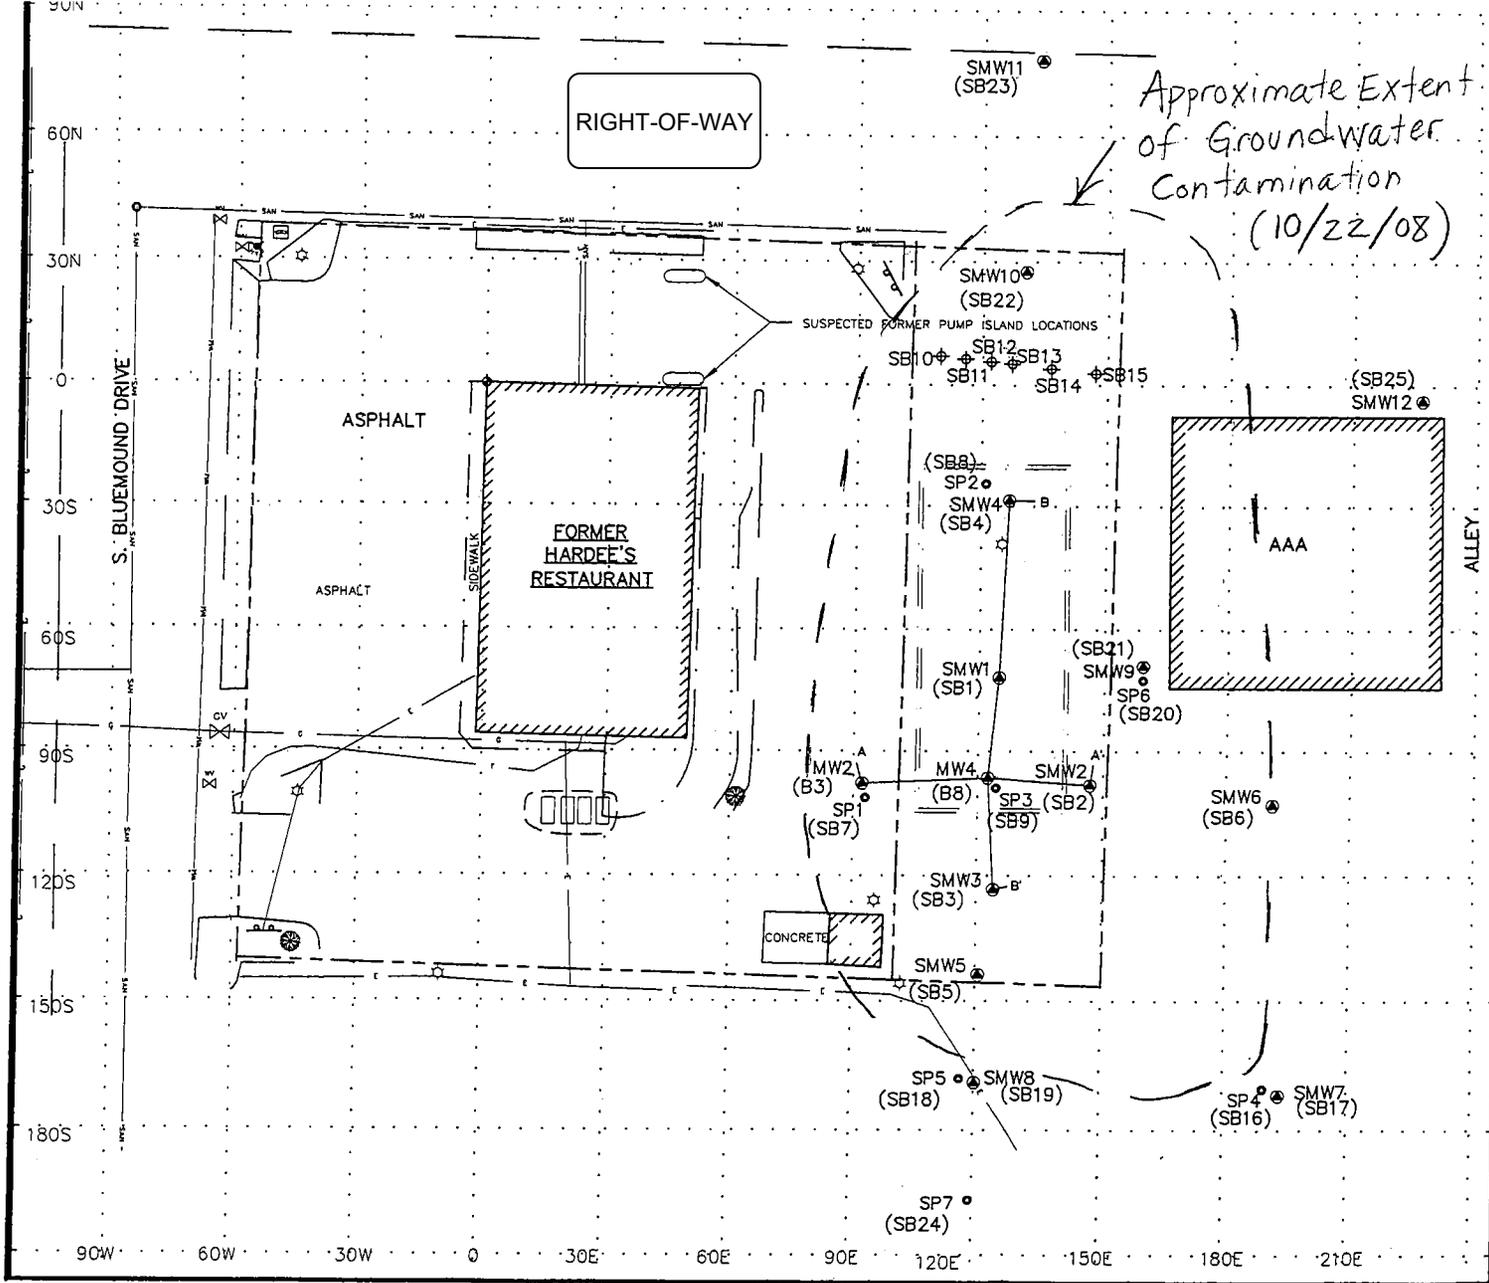
FIGURE 7  
Approximate Extent of Groundwater Contamination (10/22/08)

- SCALE: 1" = 30'
- LOCAL GRID NORTH
- Cross Section
  - MW4 Well Location and I.D. No.
  - SP4 Piezometer Location and I.D. No.
  - SB1 Soil Boring Location and I.D. No.
  - Former Building Foundation
  - Suspected Former Tank Location
  - 6,000 Gallon Gasoline USTs
  - Property Line
  - Approximate Limit of Excavation
  - Edge of Asphalt
  - Edge of Concrete Pavement
  - Building Face
  - Hydrant
  - Water Valve
  - Gas Valve
  - Gas Line
  - Watermain
  - Telephone Cable
  - Telephone Booth
  - Light Post
  - Sanitary Line with Manhole
  - Electrical Line
  - Reference Point
  - Grid Line (30' interval)
