SITE NAME:	Speedy Lube			FID #	
BRRTS #:	03-68-003611			(if appropriate):	
COMMERCE # <small>(if appropriate):</small>	53188-3604-18				
CLOSURE DATE:	July 9, 2004				
STREET ADDRESS:	518 Delafield St				
CITY:	Waukesha				
SOURCE PROPERTY GPS COORDINATES <small>(meters in WTM91 projection):</small>	X =	663519	Y =	284309	
CONTAMINATED MEDIA:	Groundwater	<input type="checkbox"/>	Soil	<input type="checkbox"/>	Both <input checked="" type="checkbox"/>
OFF-SOURCE GW CONTAMINATION >ES:	Yes	<input type="checkbox"/>	No	<input checked="" type="checkbox"/>

Commerce # 53188-3604-18 WDNR BRRTS # 03-68-003611
Speedy Lube, 518 Delafield Street, Waukesha

One 3,000-gallon premium unleaded gasoline underground storage tank (UST) abandoned in place in 1996 and one 550-gallon waste oil UST removed in 1998

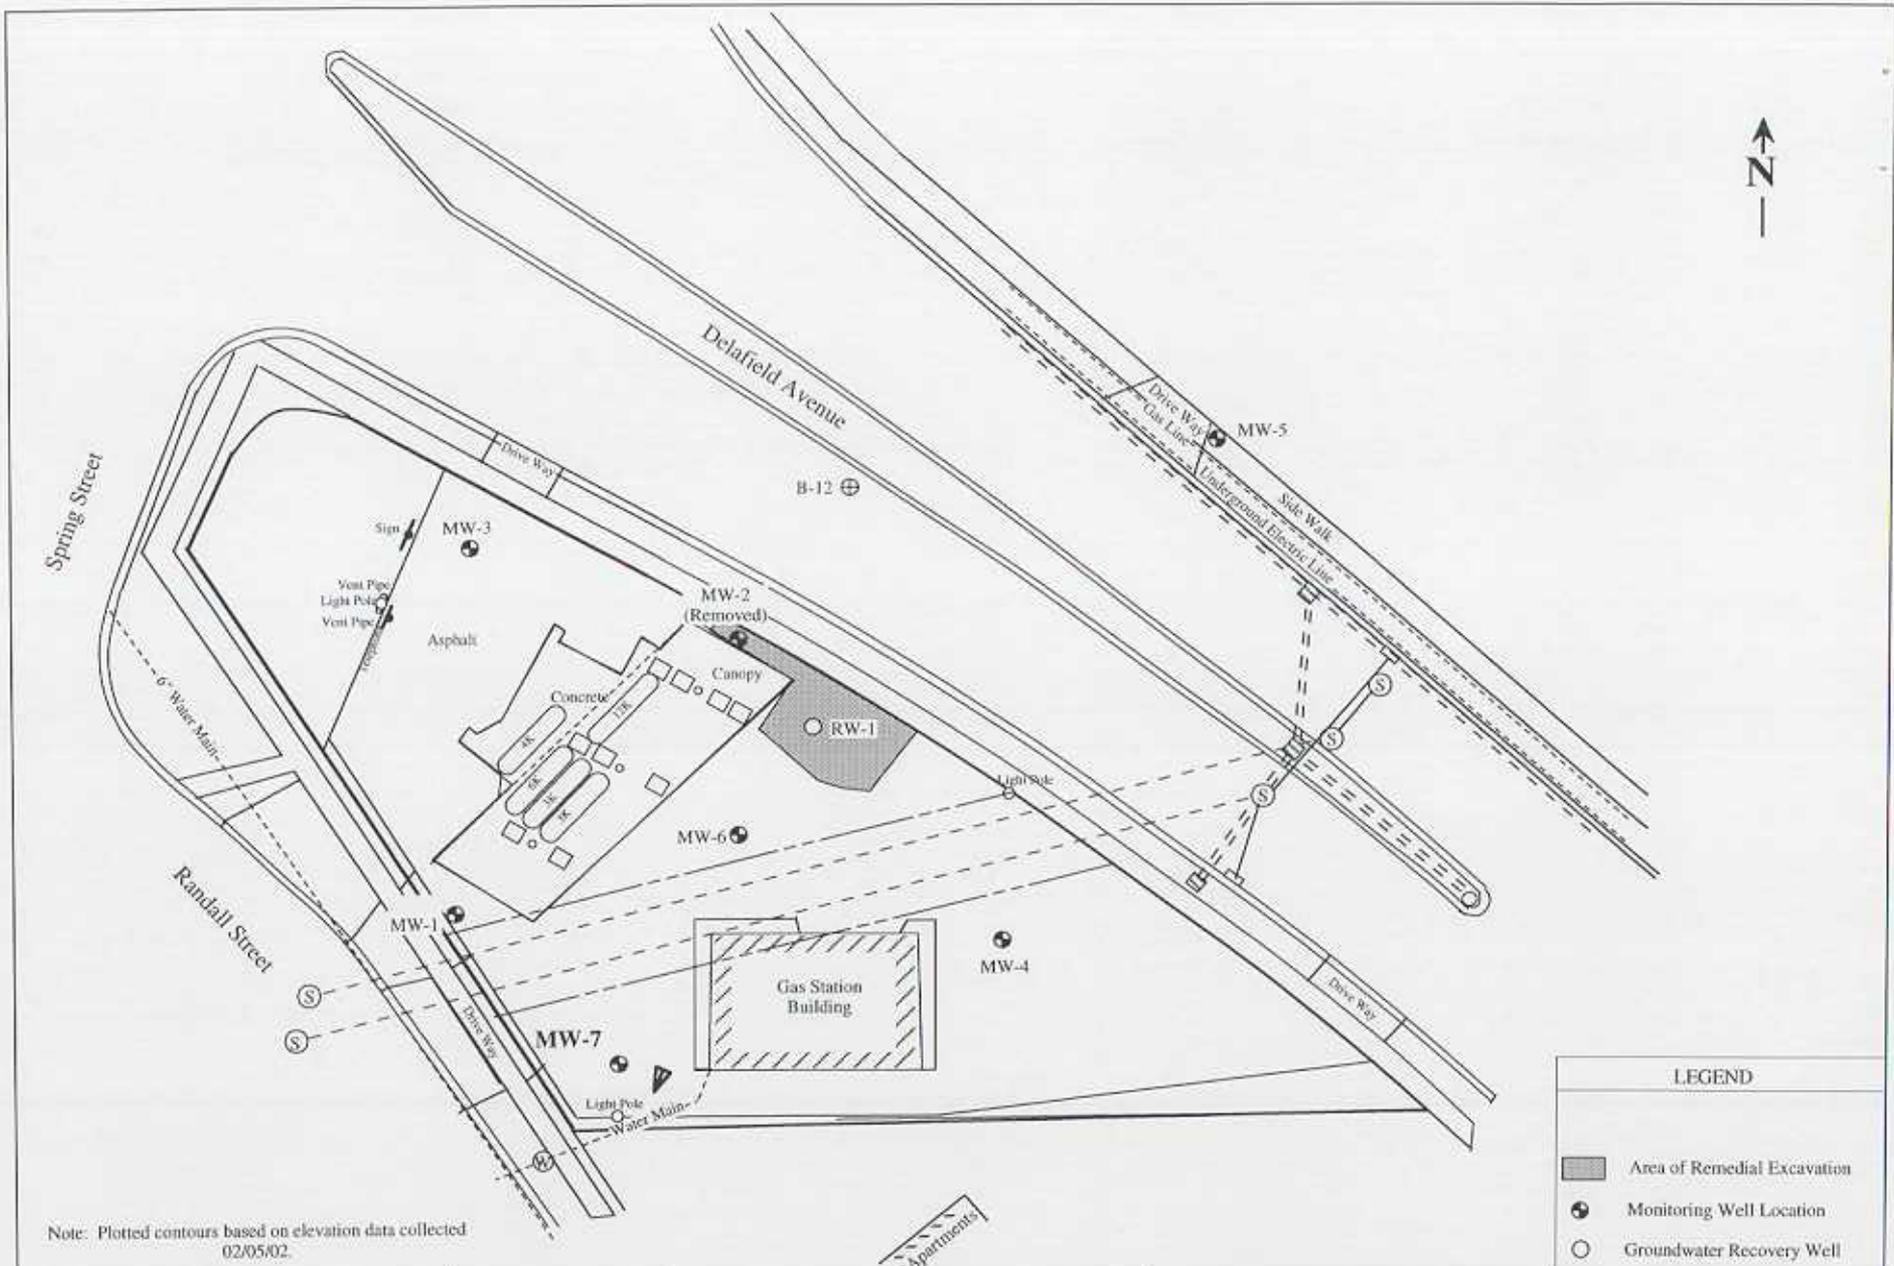
Figure 1: Monitoring Well Location Map				
Date	Drawn by	Revised by	Date	Project No.
April 1, 1998	M.K.J.			4003
	Checked by	M.K.J.	September 18, 1998	Sheet No.
	P.N.S.			One

Note: Plotted contours based on elevation data collected 02/05/02.

LEGEND				
	Area of Remedial Excavation			
	Monitoring Well Location			
	Groundwater Recovery Well

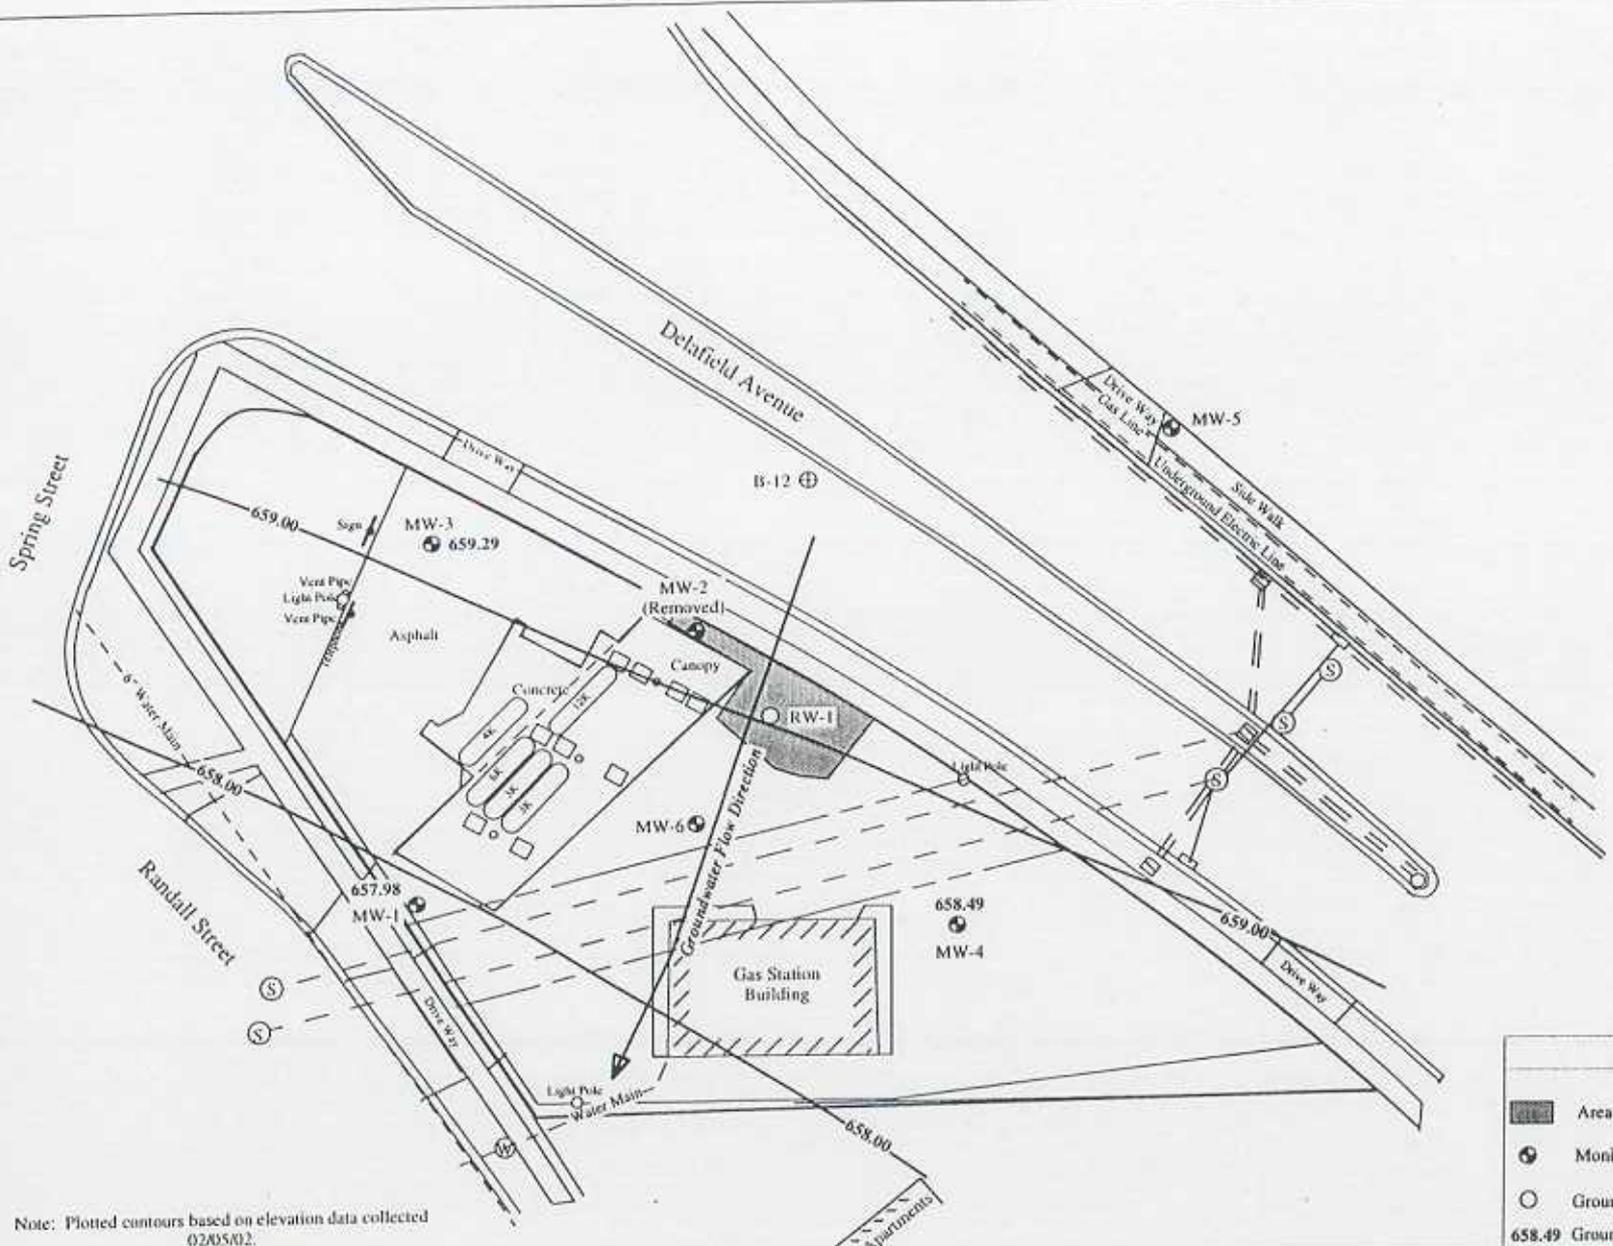
Figure . Groundwater Elevation Contour Map - 02/05/02 (Post-Excavation)

Note: Plotted contours based on elevation data collected 02/05/02.

- Area of Remedial Excavation
- Monitoring Well Location
- Groundwater Recovery Well
- 658.49 Groundwater Elevation (ft. MSL)

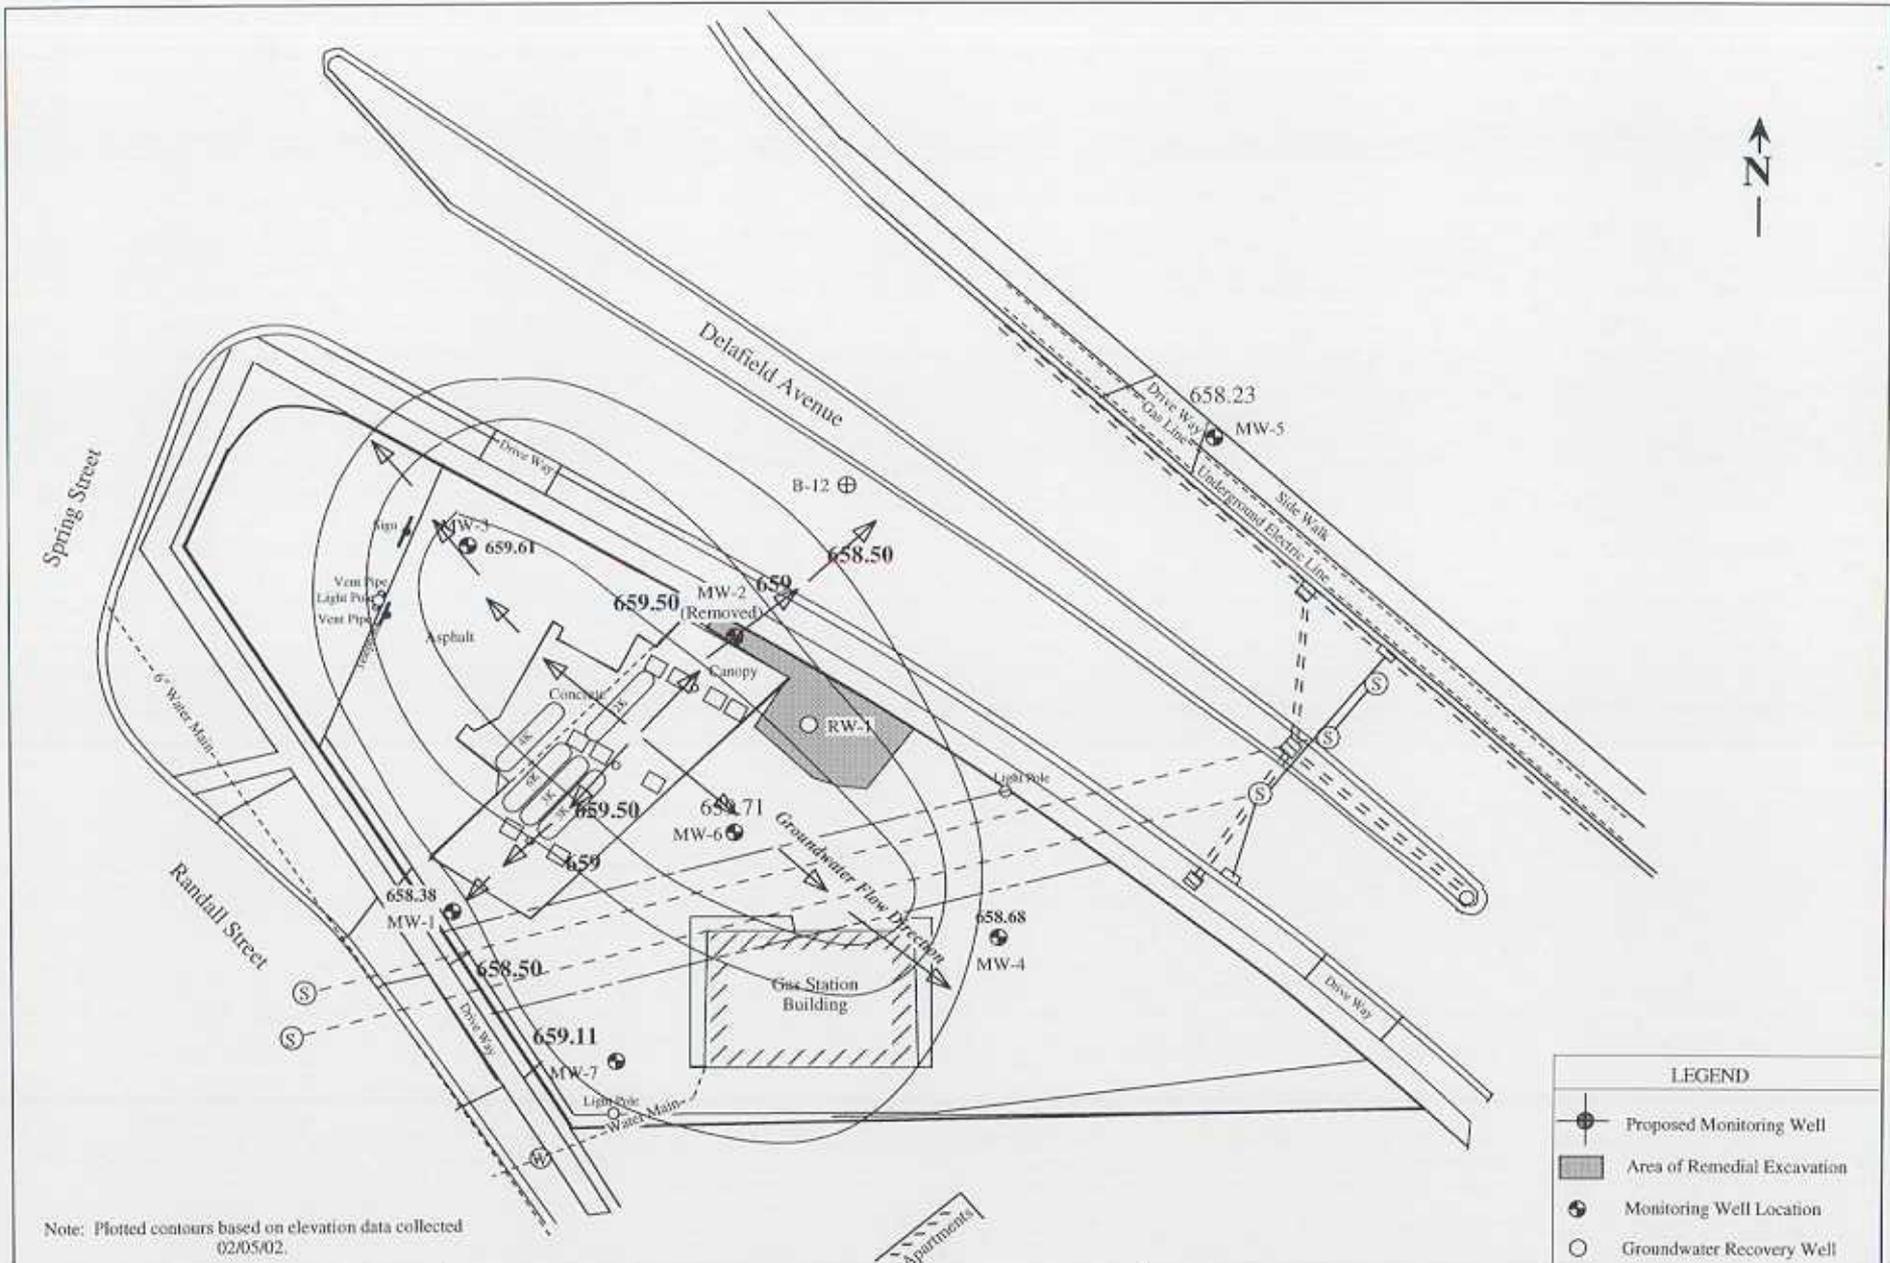
Figure 2. Groundwater Contours on December 18, 2002				
Date	Drawn by	Revised by	Date	Project No.
April 1, 1998	M.K.J			4003
	Checked by	M.K.J	September 18, 1998	Sheet No.
	P.N.S			One

Note: Plotted contours based on elevation data collected 02/05/02.

LEGEND					
	Proposed Monitoring Well		Area of Remedial Excavation		Monitoring Well Location
	Groundwater Recovery Well

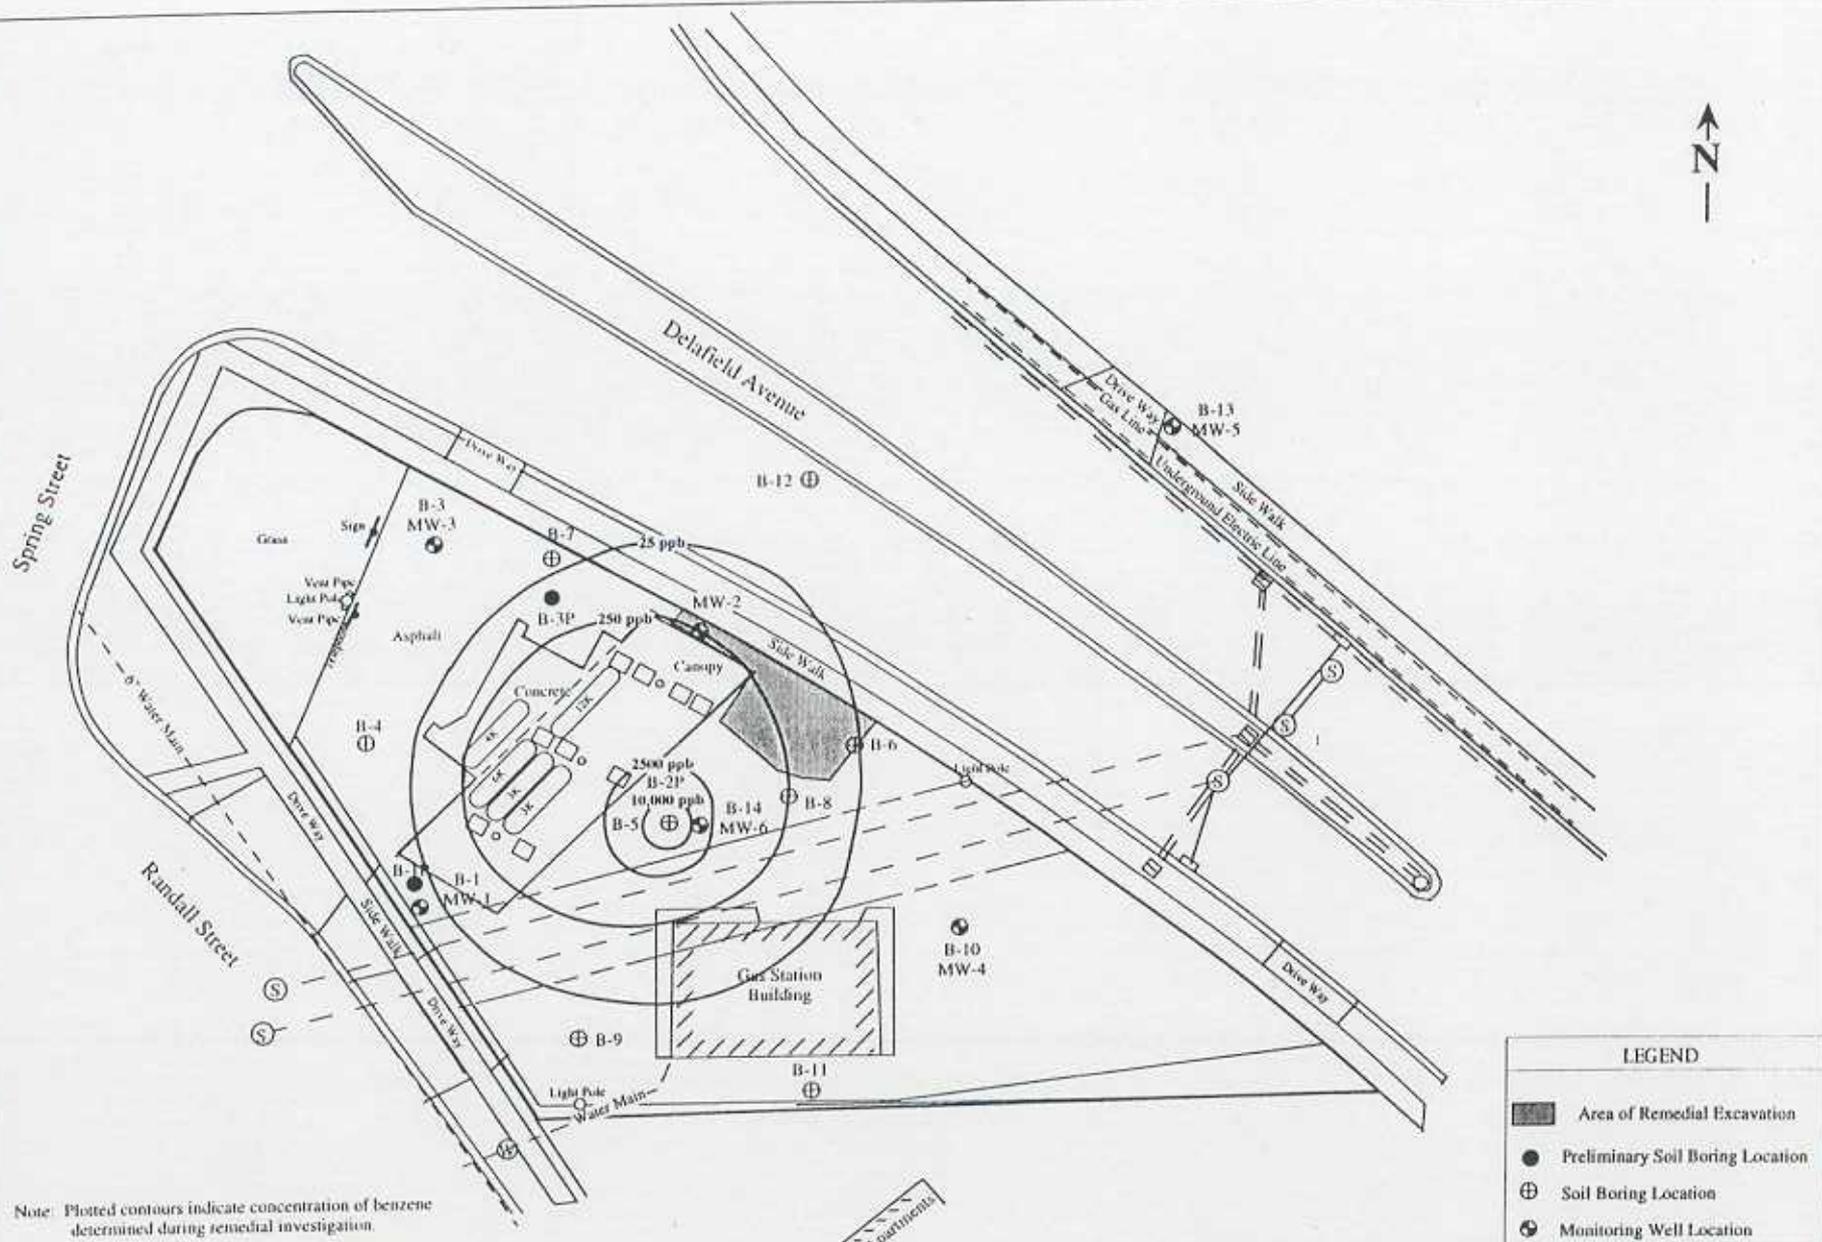
Figure 10 Estimated Extent of Residual Soil Contamination				
Date	Drawn by	Revised by	Date	Project No.
April 1, 1998	M.K.J.	M.K.J.	September 18, 1998	4003
	Checked by			Sheet No.
	P.N.S.			One

Note: Plotted contours indicate concentration of benzene determined during remedial investigation.

LEGEND	
	Area of Remedial Excavation
	Preliminary Soil Boring Location
	Soil Boring Location
	Monitoring Well Location

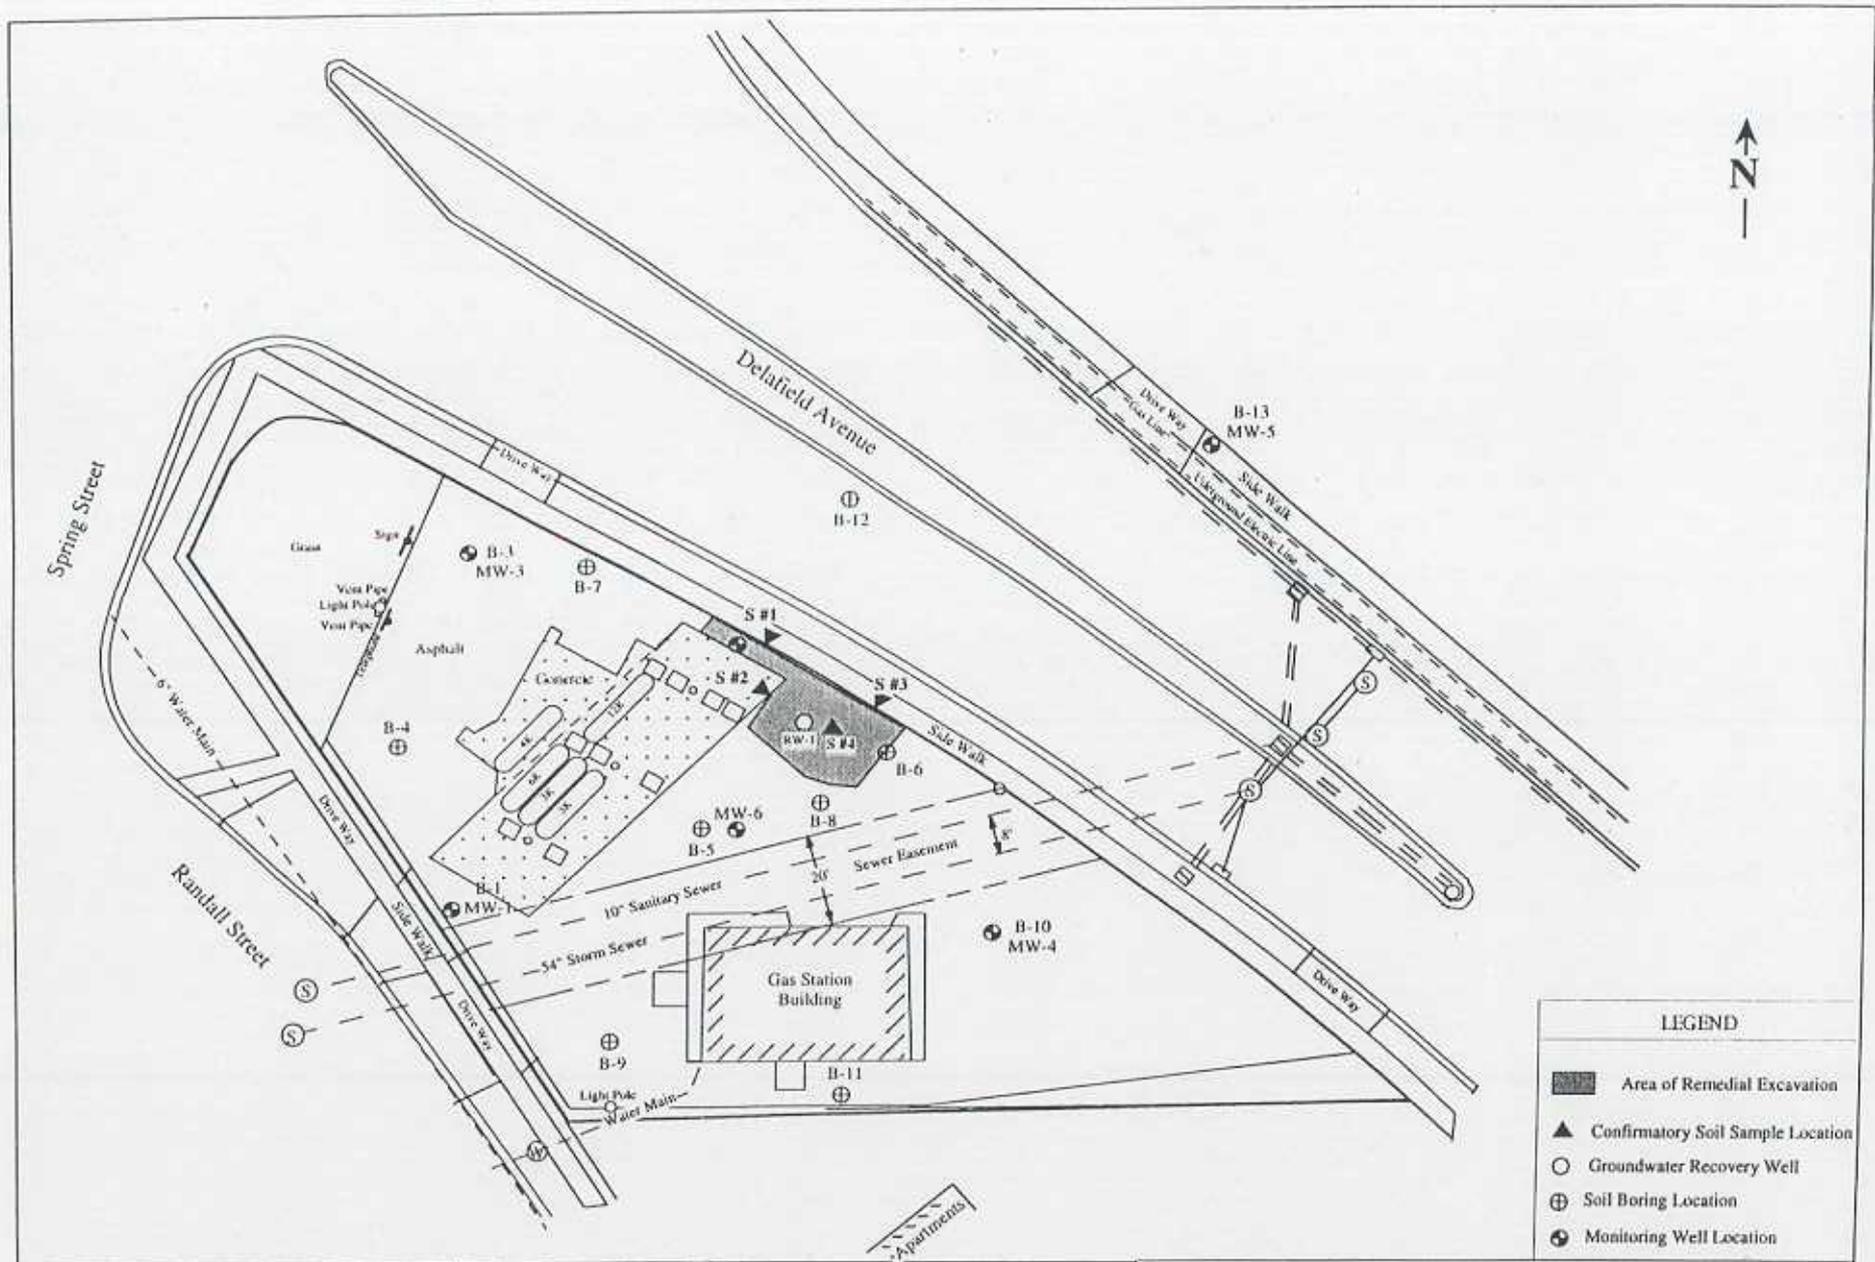
Figure 11 Area of Soil Excavation & Confirmatory Sample Location				
Date	Drawn by	Revised by	Date	Project No.
April 1, 1998	M.K.J			400
	Checked by			Sheet No.
	P.N.S			One

LEGEND	
	Area of Remedial Excavation
	Confirmatory Soil Sample Location
	Groundwater Recovery Well
	Soil Boring Location
	Monitoring Well Location

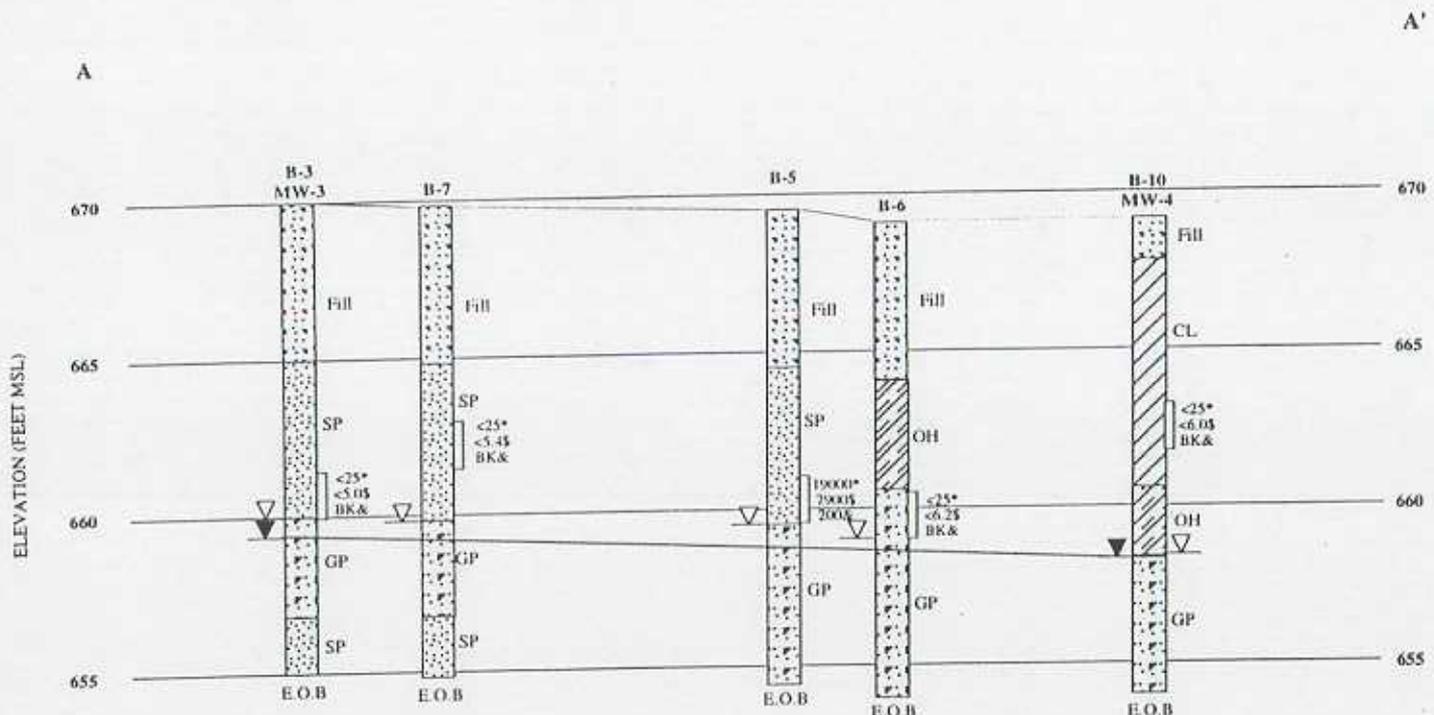
Figure 5 - Geologic Section "A-A"

Legend			
	CL Silty/Sandy Clay		
	SM Silty Sand		
	SP Sand		
	GP Sandy Gravel		
	OH Organic Clay		
	Fill		
	Depth to Water in Soil Boring		
	Depth to Water in Monitoring Well		
*	Benzene Concentrations (ppb)		
\$	GRO Concentrations (ppm)		
&	PID Meter Reading

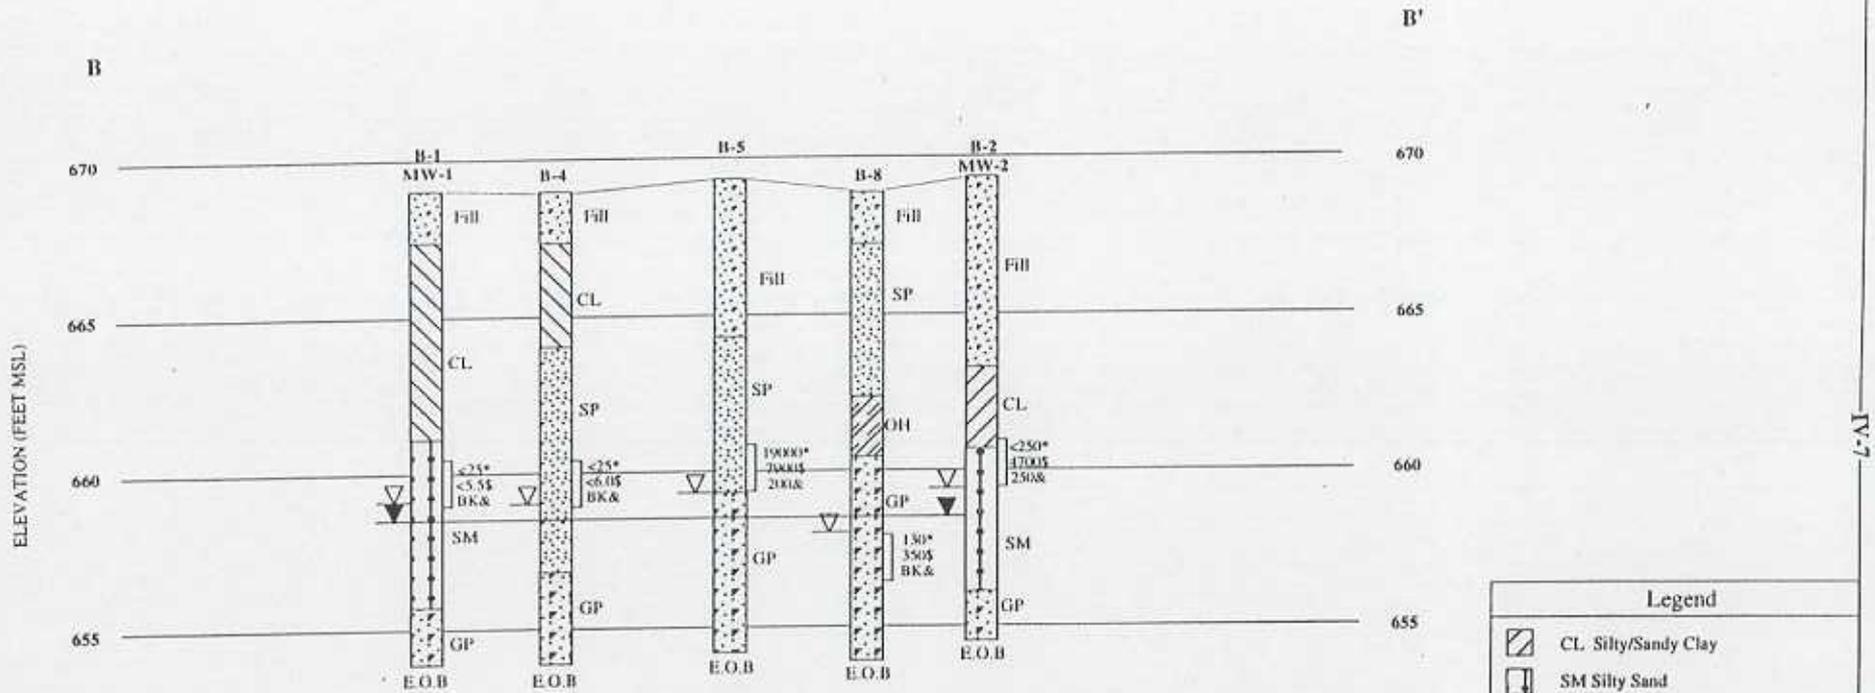
Figure 6 - Geologic Section "B-B"			
Date	Drawn by	Project no.	4001
February 19, 1998	M.K.J.	Revised by	Date
Scale	Checked by		
	P.N.S.

Legend	
	CL Silty/Sandy Clay
	SM Silty Sand
	SP Sand
	GP Sandy Gravel
	OH Organic Clay
	Fill
	Depth to Water in Soil Boring
	Depth to Water in Monitoring Well
*	Benzene Concentrations (ppb)
\$	GRO Concentrations (ppm)
&	PID Meter Reading
