GIS REGISTRY

BRRTS #: 02-09-000365

ACTIVITY NAME: River Country Coop

Re: Final Case Closure with Land Use Limitations or Conditions
River Country Co-op, 1080 West River Street, Chippewa Falls, Wisconsin
DATCP Case #91409052901; WDNR BRRTS No. 02-09-000365

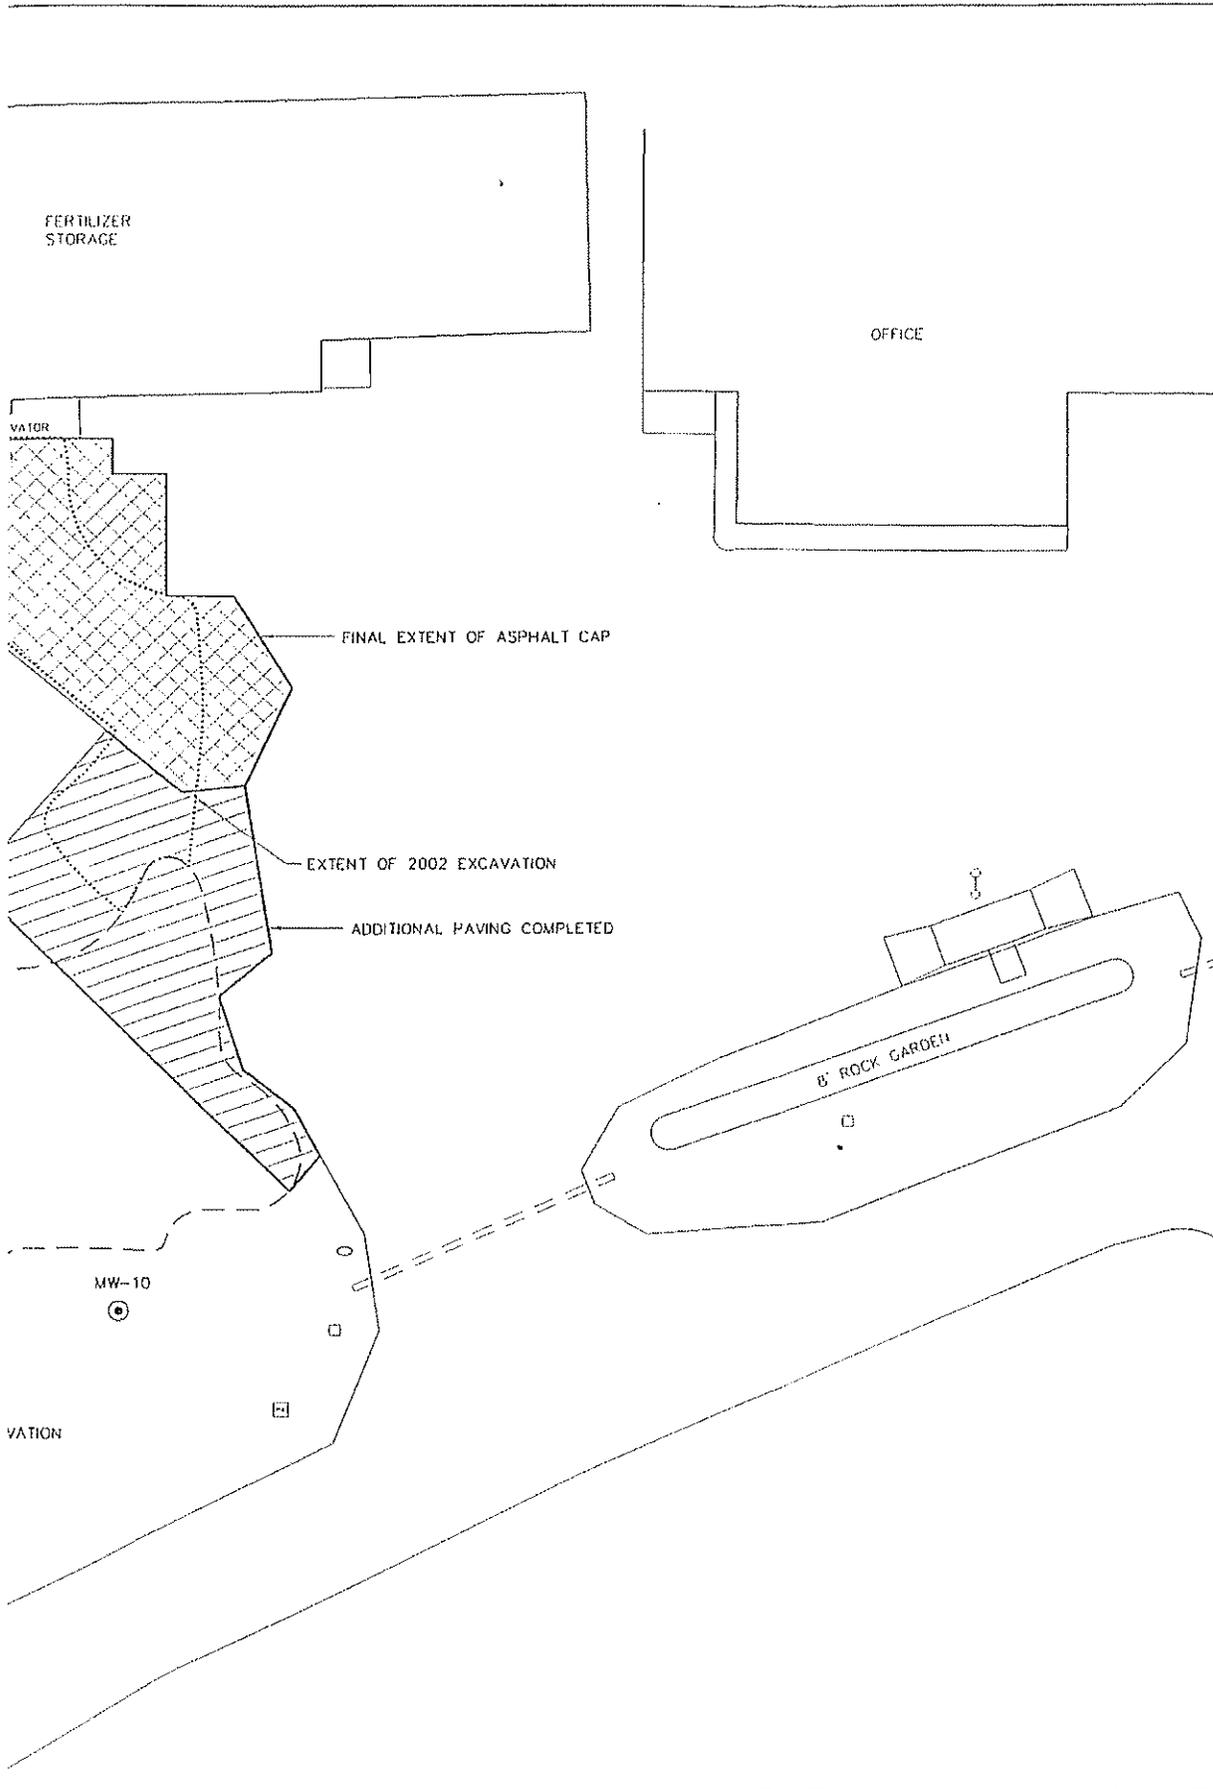
SHEET NO.
1

The paving was completed by Senn Blacktop, Chippewa Falls, WI. On May 8, 2003 Cedar Corporation personnel met on site with personnel from Senn Blacktop to delineate the extent of the proposed asphalt cap. The photos included in Attachment A show the site following the delineation of the proposed extent of the asphalt cap. The location of the cap was subsequently graded by Senn Blacktop. Soil and gravel was removed from the paving area to allow for the placement of 4 inches of asphalt. Approximately 6 inches of gravel was left in place below the asphalt to allow for a suitable base. The paving was completed on May 23, 2003. Two two-inch lifts were placed over the selected area. The photos included in Attachment A show the site following paving. A site map showing the final extent of the asphalt cap is included as Figure 1.

RIVER COUNTRY CO-OP
PROPOSED EXTENT OF ASPHALT CAP
CHIPPEWA FALLS, WI

Pursuant to s. 292.12(2)(a), Wis. Stats., the installed asphalt paving surface that currently exists in the location shown on Sheet No. 1 of the attached maintenance plan shall be maintained in compliance with the maintenance plan in order to minimize the infiltration of water and prevent additional groundwater contamination that would violate the groundwater quality standards in ch. NR 140, Wis. Adm. Code, and to prevent direct contact with residual soil contamination that might otherwise pose a threat to human

Additional paving was completed at the Chippewa Agricultural Facility at the request of River Country Cooperative. The extent of the additional paving is shown on figure 1.

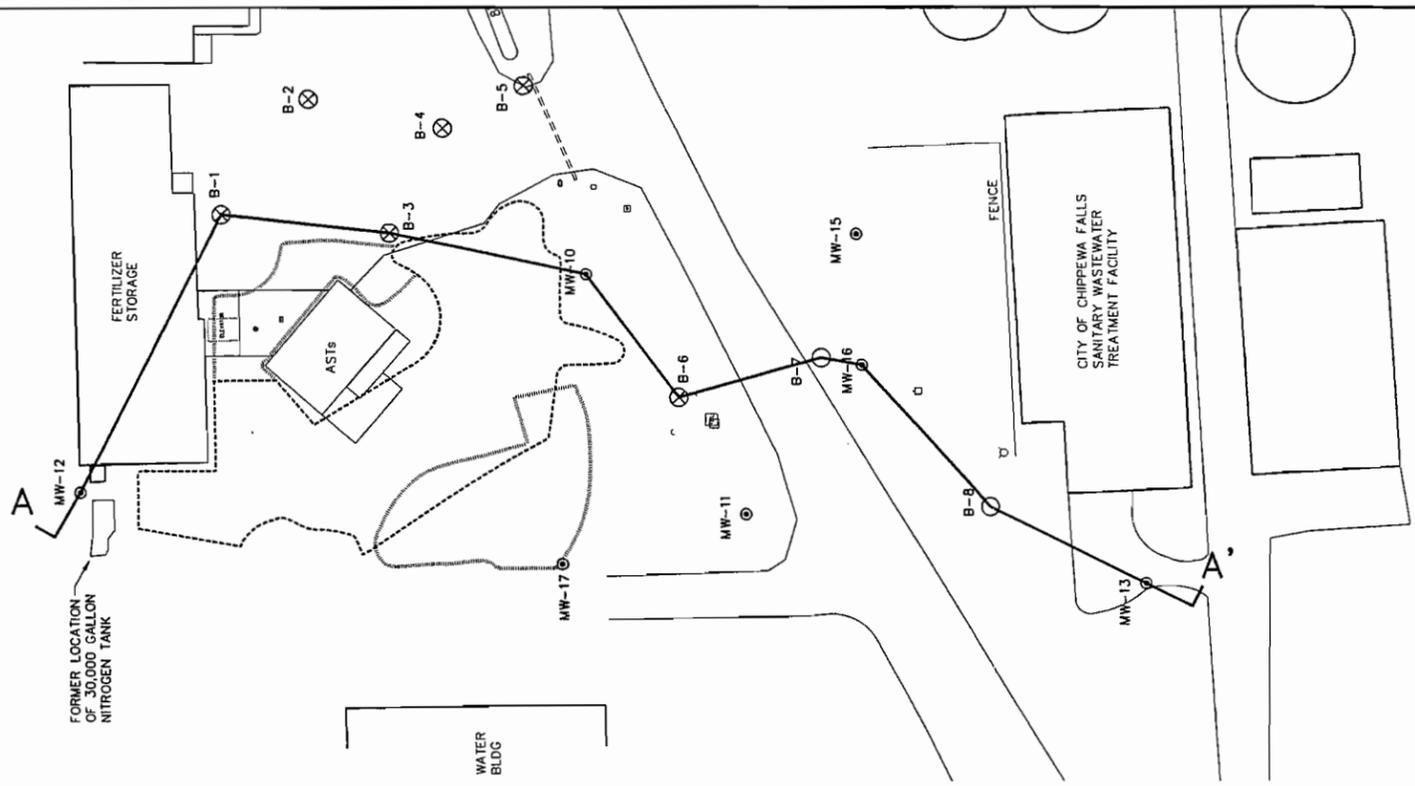
CROSS SECTION A-A'

Ground Water Elevation
 No Ground Water Observed Above This Elevation

NA = Not Analyzed
 * GRO And DRO Laboratory Results Reported in PPM
 All Other Laboratory Results Reported in PPB

Figure #: 5 **Title: Cross Section A-A' by Cedar Corporation**

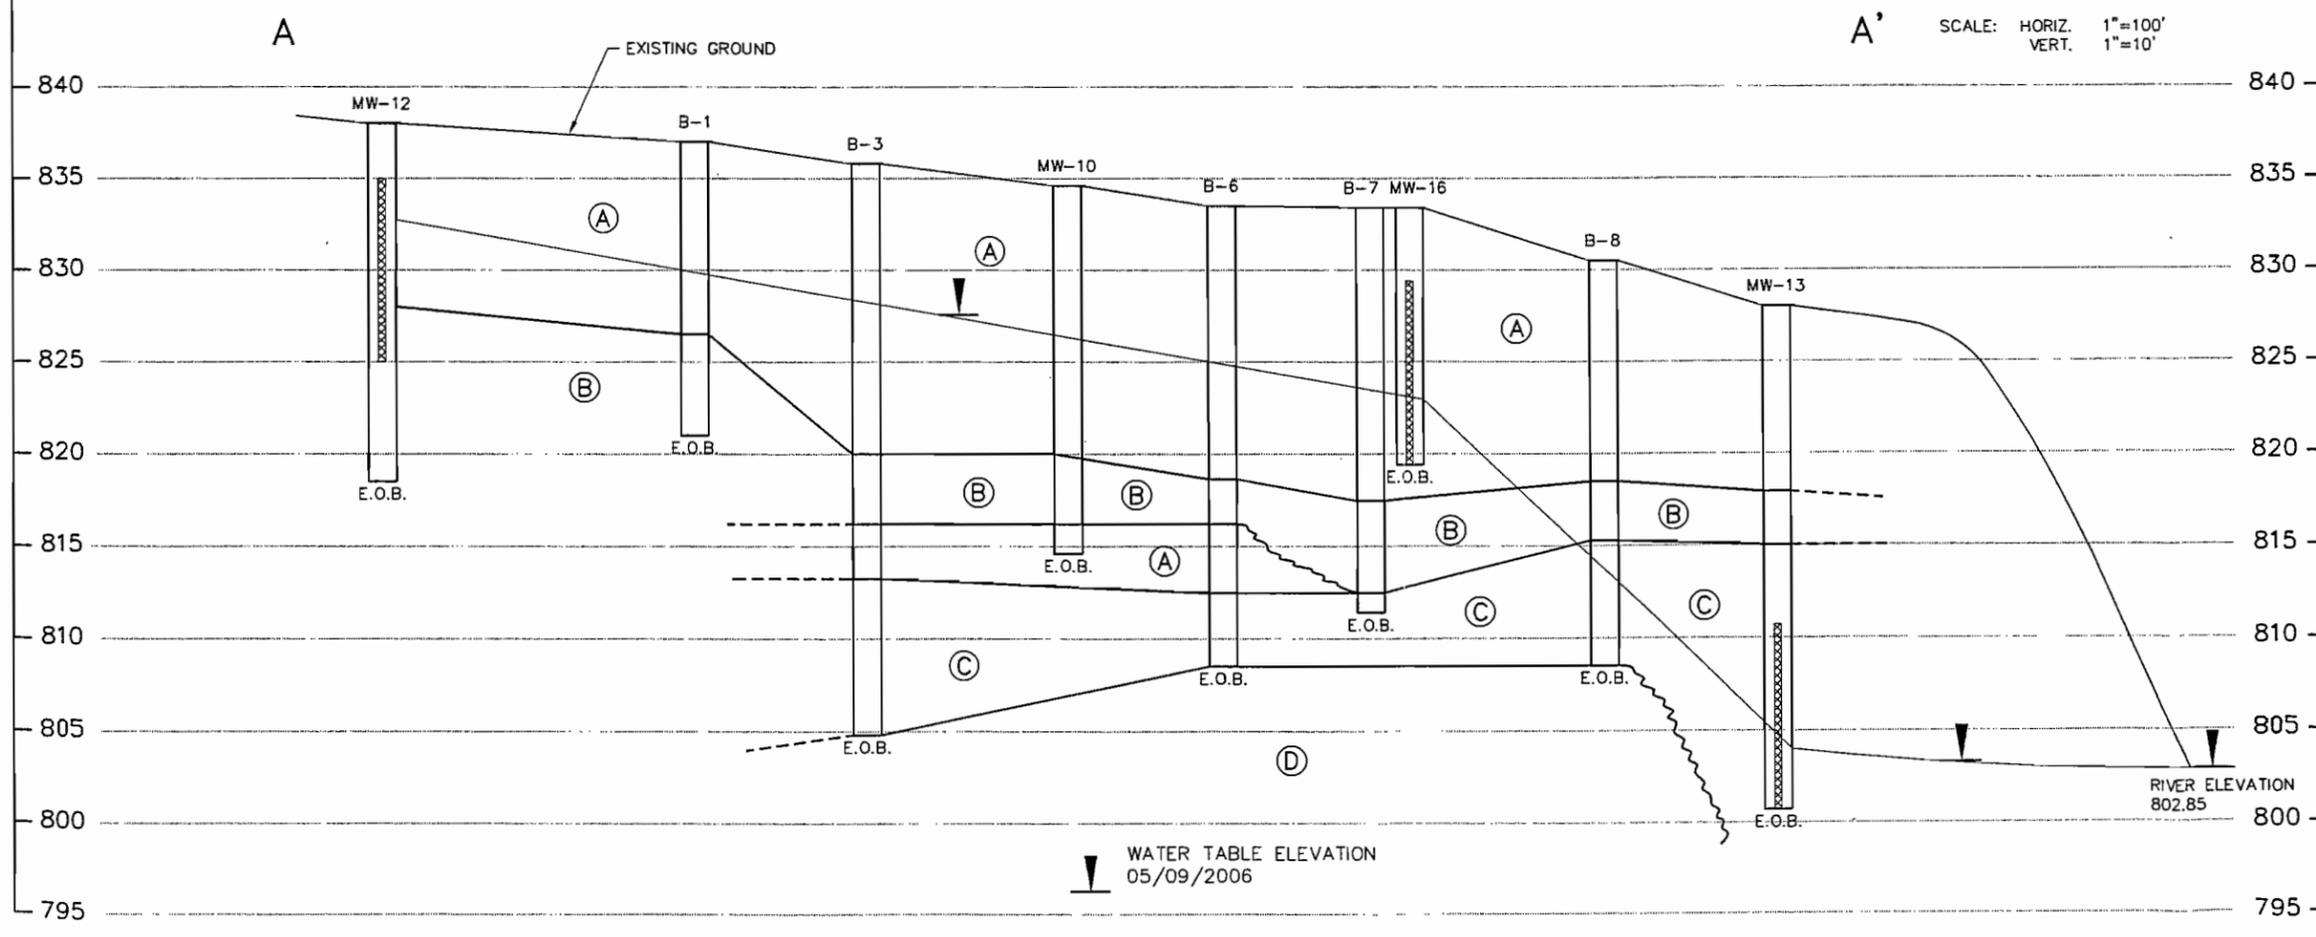
CROSS SECTION A - A'

- (A) - FINE-MEDIUM BROWN, WELL GRADED GRAVELLY SAND (USCS-SW)
- (B) - FINE, BROWN, SILTY-SAND (USCS-SM)
- (C) - MEDIUM, BROWN, POORLY-GRADED SAND (USCS-SP)
- (D) - BEDROCK (AUGER REFUSAL)

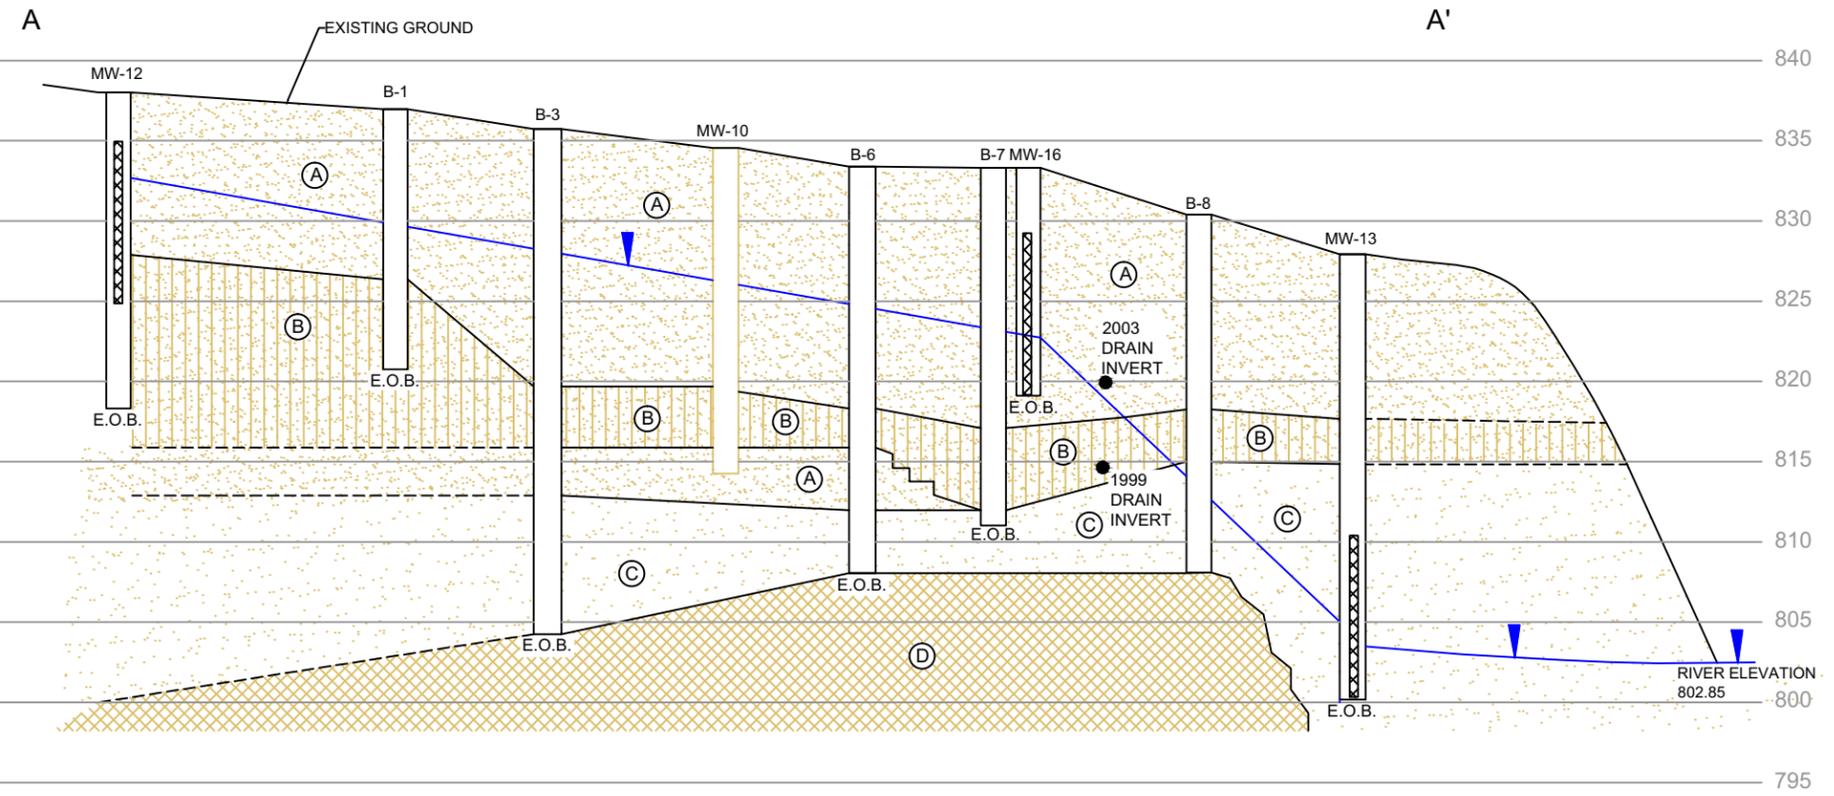
FIGURE 6
 24-SEPT-2010

- (A) FINE - MEDIUM BROWN, WELL GRADED GRAVELLY SAND (USCS-SW)
- (B) FINE, BROWN, SILTY-SAND (USCS-SM)
- (C) MEDIUM, BROWN, POORLY-GRADED SAND (USCS-SP)
- (D) BEDROCK (AUGER REFUSAL)
- ▼ WATER TABLE ELEVATION 05 / 09 / 2006

Figure #: 6 **Title: Cross Section A-A' by Sand Creek Consultants**
