SITE NAME: Tomah Coop Services Inc. Veldeys
BRRTS #: 03-42-000125 **FID #:** 642050420
COMMERCE #: 54660264717
CLOSURE DATE: 04/27/2008
STREET ADDRESS: 1517 Superior Avenue
CITY: Tomah

SUBJECT: Final Case Closure
Tomah Cooperative Services, Former Veldy's Mobil Site, Tomah WI
WDNR BRRTS Activity #: 03-42-000125

Subject: Conditional Closure Decision,
With Requirements to Achieve Final Closure
Tomah Coop Services Veldey's Site, 1517 Superior Ave, Tomah, Wisconsin
WDNR BRRTS Activity # 03-42-000125

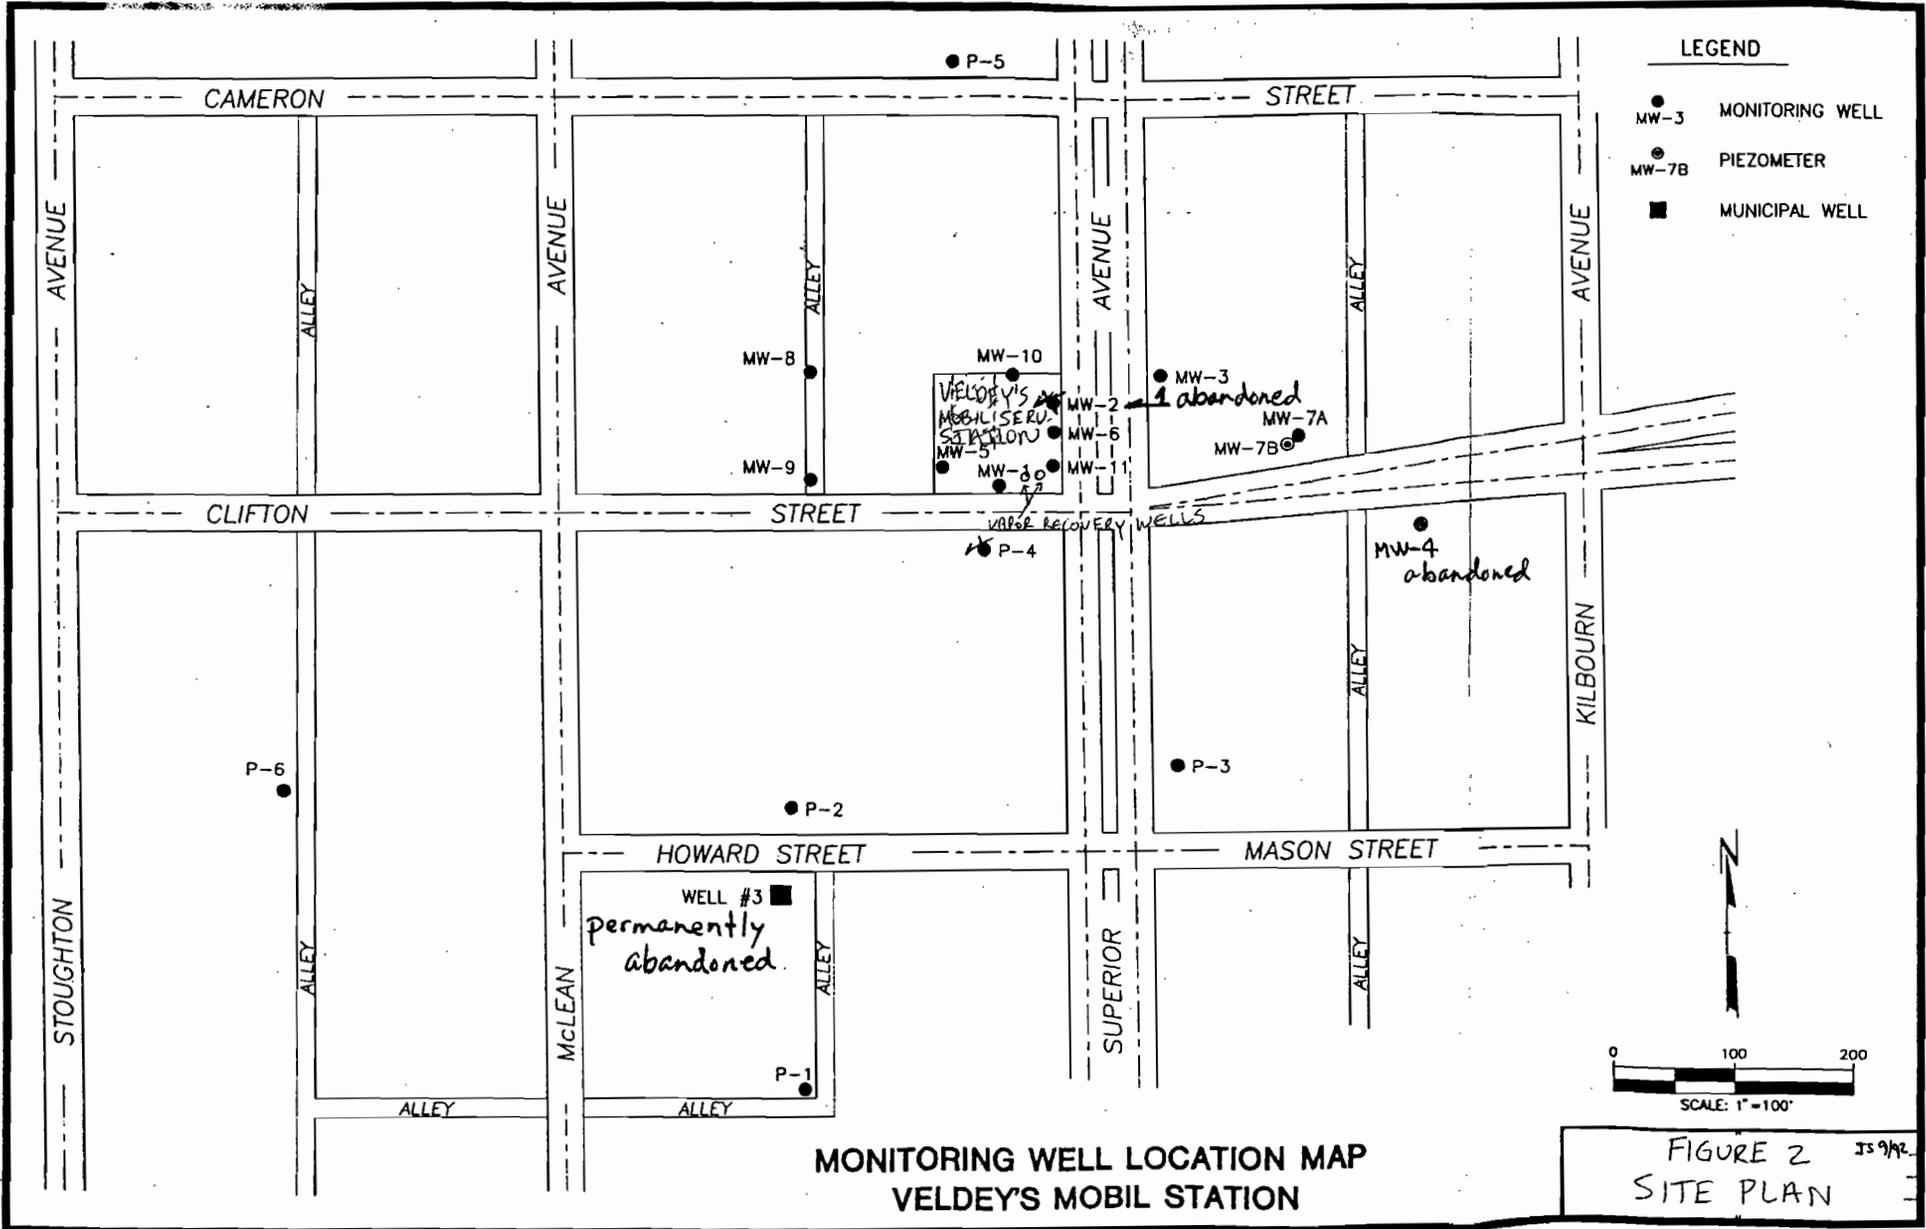
FIGURE 2 JS 9/92
SITE PLAN

- MW-3 MONITORING WELL
- MW-7B PIEZOMETER
- MUNICIPAL WELL

**MONITORING WELL LOCATION MAP
VELDEY'S MOBIL STATION**

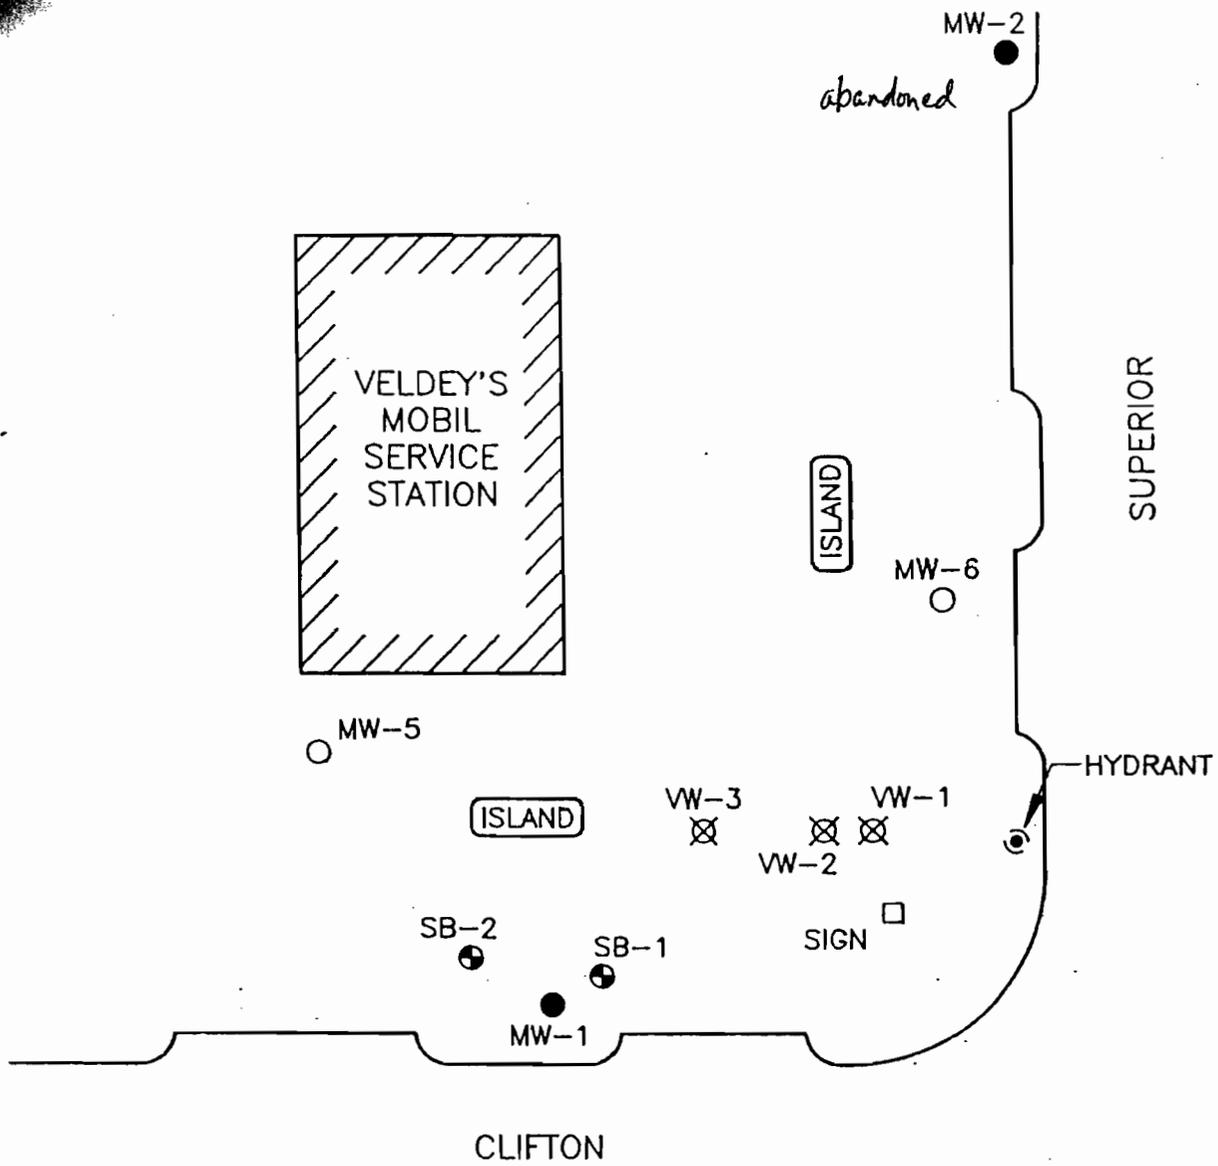
- EXISTING 2" MONITORING WELL
- EXISTING 4" MONITORING WELL
- ⊗ EXISTING 4" VAPOR WELLS
FLUSH MOUNTED
- ⊕ EXISTING SOIL BORING (8/18/89)

**MONITORING WELL AND
SOIL BORING LOCATIONS**

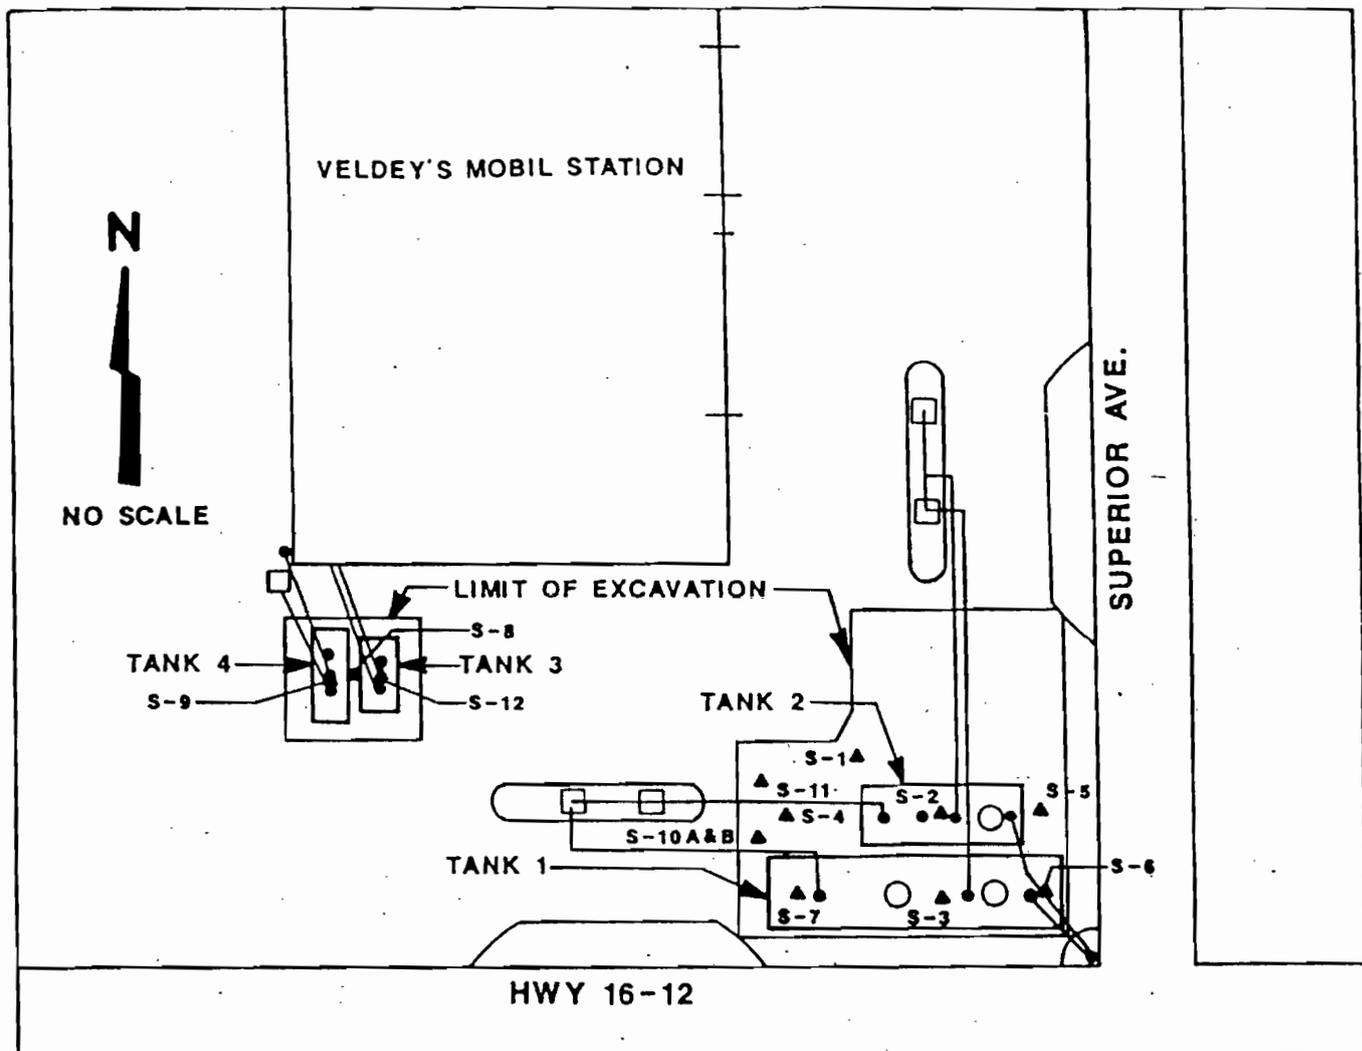
FIGURE 2
SOIL SAMPLING LOCATIONS WITHIN EXCAVATIONS

ON-SITE VOLATILE ORGANIC COMPOUND SOIL SCREENING

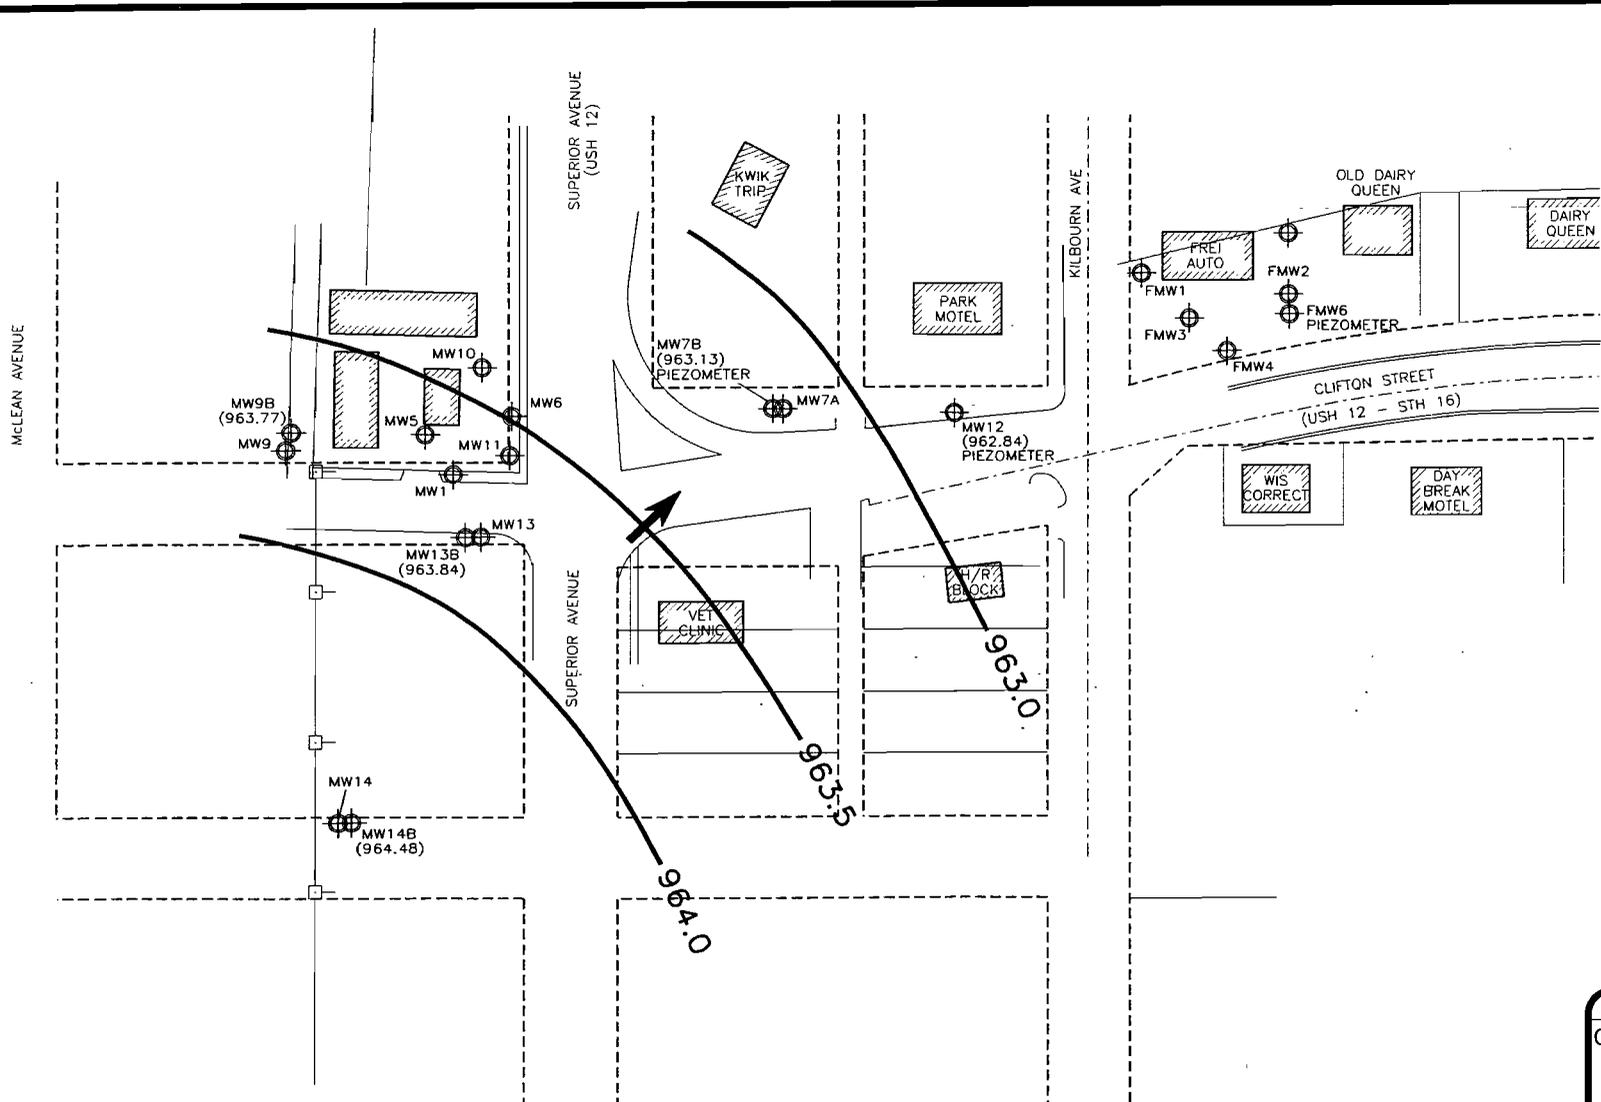
- FMW1 MONITORING WELL (FREI AUTO)
- MW9B (963.84) MONITORING WELL (TOMAH COOP) WITH GROUNDWATER ELEVATION
- 964.0 GROUNDWATER CONTOUR WITH ELEVATION
- APPROXIMATE GROUNDWATER FLOW DIRECTION

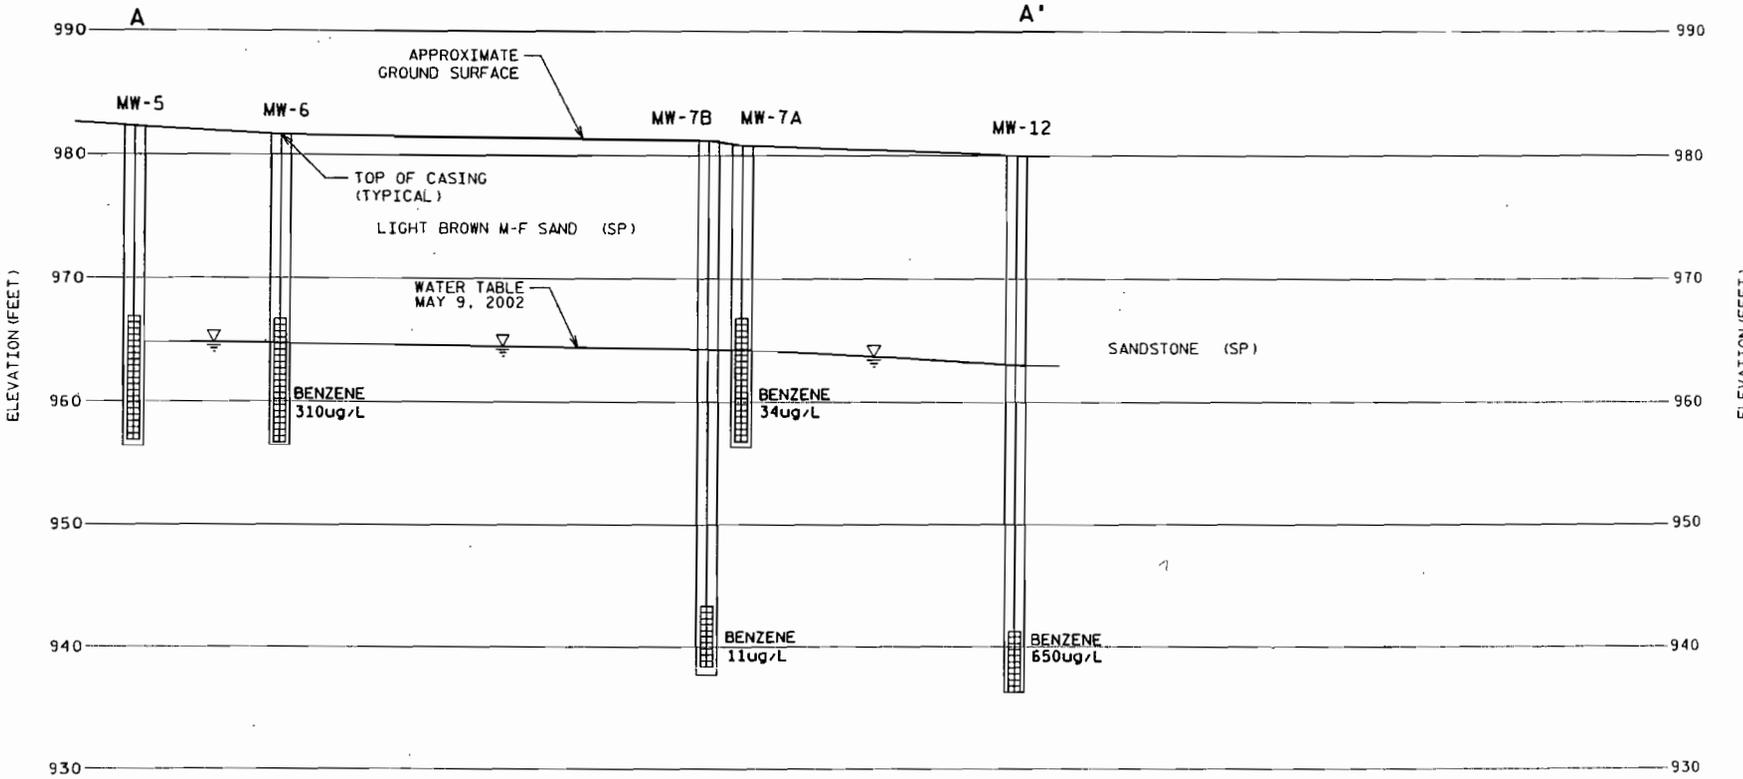
GROUND WATER ELEVATIONS
AND BENZENE CONCENTRATIONS
MAY 9, 2002

SCALE:
1"=60' HORIZ.
1"=10' VERT.

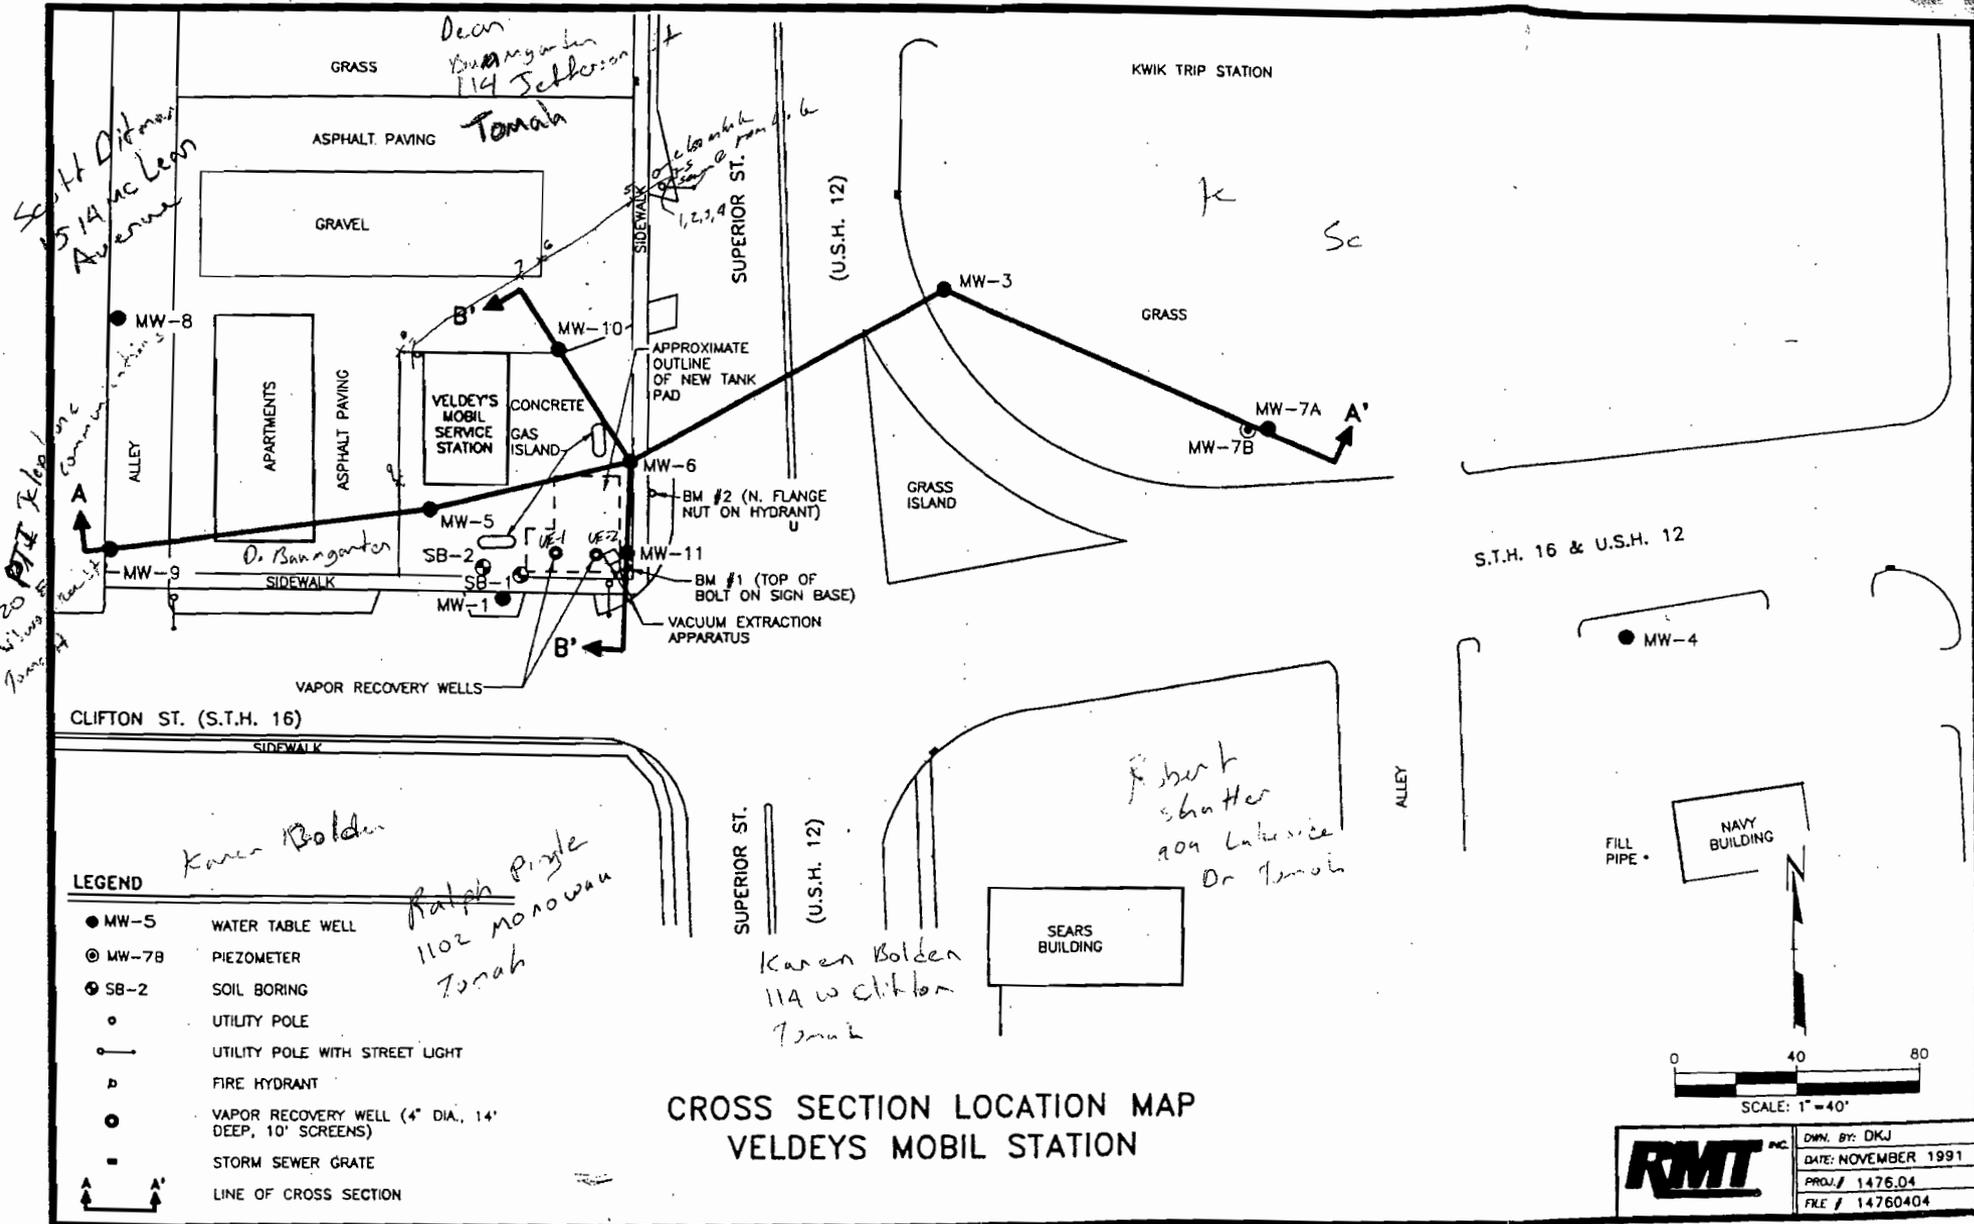
FIGURE
2

CROSS SECTION LOCATION MAP
VELDEYS MOBIL STATION

- LEGEND**
- MW-5 WATER TABLE WELL
 - ⊙ MW-7B PIEZOMETER
 - ⊙ SB-2 SOIL BORING
 - UTILITY POLE
 - UTILITY POLE WITH STREET LIGHT
 - ▢ FIRE HYDRANT
 - VAPOR RECOVERY WELL (4" DIA., 14' DEEP, 10' SCREENS)
 - STORM SEWER GRATE
 - LINE OF CROSS SECTION

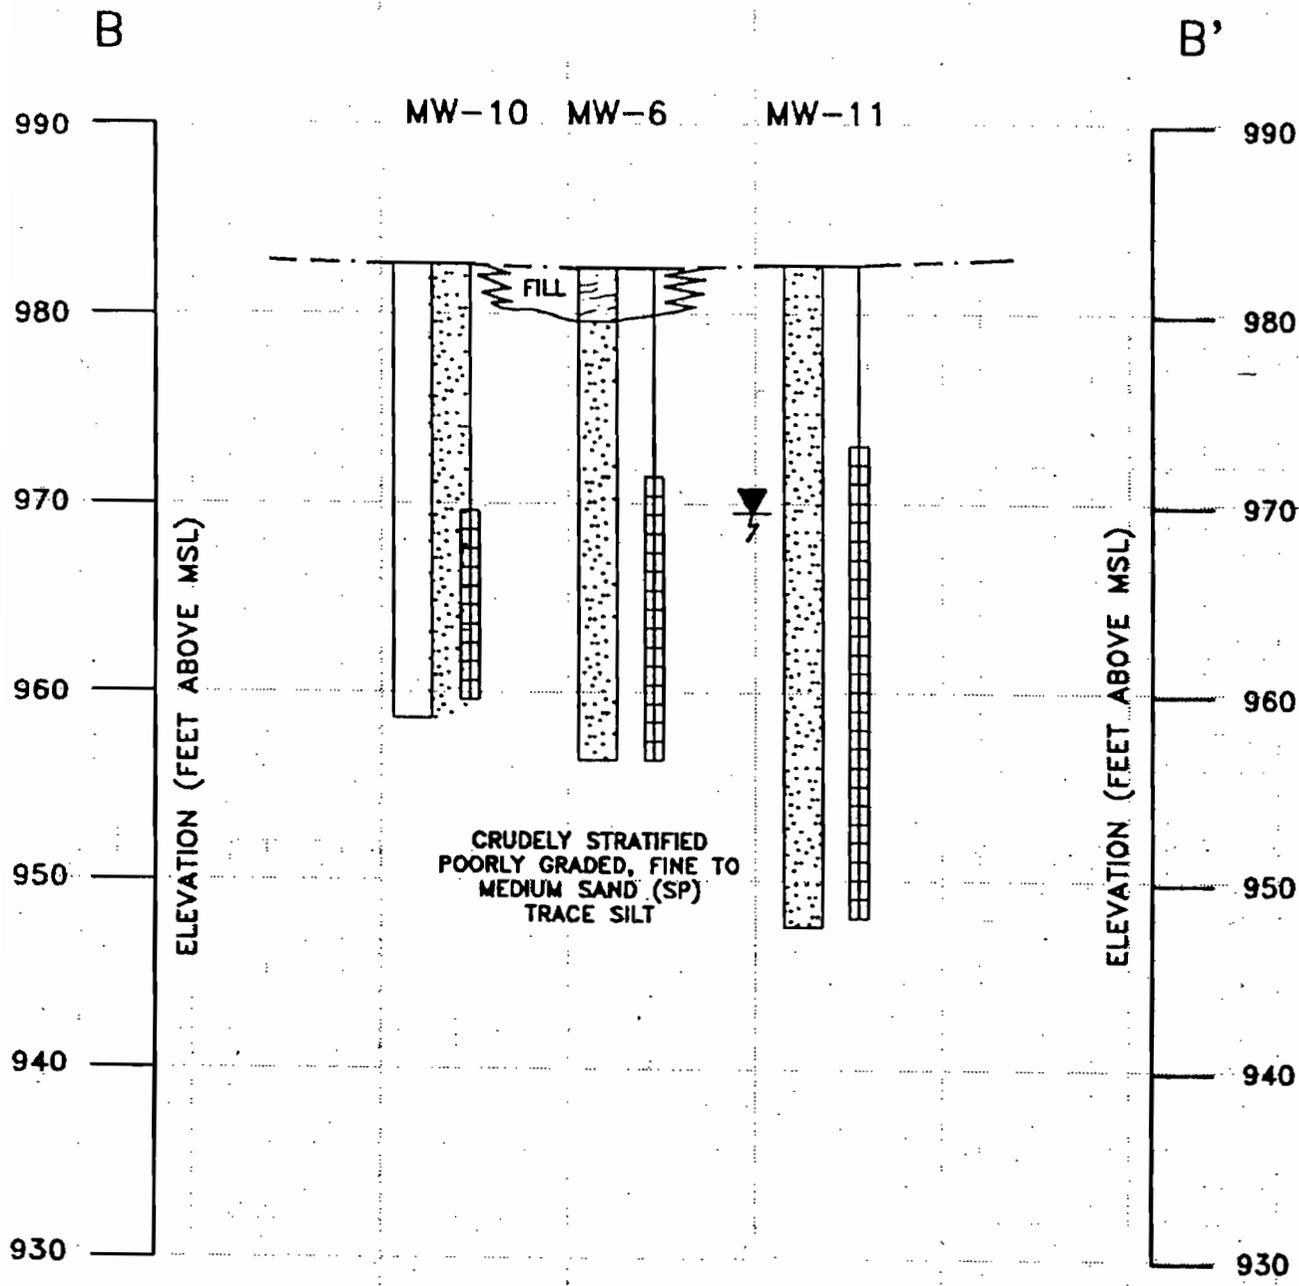
FIGURE 6

**CROSS SECTION B-B'
VELDEYS MOBIL STATION**
